**Flood Control Project Maintenance
Levee Inspections**

Fall 2008 Levee Maintenance Deficiency Summary Report

Reclamation District No. 0551

Waterway		Bank	Unit Miles
Unit No. 01 Sacramento River		Left	6.80

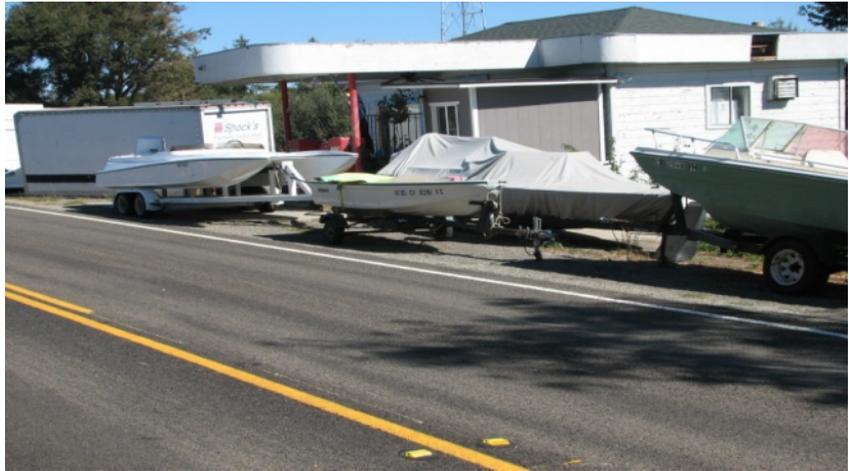
Levee Mile Report Line	5
Start Levee Mile	0.70
End Levee Mile	0.73
Location	
Category	Earthen Levee
Item	Encroachments
<p>This is a photo showing 4 of the boats with trailers parked on landward shoulder at old gas station which is not in operation.</p>

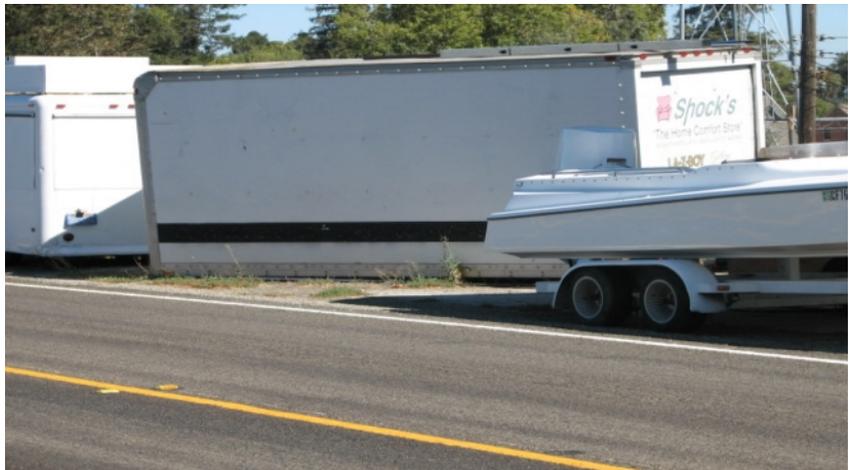
Levee Mile Report Line	5
Start Levee Mile	0.70
End Levee Mile	0.73
Location	
Category	Earthen Levee
Item	Encroachments
<p>This photo shows the box cars placed on same property, note that this unit has no wheels attached.</p>

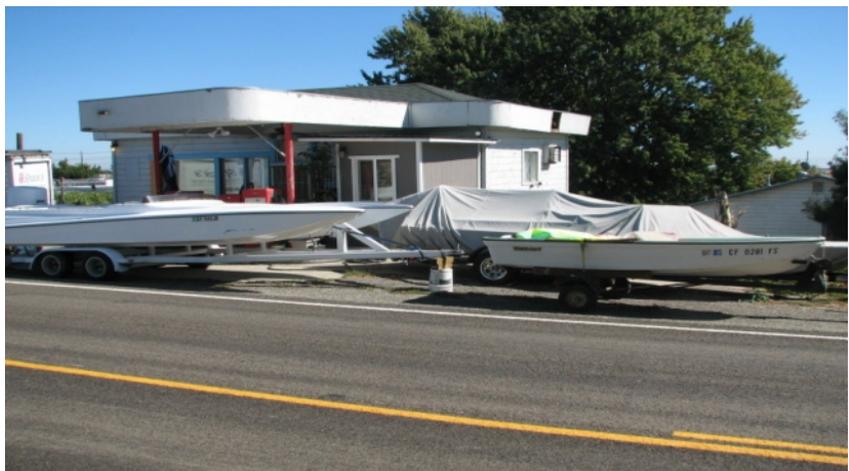
Levee Mile Report Line	5
Start Levee Mile	0.70
End Levee Mile	0.73
Location	
Category	Earthen Levee
Item	Encroachments
<p>More photos of the same, there are more objects behind the boats not visible from this angle of a hot tub and misc items all of which has no authorization to be placed on this flood control levee.</p>

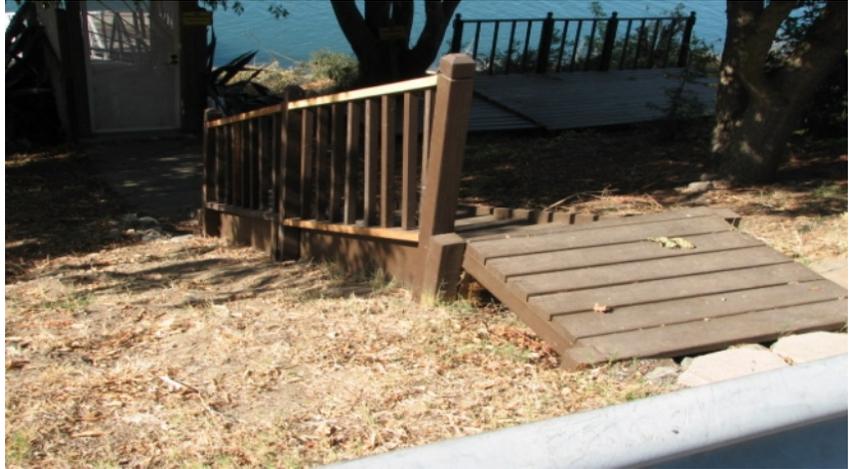
Levee Mile Report Line	7
Start Levee Mile	0.76
End Levee Mile	0.76
Location	
Category	Earthen Levee
Item	Encroachments
<p>This stairway was placed on the levee section without a Rec. Board permit. In the far background is a wooden deck on the levee slope.</p>
