**Flood Control Project Maintenance  
Levee Inspections**

**Fall 2009 Levee Maintenance Deficiency Summary Report**

**Levee Inspection Report By Mile - Fall 2009**

**Reclamation District No. 0551 Pierson**

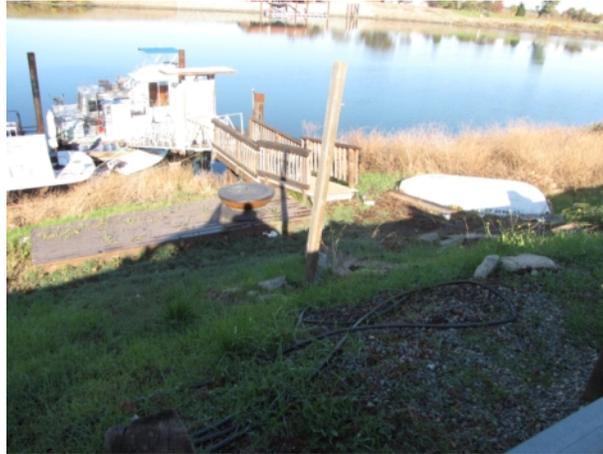
Levee Mile Report Line	1
Start Levee Mile	0.70
End Levee Mile	0.73
Location	Water Side
Category	Earthen Levee
Item	Encroachments
Gangway, wooden platform, boat on berm and dock.	
phillips_20091130_10.jpg

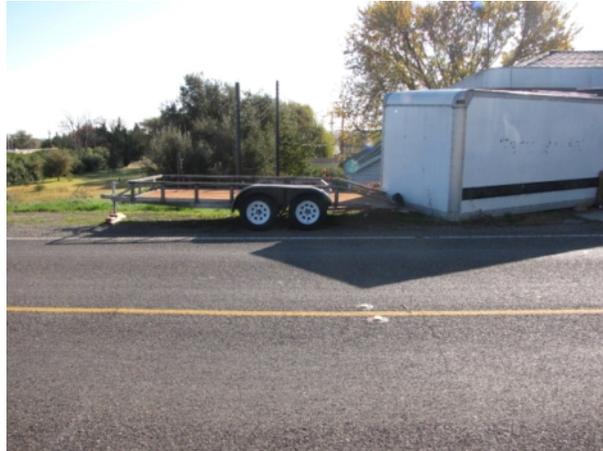
Levee Mile Report Line	1
Start Levee Mile	0.70
End Levee Mile	0.73
Location	Water Side
Category	Earthen Levee
Item	Encroachments
Boat trailer and box trailer on landward shoulder.	
phillips_20091130_11.jpg

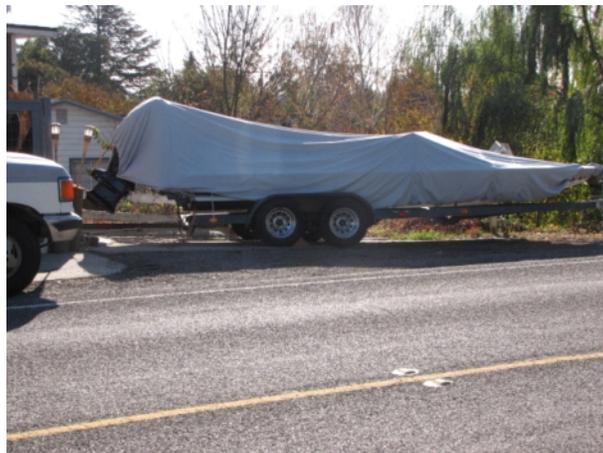
Levee Mile Report Line	1
Start Levee Mile	0.70
End Levee Mile	0.73
Location	Water Side
Category	Earthen Levee
Item	Encroachments
Boat and trailer on land side shoulder.	
phillips_20091130_12.jpg

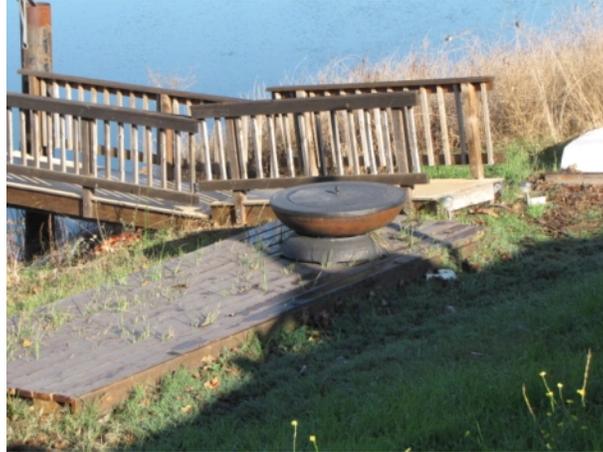
Levee Mile Report Line	1
Start Levee Mile	0.70
End Levee Mile	0.73
Location	Water Side
Category	Earthen Levee
Item	Encroachments
Another view of the gangway and the platform.	
phillips_20091130_13.jpg

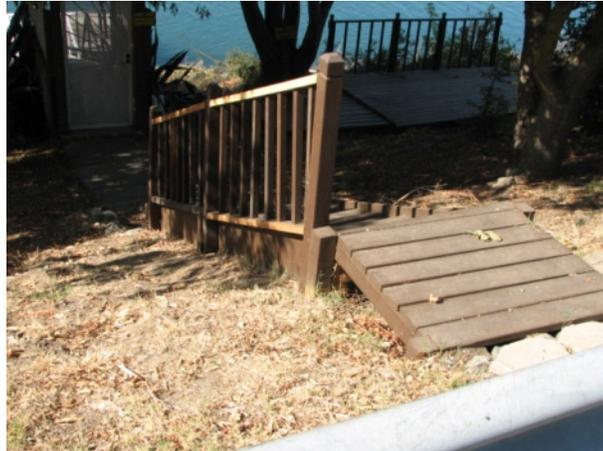
Levee Mile Report Line	2
Start Levee Mile	0.76
End Levee Mile	0.76
Location	Water Side
Category	Earthen Levee
Item	Encroachments
This stairway was placed on the levee section without a Rec. Board permit. In the far background is a wooden deck on the levee slope.	
phillips_20090924_3.jpg
