**Flood Control Project Maintenance
Levee Inspections**
LMA District Cover Sheet
Spring 2009 Levee Inspection Results

Reclamation District No. 0551

**Flood Control Project Maintenance
Levee Inspections
Unit Cover Sheet
Spring 2009 Levee Inspection Results
Reclamation District No. 0551**

Waterway		Bank	Unit Miles
Unit No. 01 Sacramento River		Left	6.80

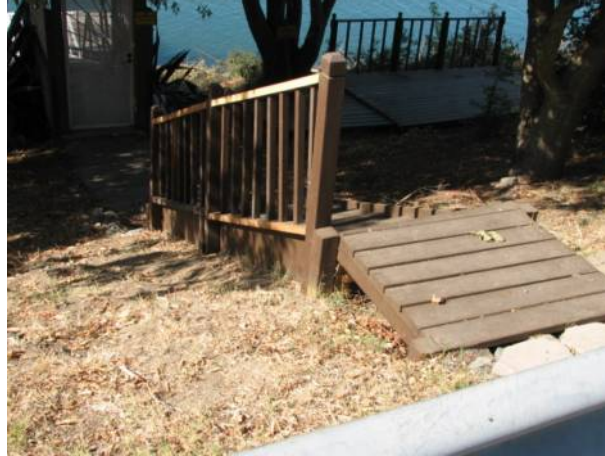
Levee Mile Report Line	7
Start Levee Mile	0.76
End Levee Mile	0.76
Location	Water Side
Category	Earthen Levee
Item	Encroachments

6	0.75	0.76	Earthen Levee	Encroachments	LS	C	Landscaping	38.327927 ° -121.573223 °	38.327777 ° -121.573338 °		23
7	0.76	0.76	Earthen Levee	Encroachments	WS PO		Stairways	38.327852 ° -121.573487 °	38.327852 ° -121.573487 °	Y	29
8	0.77	0.82	Earthen Levee	Vegetation	LS	M	Remove the wild growth other than native grasses from the levee slopes.	38.327675 ° -121.573403 °	38.327063 ° -121.573792 °		22
9	0.84	0.86	Earthen Levee	Encroachments	LS	C	Landscaping	38.326892 ° -121.573962 °	38.326560 ° -121.574185 °		21
10	0.95	0.97	Earthen Levee	Vegetation	LS	C	Control annual grass and weeds on the levee slopes and easements.	38.325563 ° -121.575003 °	38.325175 ° -121.575173 °		34
11	1.04	1.09	Earthen Levee	Vegetation	LS	C	Control annual grass and weeds on the levee slopes and easements.	38.324323 ° -121.575495 °	38.323607 ° -121.575758 °		35
12	1.04	1.07	Earthen Levee	Vegetation	LS	C	Remove the wild growth other than native grasses from the levee slopes.	38.324150 ° -121.575373 °	38.323835 ° -121.575530 °		20

This stairway was placed on the levee section without a Rec. Board permit. In the far background is a wooden deck on the levee slope.
