**Flood Control Project Maintenance
Levee Inspections
LMA District Cover Sheet
Spring 2010 Levee Inspection Results**

Reclamation District No. 0551 Pierson

Spring 2010 Levee Inspection Results

Waterway		Bank	Unit Miles
Unit No. 01 Sacramento River		Left	6.84

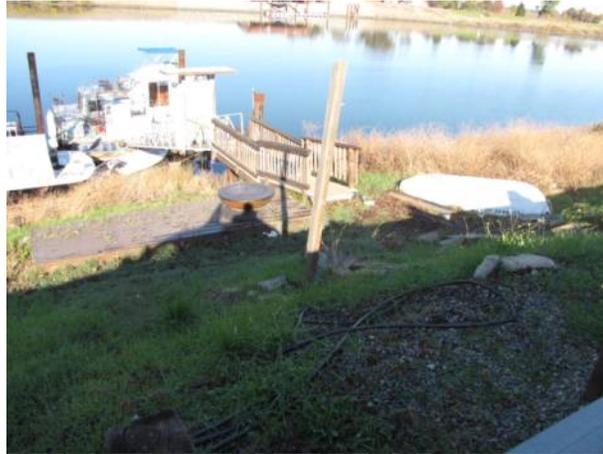
6	0.70	0.73	Earthen Levee	Encroachments	WS	M	Material Inspector Comments: This property has several listing of unauthorized encroachments that were identified during the spring inspection that still remain on location to date 11-19-2009	38.328651 ° -121.372755 °	38.328286 ° -121.573045 °	42 Y
7	0.76	0.76	Earthen Levee	Encroachments	WS	PO	Stairways Inspector Comments: There is a Permit pending for this encroachment.	38.327852 ° -121.573487 °	38.327852 ° -121.573487 °	29 Y
8	0.95	1.04	Earthen Levee	Vegetation	LS	M	Control annual grass and weeds on the levee slopes and easements.	38.325432 ° -121.574818 °	38.324202 ° -121.575327 °	25
9	1.10	1.16	Earthen Levee	Trim / Thin Trees	LS	N	Tree stumps.	38.324373 ° -121.578303 °	38.322743 ° -121.574545 °	7
10	1.54	1.62	Earthen Levee	Encroachments	WS	CO	Landscaping	38.317138 ° -121.576567 °	38.316060 ° -121.576688 °	6
11	1.62	1.68	Earthen Levee	Vegetation	LS	M	Control annual grass and weeds on the levee slopes and easements.	38.316025 ° -121.576693 °	38.315170 ° -121.576773 °	9

Levee Mile Report Line	6
Start Levee Mile	0.70
End Levee Mile	0.73
Location	Water Side
Category	Earthen Levee
Item	Encroachments
Gangway, wooden platform, and boat on berm and dock.	
phillips_s_20100316_017.jpg

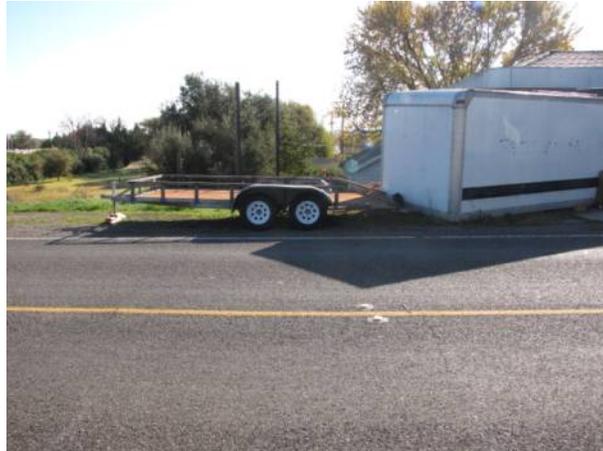
Levee Mile Report Line	6
Start Levee Mile	0.70
End Levee Mile	0.73
Location	Water Side
Category	Earthen Levee
Item	Encroachments
Boat trailer and box trailer on landward shoulder.	
phillips_s_20100316_018.jpg

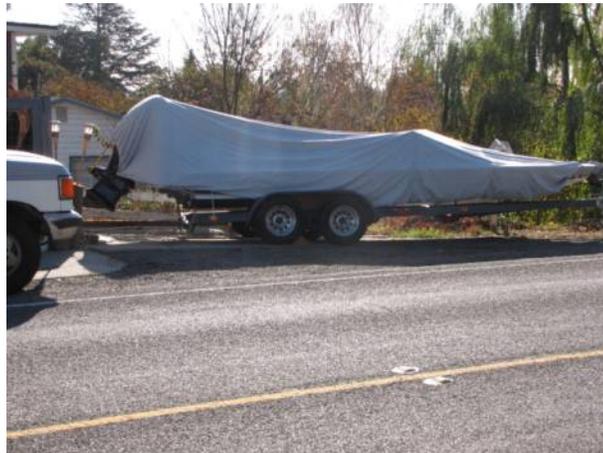
Levee Mile Report Line	6
Start Levee Mile	0.70
End Levee Mile	0.73
Location	Water Side
Category	Earthen Levee
Item	Encroachments
Boat and trailer on land side shoulder.	
phillips_s_20100316_019.jpg

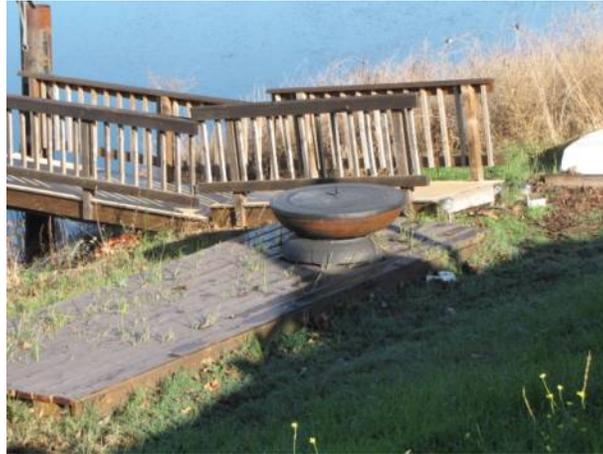
Levee Mile Report Line	6
Start Levee Mile	0.70
End Levee Mile	0.73
Location	Water Side
Category	Earthen Levee
Item	Encroachments
Another view of the gangway and the platform.	
phillips_s_20100316_020.jpg

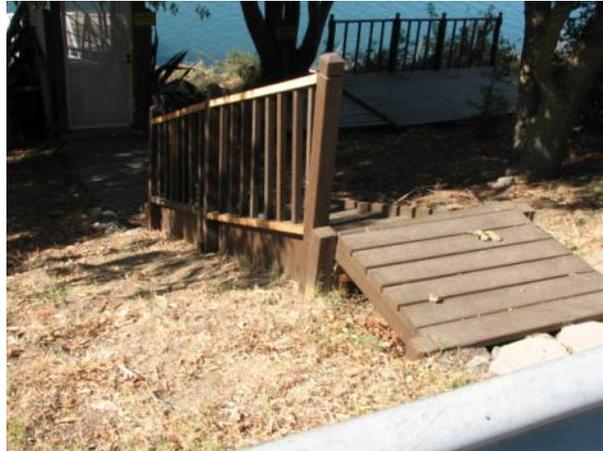
Levee Mile Report Line	7
Start Levee Mile	0.76
End Levee Mile	0.76
Location	Water Side
Category	Earthen Levee
Item	Encroachments
This stairway was placed on the levee section without a Rec. Board permit. In the far background is a wooden deck on the levee slope.	
phillips_s_20100316_016.jpg
