**Flood Control Project Maintenance
Levee Inspections****LMA District Cover Sheet****Spring 2011 Levee Inspection Results****Reclamation District No. 0551 Pierson**

Levee Inspection Report By Mile - Spring 2011

Reclamation District No. 0551 Pierson

Waterway						Bank	Unit Miles	Inspection Start/End	Inspector
Unit No. 01 Sacramento River						Left	6.84	03/09/2011 03/09/2011	Herman Phillips

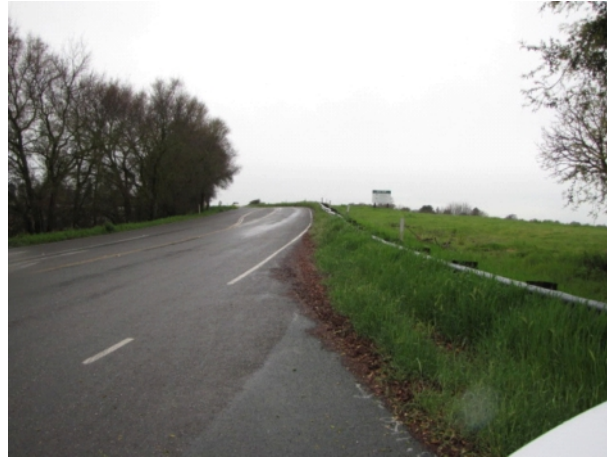
Levee Mile Report Line	1
Start Levee Mile	0.00
End Levee Mile	0.00
Location	Water Side
Category	Earthen Levee
Item	Vegetation
RD 551 Levee mile 0.00 waterside looking downstream. Photo taken 3-09-2011.	
phillips_s_20110321_203.jpg

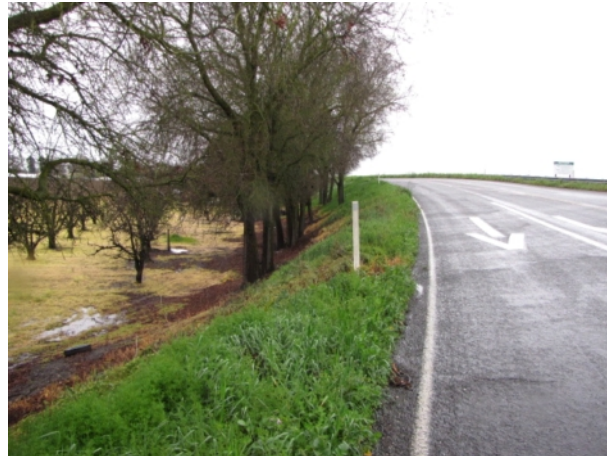
Levee Mile Report Line	2
Start Levee Mile	0.00
End Levee Mile	0.00
Location	Land Side
Category	Earthen Levee
Item	Vegetation
RD 551 Standing on landside levee mile 0.00 looking downstream. Photo taken 3-09-2011	
phillips_s_20110321_204.jpg

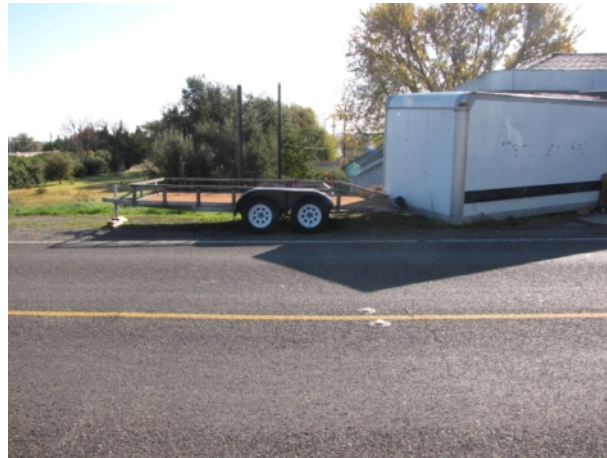
Levee Mile Report Line	6
Start Levee Mile	0.70
End Levee Mile	0.73
Location	Water Side
Category	Earthen Levee
Item	Encroachments

Boat trailer and box trailer on landward shoulder.

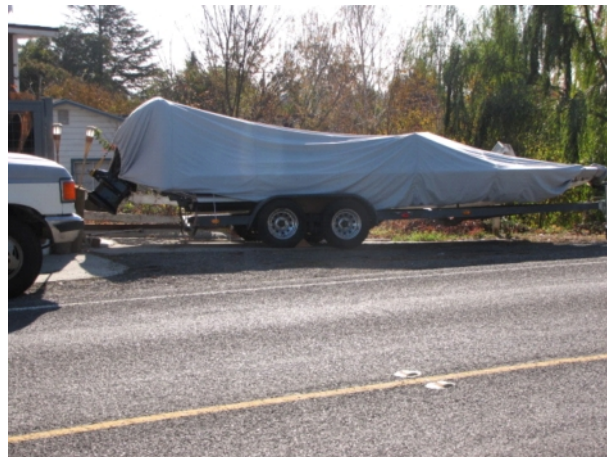
Levee Mile Report Line	6
Start Levee Mile	0.70
End Levee Mile	0.73
Location	Water Side
Category	Earthen Levee
Item	Encroachments

Boat and trailer on land side shoulder.

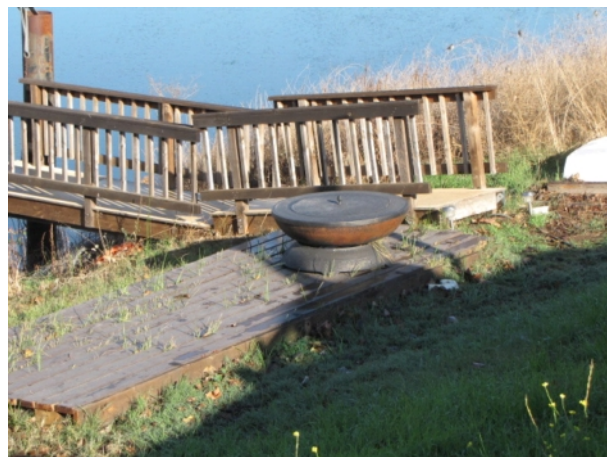
Levee Mile Report Line	6
Start Levee Mile	0.70
End Levee Mile	0.73
Location	Water Side
Category	Earthen Levee
Item	Encroachments

Another view of the gangway and the platform.

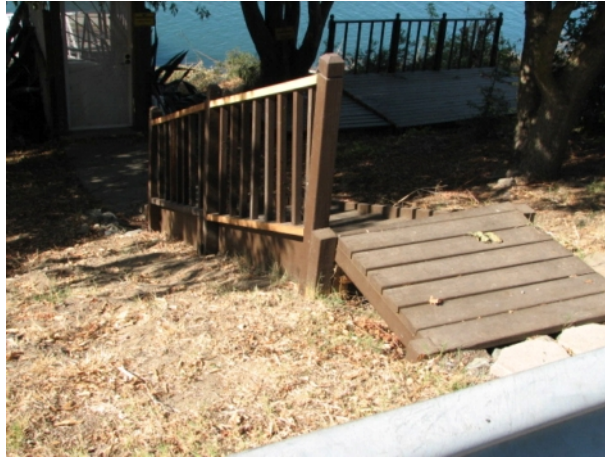
Levee Mile Report Line	7
Start Levee Mile	0.76
End Levee Mile	0.76
Location	Water Side
Category	Earthen Levee
Item	Encroachments

This stairway was placed on the levee section without a Rec. Board permit. In the far background is a wooden deck on the levee slope.
