**Flood Control Project Maintenance
Levee Inspections****LMA District Cover Sheet****Spring 2012 Levee Inspection Results****Reclamation District No. 0551 Pearson**

Spring 2012 Levee Inspection Results

Reclamation District No. 0551 Pearson

Waterway			Bank	Unit Miles
Unit No. 01 Sacramento River			Left	6.84
	Spring (March - May)	Summer (June - August)	(September - November) Fall	Winter (December - February)
Unit Maintenance Rating (Fall Only)				
Date of Inspection	3/30/2012 - 3/30/2012			
DWR Inspector	Herman Phillips			
Accompanied By	Mr. Topper Van-Loben-Sels RD 551

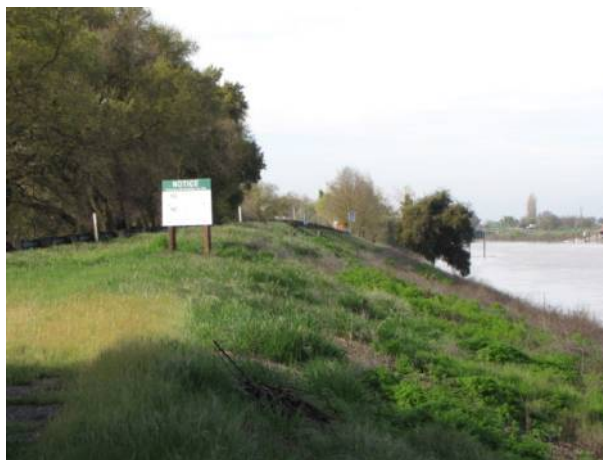
Levee Mile Report Line	4
Start Levee Mile	0.00
End Levee Mile	0.00
Location	Water Side
Category	Earthen Levee
Item	Vegetation

RD 551 Looking downstream from waterside shoulder levee mile 0.00. Photo taken 3-30-2012.

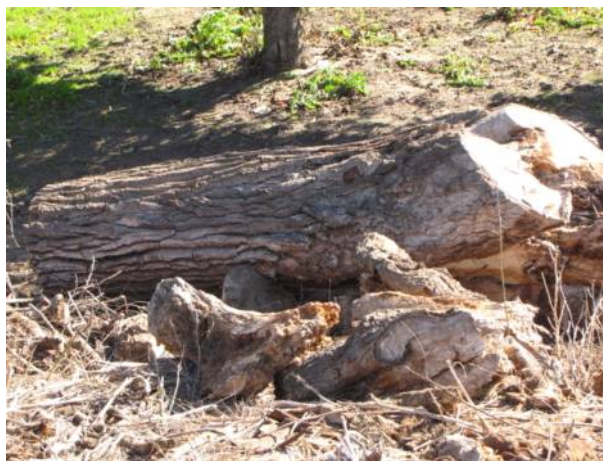
Levee Mile Report Line	6
Start Levee Mile	0.20
End Levee Mile	0.20
Location	Land Side
Category	Earthen Levee
Item	Encroachments

Landside levee mile 0.20 cut up tree sections on toe. Photo taken 12-01-2011.

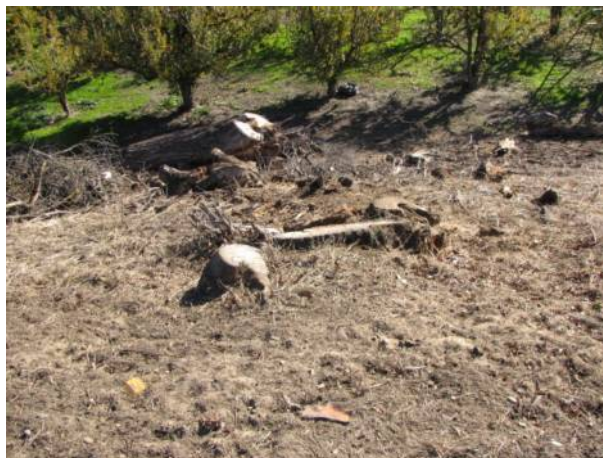
Levee Mile Report Line	7
Start Levee Mile	0.20
End Levee Mile	0.20
Location	Land Side
Category	Earthen Levee
Item	Trim / Thin Trees

Tree stumps landward toe. Levee mile 0.20. Photo taken 12-01-2011.

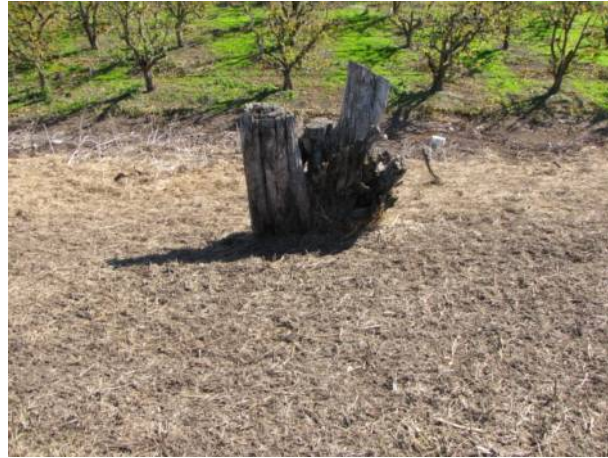
Levee Mile Report Line	8
Start Levee Mile	0.22
End Levee Mile	0.22
Location	Land Side
Category	Earthen Levee
Item	Trim / Thin Trees

Levee mile 0.22 landside. Photo taken 12-01-2011.

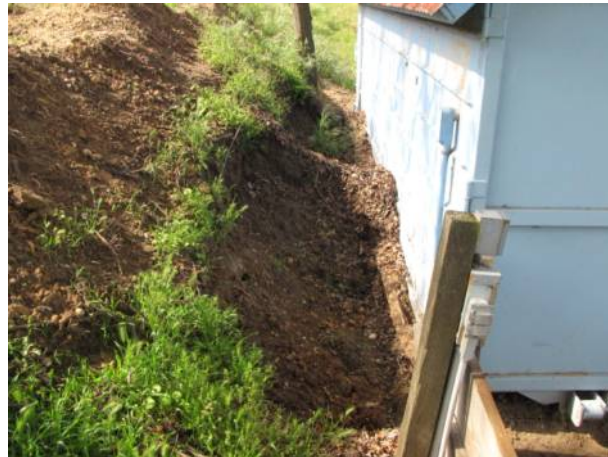
Levee Mile Report Line	18
Start Levee Mile	0.60
End Levee Mile	0.60
Location	Water Side
Category	Earthen Levee
Item	Erosion / Bank Caving

Property owner has excavated into toe of levee section at base of structure. Photo taken 3-30-2012. This property has been sold to new owner. District will notify new owner to make repairs to damage.

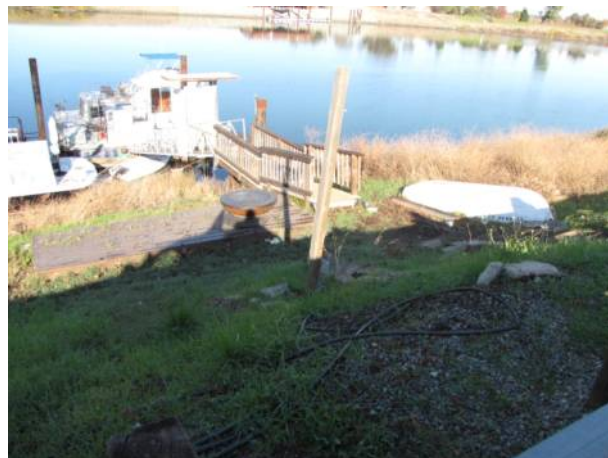
Levee Mile Report Line	19
Start Levee Mile	0.70
End Levee Mile	0.73
Location	Water Side
Category	Earthen Levee
Item	Encroachments

Gangway, wooden platform, and boat on berm and dock.

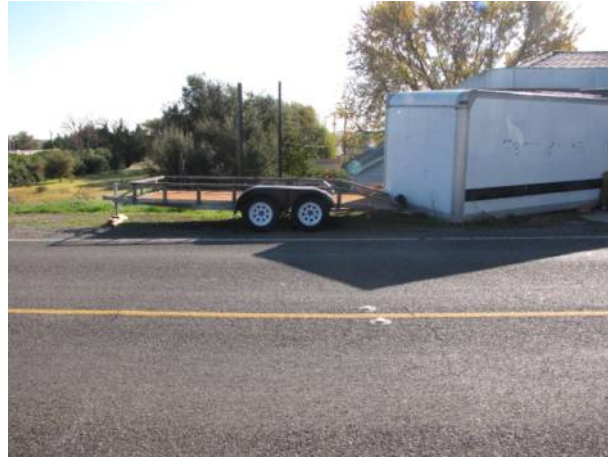
Levee Mile Report Line	19
Start Levee Mile	0.70
End Levee Mile	0.73
Location	Water Side
Category	Earthen Levee
Item	Encroachments

Boat trailer and box trailer on landward shoulder.

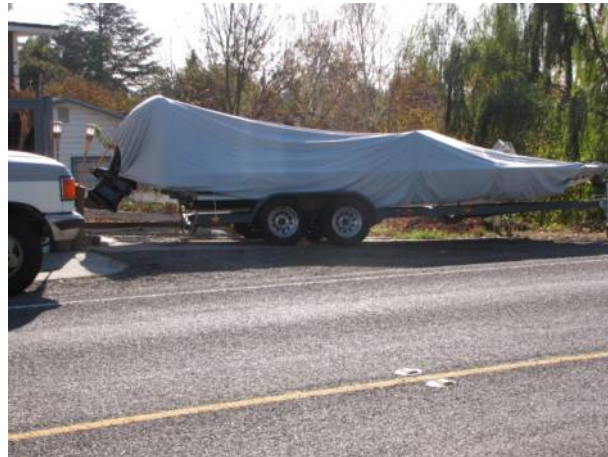
Levee Mile Report Line	19
Start Levee Mile	0.70
End Levee Mile	0.73
Location	Water Side
Category	Earthen Levee
Item	Encroachments

Boat and trailer on land side shoulder.

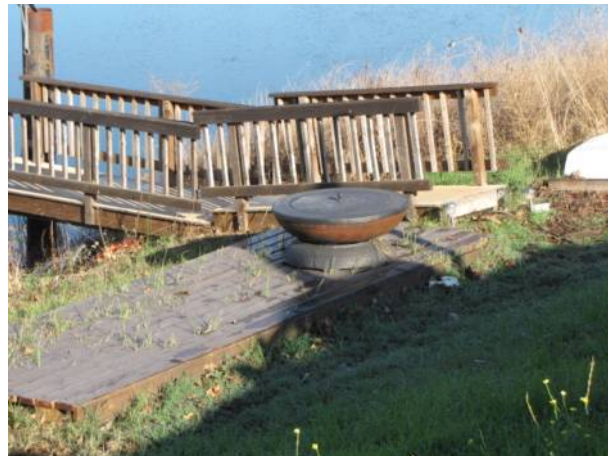
Levee Mile Report Line	19
Start Levee Mile	0.70
End Levee Mile	0.73
Location	Water Side
Category	Earthen Levee
Item	Encroachments

Another view of the gangway and the platform.

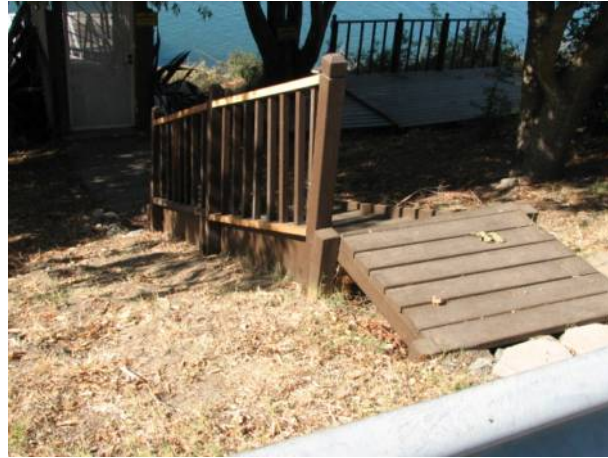
Levee Mile Report Line	20
Start Levee Mile	0.76
End Levee Mile	0.76
Location	Water Side
Category	Earthen Levee
Item	Encroachments

This stairway was placed on the levee section without a Rec. Board permit. In the far background is a wooden deck on the levee slope.

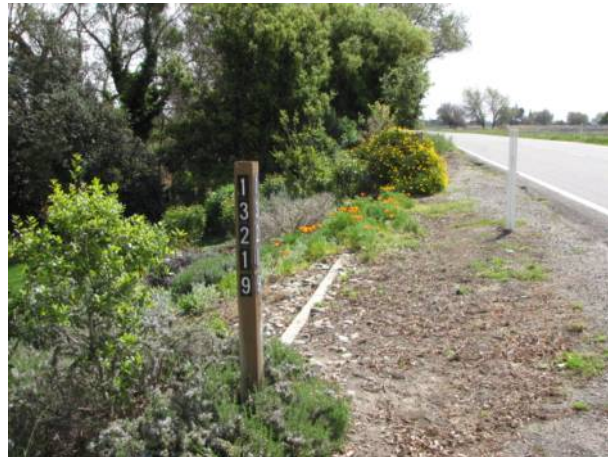
Levee Mile Report Line	31
Start Levee Mile	5.10
End Levee Mile	5.14
Location	Land Side
Category	Earthen Levee
Item	Vegetation

RD 551 Levee mile 5.10 landward slope and shoulder unauthorized landscaping. Photo taken 3-30-2012.
