**Flood Control Project Maintenance
Levee Inspections****LMA District Cover Sheet****Spring 2013 Levee Inspection Results****Reclamation District No. 0551 Pearson**

Levee Inspection Report By Mile - Spring 2013

Reclamation District No. 0551 Pearson

Waterway				Bank	Unit Miles	Inspection Start/End	Inspector	
Unit No. 01 Sacramento River				Left	6.84	03/27/2013 03/27/2013	Herman Phillips

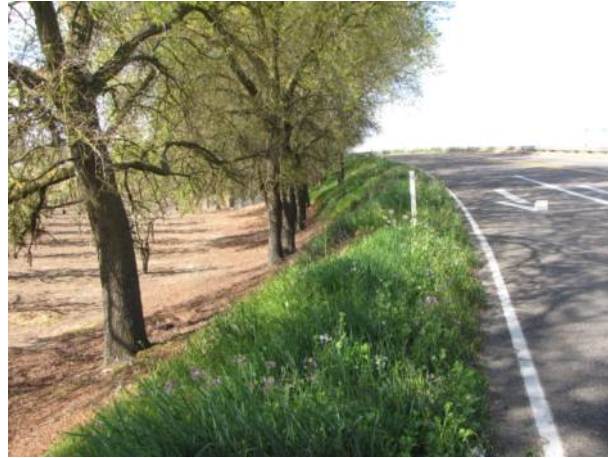
Levee Mile Report Line	4
Start Levee Mile	0.00
End Levee Mile	0.00
Location	Land Side
Category	
Item	Vegetation
RD 551 Landside looking downstream from levee mile 0.00. Photo taken 3-27-2013.	
phillips_s_20130327_354.JPG

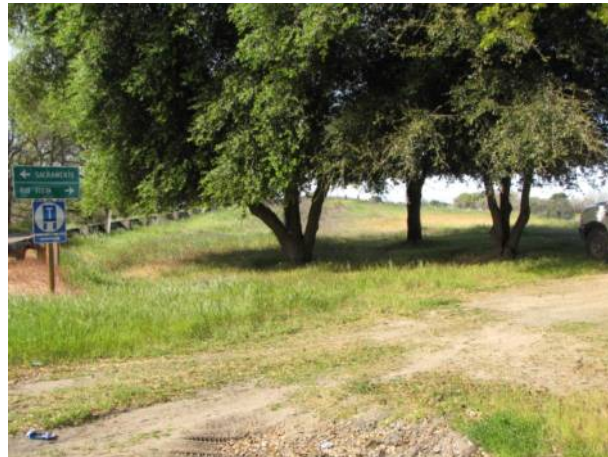
Levee Mile Report Line	5
Start Levee Mile	0.00
End Levee Mile	0.00
Location	Water Side
Category	
Item	Vegetation
RD 551 Looking downstream from levee mile 0.00 waterside. Photo taken 3-27-2013.	
phillips_s_20130327_355.JPG

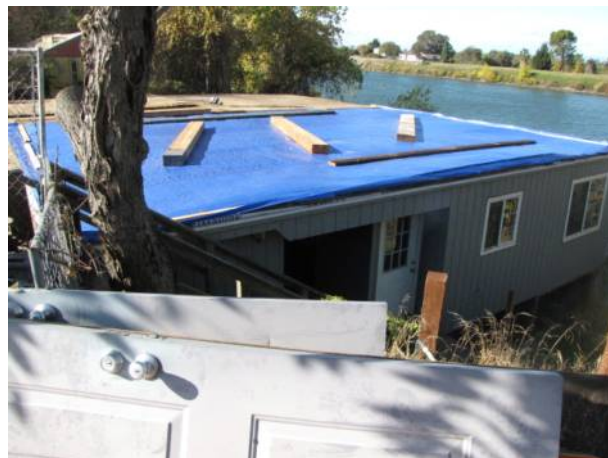
Levee Mile Report Line	6
Start Levee Mile	0.50
End Levee Mile	0.50
Location	Water Side
Category	
Item	Encroachments
RD 551 levee mile 0.49 unauthorized building construction waterside of levee section. Photo taken 11-08-2012.	
phillips_s_20130325_316.jpg

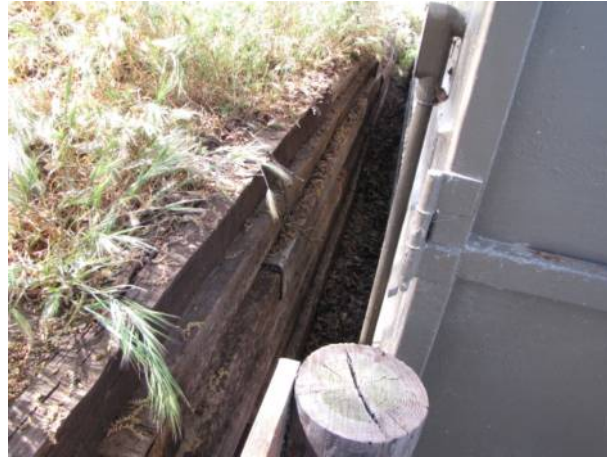
Levee Mile Report Line	9
Start Levee Mile	0.60
End Levee Mile	0.60
Location	Water Side
Category	
Item	Encroachments

Here is a picture of the railroad tie retaining wall.
Photo taken 3-27-2013.
