**Flood Control Project Maintenance
Levee Inspections****LMA District Cover Sheet****Spring 2014 Levee Inspection Results****Reclamation District No. 0551 Pearson**

Spring 2014 Levee Inspection Results

Reclamation District No. 0551 Pearson

Waterway			Bank	Unit Miles
Unit No. 01 Sacramento River			Left	6.84
	Spring (March - May)	Summer (June - August)	(September - November) Fall	Winter (December - February)
Unit Maintenance Rating (Fall Only)				
Date of Inspection	04/01/2014 - 04/01/2014			
DWR Inspector	Herman Phillips			
Accompanied By	Mr. Topper Van-Loben-Sels RD 551

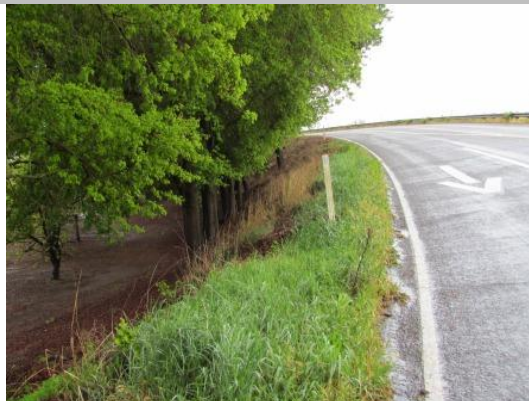
Photo 1 of 1 : phillips_s_20140523_05940.jpg

LM Start	0.00	Rating **	M	Issue No.	1
LM End	0.00	Issue Type +	Ma	Location *	LS
Category	Earthen Levee			GPS Latitude/Longitude	
				Start	End
Item	Vegetation			38.336450 °	38.336460 °
				-121.564751 °	-121.564751 °
DWR ID	DWR_RD0551_01_s_2014_1				
Action/Comments					
Control annual grass and weeds on the levee slopes and easements.

RD 551 Landside levee slope L/M 0.00. Photo taken 01-04-2014.

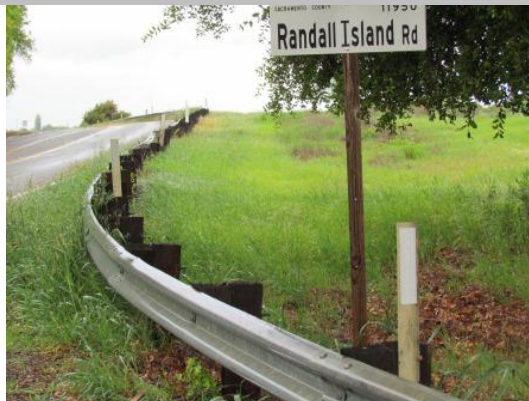
Photo 1 of 1 : phillips_s_20140523_05941.jpg

LM Start	0.00	Rating **	M	Issue No.	20
LM End	0.00	Issue Type +	Ma	Location *	WS
Category	Earthen Levee			GPS Latitude/Longitude	
				Start	End
Item	Vegetation			38.336458 °	38.336458 °
				-121.564751 °	-121.564751 °
DWR ID	DWR_RD0551_01_s_2014_20				
Action/Comments					
Control annual grass and weeds on the levee slopes and easements.

RD 551 looking downstream from the waterside slope levee mile 0.00. Photo taken 01-04-2014.

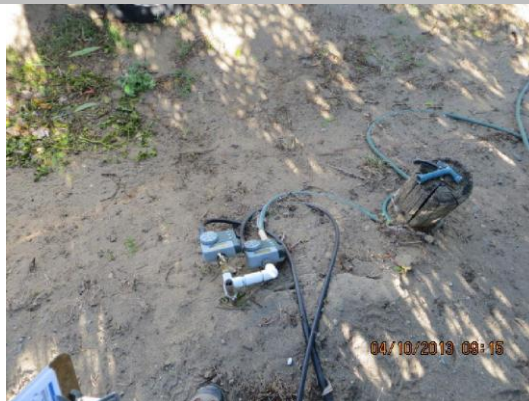
Photo 1 of 1 : UCIP_490.jpg

LM Start	0.41	Rating **	M	Issue No.	2
LM End	0.41	Issue Type +	En	Location *	WS
Category	Supplemental			GPS Latitude/Longitude	
				Start	End
Item	DWR UCIP Field Study			38.332039 °	38.332039 °
				-121.569730 °	-121.569730 °
DWR ID	DWR_RD0551_01_s_2014_2				
Action/Comments					
Inspector Comments: FS_ID:11705					
EP_NO: 2759					
Repair Type:					
Crossing Status:					
UCIP Comments: Unclear where exact crossing is located.					
FIELD_STRUCT_DESC: 1-inch steel waterline through the levee.					
Ramp, boating facilities on waterward side (Courtland boating facilities).					
Pipe visible under buildings at concrete foundation on LS. Water					
service connections for irrigation located on WS slope. (Permit No.					
2759, 1959)					
FS Date: 4/10/2013

Irrigation pipes on WS slope.

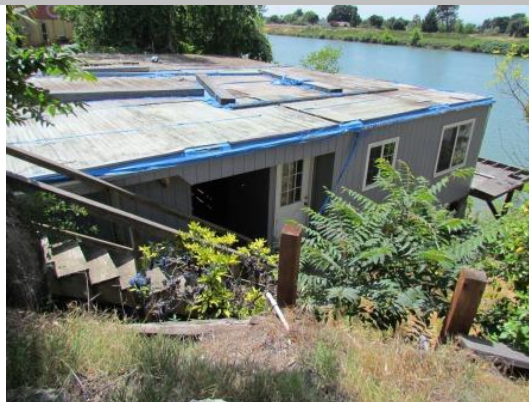
Photo 1 of 2 : phillips_s_20140523_05943.jpg

LM Start	0.50	Rating **	U	Issue No.	21
LM End	0.50	Issue Type +	En	Location *	WS
Category	Earthen Levee			GPS Latitude/Longitude	
				Start	End
Item	Encroachments			38.331158 °	38.331158 °
				-121.570751 °	-121.570751 °
DWR ID	DWR_RD0551_01_s_2014_21				
Action/Comments					
Building Inspector Comments: The new land owner is working with the LMA trying to get CVFPB Permits for this project, this is the 2nd year in process.

Building and steps waterward. Photo taken 01-04-2014.

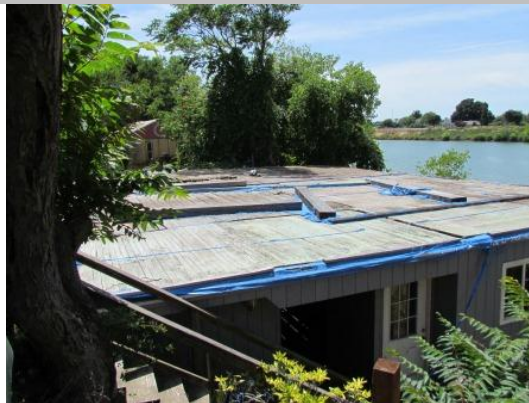
Photo 2 of 2 : phillips_s_20140523_05944.jpg

LM Start	0.50	Rating **	U	Issue No.	21 (cont)
LM End	0.50	Issue Type +	En	Location *	WS
Category	Earthen Levee			GPS Latitude/Longitude	
				Start	End
Item	Encroachments			38.331158 °	38.331158 °
				-121.570751 °	-121.570751 °
DWR ID	DWR_RD0551_01_s _ 2014_21				
Action/Comments					
Building Inspector Comments: The new land owner is working with the LMA trying to get CVFPB Permits for this project, this is the 2nd year in process.

Building remodeling project on waterside levee section. Photo taken 01-04-2014.

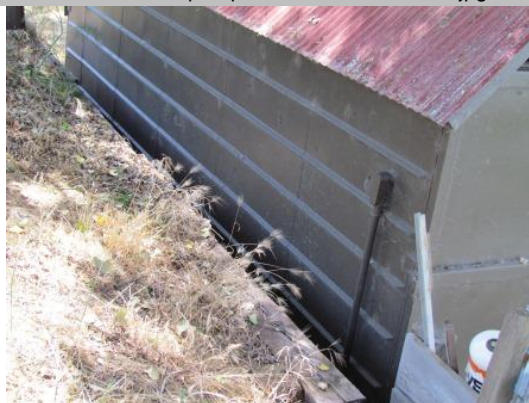
Photo 1 of 1 : phillips_s_20140523_05942.jpg

LM Start	0.60	Rating **	U	Issue No.	87
LM End	0.60	Issue Type +	En	Location *	WS
Category	Earthen Levee			GPS Latitude/Longitude	
				Start	End
Item	Encroachments			38.329895 °	38.329895 °
				-121.571840 °	-121.571840 °
DWR ID	DWR_RD0551_01_s _ 2012_87				
Action/Comments					
Retaining Wall Inspector Comments: At this location the new land owner has placed a railroad tie retaining wall against the bank adjacent to the metal building. Discovered during the spring inspection. 3-27-2013. District is working with landowner to get CVFPB permit. No new information 4-2014

This unauthorized retaining wall remains. Photo taken 01-04-2014.

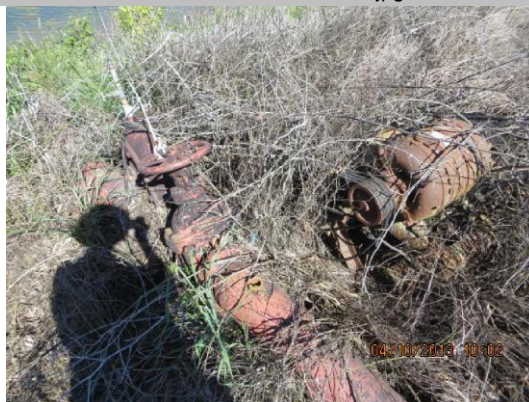
Photo 1 of 1 : UCIP_493.jpg

LM Start	0.72	Rating **	M	Issue No.	4
LM End	0.72	Issue Type +	En	Location *	WS
Category	Supplemental			GPS Latitude/Longitude	
				Start	End
Item	DWR UCIP Field Study			38.328400 °	38.328400 °
				-121.572953 °	-121.572953 °
DWR ID	DWR_RD0551_01_s _ 2014_4				
Action/Comments					
Inspector Comments: FS_ID:11726					
EP_NO: 6220					
Repair Type:					
Crossing Status:					
UCIP Comments: Pipe abandoned and should be removed.					
FIELD_STRUCT_DESC: 8-inch steel irrigation pipe through the levee					
6.1-feet below the crown. Pump on waterside with slide gate and air					
vent. (Permit No. 6220, 1968)					
FS Date: 4/10/2013

Pump, slide gate, and missing vent pipe on WS slope.

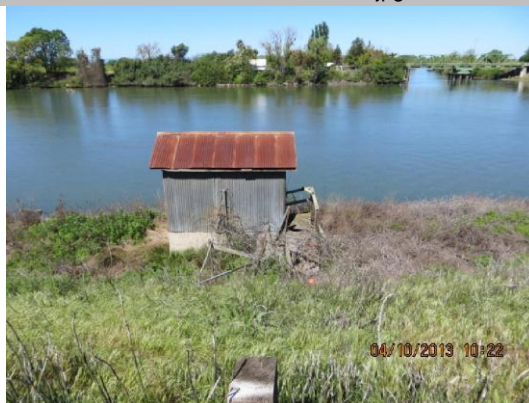
Photo 1 of 1 : UCIP_497.jpg

LM Start	0.90	Rating **	M	Issue No.	5
LM End	0.90	Issue Type +	En	Location *	WS
Category	Supplemental			GPS Latitude/Longitude	
				Start	End
Item	DWR UCIP Field Study			38.326088 °	38.326088 °
				-121.574525 °	-121.574525 °
DWR ID	DWR_RD0551_01_s_2014_5				
Action/Comments					
Inspector Comments: FS_ID:11727					
EP_NO: 701					
Repair Type:					
Crossing Status:					
UCIP Comments: Pipe appears abandoned and should be done so properly. Good candidate for video inspection.					
FIELD_STRUCT_DESC: 14-inch steel irrigation pipe through the levee, 7.2 feet below crown. Pump in pump house on waterward slope.					
Service pole on landward slope. (Permit No. 701-Smith). 1-inch galvanized filler pipe and a 2-inch electrical conduit at same location.					
Originally included in O+M manual (1959).					
FS Date: 4/10/2013

Pump house and pipes visible on WS slope.

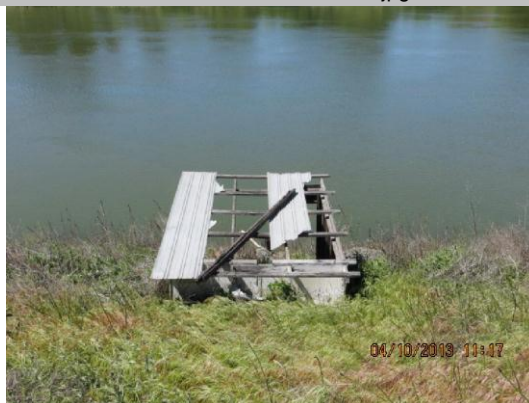
Photo 1 of 1 : UCIP_5334.jpg

LM Start	1.79	Rating **	M	Issue No.	7
LM End	1.79	Issue Type +	En	Location *	LS
Category	Supplemental			GPS Latitude/Longitude	
				Start	End
Item	DWR UCIP Field Study			38.313552 °	38.313552 °
				-121.576640 °	-121.576640 °
DWR ID	DWR_RD0551_01_s _ 2014_7				
Action/Comments					
Inspector Comments: FS_ID:26874					
EP_NO: 11145					
Repair Type:					
Crossing Status:					
UCIP Comments: Based on District notes from January 14, 2014, pump discharge pipe has been repaired. Pipe failing on LS slope causing erosion along pipe alignment. Pipe debris on both slopes should be removed as well.: As of 12/13/2013 District President noted that the landowner had made repairs to the LS slope leaks.: As of 12/17/2013 District submitted letter to landowner explaining UCIP report details including photos of the pipe problems					
FIELD_STRUCT_DESC: 10-inch pipe through levee, 4.7 feet below crown. Pump in 7’X9’ concrete pump house on waterward slope. 36-inch concrete riser on LS toe. 1-inch electrical conduit at same location. Service pole at landward toe (ABO No. 11145-Towne). Originally included in O+M manual (1959).

Pumphouse on WS slope.

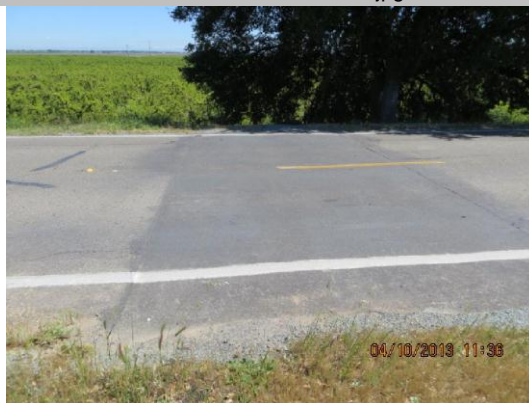
Photo 1 of 1 : UCIP_499.jpg

LM Start	2.03	Rating **	M	Issue No.	8
LM End	2.03	Issue Type +	En	Location *	LS
Category	Supplemental			GPS Latitude/Longitude	
				Start	End
Item	DWR UCIP Field Study			38.310237 °	38.310237 °
				-121.575470 °	-121.575470 °
DWR ID	DWR_RD0551_01_s_2014_8				
Action/Comments					
Inspector Comments: FS_ID:11749					
EP_NO: 3676					
Repair Type:					
Crossing Status:					
UCIP Comments: Fresh cut through pavement on crown indicates recent work on pipes at this location. Need to determine if pipe was removed or abandoned in place.					
FIELD_STRUCT_DESC: 2 of 2: 8-inch steel irrigation pipe sleeved through a 12-inch pipe, 5 feet below crown. Pump on platform waterside. (Permit No. 3676-Wheeler).					
FS Date: 4/10/2013

Fresh cut through pavement at crown.

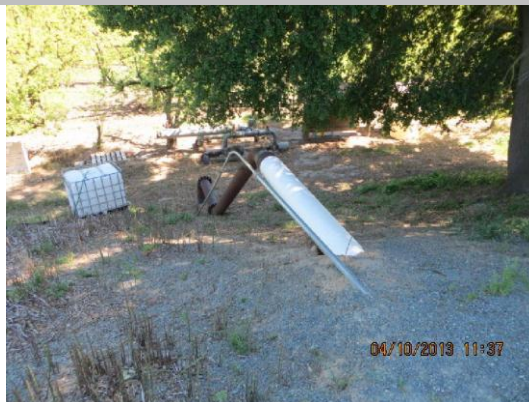
Photo 1 of 1 : UCIP_501.jpg

LM Start	2.03	Rating **	M	Issue No.	10
LM End	2.03	Issue Type +	En	Location *	LS
Category	Supplemental			GPS Latitude/Longitude	
				Start	End
Item	DWR UCIP Field Study			38.310223 °	38.310223 °
				-121.575458 °	-121.575458 °
DWR ID	DWR_RD0551_01_s_2014_10				
Action/Comments					
Inspector Comments: FS_ID:11763					
EP_NO: 6551					
Repair Type:					
Crossing Status:					
UCIP Comments: Rodent activity undermining pipe on LS slope.					
FIELD_STRUCT_DESC: 1 of 2: 14-inch PVC wrapped Steel irrigation					
pipe 3-feet below the crown. Butterfly valve on WS shoulder. 2-inch					
galvanized electric conduit at same location. Pump on pile structure on					
WS toe. Pressure booster and pump on LS toe. (Permit No. 6551-					
Wheeler 1969).					
FS Date: 4/10/2013

Pipe, electrical conduit, and booster pump on LS toe.

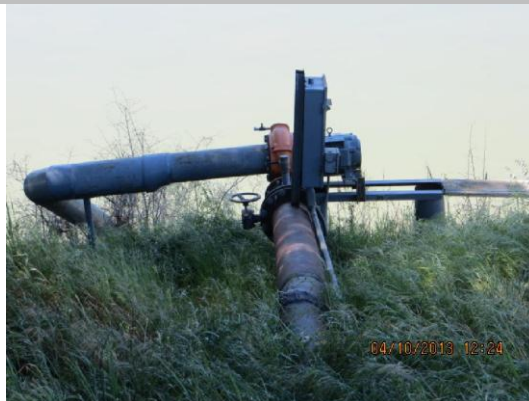
Photo 1 of 1 : UCIP_503.jpg

LM Start	2.43	Rating **	M	Issue No.	12
LM End	2.43	Issue Type +	En	Location *	LS
Category	Supplemental			GPS Latitude/Longitude	
				Start	End
Item	DWR UCIP Field Study			38.305188 °	38.305188 °
				-121.572012 °	-121.572012 °
DWR ID	DWR_RD0551_01_s_2014_12				
Action/Comments					
Inspector Comments: FS_ID:11783					
EP_NO: 11141					
Repair Type:					
Crossing Status:					
UCIP Comments: Records indicate this pipe was abandoned, but it appears to be active. Verify status.					
FIELD_STRUCT_DESC: 10-inch steel irrigation pipe through levee, 8.0 feet below the crown. Slant pump on waterward slope. Service pole on landward slope with a 1.5-inch galvanized iron electrical conduit through the levee at same location. (ABO No. 11141-Runyon). Originally included in O+M manual (1959).					
FS Date: 4/10/2013

Pump, pipe, and butterfly valve on WS slope.

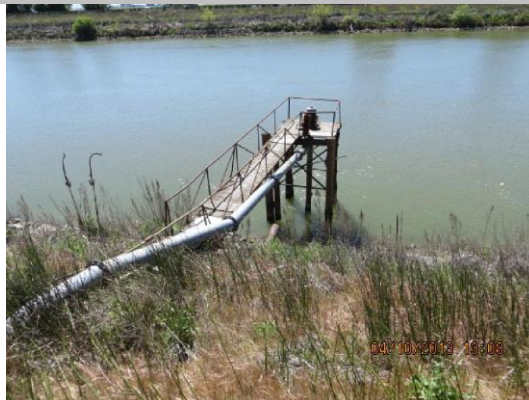
Photo 1 of 1 : UCIP_505.jpg

LM Start	2.99	Rating **	M	Issue No.	13
LM End	2.99	Issue Type +	En	Location *	LS
Category	Supplemental			GPS Latitude/Longitude	
				Start	End
Item	DWR UCIP Field Study			38.298322 °	38.298322 °
				-121.566940 °	-121.566940 °
DWR ID	DWR_RD0551_01_s_2014_13				
Action/Comments					
Inspector Comments: FS_ID:11803					
EP_NO: 1204					
Repair Type:					
Crossing Status:					
UCIP Comments: Gap between sleeved pipes does not appear to be grouted on LS slope.					
FIELD_STRUCT_DESC: 12-inch steel conduit with 10-inch irrigation pipe sleeved through it 6-feet below the crown. Pump on pile structure on the Water Side toe. 48-inch concrete riser on LS toe. (Permit No. 1204-Wheeler). Originally included in the O+M manual 1959.					
FS Date: 4/10/2013

10-inch steel irrigation pipe and steel pump structure on WS toe.

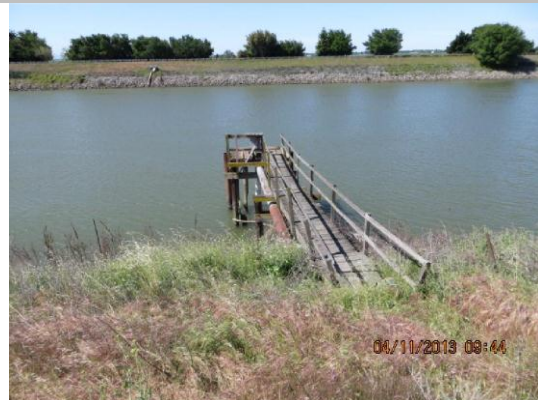
Photo 1 of 1 : UCIP_509.jpg

LM Start	4.05	Rating **	M	Issue No.	16
LM End	4.05	Issue Type +	En	Location *	LS
Category	Supplemental			GPS Latitude/Longitude	
				Start	End
Item	DWR UCIP Field Study			38.286567 °	38.286567 °
				-121.554568 °	-121.554568 °
DWR ID	DWR_RD0551_01_s _ 2014_16				
Action/Comments					
Inspector Comments: FS_ID:11823					
EP_NO: 11146					
Repair Type:					
Crossing Status:					
UCIP Comments: Wooden walkway in bad repair and presents a hazard to the public.					
FIELD_STRUCT_DESC: 14-inch pipe through levee, 10.4 feet below crown. Pump on pile structure in stream with wooden walkway. 48-inch concrete standpipe on LS toe with booster pump and electric panel. Siphon breaker in 24-inch CMP riser on LS slope. 1.5-inch electrical conduit at same location.(ABO No. 11146- Turner). Originally included in O+M manual 1959.					
FS Date: 4/11/2013

Pump on pier with wooden walkway on WS toe.

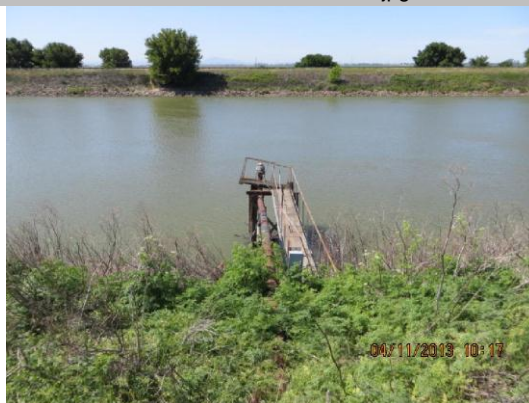
Photo 1 of 1 : UCIP_4791.jpg

UCIP Comments: Pier for pump is falling apart and is a hazard to the public. Some settlement along pipe on LS slope.: As of 12/13/2013 the District has contacted the tenant farmer who is in the process of contacting the owner to update on condition of pipe: As of 12/17/2013 District submitted letter to landowner explaining UCIP report details including photos of the pipe problems

FIELD_STRUCT_DESC: 10-inch steel irrigation pipe through the levee 6.5 feet below the crown. Pump on pile structure in stream. Service pole at landward toe and a 36-inch concrete riser on the LS toe. 1-inch electrical conduit at same location. (ABO No. 11152-Wilcox) Originally included in O+M manual 1959.

Pump on pier showing structural failure on WS toe.

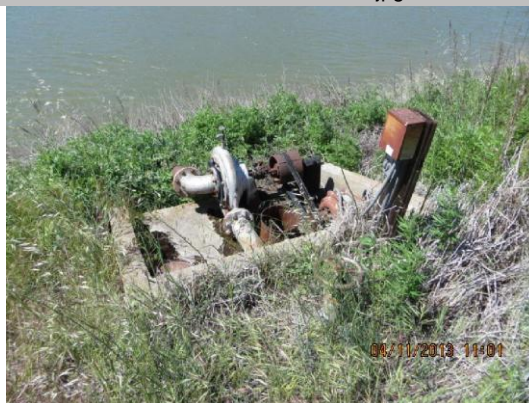
Photo 1 of 1 : UCIP_536.jpg

UCIP Comments: Pumphouse has been removed from pump and pump is in disrepair. Pipe at LS toe is sleeved or has been replaced with a 6-inch PVC pipe. This pump appears abandoned and should be done so properly.

FIELD_STRUCT_DESC: 6-inch pipe through the levee 6.5-feet below the crown. Pump and slide gate on WS slope. 1-inch electrical conduit at same location with service pole at landward toe. 4'X6' concrete distribution box at LS toe (ABO No. 11125- Cortopassi). Originally included in O+M manual 1959.

Pump and slide gate on concrete pad at WS slope.

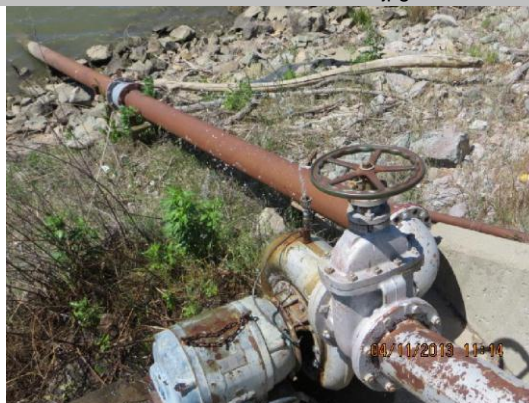
Photo 1 of 1 : UCIP_5339.jpg

Action/Comments					
Inspector Comments: FS_ID:26875					
EP_NO: 11131					
Repair Type:					
Crossing Status:					
UCIP Comments: Based on District notes from January 15, 2014, pump discharge pipe has been repaired. Corrosion holes in pipe at LS toe good indicator that pipe is failing internally. Pipe should be examined internally for damage (video inspect).: As of 12/12/2013 the District discussed with farmer tenant what needed to be done, and the tenant informed the District that they would address the repairs.: As of 12/17/2013 District submitted letter to landowner explaining UCIP report details including photos of the pipe problems					
FIELD_STRUCT_DESC: 10-inch pipe through the levee 7.7-feet below the crown. Pump and slide gate on concrete pad on waterward slope. Siphon breaker in 24-inch CMP riser on LS slope. Concrete riser, power pole with panel box on landward toe. (ABO No. 11131-Latimer). Originally included in the O+M manual 1959.

Pump and slide gate at Concrete pad on WS slope.
