**Flood Control Project Maintenance
Levee Inspections****LMA District Cover Sheet****Spring 2015 Levee Inspection Results****Reclamation District No. 0551 Pearson**

Levee Inspection Report By Mile - Spring 2015

Reclamation District No. 0551 Pearson

Waterway	Bank	Unit Miles	Inspection Start/End	Inspector
Unit No. 01 Sacramento River	Left	6.78	04/28/2015 04/28/2015	Herman Phillips

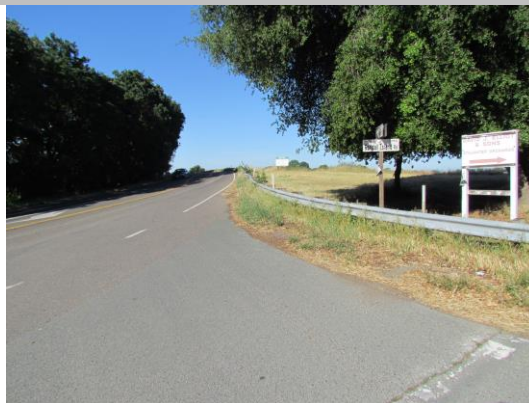
Photo 1 of 1 : SP_2015_RD0551_175_26_20150601_00017.jpg

LM Start	0.00	Rating **	A	Issue No.	26
LM End	0.00	Issue Type +	Ma	Location *	WS
Category	Earthen Levee			GPS Latitude/Longitude	
				Start	End
Item	Vegetation			38.336458 °	38.336458 °
				-121.564751 °	-121.564750 °
DWR ID	DWR_RD0551_01_f_2014_26				
Action/Comments					
Control annual grass and weeds on the levee slopes and easements.

View looking downstream from the waterside shoulder.

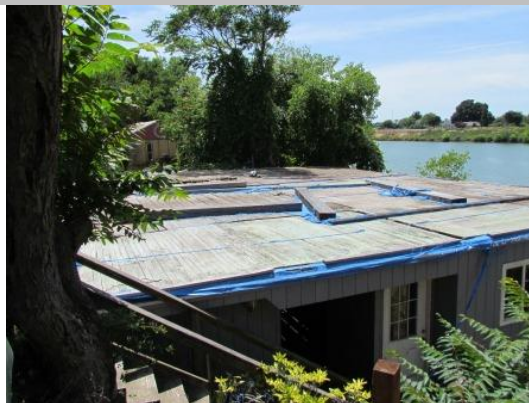
Photo 1 of 2 : SP_2015_RD0551_175_21_20150312_00002.jpg

LM Start	0.49	Rating **	U	Issue No.	21
LM End	0.49	Issue Type +	En	Location *	WS
Category	Earthen Levee			GPS Latitude/Longitude	
				Start	End
Item	Encroachments			38.331158 °	38.331158 °
				-121.570751 °	-121.570751 °
DWR ID	DWR_RD0551_01_s _ 2014_21				
Action/Comments					
Building					
Inspector Comments: The new landowner is working with the LMA to get CVFPB permits for this project. It has taken more than 2 years now. No other pictures were taken for this project.

Building remodel project on waterside levee section. Photo taken 01-04-2014.

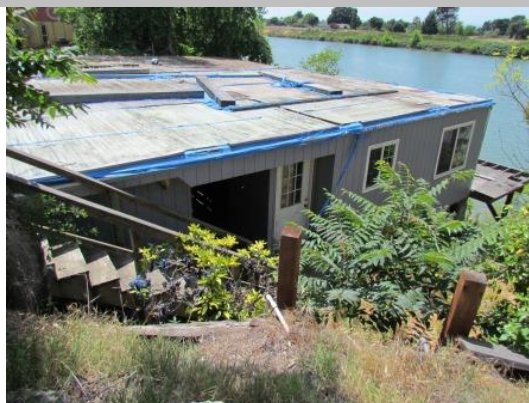
Photo 2 of 2 : SP_2015_RD0551_175_21_20150312_00001.jpg

Building and steps waterward. Photo taken 01-04-2014.

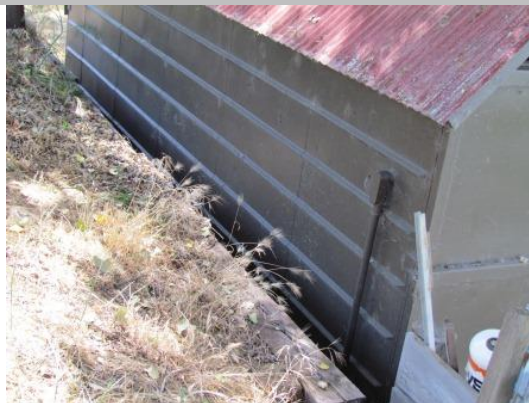
Photo 1 of 1 : SP_2015_RD0551_175_87_20150312_00004.jpg

LM Start	0.59	Rating **	U	Issue No.	87
LM End	0.59	Issue Type +	En	Location *	WS
Category	Earthen Levee			GPS Latitude/Longitude	
				Start	End
Item	Encroachments			38.329895 °	38.329895 °
				-121.571840 °	-121.571840 °
DWR ID	DWR_RD0551_01_s _ 2012_87				
Action/Comments					
Retaining Wall					
Inspector Comments: At this location the new landowner has placed a railroad tie retaining wall against the bank adjacent to the metal building. The district is working with the landowner to get a CVFPB permit. No new information for the fall 2014 inspection.

The unauthorized retaining wall remains. Photo taken 01-04-2014.

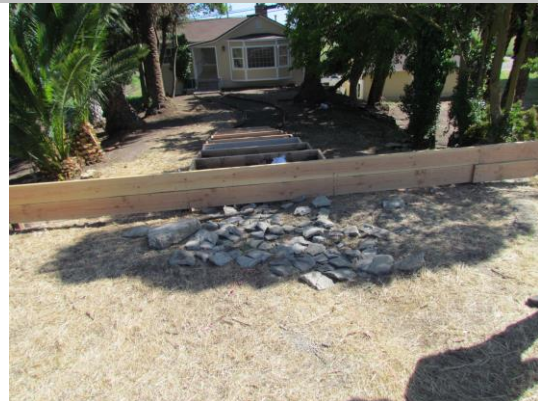
Photo 1 of 1 : SP_2015_RD0551_175_37_20150601_00018.jpg

LM Start	4.62	Rating **	M	Issue No.	37
LM End	4.62	Issue Type +	En	Location *	LS
Category	Earthen Levee			GPS Latitude/Longitude	
				Start	End
Item	Encroachments			38.280798 °	38.280798 °
				-121.546257 °	-121.546257 °
DWR ID	DWR_RD0551_01_s_2015_37				
Action/Comments					
Stairway					
Inspector Comments: The landowner is installing a stairway and headwall on landward slope at ramp. Gil Labrie is processing the permit.

View of unauthorized construction of a stairway on landside slope.
