**Flood Control Project Maintenance
Levee Inspections****LMA District Cover Sheet****Spring 2016 Levee Inspection Results****Reclamation District No. 0551 Pearson**

Levee Inspection Report By Mile - Spring 2016

Reclamation District No. 0551 Pearson

Waterway	Bank	Unit Miles	Inspection Start/End	Inspector
Unit No. 01 Sacramento River	Left	6.78	03/15/2016 03/15/2016	Herman Phillips

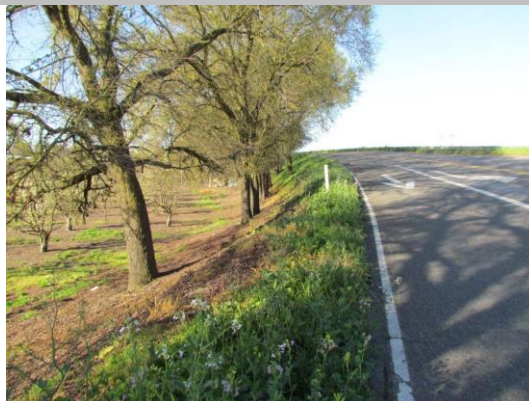
Photo 1 of 1 : SP_2016_RD0551_175_31_20160329_00037.jpg

LM Start	0.02	Rating **	M	Issue No.	31
LM End	0.02	Issue Type +	Ma	Location *	LS
Category	Earthen Levee			GPS Latitude/Longitude	
				Start	End
Item	Vegetation			38.336057 °	38.336057 °
				-121.564750 °	-121.564750 °
DWR ID	DWR_RD0551_01_s_2016_31				
Comment Code					
V1 : Control annual grass and weeds on the levee slopes and easements.					
Inspector Comment

Looking upstream from levee mile 0.00 landside slope RD 551.

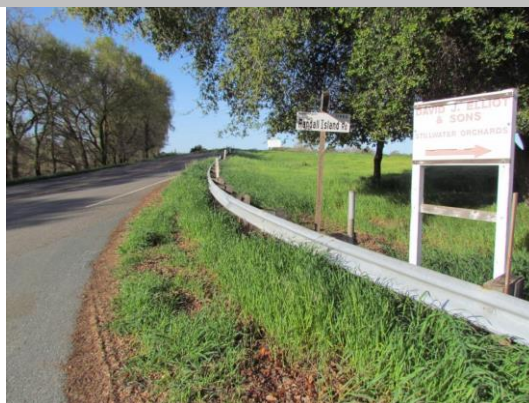
Photo 1 of 1 : SP_2016_RD0551_175_20_20160329_00038.jpg

LM Start	0.02	Rating **	M	Issue No.	20
LM End	6.78	Issue Type +	Ma	Location *	WS
Category	Earthen Levee			GPS Latitude/Longitude	
				Start	End
Item	Vegetation			38.336057 °	38.258923 °
				-121.564752 °	-121.517765 °
DWR ID	DWR_RD0551_01_s_2016_20				
Comment Code					
V1 : Control annual grass and weeds on the levee slopes and easements.					
Inspector Comment					
Weeds present on the waterside slope and shoulder.

Looking downstream from levee mile 0.00 waterside shoulder and slope.

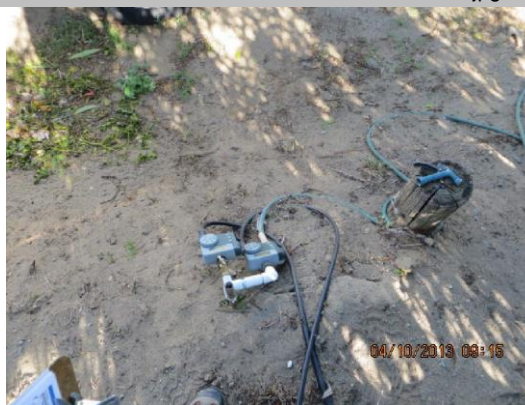
Photo 1 of 2 : UCIP_SP_2016_11705_19145.jpg

LM Start	0.41	Rating **	M	Issue No.	38
LM End	0.41	Issue Type +	En	Location *	WS
Category	Supplemental			GPS Latitude/Longitude	
				Start	End
Item	DWR UCIP Field Study			38.332039 °	38.332039 °
				-121.569730 °	-121.569730 °
DWR ID					
Comment Code					
Inspector Comment					
FS_ID:11705					
DS_ID:21982					
EP_NO: 2759					
Repair Type: Non-Urgent					
Crossing Status: Found					
UCIP Comments: Unclear where exact crossing is located.					
FIELD_STRUCT_DESC: 1-inch steel waterline through the levee.					
Ramp, boating facilities on waterward side (Courtland boating facilities).					
Pipe visible under buildings at concrete foundation on LS. Water					
service connections for irrigation located on WS slope. (Permit No.					
2759, 1959)					
FS Date: 4/10/2013

Irrigation pipes on WS slope.

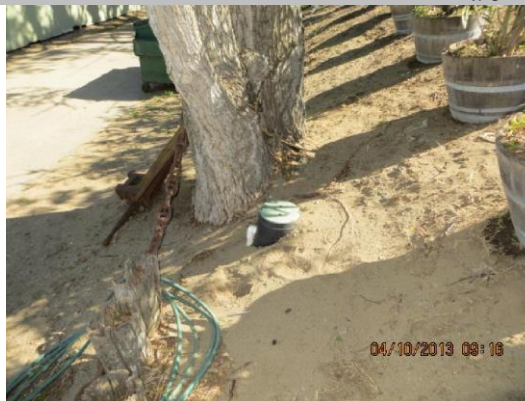
Photo 2 of 2 : UCIP_SP_2016_11705_19144.jpg

LM Start	0.41	Rating **	M	Issue No.	38 (cont)	
LM End	0.41	Issue Type +	En	Location *	WS	
Category	Supplemental			GPS Latitude/Longitude		
				Start	End	
Item	DWR UCIP Field Study			38.332039 °	38.332039 °	
				-121.569730 °	-121.569730 °	
DWR ID						
Comment Code						
Inspector Comment						
FS_ID:11705						
DS_ID:21982						
EP_NO: 2759						
Repair Type: Non-Urgent						
Crossing Status: Found						
UCIP Comments: Unclear where exact crossing is located.						
FIELD_STRUCT_DESC: 1-inch steel waterline through the levee.						
Ramp, boating facilities on waterward side (Courtland boating facilities).						
Pipe visible under buildings at concrete foundation on LS. Water						
service connections for irrigation located on WS slope. (Permit No.						
2759, 1959)						
FS Date: 4/10/2013

Irrigation pipes on WS slope.

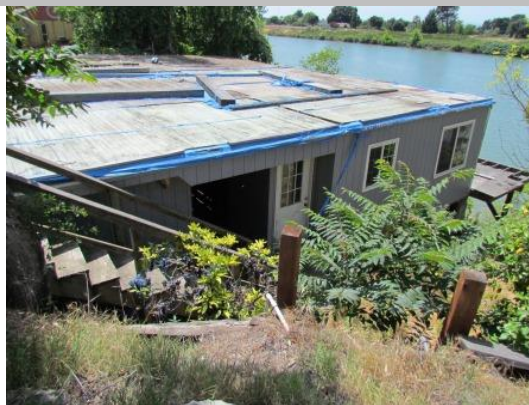
Photo 2 of 2 : SP_2016_RD0551_175_21_20160223_00002.jpg

Building and steps waterward. Photo taken 01-04-2014.

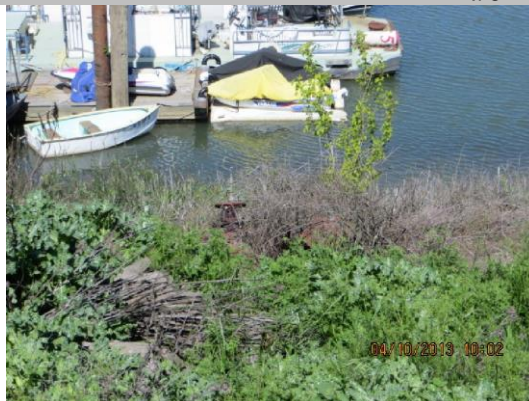
Photo 1 of 2 : UCIP_SP_2016_11726_19165.jpg

LM Start	0.71	Rating **	M	Issue No.	39
LM End	0.71	Issue Type +	En	Location *	WS
Category	Supplemental			GPS Latitude/Longitude	
				Start	End
Item	DWR UCIP Field Study			38.328401 °	38.328401 °
				-121.572954 °	-121.572954 °
DWR ID					
Comment Code					
Inspector Comment					
FS_ID:11726 DS_ID:21985 EP_NO: 6220 Repair Type: Non-Urgent Crossing Status: Found UCIP Comments: Pipe abandoned and should be removed. FIELD_STRUCT_DESC: 8-inch steel irrigation pipe through the levee 6.1-feet below the crown. Pump on waterside with slide gate and air vent. (Permit No. 6220, 1968) FS Date: 4/10/2013

Abandoned pump covered in vegetation on WS slope.

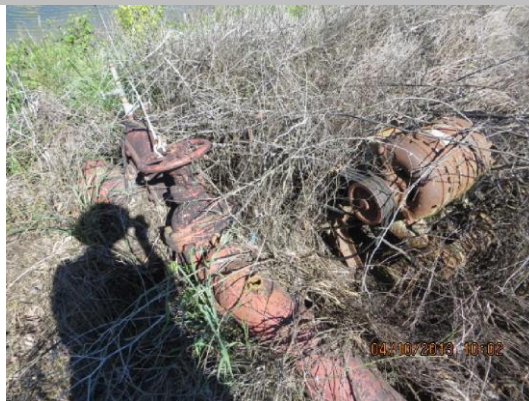
Photo 2 of 2 : UCIP_SP_2016_11726_19164.jpg

Pump, slide gate, and missing vent pipe on WS slope.

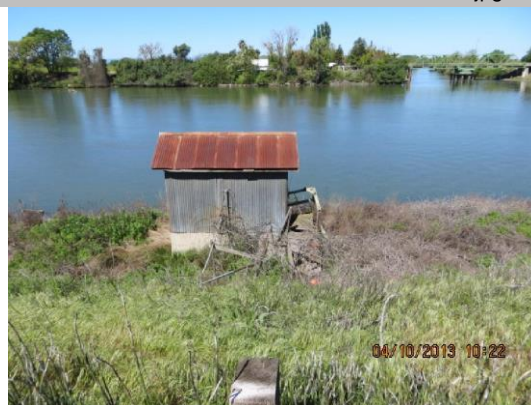
Photo 1 of 2 : UCIP_SP_2016_11727_19168.jpg

LM Start	0.89	Rating **	M	Issue No.	40
LM End	0.89	Issue Type +	En	Location *	LS
Category	Supplemental			GPS Latitude/Longitude	
				Start	End
Item	DWR UCIP Field Study			38.326088 °	38.326088 °
				-121.574525 °	-121.574525 °
DWR ID					
Comment Code					
Inspector Comment					
FS_ID:11727 DS_ID:21986 EP_NO: 701 Repair Type: Non-Urgent Crossing Status: Found UCIP Comments: Pipe appears abandoned and should be done so properly. Good candidate for video inspection. FIELD_STRUCT_DESC: 14-inch steel irrigation pipe through the levee, 7.2 feet below crown. Pump in pump house on waterward slope. Service pole on landward slope. (Permit No. 701-Smith). 1-inch galvanized filler pipe and a 2-inch electrical conduit at same location. Originally included in O+M manual (1959). FS Date: 4/10/2013

Pump house and pipes visible on WS slope.

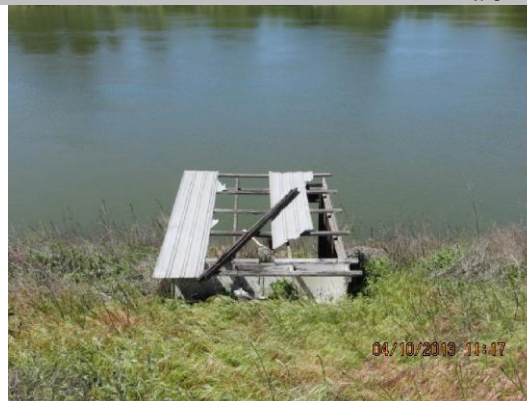
Photo 1 of 2 : UCIP_SP_2016_26874_49596.jpg

FS_ID:26874
DS_ID:21990
EP_NO: 11145
Repair Type: Non-Urgent
Crossing Status: Found
UCIP Comments: Based on District notes from January 14, 2014, pump discharge pipe has been repaired. Pipe failing on LS slope causing erosion along pipe alignment. Pipe debris on both slopes should be removed as well.: As of 12/13/2013 District President noted that the landowner had made repairs to the LS slope leaks.: As of 12/17/2013 District submitted letter to landowner explaining UCIP report details including photos of the pipe problems
FIELD_STRUCT_DESC: 10-inch pipe through levee, 4.7 feet below crown. Pump in 7'X9' concrete pump house on waterward slope. 36-inch concrete riser on LS toe. 1-inch electrical conduit at same location. Service pole at landward toe (ABO No. 11145-Towne). Originally included in O+M manual (1959).
FS Date: 1/15/2014

Pumphouse on WS slope.

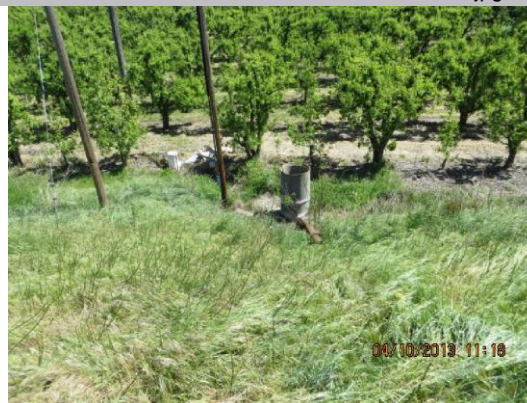
Photo 2 of 2 : UCIP_SP_2016_26874_49595.jpg

36-inch concrete standpipe at LS toe.

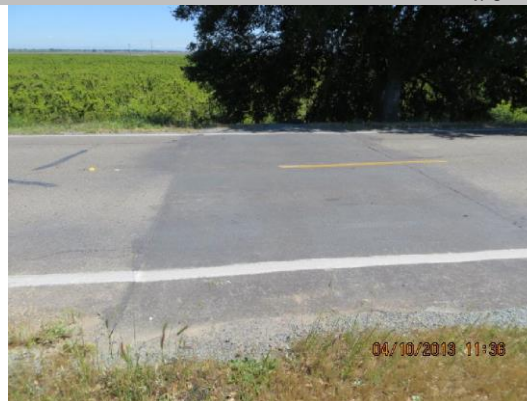
Photo 1 of 1 : UCIP_SP_2016_11749_19217.jpg

LM Start	2.01	Rating **	M	Issue No.	41
LM End	2.01	Issue Type +	En	Location *	WS
Category	Supplemental			GPS Latitude/Longitude	
				Start	End
Item	DWR UCIP Field Study			38.310237 °	38.310237 °
				-121.575470 °	-121.575470 °
DWR ID					
Comment Code					
Inspector Comment					
FS_ID:11749					
DS_ID:22040					
EP_NO: 3676					
Repair Type: Non-Urgent					
Crossing Status: Not Found					
UCIP Comments: Fresh cut through pavement on crown indicates recent work on pipes at this location. Need to determine if pipe was removed or abandoned in place.					
FIELD_STRUCT_DESC: 2 of 2: 8-inch steel irrigation pipe sleeved through a 12-inch pipe, 5 feet below crown. Pump on platform waterside. (Permit No. 3676-Wheeler).					
FS Date: 4/10/2013

Fresh cut through pavement at crown.

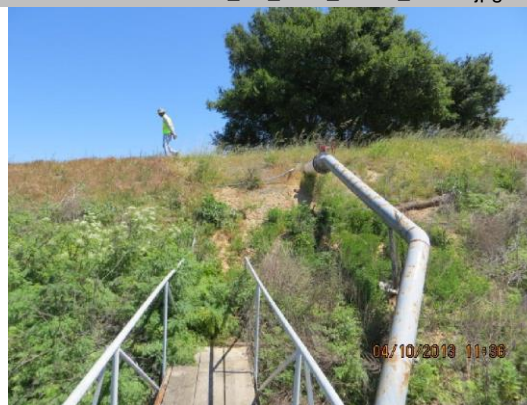
Photo 1 of 2 : UCIP_SP_2016_11763_19222.jpg

LM Start	2.01	Rating **	M	Issue No.	32
LM End	2.01	Issue Type +	En	Location *	WS
Category	Supplemental			GPS Latitude/Longitude	
				Start	End
Item	DWR UCIP Field Study			38.310223 °	38.310223 °
				-121.575458 °	-121.575458 °
DWR ID					
Comment Code					
Inspector Comment					
FS_ID:11763					
DS_ID:21991					
EP_NO: 6551					
Repair Type: Non-Urgent					
Crossing Status: Found					
UCIP Comments: Rodent activity undermining pipe on LS slope.					
FIELD_STRUCT_DESC: 1 of 2: 14-inch PVC wrapped Steel irrigation					
pipe 3-feet below the crown. Butterfly valve on WS shoulder. 2-inch					
galvanized electric conduit at same location. Pump on pile structure on					
WS toe. Pressure booster and pump on LS toe. (Permit No. 6551-					
Wheeler 1969).					
FS Date: 4/10/2013

Pipe, butterfly valve, and electrical conduit 3-feet below the crown on the WS shoulder.

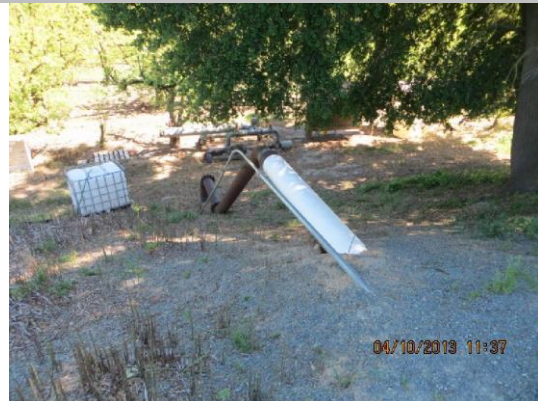
Photo 2 of 2 : UCIP_SP_2016_11763_19221.jpg

LM Start	2.01	Rating **	M	Issue No.	32 (cont)	
LM End	2.01	Issue Type +	En	Location *	WS	
Category	Supplemental			GPS Latitude/Longitude		
				Start	End	
Item	DWR UCIP Field Study			38.310223 °	38.310223 °	
				-121.575458 °	-121.575458 °	
DWR ID						
Comment Code						
Inspector Comment						
FS_ID:11763						
DS_ID:21991						
EP_NO: 6551						
Repair Type: Non-Urgent						
Crossing Status: Found						
UCIP Comments: Rodent activity undermining pipe on LS slope.						
FIELD_STRUCT_DESC: 1 of 2: 14-inch PVC wrapped Steel irrigation						
pipe 3-feet below the crown. Butterfly valve on WS shoulder. 2-inch						
galvanized electric conduit at same location. Pump on pile structure on						
WS toe. Pressure booster and pump on LS toe. (Permit No. 6551-						
Wheeler 1969).						
FS Date: 4/10/2013

Pipe, electrical conduit, and booster pump on LS toe.

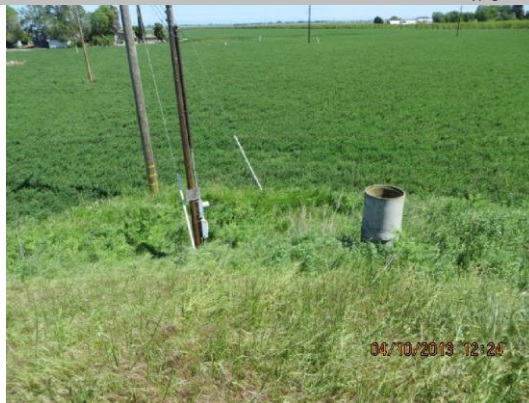
Photo 1 of 2 : UCIP_SP_2016_11783_19241.jpg

LM Start	2.41	Rating **	M	Issue No.	33
LM End	2.41	Issue Type +	En	Location *	LS
Category	Supplemental			GPS Latitude/Longitude	
				Start	End
Item	DWR UCIP Field Study			38.305189 °	38.305189 °
				-121.572012 °	-121.572012 °
DWR ID					
Comment Code					
Inspector Comment					
FS_ID:11783 DS_ID:21994 EP_NO: 11141 Repair Type: Non-Urgent Crossing Status: Found UCIP Comments: Records indicate this pipe was abandoned, but it appears to be active. Verify status. FIELD_STRUCT_DESC: 10-inch steel irrigation pipe through levee, 8.0 feet below the crown. Slant pump on waterward slope. Service pole on landward slope with a 1.5-inch galvanized iron electrical conduit through the levee at same location. (ABO No. 11141-Runyon). Originally included in O+M manual (1959). FS Date: 4/10/2013

JP and concrete standpipe on LS toe.

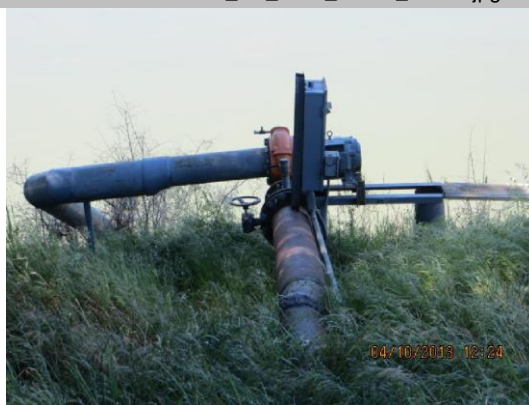
Photo 2 of 2 : UCIP_SP_2016_11783_19240.jpg

Pump, pipe, and butterfly valve on WS slope.

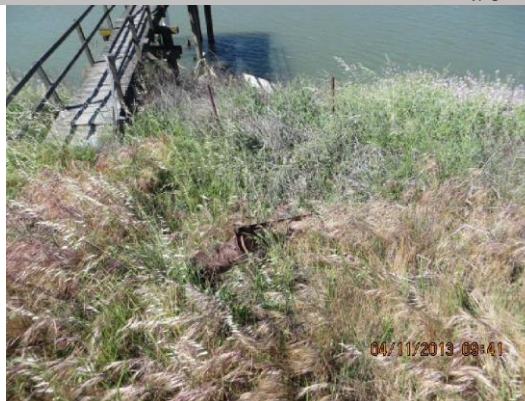
Photo 1 of 2 : UCIP_SP_2016_11817_19287.jpg

LM Start	4.01	Rating **	M	Issue No.	36
LM End	4.01	Issue Type +	En	Location *	LS
Category	Supplemental			GPS Latitude/Longitude	
				Start	End
Item	DWR UCIP Field Study			38.286593 °	38.286593 °
				-121.554591 °	-121.554591 °
DWR ID					
Comment Code					
Inspector Comment					
FS_ID:11817					
DS_ID:22034					
EP_NO: N/A					
Repair Type: Non-Urgent					
Crossing Status: Found					
UCIP Comments: Abandoned. Determine if pipe was removed or abandoned in place.					
FIELD_STRUCT_DESC: 8-inch irrigation pipe through the levee 6.7-feet below the crown. Abandoned slide gate at pad on WS slope.					
Originally included in O+M manual 1959.					
FS Date: 4/11/2013

Abandoned slide gate on WS slope.

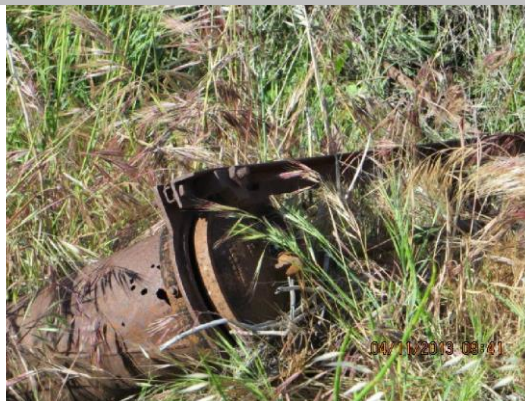
Photo 2 of 2 : UCIP_SP_2016_11817_19286.jpg

Abandoned slide gate on WS slope.

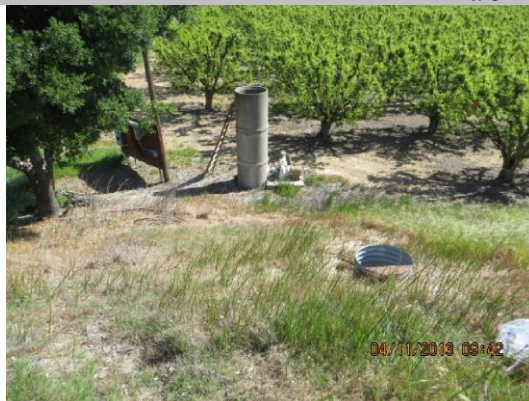
Photo 1 of 2 : UCIP_SP_2016_11823_19301.jpg

LM Start	4.02	Rating **	M	Issue No.	37
LM End	4.02	Issue Type +	En	Location *	LS
Category	Supplemental			GPS Latitude/Longitude	
				Start	End
Item	DWR UCIP Field Study			38.286568 °	38.286568 °
				-121.554569 °	-121.554569 °
DWR ID					
Comment Code					
Inspector Comment					
FS_ID:11823 DS_ID:22018 EP_NO: 11146 Repair Type: Non-Urgent Crossing Status: Found UCIP Comments: Wooden walkway in bad repair and presents a hazard to the public. FIELD_STRUCT_DESC: 14-inch pipe through levee, 10.4 feet below crown. Pump on pile structure in stream with wooden walkway. 48-inch concrete standpipe on LS toe with booster pump and electric panel. Siphon breaker in 24-inch CMP riser on LS slope. 1.5-inch electrical conduit at same location.(ABO No. 11146- Turner). Originally included in O+M manual 1959. FS Date: 4/11/2013

24-inch CMP riser and 48-inch concrete riser on LS slope.

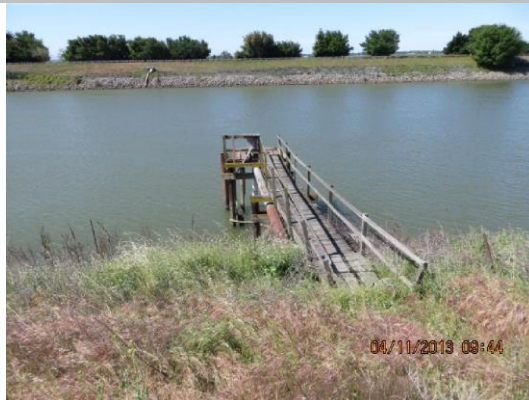
Photo 2 of 2 : UCIP_SP_2016_11823_19300.jpg

Pump on pier with wooden walkway on WS toe.

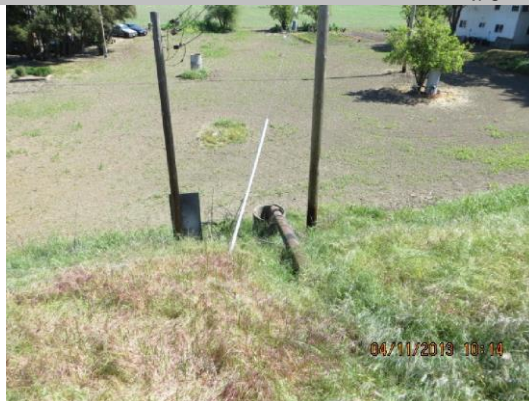
Photo 1 of 2 : UCIP_SP_2016_46644_46281.jpg

FS_ID:46644
DS_ID:22020
EP_NO: 11152
Repair Type: Urgent
Crossing Status: Found
UCIP Comments: Pier for pump is falling apart and is a hazard to the public. Some settlement along pipe on LS slope.: As of 12/13/2013 the District has contacted the tenant farmer who is in the process of contacting the owner to update on condition of pipe: As of 12/17/2013 District submitted letter to landowner explaining UCIP report details including photos of the pipe problems: (Olivia) As of 09/21/2015 owner is working with Gilbert Labrie, LMA consultant, to resolve issue.
FIELD_STRUCT_DESC: 10-inch steel irrigation pipe through the levee 6.5 feet below the crown. Pump on pile structure in stream. Service pole at landward toe and a 36-inch concrete riser on the LS toe. 1-inch electrical conduit at same location. (ABO No. 11152-Wilcox) Originally included in O+M manual 1959.
FS Date: 4/11/2013

Pipe and stand pipe on LS toe with subsidence along pipe on LS slope.

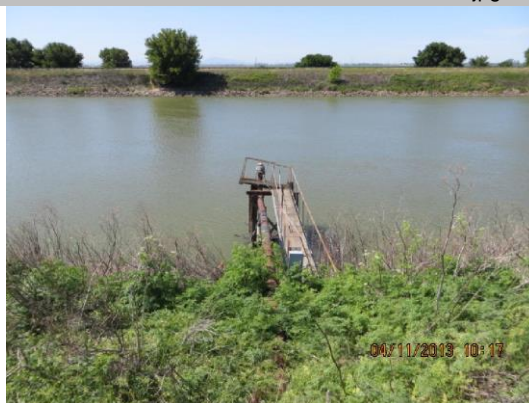
Photo 2 of 2 : UCIP_SP_2016_46644_46280.jpg

Pump on pier showing structural failure on WS toe.

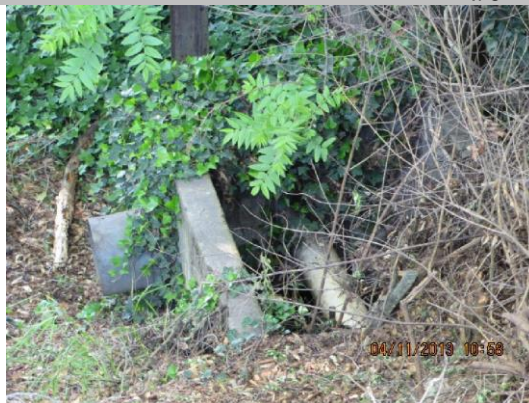
Photo 1 of 2 : UCIP_SP_2016_12105_19649.jpg

LM Start	5.05	Rating **	M	Issue No.	35
LM End	5.05	Issue Type +	En	Location *	LS
Category	Supplemental			GPS Latitude/Longitude	
				Start	End
Item	DWR UCIP Field Study			38.276220 °	38.276220 °
				-121.540811 °	-121.540811 °
DWR ID					
Comment Code					
Inspector Comment					
FS_ID:12105 DS_ID:22022 EP_NO: 11125 Repair Type: Non-Urgent Crossing Status: Found UCIP Comments: Pumphouse has been removed from pump and pump is in disrepair. Pipe at LS toe is sleeved or has been replaced with a 6-inch PVC pipe. This pump appears abandoned and should be done so properly. FIELD_STRUCT_DESC: 6-inch pipe through the levee 6.5-feet below the crown. Pump and slide gate on WS slope. 1-inch electrical conduit at same location with service pole at landward toe. 4'X6' concrete distribution box at LS toe (ABO No. 11125- Cortopassi). Originally included in O+M manual 1959. FS Date: 4/11/2013

Pipe in distribution box at LS toe.

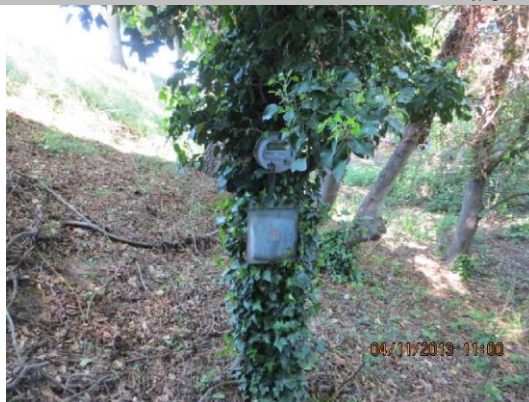
Photo 2 of 2 : UCIP_SP_2016_12105_19648.jpg

Meter on pole at LS toe.

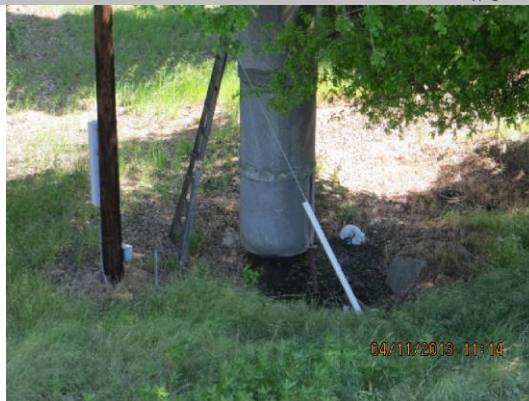
Photo 1 of 2 : UCIP_SP_2016_26875_49602.jpg

Comment Code					
Inspector Comment					
FS_ID:26875 DS_ID:22023 EP_NO: 11131 Repair Type: Non-Urgent Crossing Status: Found UCIP Comments: Based on District notes from January 15, 2014, pump discharge pipe has been repaired. Corrosion holes in pipe at LS toe good indicator that pipe is failing internally. Pipe should be examined internally for damage (video inspect).: As of 12/12/2013 the District discussed with farmer tenant what needed to be done, and the tenant informed the District that they would address the repairs.: As of 12/17/2013 District submitted letter to landowner explaining UCIP report details including photos of the pipe problems FIELD_STRUCT_DESC: 10-inch pipe through the levee 7.7-feet below the crown. Pump and slide gate on concrete pad on waterward slope. Siphon breaker in 24-inch CMP riser on LS slope. Concrete riser, power pole with panel box on landward toe. (ABO No. 11131-Latimer). Originally included in the O+M manual 1959. FS Date: 1/15/2014

Concrete standpipe, JP and meter, and 4-inch steel pipe visible at LS toe.

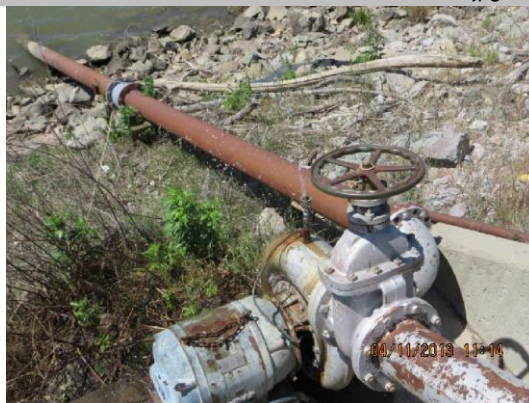
Photo 2 of 2 : UCIP_SP_2016_26875_49601.jpg

Pump and slide gate at Concrete pad on WS slope.
