**Flood Control Project Maintenance
Levee Inspections**
LMA District Cover Sheet
Spring 2017 Levee Inspection Results

Reclamation District No. 0551 Pearson

Levee Inspection Report By Mile - Spring 2017

| Waterway | Bank | Unit Miles | Inspection Start/End | Inspector |
|---|---|---|---|---|
| Unit No. 01 Sacramento River | Left | 6.78 | 04/06/2017 04/06/2017 | Herman Phillips |

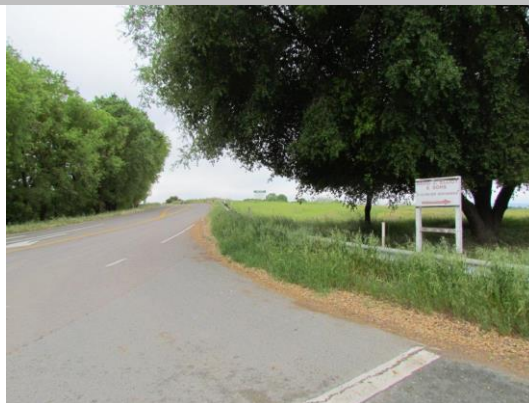
Photo 1 of 1 : SP_2017_RD0551_175_18_20170410_00037.jpg

| Item | Vegetation | | | 38.335987 ° | 38.258998 ° |

Levee mile 0.00 looking downstream waterside levee slope.

| Control the weed growth on the waterside levee slope. | | | | | |

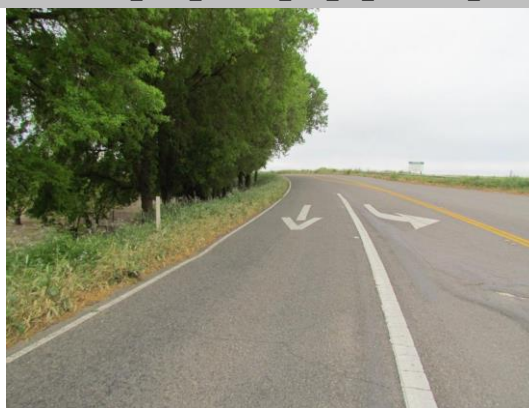
Photo 1 of 1 : SP_2017_RD0551_175_17_20170410_00038.jpg

Looking downstream at the landside levee slope.

| Control the weeds and annual grass growth on the landside levee slope. | | | | | |

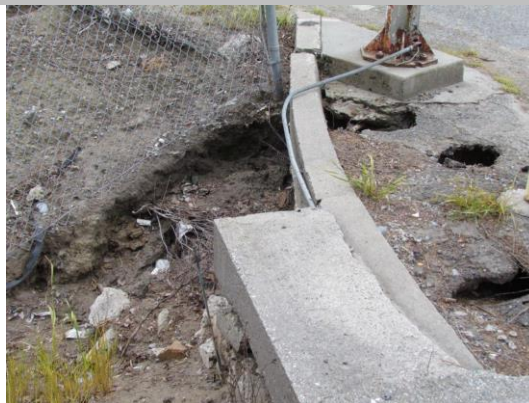
Photo 1 of 3 : SP_2017_RD0551_175_25_20170410_00039.jpg

| This erosion was discovered by the property owner during the Feb 2017 Storm event Mr. Tony of Tony's Market Courtland Ca. It was brought to our attention during this Spring inspection 4-06-2017. | | | | | |

From landside standing North of erosion. The concrete footing is being undermined.

| E2 : Schedule repair of erosion site prior to the next inspection. | | | | | |

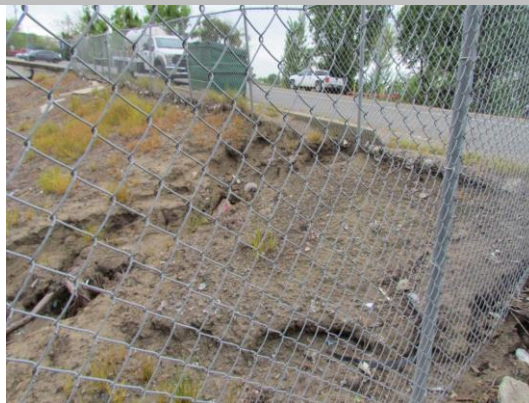
Photo 2 of 3 : SP_2017_RD0551_175_25_20170410_00040.jpg

Standing on the shoulder North of the eroded slope looking downstream of slope.

| E2 : Schedule repair of erosion site prior to the next inspection. | | | | | | |

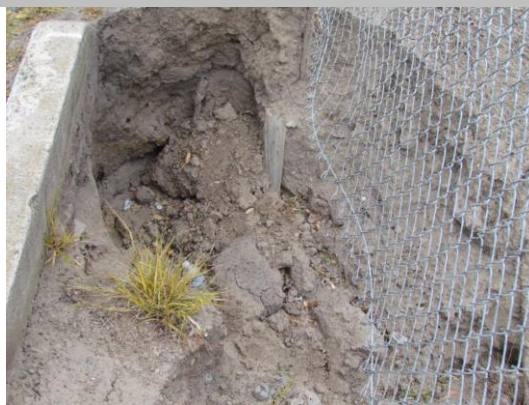
Photo 3 of 3 : SP_2017_RD0551_175_25_20170410_00041.jpg

Standing south of the eroded slope looking upstream. The cut is 3 foot deep and 6 foot wide.

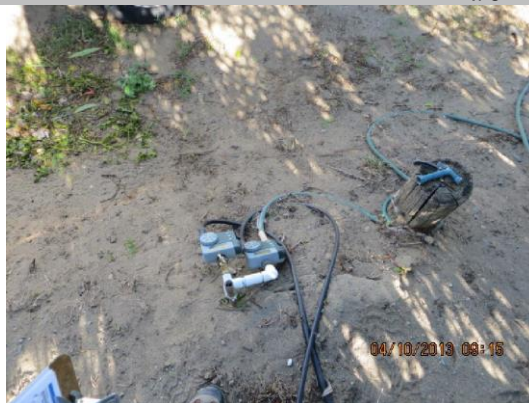
Photo 1 of 3 : UCIP_SP_2017_11705_19145.jpg

| Pipe visible under buildings at concrete foundation on LS. Water | | | | | |

Irrigation pipes on WS slope.

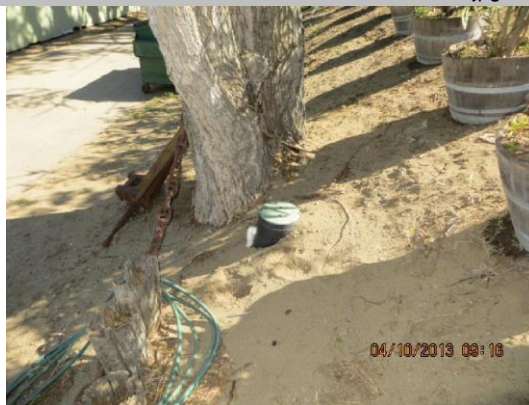
Photo 2 of 3 : UCIP_SP_2017_11705_19144.jpg

Irrigation pipes on WS slope.

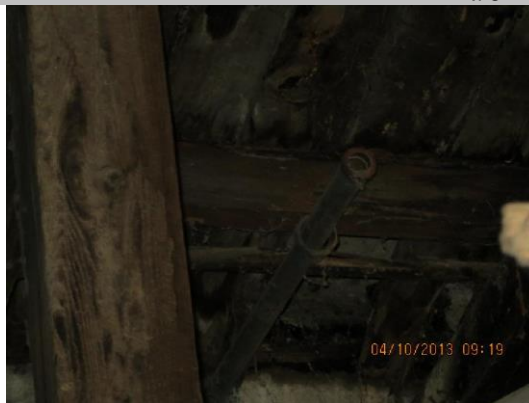
Photo 3 of 3 : UCIP_SP_2017_11705_19143.jpg

| Pipe visible under buildings at concrete foundation on LS. Water | | | | | | |

Various disconnected pipes visible at foundation/retaining wall under buildings on LS.

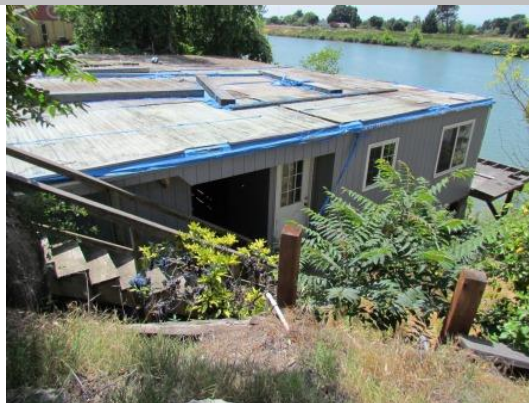
Photo 1 of 3 : SP_2017_RD0551_175_21_20170404_00001.jpg

Building and steps waterward. Photo taken 01-04-2014.

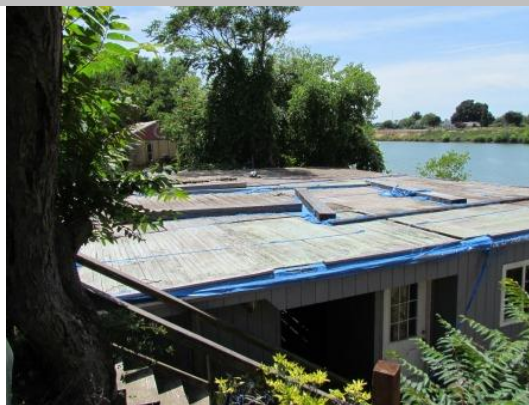
Photo 2 of 3 : SP_2017_RD0551_175_21_20170404_00002.jpg

Building remodeling project on waterside levee section. Photo taken 01-04-2014.

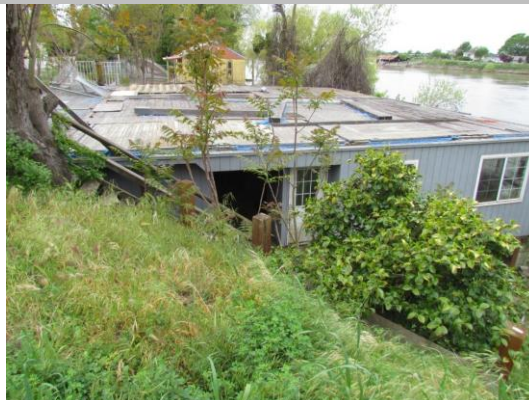
Photo 3 of 3 : SP_2017_RD0551_175_21_20170410_00042.jpg

Photo taken 4-06-2017 no change. No work done, no permit issued.

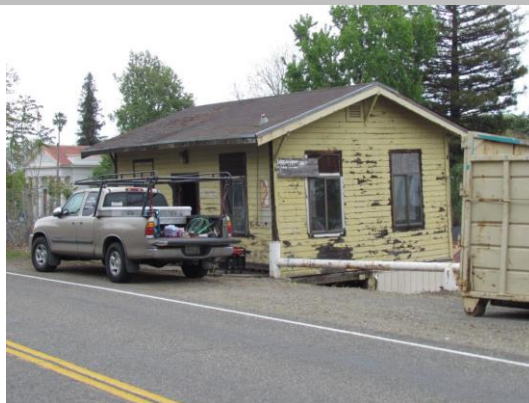
Photo 1 of 1 : SP_2017_RD0551_175_20_20170410_00036.jpg

| Unauthorized restoration work on building. No CVFPB Permit. | | | | | |

Landside shoulder levee mile 0.53 unauthorized restoration work.

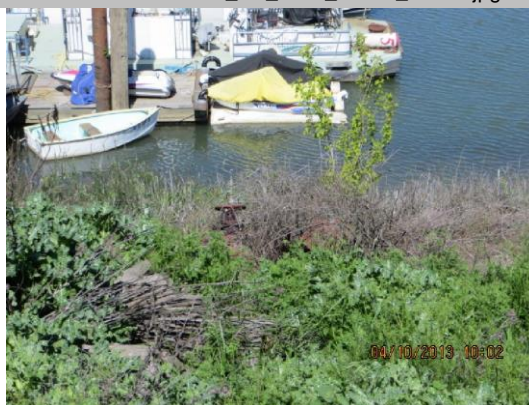
Photo 1 of 3 : UCIP_SP_2017_11726_19165.jpg

| FS_ID:11726 DS_ID:21985 EP_NO: 6220 Repair Type: Non-Urgent Crossing Status: Found UCIP Comments: Pipe abandoned and should be removed. FIELD_STRUCT_DESC: 8-inch steel irrigation pipe through the levee 6.1-feet below the crown. Pump on waterside with slide gate and air vent. (Permit No. 6220, 1968) FS Date: 4/10/2013 | | | | | |

Abandoned pump covered in vegetation on WS slope.

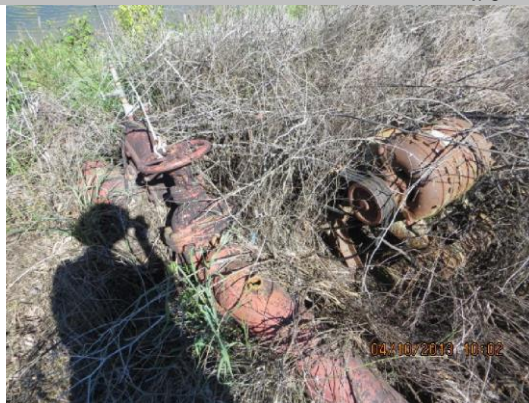
Photo 2 of 3 : UCIP_SP_2017_11726_19164.jpg

Pump, slide gate, and missing vent pipe on WS slope.

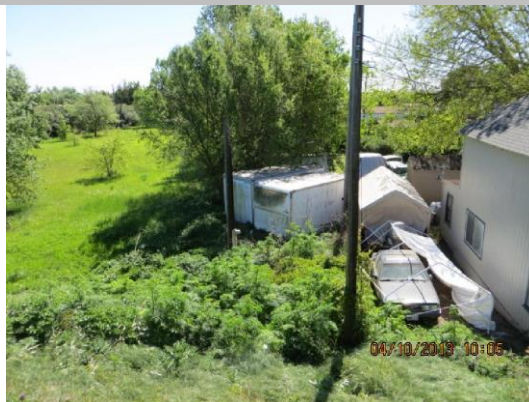
Photo 3 of 3 : UCIP_SP_2017_11726_19163.jpg

JP and pipe covered with vegetation on LS toe.

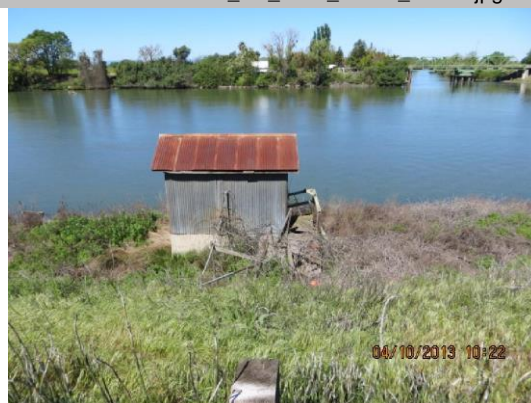
Photo 1 of 3 : UCIP_SP_2017_11727_19168.jpg

Pump house and pipes visible on WS slope.

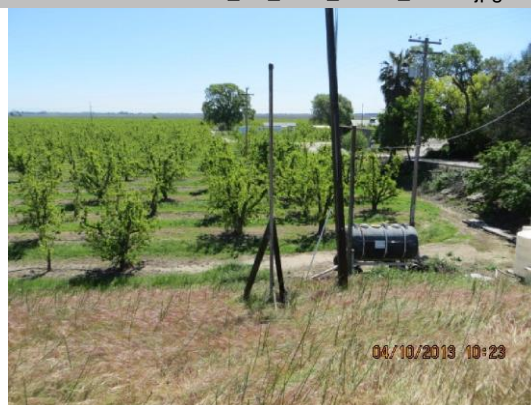
Photo 2 of 3 : UCIP_SP_2017_11727_19167.jpg

Pipe and JP visible on LS toe.

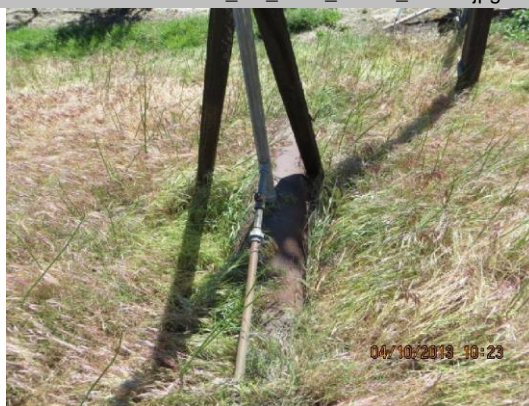
Photo 3 of 3 : UCIP_SP_2017_11727_19166.jpg

galvanized iron filler pipe and 16-inch pipe visible at LS toe.

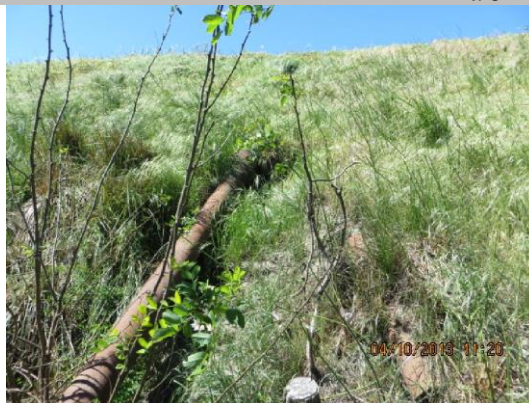
Photo 3 of 3 : UCIP_SP_2017_26874_49594.jpg

| FS_ID:26874 DS_ID:21990 EP_NO: 11145 Repair Type: Non-Urgent Crossing Status: Found UCIP Comments: Based on District notes from January 14, 2014, pump discharge pipe has been repaired. Pipe failing on LS slope causing erosion along pipe alignment. Pipe debris on both slopes should be removed as well.: As of 12/13/2013 District President noted that the landowner had made repairs to the LS slope leaks.: As of 12/17/2013 District submitted letter to landowner explaining UCIP report details including photos of the pipe problems FIELD_STRUCT_DESC: 10-inch pipe through levee, 4.7 feet below crown. Pump in 7'X9' concrete pump house on waterward slope. 36-inch concrete riser on LS toe. 1-inch electrical conduit at same location. Service pole at landward toe (ABO No. 11145-Towne). Originally included in O+M manual (1959). FS Date: 1/15/2014 | | | | | | |

Pipe failing on LS slope due to corrosion holes causing erosion.

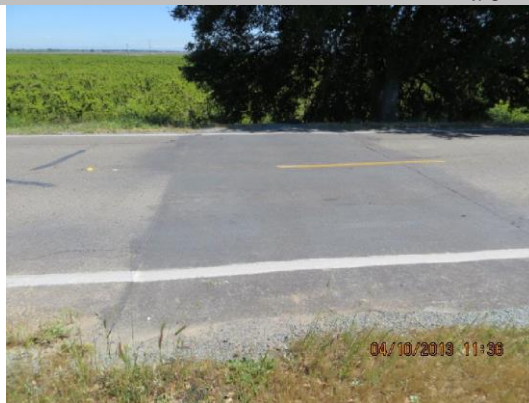
Photo 1 of 1 : UCIP_SP_2017_11749_19217.jpg

Fresh cut through pavement at crown.

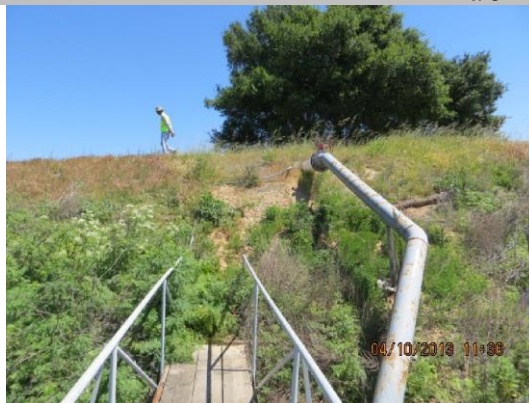
Photo 1 of 3 : UCIP_SP_2017_11763_19222.jpg

Pipe, butterfly valve, and electrical conduit 3-feet below the crown on the WS shoulder.

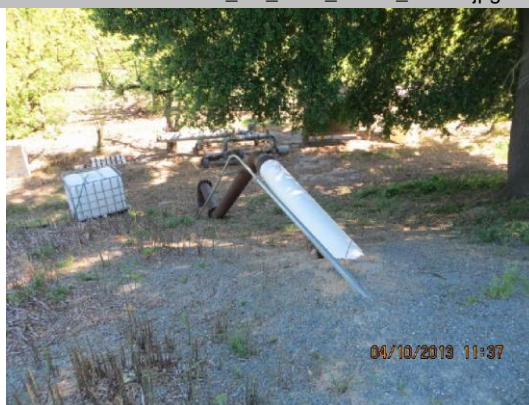
Photo 2 of 3 : UCIP_SP_2017_11763_19221.jpg

Pipe, electrical conduit, and booster pump on LS toe.

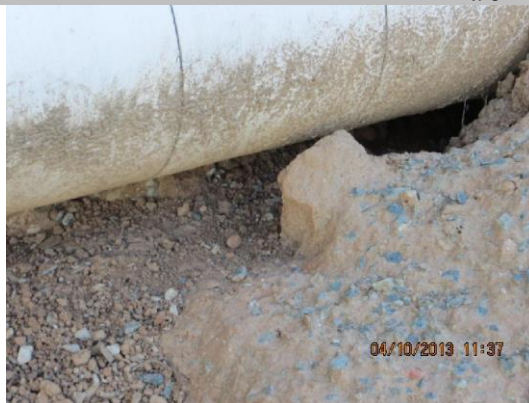
Photo 3 of 3 : UCIP_SP_2017_11763_19220.jpg

| FS_ID:11763 DS_ID:21991 EP_NO: 6551 Repair Type: Non-Urgent Crossing Status: Found UCIP Comments: Rodent activity undermining pipe on LS slope. FIELD_STRUCT_DESC: 1 of 2: 14-inch PVC wrapped Steel irrigation pipe 3-feet below the crown. Butterfly valve on WS shoulder. 2-inch galvanized electric conduit at same location. Pump on pile structure on WS toe. Pressure booster and pump on LS toe. (Permit No. 6551-Wheeler 1969). FS Date: 4/10/2013 | | | | | |

Rodent activity undermining pipe on LS slope.

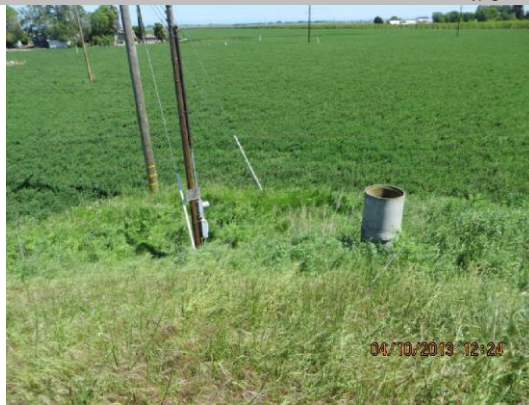
Photo 1 of 2 : UCIP_SP_2017_11783_19241.jpg

| FS_ID:11783 DS_ID:21994 EP_NO: 11141 Repair Type: Non-Urgent Crossing Status: Found UCIP Comments: Records indicate this pipe was abandoned, but it appears to be active. Verify status. FIELD_STRUCT_DESC: 10-inch steel irrigation pipe through levee, 8.0 feet below the crown. Slant pump on waterward slope. Service pole on landward slope with a 1.5-inch galvanized iron electrical conduit through the levee at same location. (ABO No. 11141-Runyon). Originally included in O+M manual (1959). FS Date: 4/10/2013 | | | | | |

JP and concrete standpipe on LS toe.

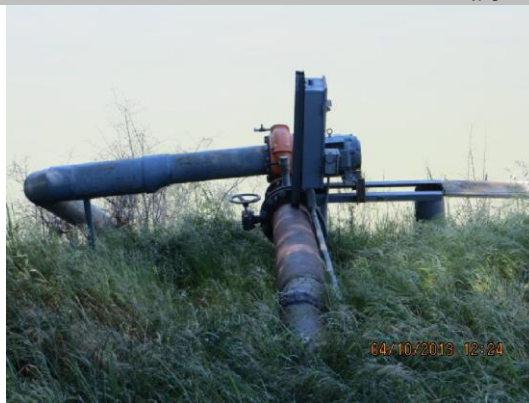
Photo 2 of 2 : UCIP_SP_2017_11783_19240.jpg

Pump, pipe, and butterfly valve on WS slope.

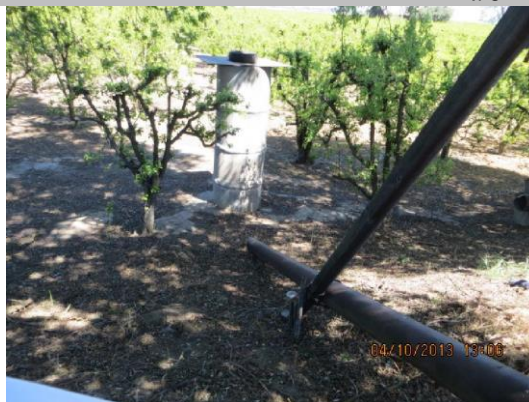
Photo 1 of 2 : UCIP_SP_2017_11803_19261.jpg

48-inch concrete riser on LS toe.

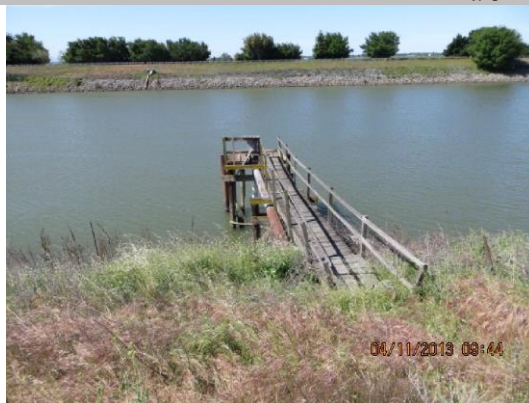
Photo 2 of 2 : UCIP_SP_2017_11823_19300.jpg

| FS_ID:11823 DS_ID:22018 EP_NO: 11146 Repair Type: Non-Urgent Crossing Status: Found UCIP Comments: Wooden walkway in bad repair and presents a hazard to the public. FIELD_STRUCT_DESC: 14-inch pipe through levee, 10.4 feet below crown. Pump on pile structure in stream with wooden walkway. 48-inch concrete standpipe on LS toe with booster pump and electric panel. Siphon breaker in 24-inch CMP riser on LS slope. 1.5-inch electrical conduit at same location.(ABO No. 11146- Turner). Originally included in O+M manual 1959. FS Date: 4/11/2013 | | | | | | |

Pump on pier with wooden walkway on WS toe.

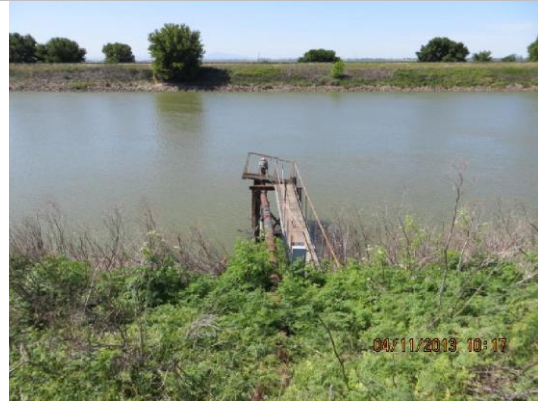
Photo 2 of 3 : UCIP_SP_2017_51324_46280.jpg

FS_ID:51324
DS_ID:22020
EP_NO: 11152
Repair Type: Non-Urgent
Crossing Status: Found
UCIP Comments: 10/24/2016 Per Mr. Topper Van Loben, LMA contact, new owner is working with DCC Engineering to obtain CVFPB permit for pipe rehabilitation. Work rehabilitation for existing pipe includes sleeving an 8-inch steel pipe through existing pipe and grouting space between pipes. Crossing has been downgraded to Non-Urgent since walkway has been repaired and pipe in the process of being rehabilitated. UCIP staff is waiting for permit authorizing pipe rehabilitation. (O. Magana - DWR UCIP) (Olivia) As of 09/21/2015 owner is working with Gilbert Labrie, LMA consultant, to resolve issue. (T. Van Loben - LMA representative / G. Labrie - LMA Engineer - DCC Engineering) As of 12/17/2013 District submitted letter to landowner explaining UCIP report details including photos of the pipe problems. (T. Van Loben - LMA representative / G. Labrie - LMA Engineer - DCC Engineering) As of 12/13/2013 the District has contacted the tenant farmer who is in the process of contacting the owner to update on condition of pipe. (T. Van Loben - LMA representative / G. Labrie - LMA Engineer - DCC Engineering) 04/11/2013 Pier for pump is falling apart and is a hazard to the public. Some settlement along pipe on LS slope. (W. Wylie - DWR UCIP)

Pump on pier showing structural failure on WS toe.

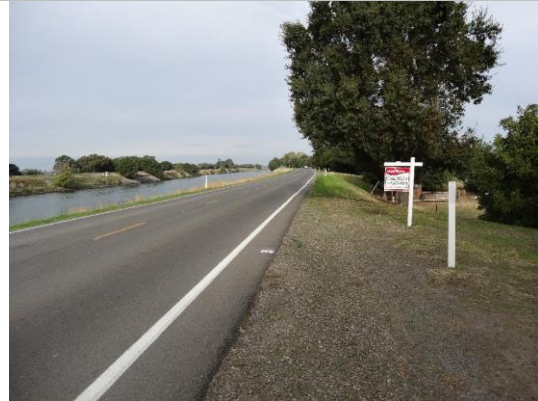
Photo 3 of 3 : UCIP_SP_2017_51324_76157.jpg

View of levee crown and LS slope, photo taken downstream of crossing looking upstream.

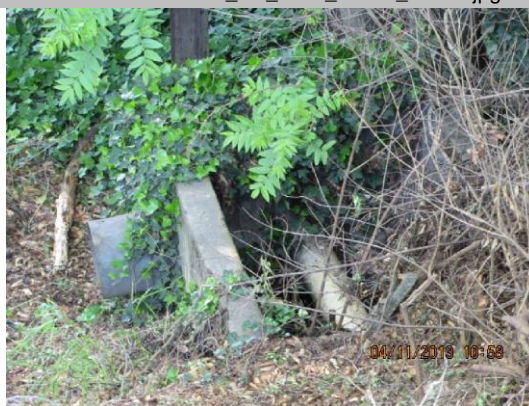
Photo 1 of 3 : UCIP_SP_2017_12105_19649.jpg

| FS_ID:12105 DS_ID:22022 EP_NO: 11125 Repair Type: Non-Urgent Crossing Status: Found UCIP Comments: Pumphouse has been removed from pump and pump is in disrepair. Pipe at LS toe is sleeved or has been replaced with a 6-inch PVC pipe. This pump appears abandoned and should be done so properly. FIELD_STRUCT_DESC: 6-inch pipe through the levee 6.5-feet below the crown. Pump and slide gate on WS slope. 1-inch electrical conduit at same location with service pole at landward toe. 4'X6' concrete distribution box at LS toe (ABO No. 11125- Cortopassi). Originally included in O+M manual 1959. FS Date: 4/11/2013 | | | | | |

Pipe in distribution box at LS toe.

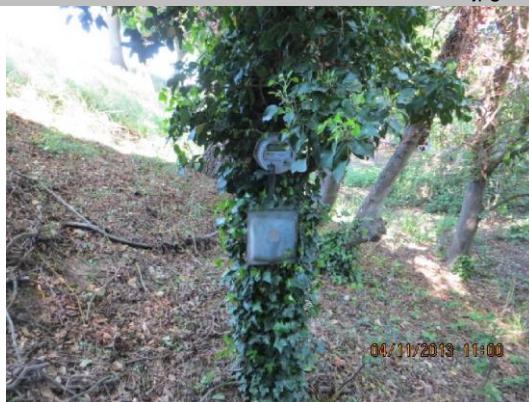
Photo 2 of 3 : UCIP_SP_2017_12105_19648.jpg

Meter on pole at LS toe.

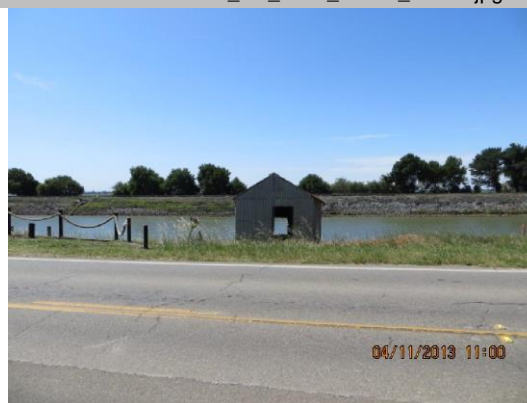
Photo 3 of 3 : UCIP_SP_2017_12105_19647.jpg

Relocated pumphouse on WS shoulder.

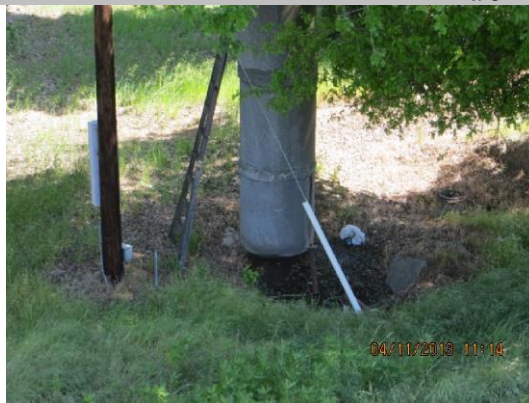
Photo 1 of 3 : UCIP_SP_2017_26875_49602.jpg

FS_ID:26875
DS_ID:22023
EP_NO: 11131
Repair Type: Non-Urgent
Crossing Status: Found
UCIP Comments: Based on District notes from January 15, 2014, pump discharge pipe has been repaired. Corrosion holes in pipe at LS toe good indicator that pipe is failing internally. Pipe should be examined internally for damage (video inspect).: As of 12/12/2013 the District discussed with farmer tenant what needed to be done, and the tenant informed the District that they would address the repairs.: As of 12/17/2013 District submitted letter to landowner explaining UCIP report details including photos of the pipe problems
FIELD_STRUCT_DESC: 10-inch pipe through the levee 7.7-feet below the crown. Pump and slide gate on concrete pad on waterward slope. Siphon breaker in 24-inch CMP riser on LS slope. Concrete riser, power pole with panel box on landward toe. (ABO No. 11131-Latimer). Originally included in the O+M manual 1959.

Concrete standpipe, JP and meter, and 4-inch steel pipe visible at LS toe.

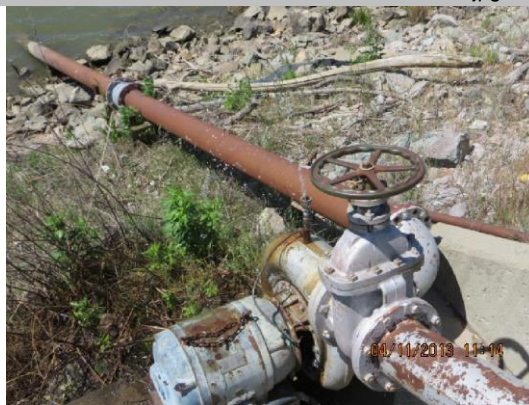
Photo 2 of 3 : UCIP_SP_2017_26875_49601.jpg

Pump and slide gate at Concrete pad on WS slope.

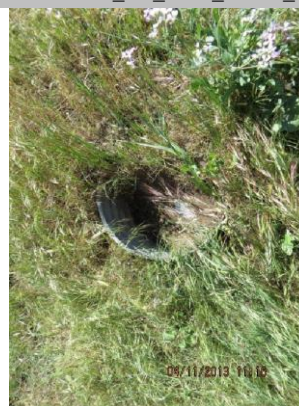
Photo 3 of 3 : UCIP_SP_2017_26875_49600.jpg

Siphon breaker in 24-inch CMP riser on LS slope.
