**Flood Control Project Maintenance  
Levee Inspections**  
**LMA District Cover Sheet**  
**Spring 2018 Levee Inspection Results**

**Reclamation District No. 0551 Pearson**

**Spring 2018 Levee Inspection Results**

## Levee Inspection Report By Mile - Spring 2018

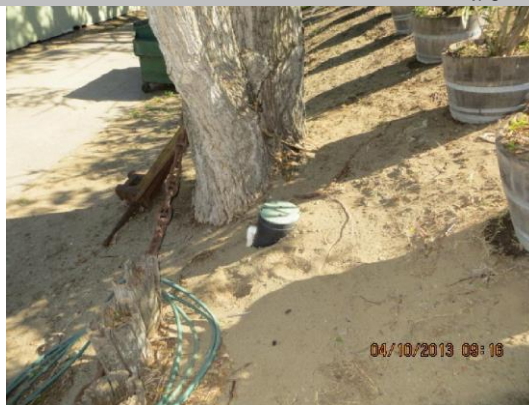
Photo 2 of 3 : UCIP\_SP\_2018\_11705\_19144.jpg

Irrigation pipes on WS slope.

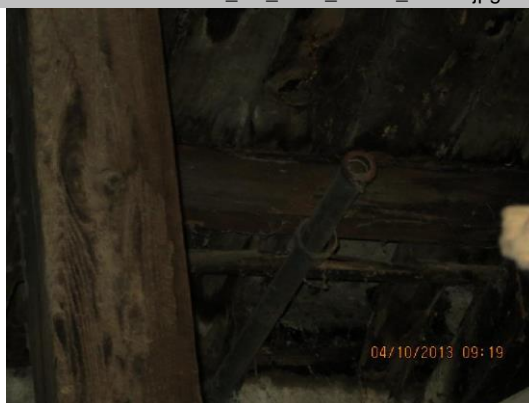
Photo 3 of 3 : UCIP\_SP\_2018\_11705\_19143.jpg

Various disconnected pipes visible at foundation/retaining wall under buildings on LS.

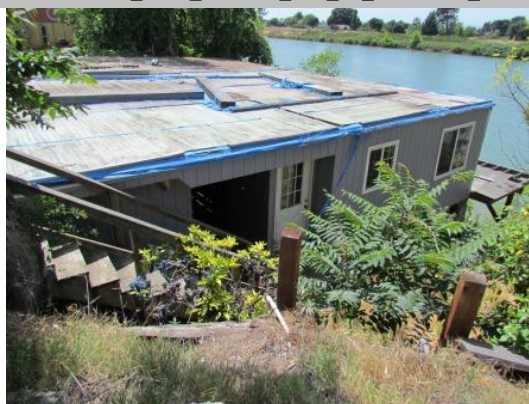
Photo 1 of 3 : SP\_2018\_RD0551\_175\_21\_20180305\_00009.jpg

Building and steps waterward. Photo taken 01-04-2014.

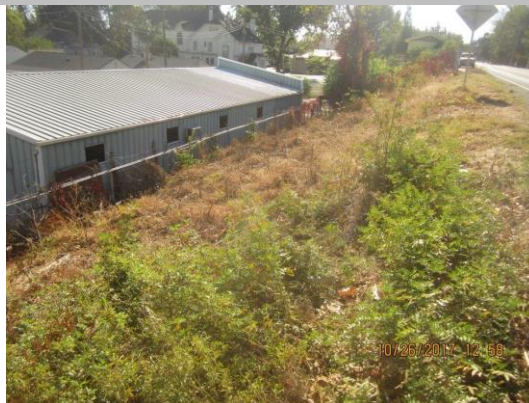
Photo 2 of 2 : SP\_2018\_RD0551\_175\_19\_20180305\_00008.jpg

Tall landside vegetation has been cleared.

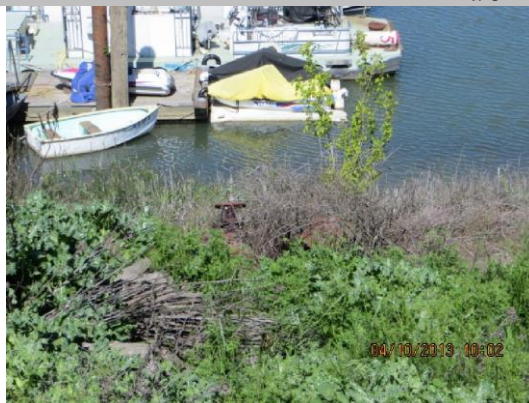
Photo 1 of 3 : UCIP\_SP\_2018\_11726\_19165.jpg

Abandoned pump covered in vegetation on WS slope.

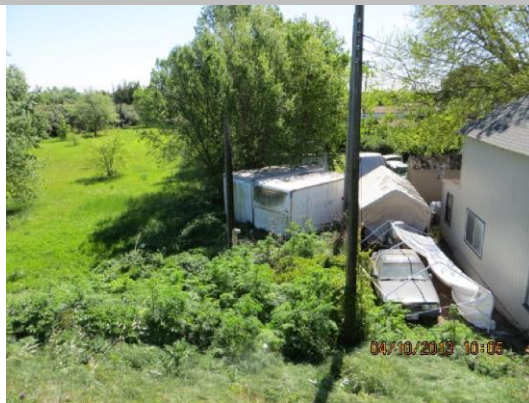
Photo 3 of 3 : UCIP\_SP\_2018\_11726\_19163.jpg

JP and pipe covered with vegetation on LS toe.

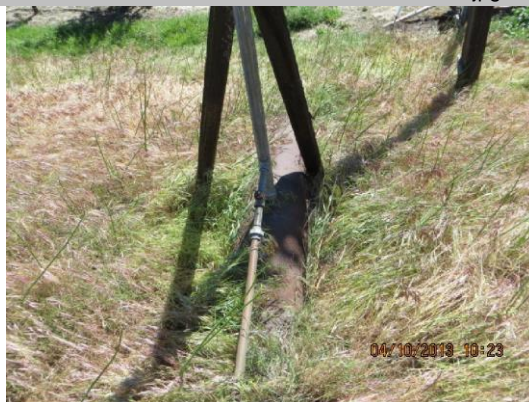
Photo 3 of 3 : UCIP\_SP\_2018\_11727\_19166.jpg

galvanized iron filler pipe and 16-inch pipe visible at LS toe.

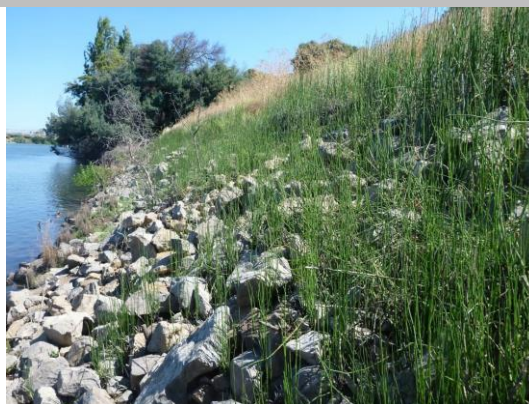
Photo 2 of 3 : SP\_2018\_RD0551\_175\_18\_20180305\_00005.jpg

Comment Code					
Inspector Comment					
Levee Evaluation Comments					
Description:District Station 84+15 to 87+60, Sec. 06, T. 5 N. R. 4 E., M.D.M. Approximately 135 linear-feet of erosion/sloughing exists along the waterside levee slope of the Sacramento River. Sloughing commences approximately 3/4 of the way down the slope from the crown and extends into the rip rap. Some existing rip rap has been pulled off in this section.					
Site ID No:331					
Site Designation:LMA-158					
Repair Type: Erosion					
Rating:Area of Concern					
Field Date:7/13/2017					
Notes: thorney veg on upper slope, light veg within rip rap. Crown is a paved road. 1 ft vertical scarp max just above rip rap so we rated it as a lower priority.

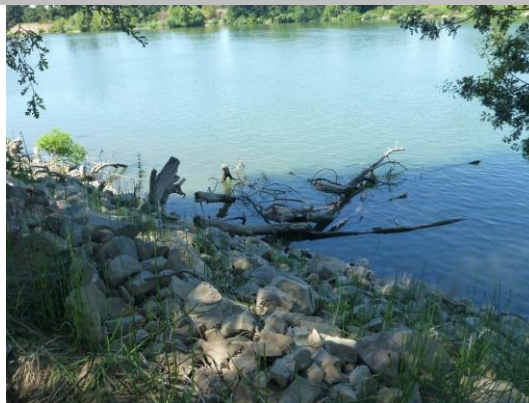
Photo 3 of 3 : SP\_2018\_RD0551\_175\_18\_20180305\_00006.jpg

Comment Code						
Inspector Comment						
Levee Evaluation Comments						
Description:District Station 84+15 to 87+60, Sec. 06, T. 5 N. R. 4 E., M.D.M. Approximately 135 linear-feet of erosion/sloughing exists along the waterside levee slope of the Sacramento River. Sloughing commences approximately 3/4 of the way down the slope from the crown and extends into the rip rap. Some existing rip rap has been pulled off in this section.						
Site ID No:331						
Site Designation:LMA-158						
Repair Type: Erosion						
Rating:Area of Concern						
Field Date:7/13/2017						
Notes: thorney veg on upper slope, light veg within rip rap. Crown is a paved road. 1 ft vertical scarp max just above rip rap so we rated it as a lower priority.

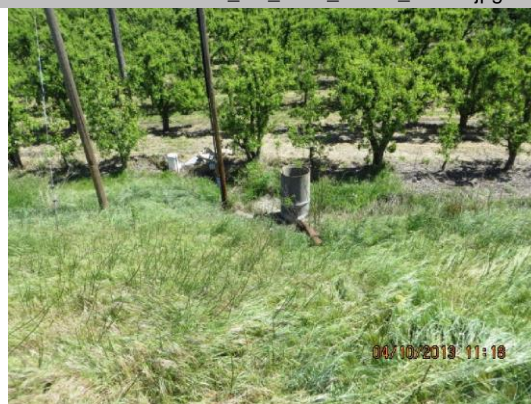
Photo 2 of 3 : UCIP\_SP\_2018\_26874\_49595.jpg

36-inch concrete standpipe at LS toe.

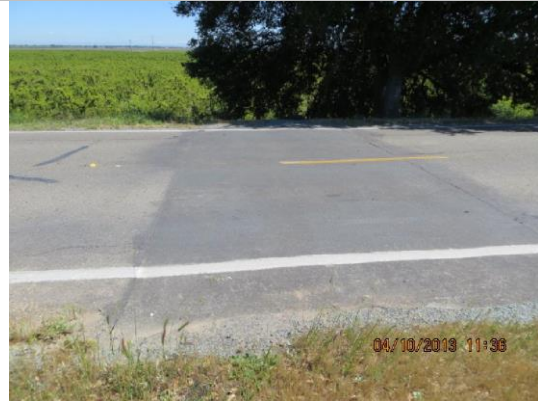
Photo 1 of 1 : UCIP\_SP\_2018\_11749\_19217.jpg

Fresh cut through pavement at crown.

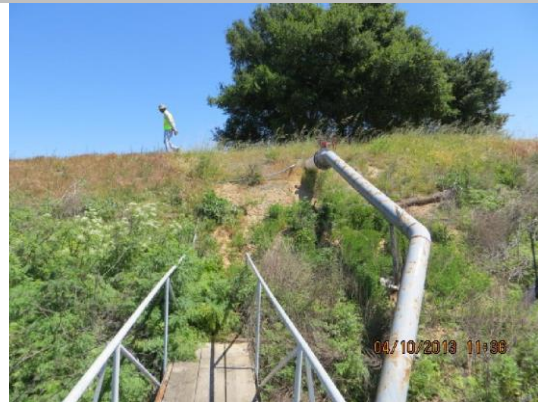
Photo 1 of 3 : UCIP\_SP\_2018\_11763\_19222.jpg

Pipe, butterfly valve, and electrical conduit 3-feet below the crown on the WS shoulder.

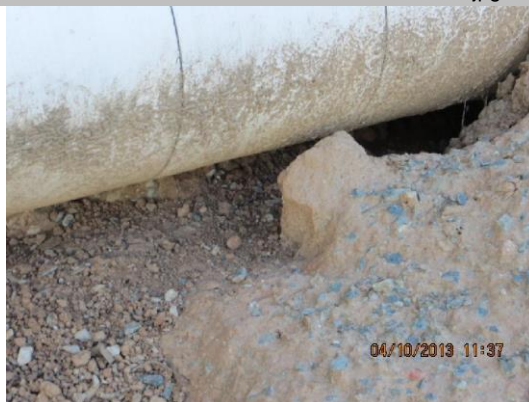
Photo 3 of 3 : UCIP\_SP\_2018\_11763\_19220.jpg

Comment Code						
Inspector Comment						
FS_ID:11763 DS_ID:21991 EP_NO: 6551 Repair Type: Non-Urgent Crossing Status: Found UCIP Comments: Rodent activity undermining pipe on LS slope. FIELD_STRUCT_DESC: 1 of 2: 14-inch polyvinyl chloride (PVC) wrapped steel irrigation pipe through the levee, 3 feet below the crown. Butterfly valve on the waterside (WS) shoulder. 2-inch galvanized electrical conduit at the same location. Pump on pile structure on the WS toe. Pressure booster and pump on the landside (LS) toe. (Permit No. 6551, 1969 - John D. Wheeler). [Additional Reference(s): DWR Levee Log, 2005. USACE Sacramento O&M Manual 111, May 1959, (RM 32.78)]. FS Date: 4/10/2013

Rodent activity undermining pipe on LS slope.

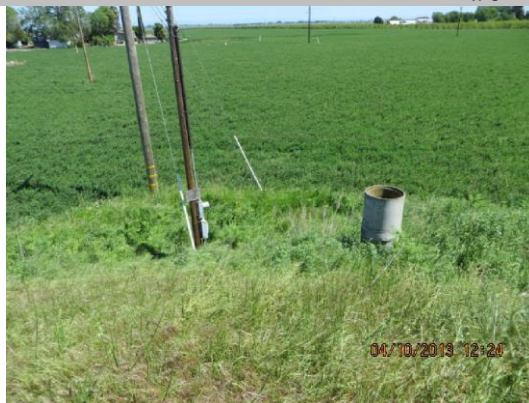
Photo 1 of 2 : UCIP\_SP\_2018\_11783\_19241.jpg

Comment Code						
Inspector Comment						
FS_ID:11783 DS_ID:21994 EP_NO: 11141 Repair Type: Non-Urgent Crossing Status: Found UCIP Comments: Records indicate this pipe was abandoned, but it appears to be active. Verify status. FIELD_STRUCT_DESC: 10-inch steel irrigation pipe through the levee, 8 feet below the crown. Slant pump on the waterside (WS) slope. Service pole on the landside (LS) slope with a 1.5-inch galvanized iron electrical conduit through the levee at the same location. (Automatic Board Order (ABO) issued as Permit No. 11141, 1975 - Adele Runyon, et al.). [Additional Reference(s): DWR Levee Log, 2005. USACE Sacramento O&M Manual 111, May 1959, (RM 32.38), listed as a 12-inch pipe]. FS Date: 4/10/2013

JP and concrete standpipe on LS toe.

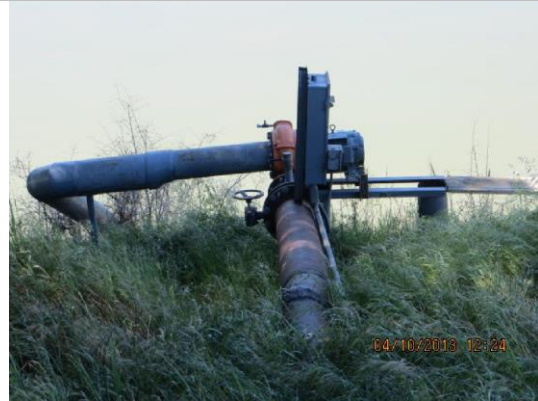
Photo 2 of 2 : UCIP\_SP\_2018\_11783\_19240.jpg

Pump, pipe, and butterfly valve on WS slope.

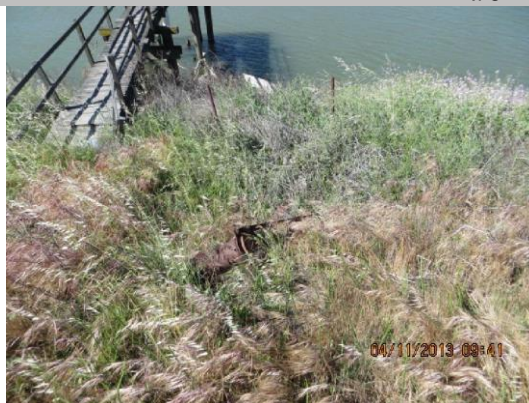
Photo 1 of 2 : UCIP\_SP\_2018\_11817\_19287.jpg

Abandoned slide gate on WS slope.

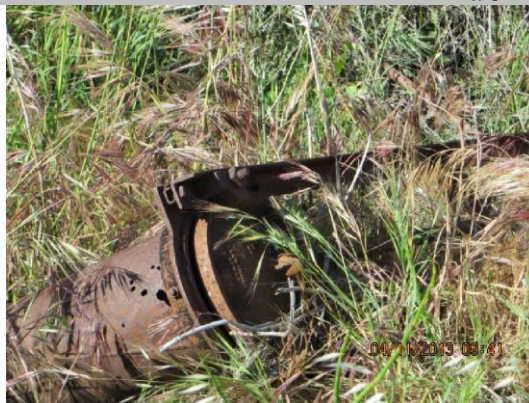
Photo 2 of 2 : UCIP\_SP\_2018\_11817\_19286.jpg

Abandoned slide gate on WS slope.

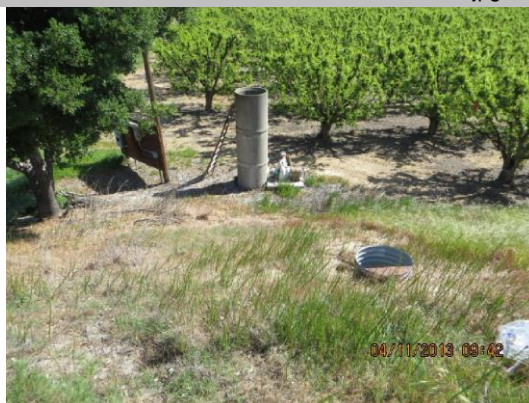
Photo 1 of 2 : UCIP\_SP\_2018\_11823\_19301.jpg

24-inch CMP riser and 48-inch concrete riser on LS slope.

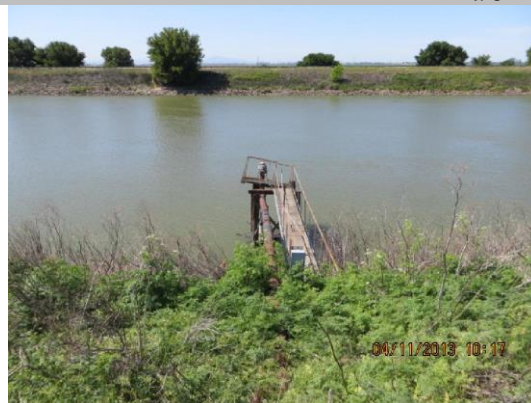
Photo 2 of 3 : UCIP\_SP\_2018\_51324\_46280.jpg

Pump on pier showing structural failure on WS toe.

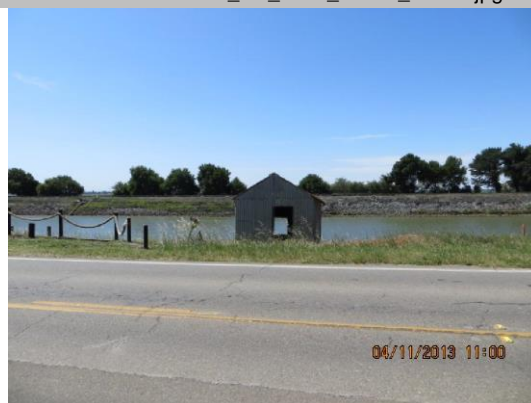
Photo 3 of 3 : UCIP\_SP\_2018\_12105\_19647.jpg

Relocated pumphouse on WS shoulder.

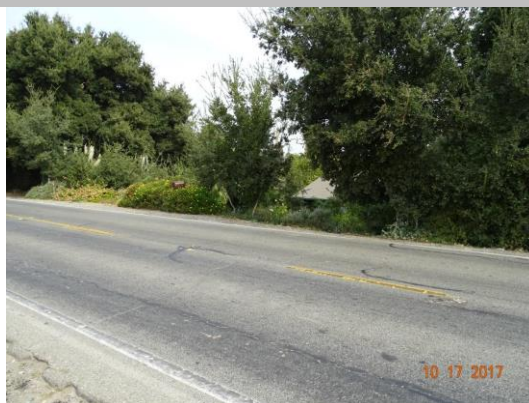
Photo 1 of 1 : SP\_2018\_RD0551\_175\_49\_20180305\_00074.jpg

LM Start	5.08	Rating **	M	Issue No.	49
LM End	5.08	Issue Type +	En	Location *	LS
Category	Earthen Levee			GPS Latitude/Longitude	
				Start	End
Item	Vegetation			38.275865 °	38.275865 °
				-121.540461 °	-121.540461 °
DWR ID	DWR_RD0551_01_f_2017_49				
Comment Code					
V6 : Landscaping					
Inspector Comment					
Landscaping should be maintained to allow inspection and access to landside slope and toe.

Landscaping should be maintained to allow inspection and access to landside slope and toe.

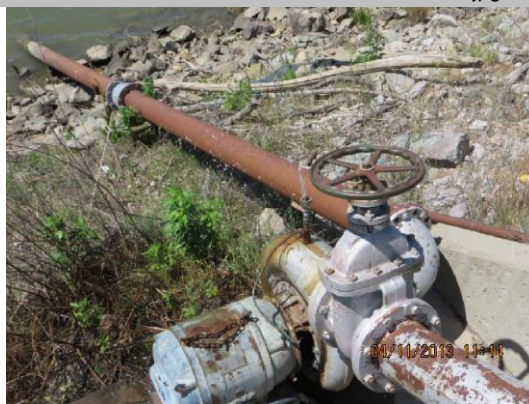
Photo 2 of 3 : UCIP\_SP\_2018\_26875\_49601.jpg

Pump and slide gate at Concrete pad on WS slope.
