**Flood Control Project Maintenance  
Levee Inspections**  
**LMA District Cover Sheet**  
**Spring 2019 Levee Inspection Results**

**Reclamation District No. 0551 Pearson**

**Levee Inspection Report By Mile - Spring 2019**

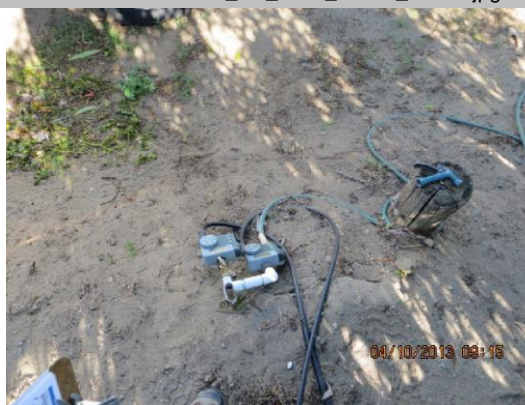
Photo 1 of 3 : UCIP\_SP\_2019\_11705\_19145.jpg

LM Start	0.41	Rating **	M	Issue No.	64
LM End	0.41	Issue Type +	En	Location *	
Category	Supplemental			GPS Latitude/Longitude	
				Start	End
Item	DWR UCIP Field Study			38.332039 °	38.332039 °
				-121.569730 °	-121.569730 °
DWR ID	21982				
Comment Code					
Inspector Comment					
FS_ID:11705 DS_ID:21982 EP_NO: 2759 Repair Type: Non-Urgent Crossing Status: Found UCIP Comments: Unclear where exact crossing is located. FIELD_STRUCT_DESC: [Courtland Boating Facilities] 1-inch steel water line through the levee, at an unknown depth. Ramp and boating facilities on the waterside (WS). Pipe visible under buildings at concrete foundation on the landside (LS). Water service connections for irrigation located on the WS slope. (Permit No. 2759, 1958 - Courtland Dock). [Additional Reference(s): DWR Levee Log, 2005]. FS Date: 4/10/2013

Irrigation pipes on WS slope.

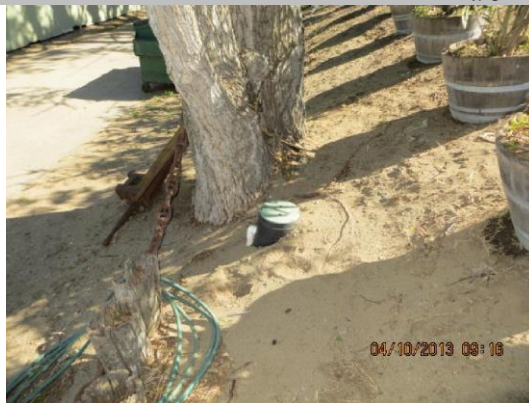
Photo 2 of 3 : UCIP\_SP\_2019\_11705\_19144.jpg

Irrigation pipes on WS slope.

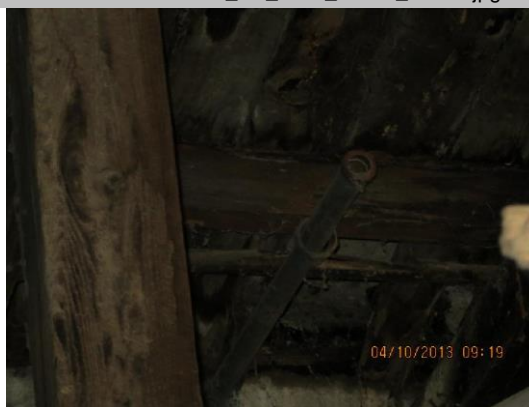
Photo 3 of 3 : UCIP\_SP\_2019\_11705\_19143.jpg

Various disconnected pipes visible at foundation/retaining wall under buildings on LS.

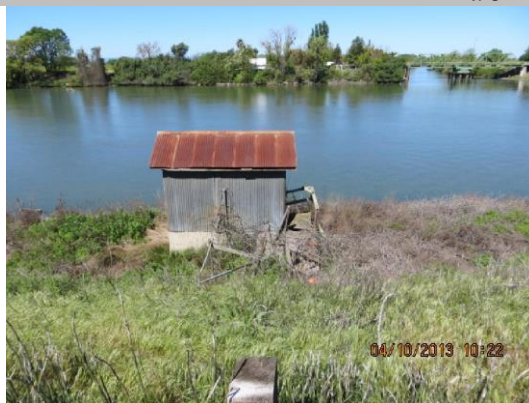
Photo 1 of 3 : UCIP\_SP\_2019\_11727\_19168.jpg

Comment Code					
Inspector Comment					
FS_ID:11727					
DS_ID:21986					
EP_NO: 701					
Repair Type: Non-Urgent					
Crossing Status: Found					
UCIP Comments: Pipe appears abandoned and should be done so properly. Good candidate for video inspection.					
FIELD_STRUCT_DESC: 14-inch steel irrigation pipe through the levee, 7.2 feet below the crown. Pump in pump house on the waterside (WS) slope. Service pole on the landside (LS) slope. 1-inch galvanized filler pipe, and a 2-inch electrical conduit at the same location. (Permit No. 701, 1937 - American Trust Company). [Additional Reference(s): DWR Levee Log, 2005. USACE Sacramento O&M Manual 111, May 1959, (RM 33.91)].					
FS Date: 4/10/2013

Pump house and pipes visible on WS slope.

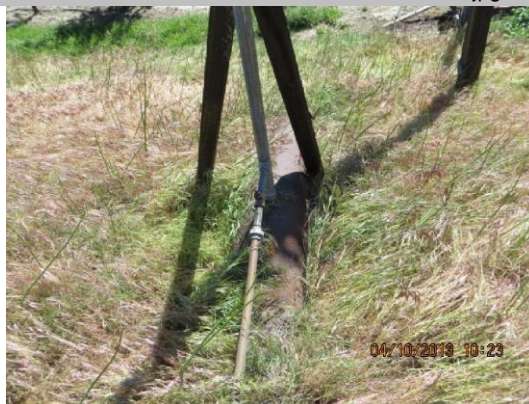
Photo 3 of 3 : UCIP\_SP\_2019\_11727\_19166.jpg

galvanized iron filler pipe and 16-inch pipe visible at LS toe.

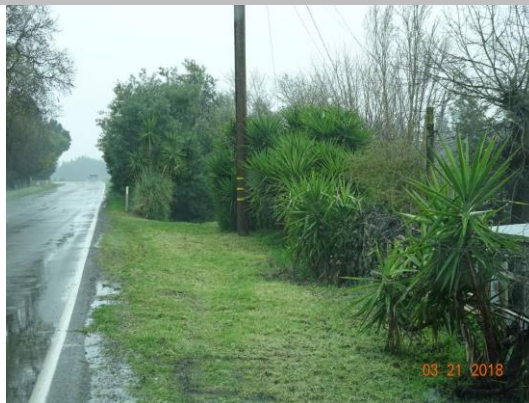
Photo 1 of 1 : SP\_2019\_RD0551\_175\_6\_20190311\_00001.jpg

View looking downstream at landscaping on the waterside shoulder (Spring 2018).

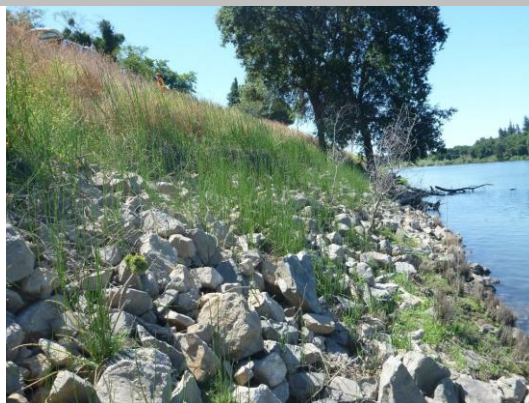
Comment Code						
Inspector Comment						
Levee Evaluation Comments						
Description:District Station 84+15 to 87+60, Sec. 06, T. 5 N. R. 4 E., M.D.M. Approximately 135 linear-feet of erosion/sloughing exists along the waterside levee slope of the Sacramento River. Sloughing commences approximately 3/4 of the way down the slope from the crown and extends into the rip rap. Some existing rip rap has been pulled off in this section.						
Site ID No:331						
Site Designation:LMA-158						
Repair Type: Erosion						
Rating:Area of Concern						
Field Date:7/13/2017						
Notes: thorney veg on upper slope, light veg within rip rap. Crown is a paved road. 1 ft vertical scarp max just above rip rap so we rated it as a lower priority.

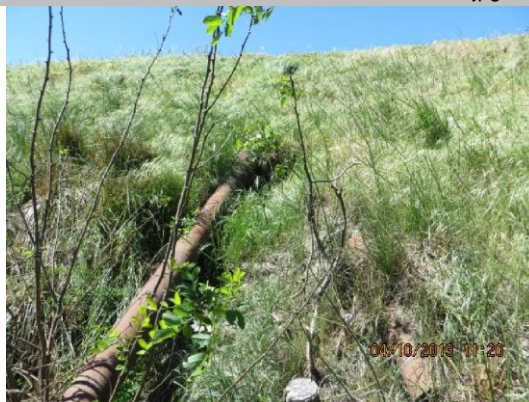
Photo 3 of 3 : UCIP\_SP\_2019\_26874\_49594.jpg

Comment Code						
Inspector Comment						
FS_ID:26874 DS_ID:21990 EP_NO: 11145 Repair Type: Non-Urgent Crossing Status: Found UCIP Comments: Based on District notes from January 14, 2014, pump discharge pipe has been repaired. Pipe failing on LS slope causing erosion along pipe alignment. Pipe debris on both slopes should be removed as well.: As of 12/13/2013 District President noted that the landowner had made repairs to the LS slope leaks.: As of 12/17/2013 District submitted letter to landowner explaining UCIP report details including photos of the pipe problems FIELD_STRUCT_DESC: 10-inch irrigation pipe of an unknown material through the levee, 4.7 feet below the crown. Pump in a 7-foot by 9-foot concrete pump house on the waterside (WS) slope. 36-inch concrete riser on the landside (LS) toe. 1-inch electrical conduit at the same location. Service pole at the LS toe. (Automatic Board Order (ABO) issued as Permit No. 11145, 1975 - Horace D. and Lucile Towne). [Additional Reference(s): DWR Levee Log, 2005. USACE Sacramento O&M Manual 111, May 1959, (RM 33.02), listed as an 8-inch pipe]. FS Date: 1/15/2014

Pipe failing on LS slope due to corrosion holes causing erosion.

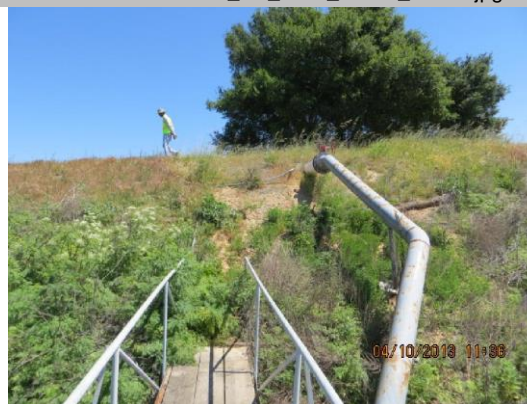
Photo 1 of 3 : UCIP\_SP\_2019\_11763\_19222.jpg

Pipe, butterfly valve, and electrical conduit 3-feet below the crown on the WS shoulder.

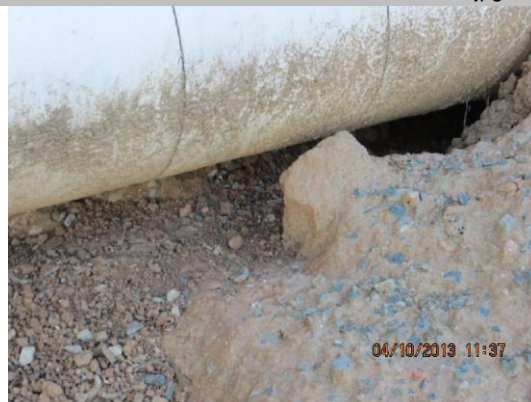
Photo 3 of 3 : UCIP\_SP\_2019\_11763\_19220.jpg

Comment Code						
Inspector Comment						
FS_ID:11763 DS_ID:21991 EP_NO: 6551 Repair Type: Non-Urgent Crossing Status: Found UCIP Comments: Rodent activity undermining pipe on LS slope. FIELD_STRUCT_DESC: 1 of 2: 14-inch polyvinyl chloride (PVC) wrapped steel irrigation pipe through the levee, 3 feet below the crown. Butterfly valve on the waterside (WS) shoulder. 2-inch galvanized electrical conduit at the same location. Pump on pile structure on the WS toe. Pressure booster and pump on the landside (LS) toe. (Permit No. 6551, 1969 - John D. Wheeler). [Additional Reference(s): DWR Levee Log, 2005. USACE Sacramento O&M Manual 111, May 1959, (RM 32.78)]. FS Date: 4/10/2013

Rodent activity undermining pipe on LS slope.

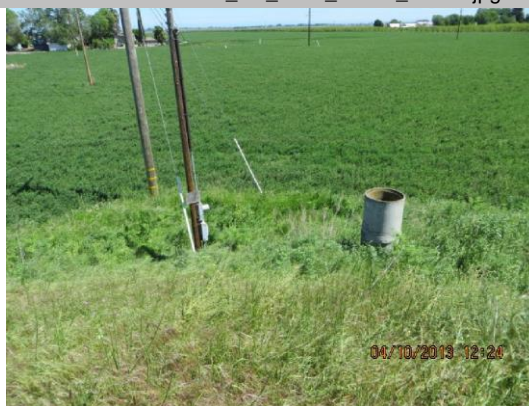
Photo 1 of 2 : UCIP\_SP\_2019\_11783\_19241.jpg

Comment Code					
Inspector Comment					
FS_ID:11783 DS_ID:21994 EP_NO: 11141 Repair Type: Non-Urgent Crossing Status: Found UCIP Comments: Records indicate this pipe was abandoned, but it appears to be active. Verify status. FIELD_STRUCT_DESC: 10-inch steel irrigation pipe through the levee, 8 feet below the crown. Slant pump on the waterside (WS) slope. Service pole on the landside (LS) slope with a 1.5-inch galvanized iron electrical conduit through the levee at the same location. (Automatic Board Order (ABO) issued as Permit No. 11141, 1975 - Adele Runyon, et al.). [Additional Reference(s): DWR Levee Log, 2005. USACE Sacramento O&M Manual 111, May 1959, (RM 32.38), listed as a 12-inch pipe]. FS Date: 4/10/2013

JP and concrete standpipe on LS toe.

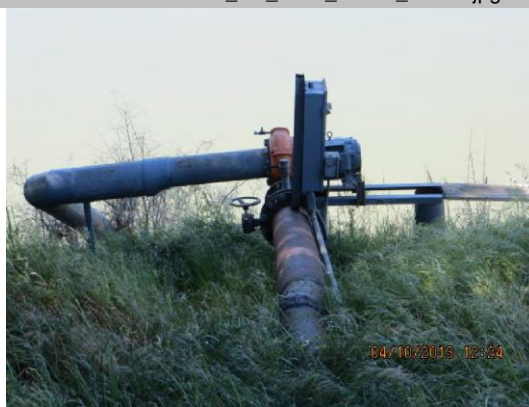
Photo 2 of 2 : UCIP\_SP\_2019\_11783\_19240.jpg

Pump, pipe, and butterfly valve on WS slope.

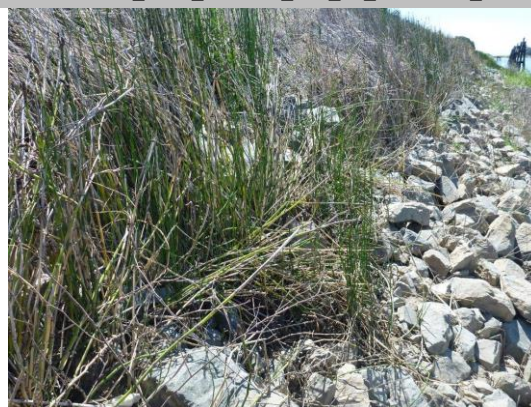
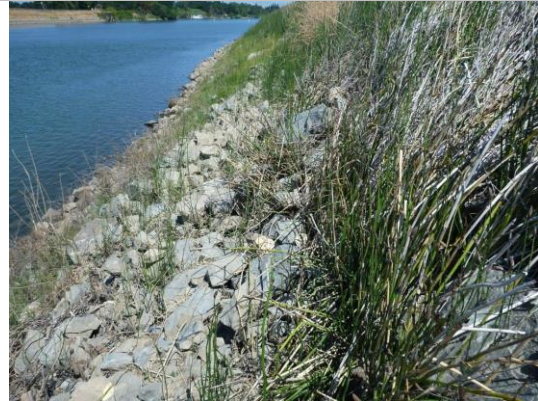
LM Start	2.71	Rating **	A/W	Issue No.	22
LM End	2.74	Issue Type +	Ma	Location *	
Category	Supplemental			GPS Latitude/Longitude	
				Start	End
Item	2017 Storm Damage			38.301258 °	38.300922 °
				-121.569550 °	-121.569258 °
DWR ID	DWR_RD0551_01_f_2017_22				
Comment Code					
Inspector Comment					
Levee Evaluation Comments					
Description:District Station 142+31 to 143+80, Sec. 08, T. 5 N. R. 4 E., M.D.M. Approximately 149 linear-feet of erosion exists along the waterside slope of the Sacramento River. The erosion exists near the rip rap line about 3/4 of the way down the slope. Some existing rip rap has been pulled off in this section.					
Site ID No:332					
Site Designation:LMA-159					
Repair Type: Erosion					
Rating:Area of Concern					
Field Date:7/13/2017					
Notes: Crown is a paved road. Minor errosion right above and in the top of the rip rap.

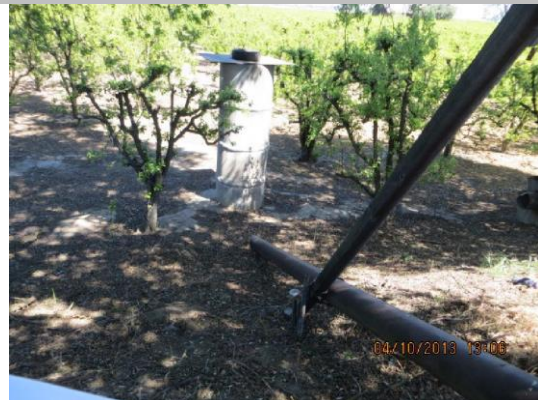
Photo 1 of 2 : UCIP\_SP\_2019\_11803\_19261.jpg

LM Start	2.96	Rating **	M	Issue No.	71
LM End	2.96	Issue Type +	En	Location *	
Category	Supplemental			GPS Latitude/Longitude	
				Start	End
Item	DWR UCIP Field Study			38.298323 °	38.298323 °
				-121.566941 °	-121.566941 °
DWR ID	22032				
Comment Code					
Inspector Comment					
FS_ID:11803 DS_ID:22032 EP_NO: 1204 Repair Type: Non-Urgent Crossing Status: Found UCIP Comments: Gap between sleeved pipes does not appear to be grouted on LS slope. FIELD_STRUCT_DESC: 12-inch steel irrigation conduit through the levee, 6 feet below the crown. 10-inch irrigation pipe sleeved through the 12-inch conduit. Pump on pile structure on the waterside (WS) toe. 48-inch concrete riser on the landside (LS) toe. (Permit No. 1204, 1947 - M. J. Barry Estate). [Additional Reference(s): USACE Sacramento O&M Manual 111, May 1959, (RM 31.82)]. FS Date: 4/10/2013

48-inch concrete riser on LS toe.

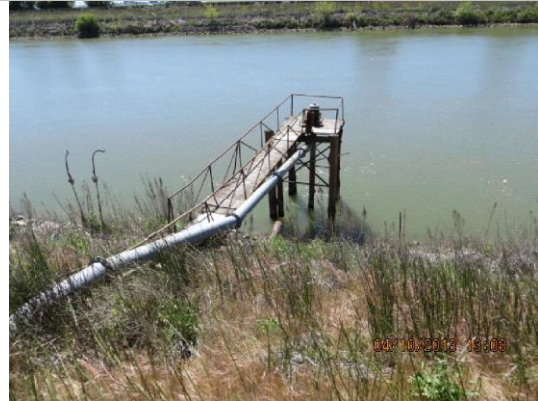
Photo 2 of 2 : UCIP\_SP\_2019\_11803\_19260.jpg

10-inch steel irrigation pipe and steel pump structure on WS toe.

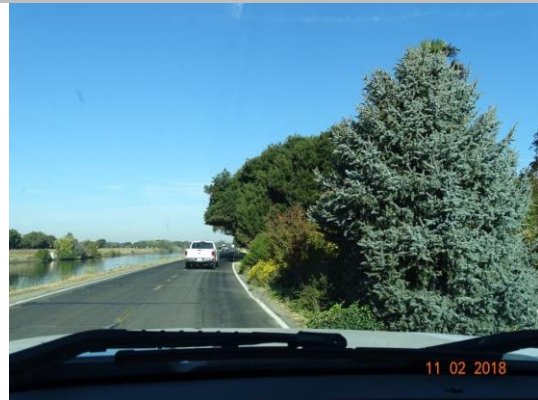
Photo 1 of 1 : SP\_2019\_RD0551\_175\_56\_20190311\_00078.jpg

View looking upstream at landscaping on the landside slope (November 2018).

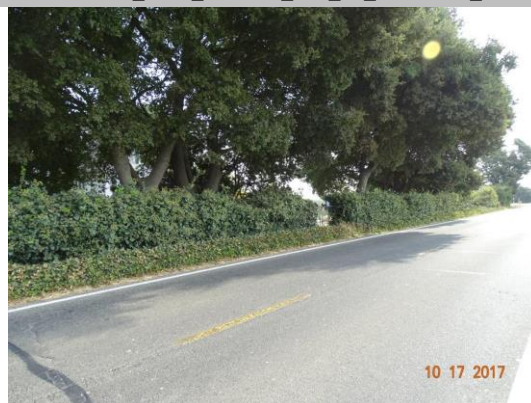
Photo 1 of 1 : SP\_2019\_RD0551\_175\_48\_20190311\_00073.jpg

View of landscaping on landside slope and toe.

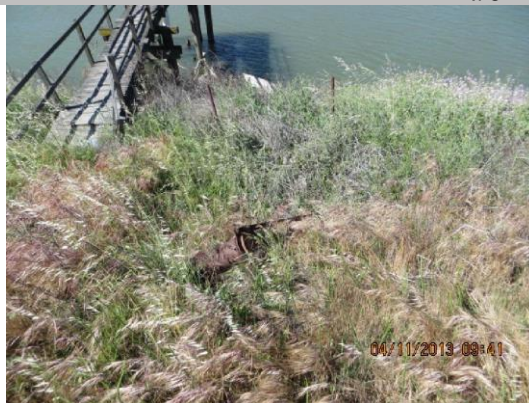
Photo 1 of 2 : UCIP\_SP\_2019\_11817\_19287.jpg

Abandoned slide gate on WS slope.

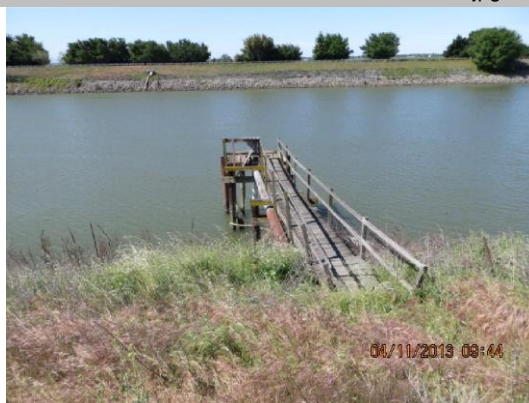
Photo 2 of 2 : UCIP\_SP\_2019\_11823\_19300.jpg

Pump on pier with wooden walkway on WS toe.

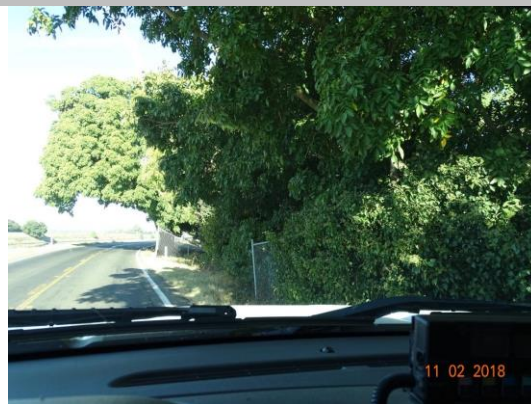
Photo 1 of 1 : SP\_2019\_RD0551\_175\_52\_20190311\_00077.jpg

View looking upstream at landscaping on the landside slope (November 2018).

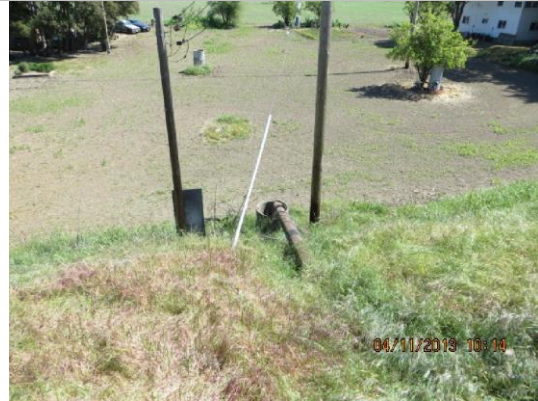
Photo 1 of 3 : UCIP\_SP\_2019\_51324\_46281.jpg

Pipe and stand pipe on LS toe with subsidence along pipe on LS slope.

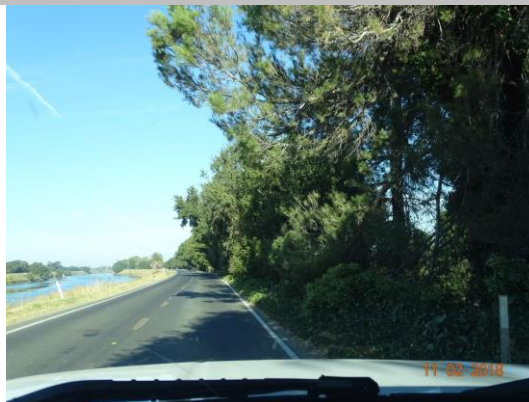
Photo 1 of 1 : SP\_2019\_RD0551\_175\_25\_20190311\_00014.jpg

LM Start	4.82	Rating **	U	Issue No.	25
LM End	4.86	Issue Type +	En	Location *	LS
Category	Earthen Levee			GPS Latitude/Longitude	
				Start	End
Item	Vegetation			38.278760 °	38.278287 °
				-121.543608 °	-121.543132 °
DWR ID	DWR_RD0551_01_f_2018_25				
Comment Code					
V6 : Landscaping					
Inspector Comment

View looking upstream at landscaping on the landside slope (November 2018).

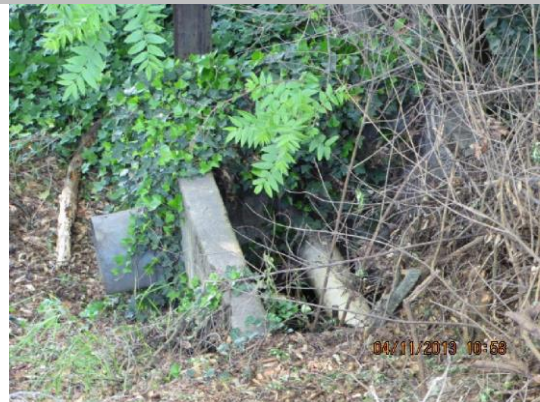
Photo 1 of 3 : UCIP\_SP\_2019\_12105\_19649.jpg

LM Start	5.05	Rating **	M	Issue No.	75	
LM End	5.05	Issue Type +	En	Location *		
Category	Supplemental			GPS Latitude/Longitude		
				Start	End	
Item	DWR UCIP Field Study			38.276220 °	38.276220 °	
				-121.540811 °	-121.540811 °	
DWR ID	22022

Pipe in distribution box at LS toe.

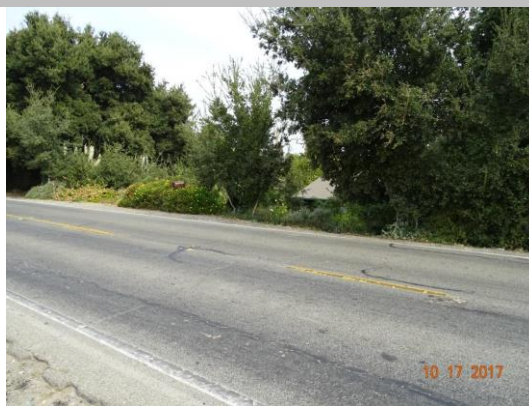
Photo 1 of 1 : SP\_2019\_RD0551\_175\_49\_20190311\_00074.jpg

LM Start	5.08	Rating **	M	Issue No.	49
LM End	5.08	Issue Type +	En	Location *	LS
Category	Earthen Levee			GPS Latitude/Longitude	
				Start	End
Item	Vegetation			38.275865 °	38.275865 °
				-121.540461 °	-121.540461 °
DWR ID	DWR_RD0551_01_f_2017_49				
Comment Code					
V6 : Landscaping					
Inspector Comment					
Landscaping should be maintained to allow inspection and access to lanside slope and toe.

View of landscaping on landside slope and toe.

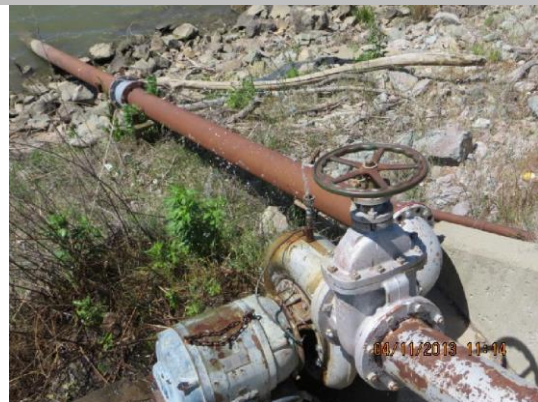
Photo 2 of 3 : UCIP\_SP\_2019\_26875\_49601.jpg

Pump and slide gate at Concrete pad on WS slope.

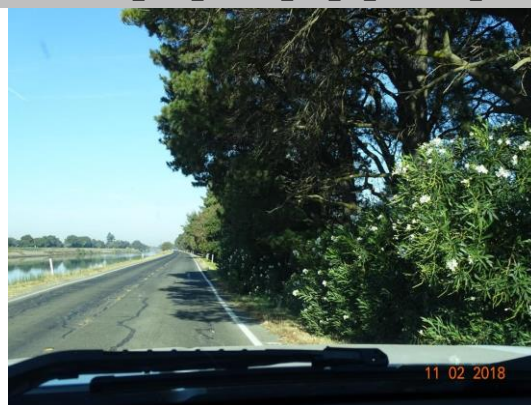
Photo 1 of 1 : SP\_2019\_RD0551\_175\_24\_20190311\_00013.jpg

View looking upstream at land scaping on the landside slope (November 2018).

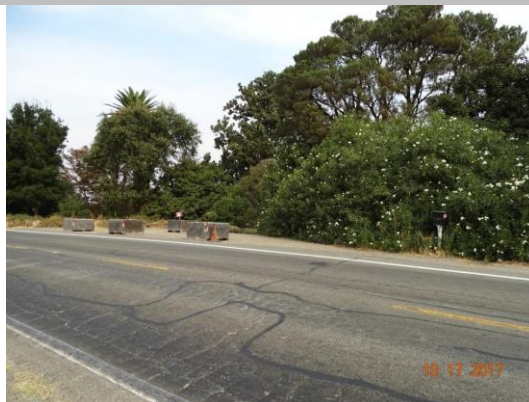
Photo 1 of 1 : SP\_2019\_RD0551\_175\_50\_20190311\_00075.jpg

LM Start	5.90	Rating **	M	Issue No.	50
LM End	5.90	Issue Type +	En	Location *	LS
Category	Earthen Levee			GPS Latitude/Longitude	
				Start	End
Item	Vegetation			38.267833 °	38.267833 °
				-121.529438 °	-121.529438 °
DWR ID	DWR_RD0551_01_f_2017_50				
Comment Code					
V6 : Landscaping					
Inspector Comment					
Landscaping should be maintained to allow inspection and access to landside slope and toe. Trim/thin oleanders and ivy

View of landscaping on landside slope and toe.

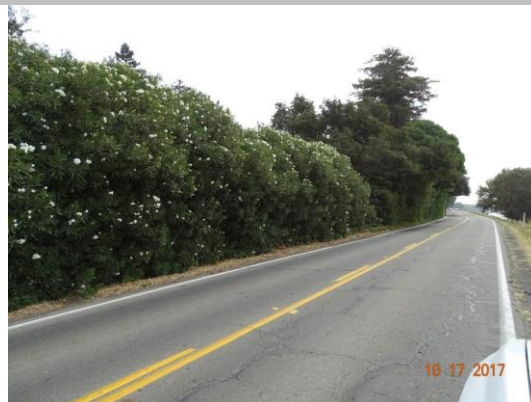
LM Start	<b>6.19</b>	Rating **	U	Issue No.	<b>51</b>
LM End	<b>6.26</b>	Issue Type +	En	Location *	LS
Category	Earthen Levee			GPS Latitude/Longitude	
				Start	End
Item	Vegetation			38.264814 °	38.264112 °
				-121.525728 °	-121.524845 °
DWR ID	DWR_RD0551_01_f_2017_51				
Comment Code					
V6 : Landscaping					
Inspector Comment					
<p>Landscaping should be maintained to allow inspection and access to landside slope and toe.</p>

View of landscaping on landside slope and toe.

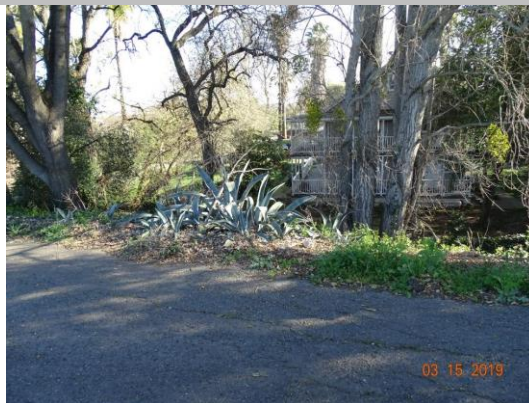
View of cactus on the landside shoulder (Spring 2019).
