**Flood Control Project Maintenance  
Levee Inspections**  
**LMA District Cover Sheet**  
**Spring 2020 Levee Inspection Results**

**Reclamation District No. 0551 Pearson**

**Spring 2020 Levee Inspection Results**

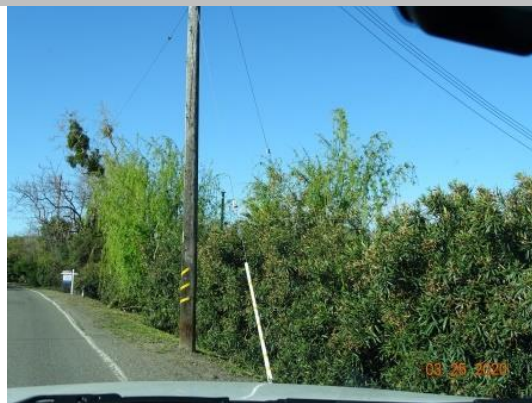
Photo 1 of 1 : SP\_2020\_RD0551\_175\_17\_20200325\_00123.jpg

View looking downstream of landscaping blocking view down waterside slope (Spring 2020).

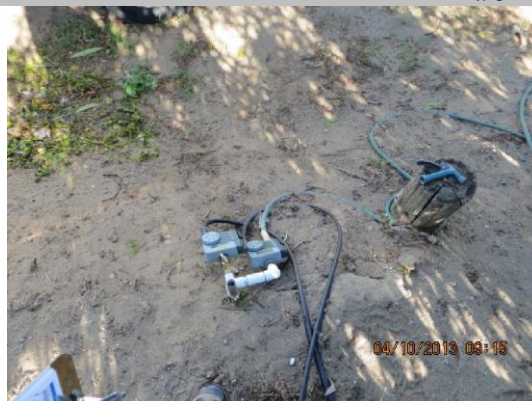
Photo 1 of 3 : UCIP\_SP\_2020\_11705\_19145.jpg

Irrigation pipes on WS slope.

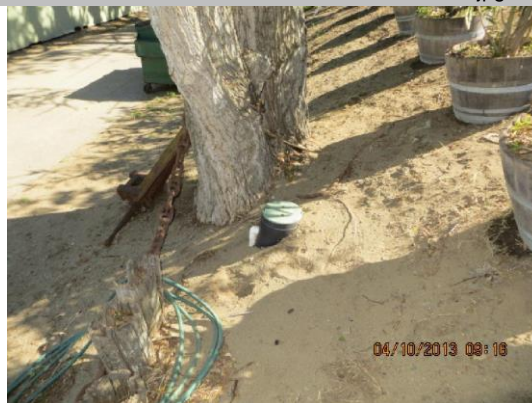
Photo 2 of 3 : UCIP\_SP\_2020\_11705\_19144.jpg

Irrigation pipes on WS slope.

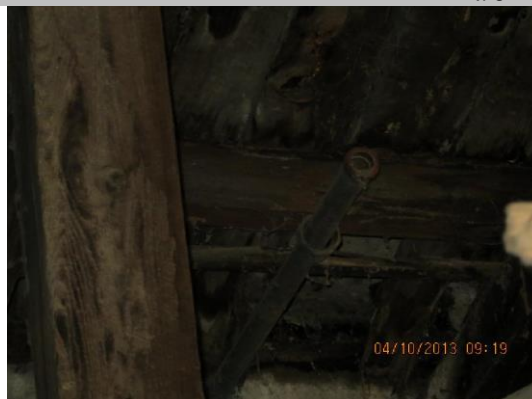
Photo 3 of 3 : UCIP\_SP\_2020\_11705\_19143.jpg

Various disconnected pipes visible at foundation/retaining wall under buildings on LS.

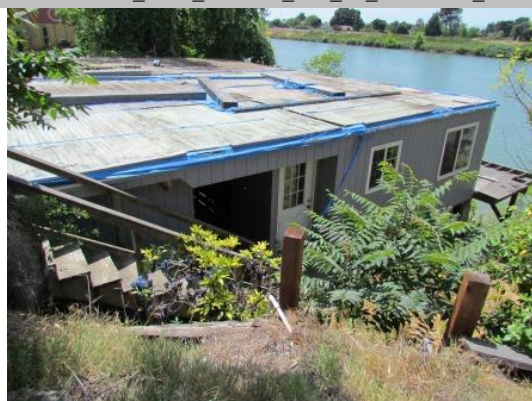
Photo 1 of 3 : SP\_2020\_RD0551\_175\_21\_20200304\_00006.jpg

Building and steps waterward. Photo taken 01-04-2014.

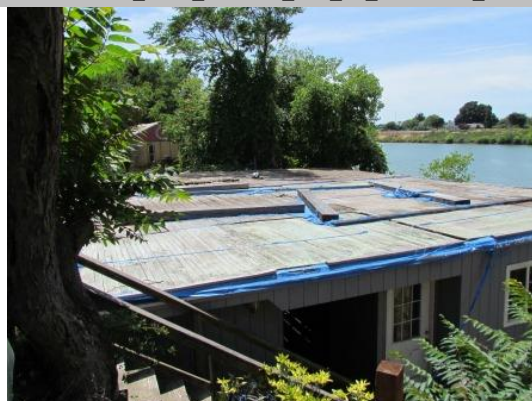
Photo 2 of 3 : SP\_2020\_RD0551\_175\_21\_20200304\_00007.jpg

Building remodeling project on waterside levee section. Photo taken 01-04-2014.

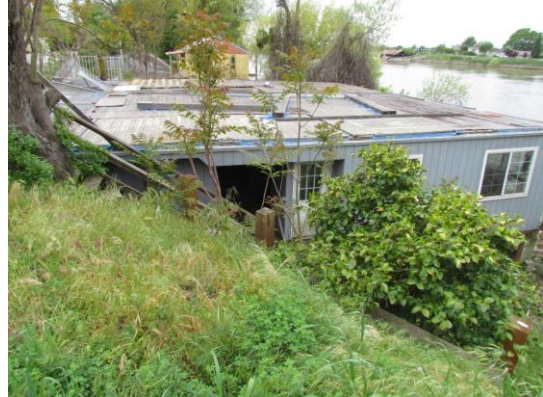
Photo 3 of 3 : SP\_2020\_RD0551\_175\_21\_20200304\_00008.jpg

Photo taken 4-06-2017 no change. No work done, no permit issued.

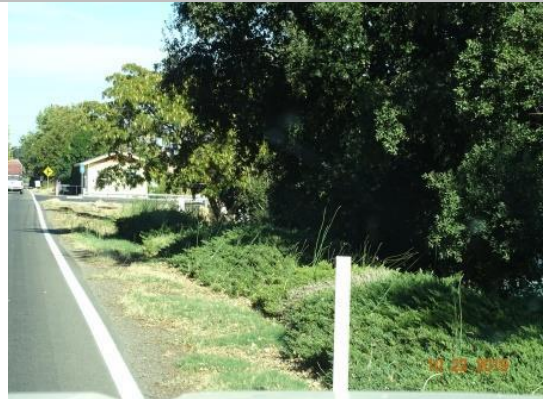
Photo 1 of 1 : SP\_2020\_RD0551\_175\_69\_20200304\_00089.jpg

View looking downstream at landscaping on the landside slope (Fall 2019).

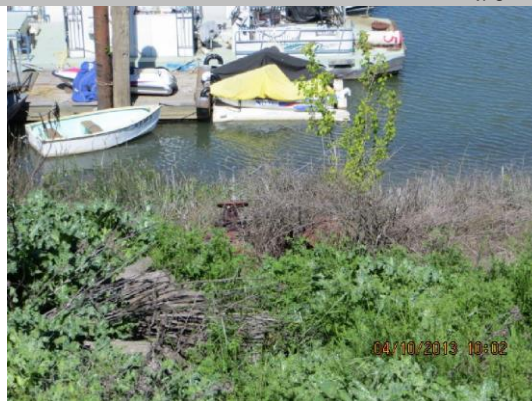
Photo 1 of 3 : UCIP\_SP\_2020\_11726\_19165.jpg

Abandoned pump covered in vegetation on WS slope.

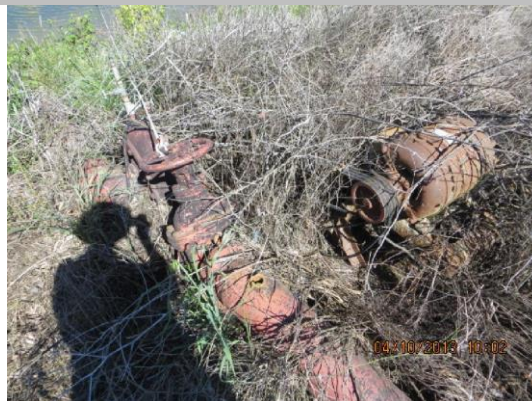
Photo 2 of 3 : UCIP\_SP\_2020\_11726\_19164.jpg

Pump, slide gate, and missing vent pipe on WS slope.

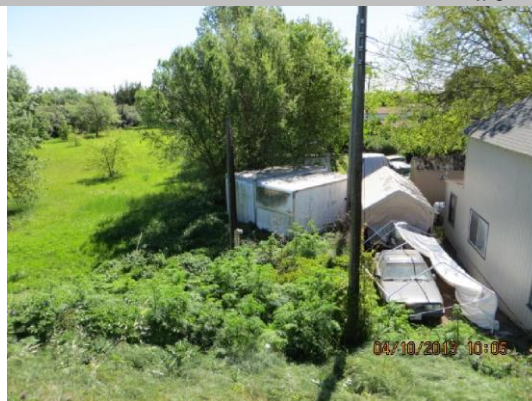
Photo 3 of 3 : UCIP\_SP\_2020\_11726\_19163.jpg

JP and pipe covered with vegetation on LS toe.

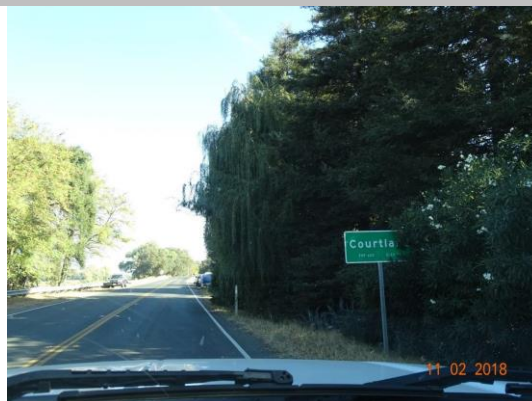
Photo 1 of 1 : SP\_2020\_RD0551\_175\_57\_20200304\_00080.jpg

View looking upstream at landscaping on the landside slope (November 2018).

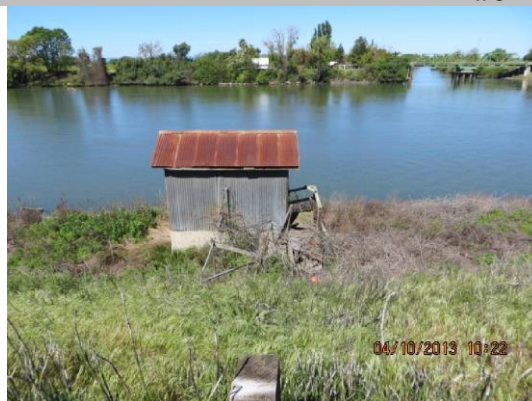
Photo 1 of 3 : UCIP\_SP\_2020\_11727\_19168.jpg

Comment Code						
Inspector Comment						
DS_ID:21986						
FS_ID:11727						
EP_NO: 701						
Repair Type: Non-Urgent						
Crossing Status: Found						
UCIP Comments: Pipe appears abandoned and should be done so properly. Good candidate for video inspection.						
FIELD_STRUCT_DESC: 14-inch steel irrigation pipe through the levee, 7.2 feet below the crown. Pump in pump house on the waterside (WS) slope. Service pole on the landside (LS) slope. 1-inch galvanized filler pipe, and a 2-inch electrical conduit at the same location. (Permit No. 701, 1937 - American Trust Company). [Additional Reference(s): DWR Levee Log, 2005. USACE Sacramento O&M Manual 111, May 1959, (RM 33.91)].						
FS Date: 4/10/2013

Pump house and pipes visible on WS slope.

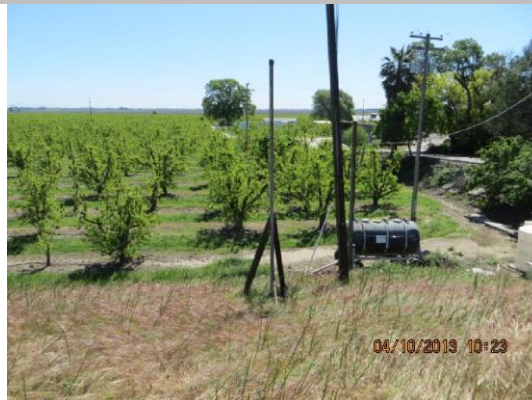
Photo 2 of 3 : UCIP\_SP\_2020\_11727\_19167.jpg

Pipe and JP visible on LS toe.

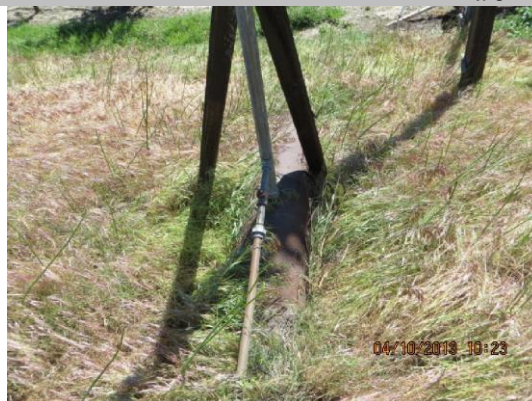
Photo 3 of 3 : UCIP\_SP\_2020\_11727\_19166.jpg

galvanized iron filler pipe and 16-inch pipe visible at LS toe.

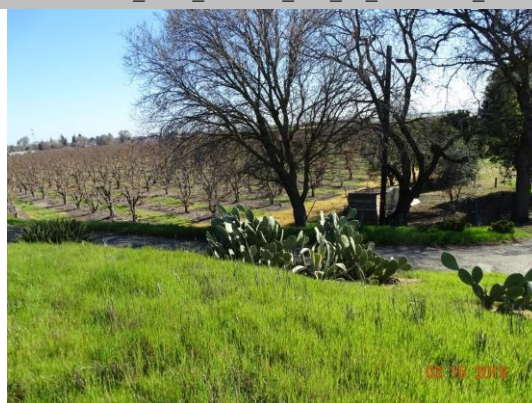
Photo 1 of 1 : SP\_2020\_RD0551\_175\_63\_20200304\_00086.jpg

View of cactus at the bottom of the landside slope (Spring 2019).

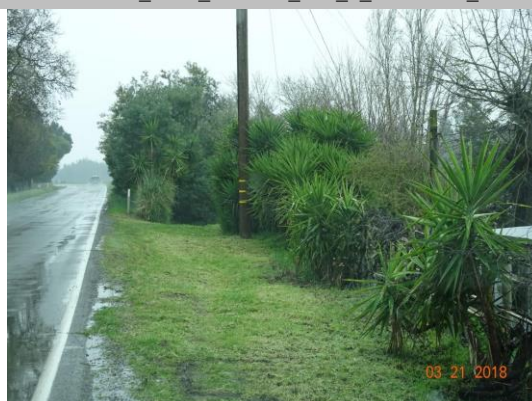
Photo 1 of 1 : SP\_2020\_RD0551\_175\_6\_20200304\_00001.jpg

View looking downstream at landscaping on the waterside shoulder (Spring 2018).

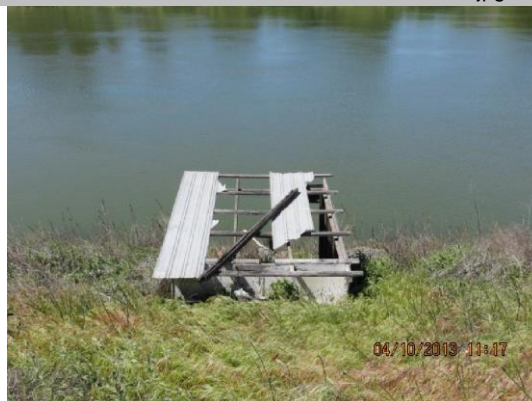
Photo 1 of 3 : UCIP\_SP\_2020\_26874\_49596.jpg

Pumphouse on WS slope.

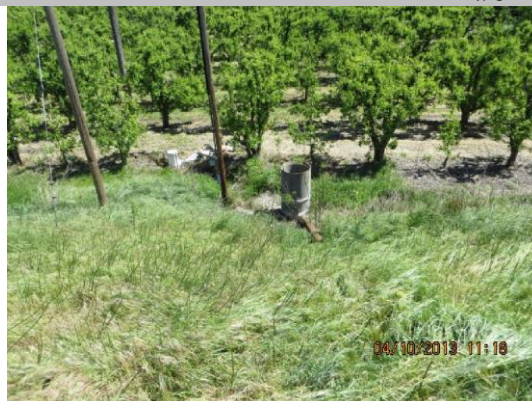
Photo 2 of 3 : UCIP\_SP\_2020\_26874\_49595.jpg

36-inch concrete standpipe at LS toe.

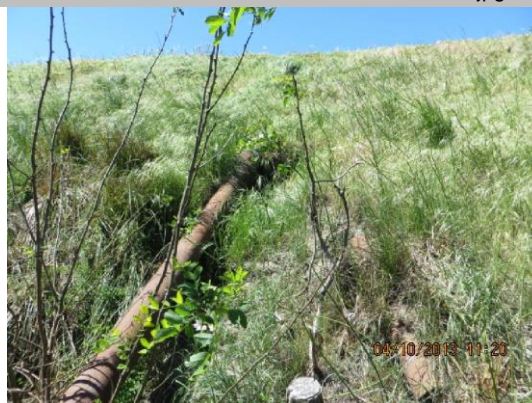
Photo 3 of 3 : UCIP\_SP\_2020\_26874\_49594.jpg

Comment Code					
Inspector Comment					
DS_ID:21990 FS_ID:26874 EP_NO: 11145 Repair Type: Non-Urgent Crossing Status: Found UCIP Comments: Based on District notes from January 14, 2014, pump discharge pipe has been repaired. Pipe failing on LS slope causing erosion along pipe alignment. Pipe debris on both slopes should be removed as well.: As of 12/13/2013 District President noted that the landowner had made repairs to the LS slope leaks.: As of 12/17/2013 District submitted letter to landowner explaining UCIP report details including photos of the pipe problems FIELD_STRUCT_DESC: 10-inch irrigation pipe of an unknown material through the levee, 4.7 feet below the crown. Pump in a 7-foot by 9-foot concrete pump house on the waterside (WS) slope. 36-inch concrete riser on the landside (LS) toe. 1-inch electrical conduit at the same location. Service pole at the LS toe. (Automatic Board Order (ABO) issued as Permit No. 11145, 1975 - Horace D. and Lucile Towne). [Additional Reference(s): DWR Levee Log, 2005. USACE Sacramento O&M Manual 111, May 1959, (RM 33.02), listed as an 8-inch pipe]. FS Date: 1/15/2014

Pipe failing on LS slope due to corrosion holes causing erosion.

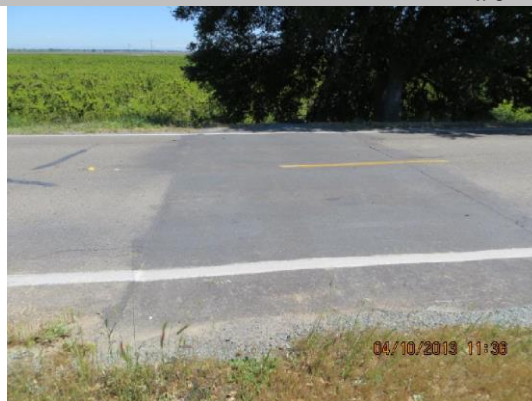
Photo 1 of 1 : UCIP\_SP\_2020\_11749\_19217.jpg

Comment Code						
Inspector Comment						
DS_ID:22040						
FS_ID:11749						
EP_NO: 3676						
Repair Type: Non-Urgent						
Crossing Status: Not Found						
UCIP Comments: Fresh cut through pavement on crown indicates recent work on pipes at this location. Need to determine if pipe was removed or abandoned in place.						
FIELD_STRUCT_DESC: 2 of 2: 8-inch coated steel irrigation pipe through the levee, 5 feet below the crown. 8-inch pipe sleeved through a 12-inch pipe. Pump on platform on the waterside (WS). (Permit No. 3676, 1961 - Runyon and Dorsey). [Additional Reference(s): DWR Levee Log, 2005. USACE Sacramento O&M Manual 111, May 1959, (RM 33.02)].						
FS Date: 4/10/2013

Fresh cut through pavement at crown.

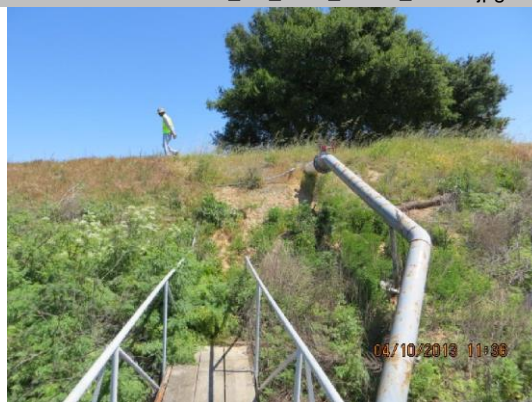
Photo 1 of 3 : UCIP\_SP\_2020\_11763\_19222.jpg

Pipe, butterfly valve, and electrical conduit 3-feet below the crown on the WS shoulder.

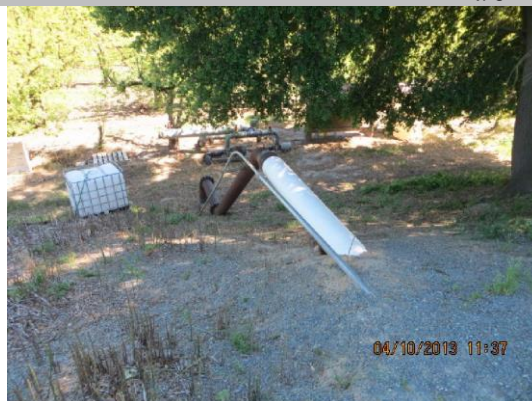
Photo 2 of 3 : UCIP\_SP\_2020\_11763\_19221.jpg

Pipe, electrical conduit, and booster pump on LS toe.

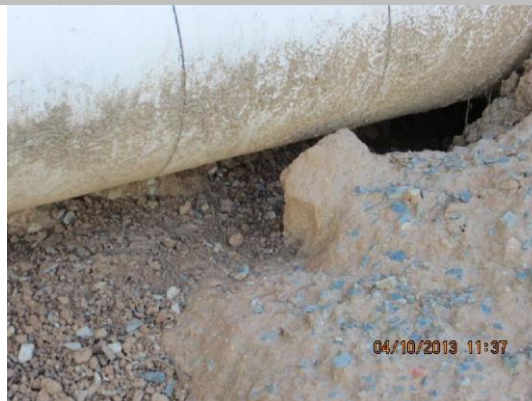
Photo 3 of 3 : UCIP\_SP\_2020\_11763\_19220.jpg

Comment Code						
Inspector Comment						
DS_ID:21991 FS_ID:11763 EP_NO: 6551 Repair Type: Non-Urgent Crossing Status: Found UCIP Comments: Rodent activity undermining pipe on LS slope. FIELD_STRUCT_DESC: 1 of 2: 14-inch polyvinyl chloride (PVC) wrapped steel irrigation pipe through the levee, 3 feet below the crown. Butterfly valve on the waterside (WS) shoulder. 2-inch galvanized electrical conduit at the same location. Pump on pile structure on the WS toe. Pressure booster and pump on the landside (LS) toe. (Permit No. 6551, 1969 - John D. Wheeler). [Additional Reference(s): DWR Levee Log, 2005. USACE Sacramento O&M Manual 111, May 1959, (RM 32.78)]. FS Date: 4/10/2013

Rodent activity undermining pipe on LS slope.

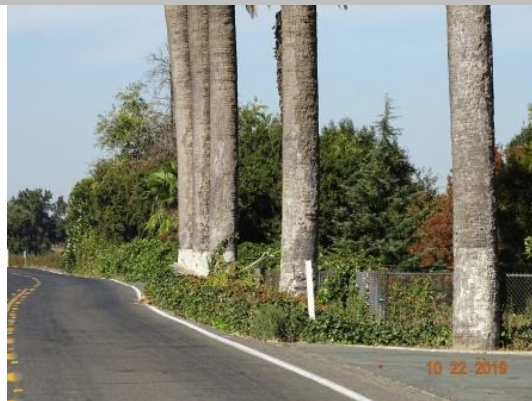
Photo 1 of 1 : SP\_2020\_RD0551\_175\_47\_20200304\_00071.jpg

View looking upstream at landscaping on the landside slope (Fall 2019).

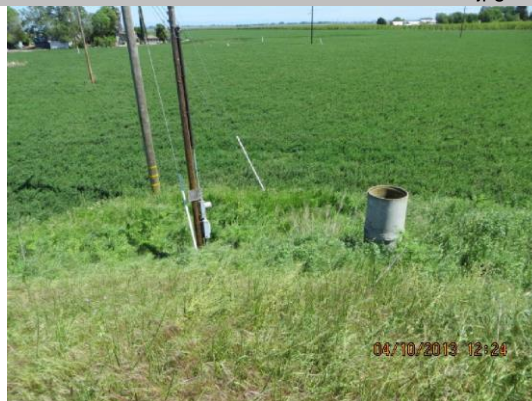
Photo 1 of 2 : UCIP\_SP\_2020\_11783\_19241.jpg

Comment Code						
Inspector Comment						
DS_ID:21994 FS_ID:11783 EP_NO: 11141 Repair Type: Non-Urgent Crossing Status: Found UCIP Comments: Records indicate this pipe was abandoned, but it appears to be active. Verify status. FIELD_STRUCT_DESC: 10-inch steel irrigation pipe through the levee, 8 feet below the crown. Slant pump on the waterside (WS) slope. Service pole on the landside (LS) slope with a 1.5-inch galvanized iron electrical conduit through the levee at the same location. (Automatic Board Order (ABO) issued as Permit No. 11141, 1975 - Adele Runyon, et al.). [Additional Reference(s): DWR Levee Log, 2005. USACE Sacramento O&M Manual 111, May 1959, (RM 32.38), listed as a 12-inch pipe]. FS Date: 4/10/2013

JP and concrete standpipe on LS toe.

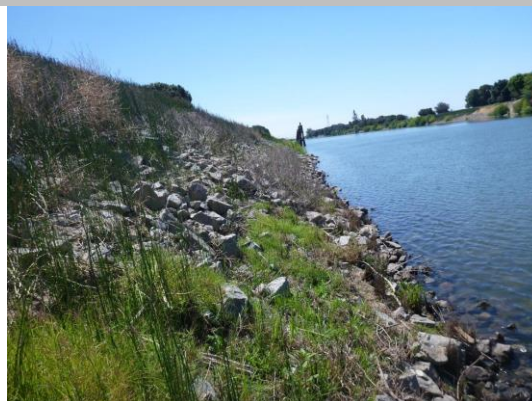
Photo 1 of 3 : SP\_2020\_RD0551\_175\_22\_20200304\_00009.jpg

This was a 2017 Storm Damage site.  
Approximately 149 linear-feet of erosion. The erosion exists near the rip rap line about 3/4 of the way down the slope. Some existing rip rap has been pulled off in this section.  
Site ID No:332  
Site Designation:LMA-159  
3/25/2020 Field Notes: Do boat inspection to verify extent of erosion.  
Monitor.

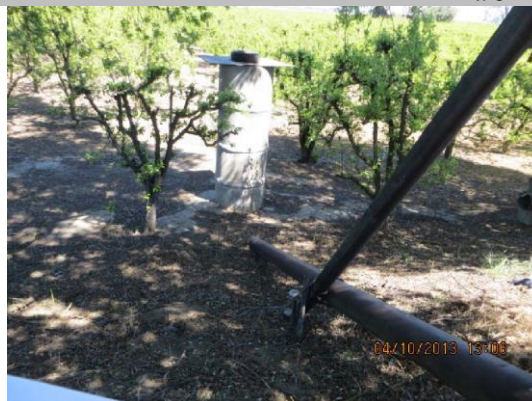
Photo 1 of 2 : UCIP\_SP\_2020\_11803\_19261.jpg

48-inch concrete riser on LS toe.

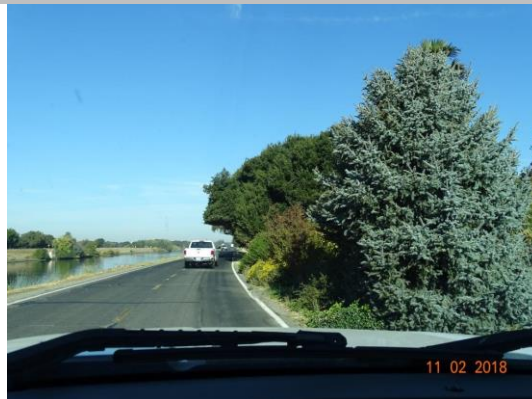
Photo 1 of 1 : SP\_2020\_RD0551\_175\_56\_20200304\_00079.jpg

View looking upstream at landscaping on the landside slope (November 2018).

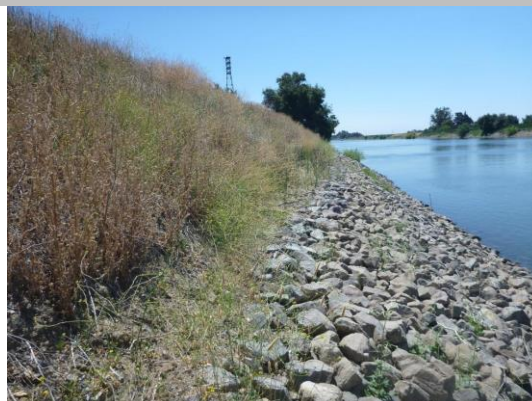
Photo 1 of 3 : SP\_2020\_RD0551\_175\_26\_20200304\_00014.jpg

LM Start	3.04	Rating **	A/W	Issue No.	26		
LM End	3.25	Issue Type +	Ma	Location *	WS		
Category	Earthen Levee			GPS Latitude/Longitude			
				Start	End		
Item	Erosion / Bank Caving			38.297258	°	38.294806	°
				-121.566231	°	-121.563958	°
DWR ID	DWR_RD0551_01_s_2020_26						
Comment Code							
E1 : Note and monitor erosion site.							
Inspector Comment							
This was a 2017 Storm Damage site. Approximately 1,104 linear-feet of erosion and subsequent sloughing. The erosion commences approximately halfway down the slope to the rip rap line. Site ID No:333 Site Designation:LMA-160 3/25/2020 Field Notes: Do boat inspection to verify extent of erosion. Monitor.

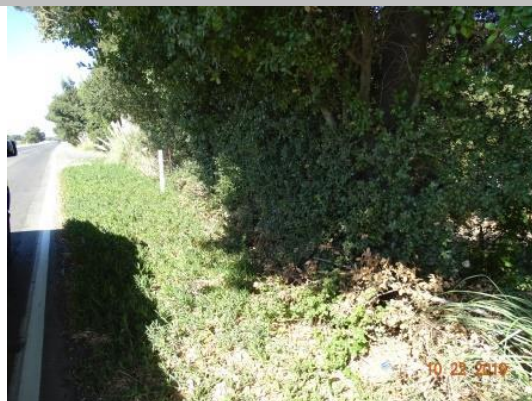
Photo 1 of 1 : SP\_2020\_RD0551\_175\_55\_20200304\_00078.jpg

View looking downstream at landscaping on the landside slope (Fall 2019).

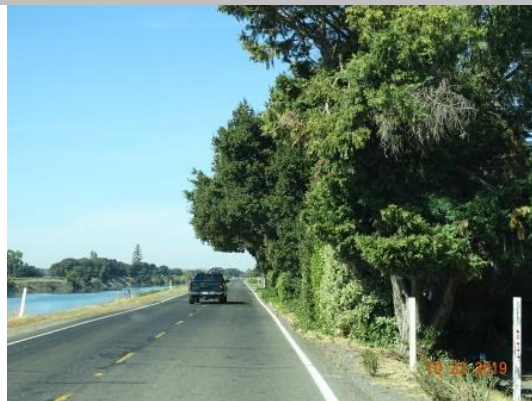
Photo 1 of 1 : SP\_2020\_RD0551\_175\_48\_20200304\_00072.jpg

View looking upstream at landscaping on the landside slope (Fall 2019).

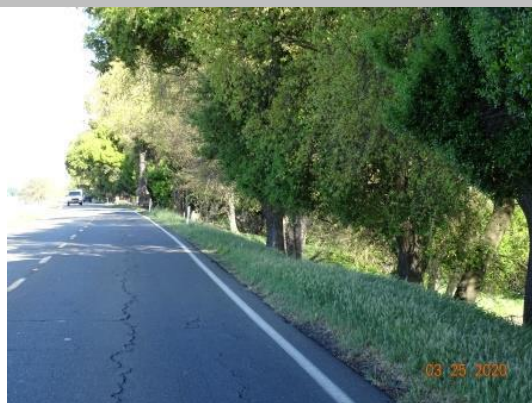
Photo 1 of 1 : SP\_2020\_RD0551\_175\_70\_20200325\_00125.jpg

View looking upstream at annual vegetation on the landside slope (Spring 2020).

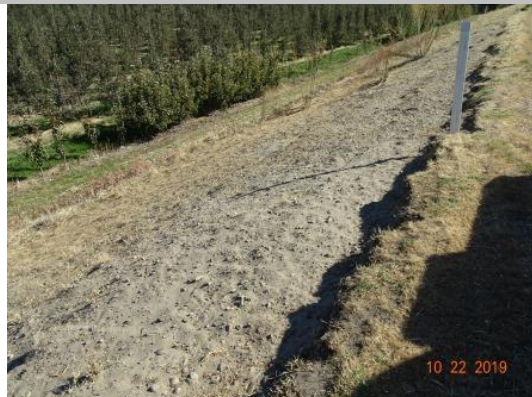
Photo 1 of 1 : SP\_2020\_RD0551\_175\_66\_20200304\_00088.jpg

View looking downstream at erosion due to goats on the landside slope (Fall 2019).

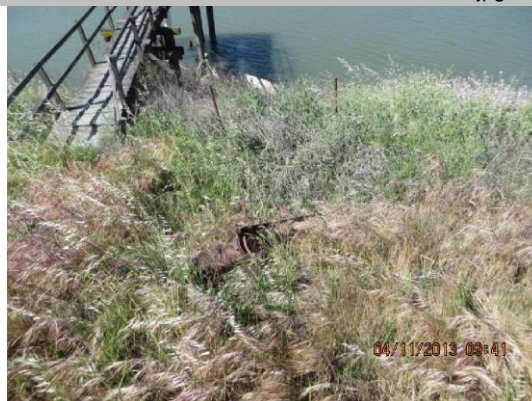
Photo 1 of 2 : UCIP\_SP\_2020\_11817\_19287.jpg

Abandoned slide gate on WS slope.

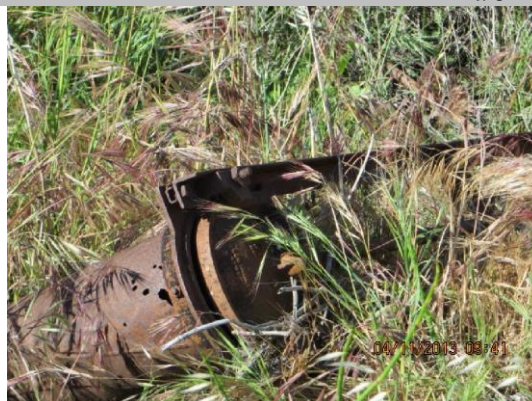
Photo 2 of 2 : UCIP\_SP\_2020\_11817\_19286.jpg

Abandoned slide gate on WS slope.

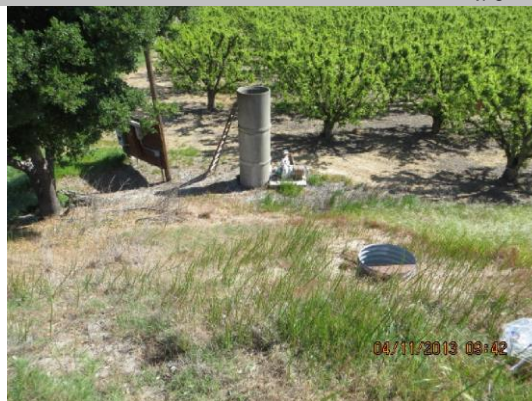
Photo 1 of 2 : UCIP\_SP\_2020\_11823\_19301.jpg

24-inch CMP riser and 48-inch concrete riser on LS slope.

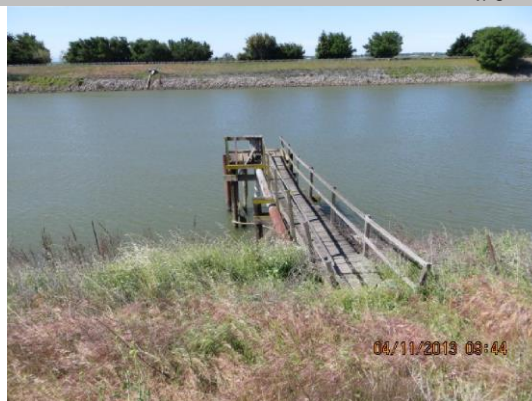
Photo 2 of 2 : UCIP\_SP\_2020\_11823\_19300.jpg

Pump on pier with wooden walkway on WS toe.

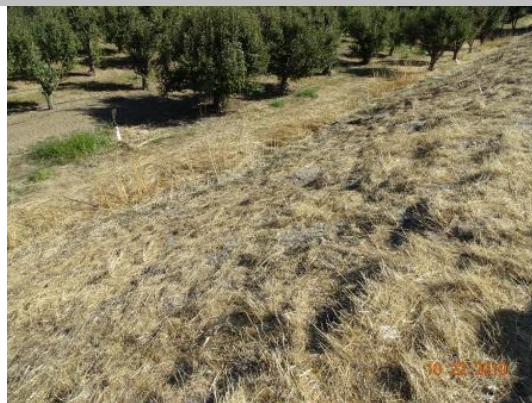
Photo 1 of 1 : SP\_2020\_RD0551\_175\_53\_20200304\_00077.jpg

View looking downstream at fresh rodent holes in the landside slope (Fall 2019).

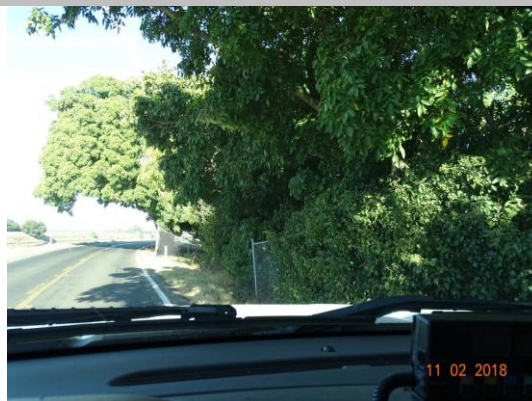
Photo 1 of 1 : SP\_2020\_RD0551\_175\_52\_20200304\_00076.jpg

View looking upstream at landscaping on the landside slope (November 2018).

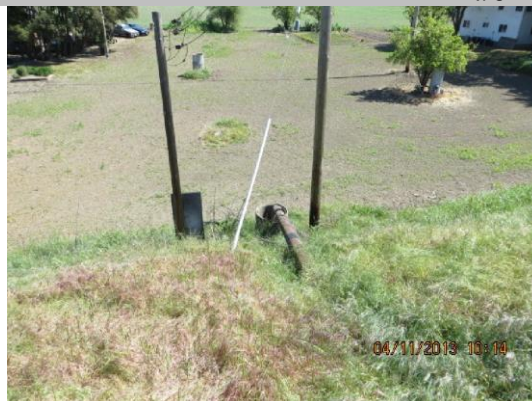
Photo 1 of 3 : UCIP\_SP\_2020\_51324\_46281.jpg

Pipe and stand pipe on LS toe with subsidence along pipe on LS slope.

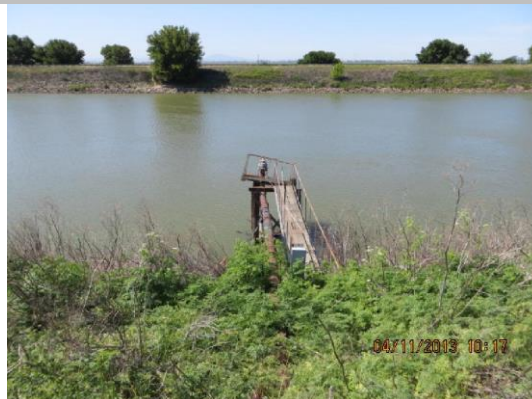
Photo 2 of 3 : UCIP\_SP\_2020\_51324\_46280.jpg

Pump on pier showing structural failure on WS toe.

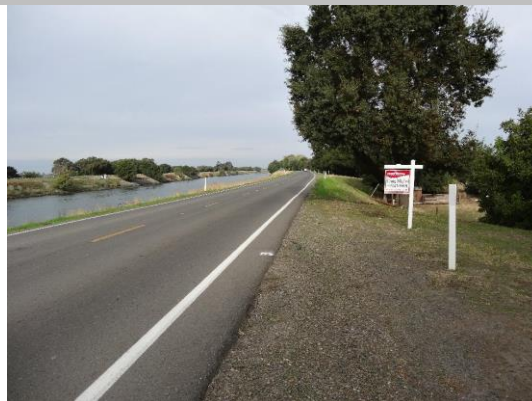
Photo 3 of 3 : UCIP\_SP\_2020\_51324\_76157.jpg

View of levee crown and LS slope, photo taken downstream of crossing looking upstream.

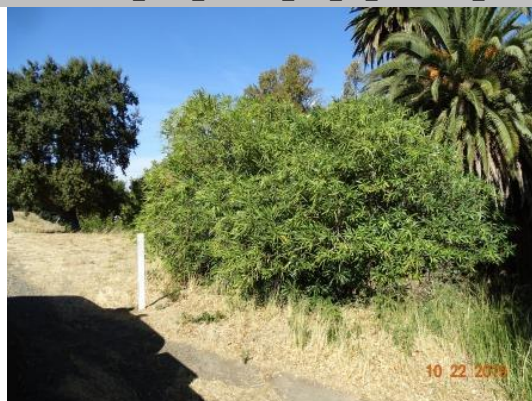
Photo 1 of 1 : SP\_2020\_RD0551\_175\_64\_20200304\_00087.jpg

View looking upstream at landscaping on the landside slope (Fall 2019).

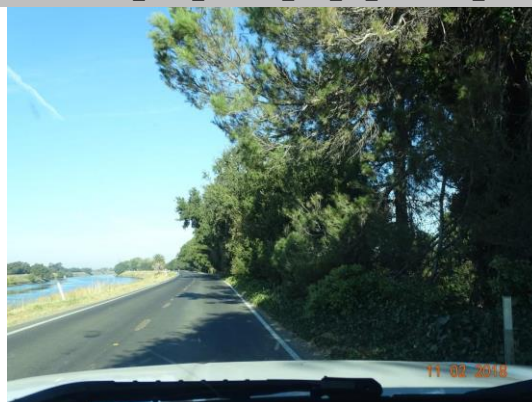
Photo 1 of 1 : SP\_2020\_RD0551\_175\_25\_20200304\_00013.jpg

View looking upstream at landscaping on the landside slope (November 2018).

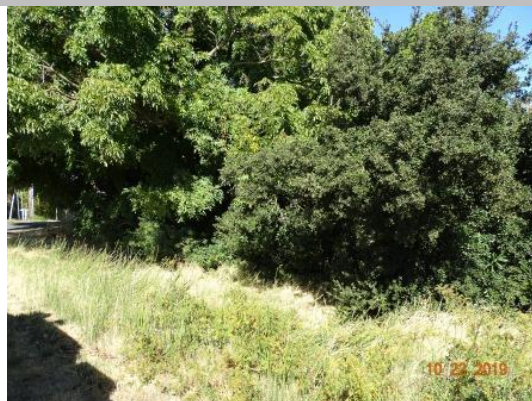
Photo 1 of 1 : SP\_2020\_RD0551\_175\_44\_20200304\_00068.jpg

View looking slightly upstream at landscaping on the landside slope (Fall 2019).

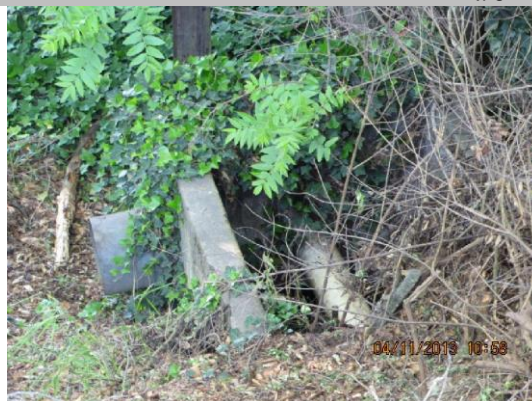
Photo 1 of 3 : UCIP\_SP\_2020\_12105\_19649.jpg

Pipe in distribution box at LS toe.

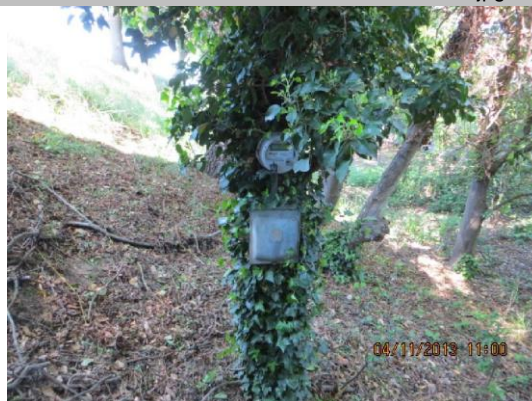
Photo 2 of 3 : UCIP\_SP\_2020\_12105\_19648.jpg

Meter on pole at LS toe.

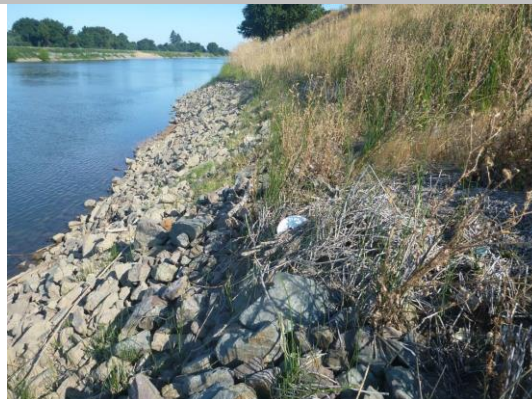
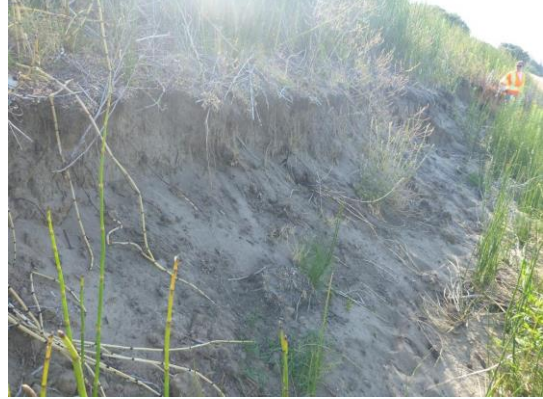
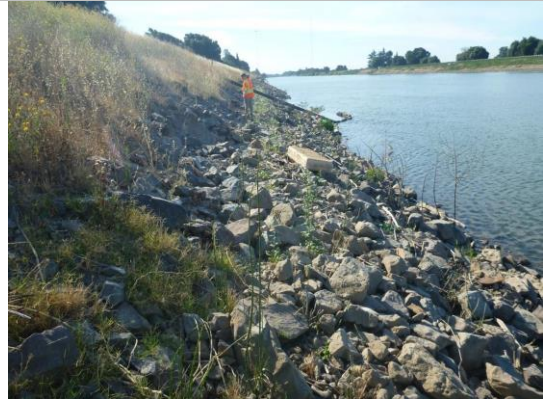
LM Start	5.20	Rating **	A/W	Issue No.	34
LM End	5.28	Issue Type +	Ma	Location *	WS
Category	Supplemental			GPS Latitude/Longitude	
				Start	End
Item	2017 Storm Damage			38.274592 °	38.273800 °
				-121.538958 °	-121.537869 °
DWR ID	LMA-169

Comment Code					
Inspector Comment					
Planned For Repair. Levee Evaluation Comments Description: District Station 273+82 to 278+08, Sec. 21 and 22, T. 5 N. R. 4 E., M.D.M. Approximately 426 linear-feet of erosion exists along the waterside slope of the Sacramento River. The erosion commences approximately halfway down the slope and extends to the rip rap. Some existing rip rap has been pulled off in this section. Site ID No: 342 Site Designation: LMA-169 Repair Type: Erosion Rating: Serious Field Date: 7/14/2017 Notes: there is a 7 ft scarp that extends for 40-60 ft in very sandy soil, scarps are 2-4 ft the rest of the length. Worst site in this RD so far. Serious because of the length of this deeper scarp and the weak soil here. Crown is a paved road.

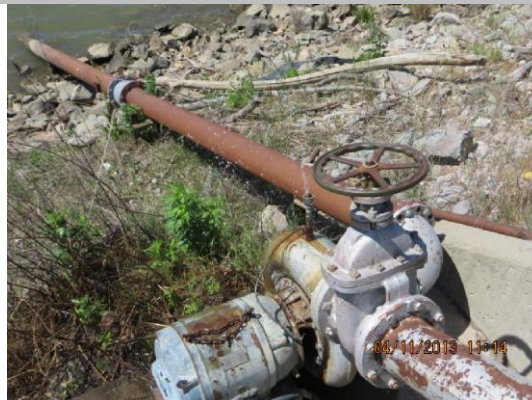
Photo 2 of 3 : UCIP\_SP\_2020\_26875\_49601.jpg

Pump and slide gate at Concrete pad on WS slope.

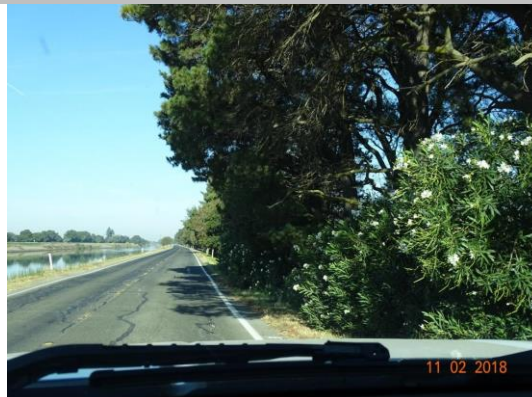
Photo 1 of 1 : SP\_2020\_RD0551\_175\_24\_20200304\_00012.jpg

View looking upstream at land scaping on the landside slope (November 2018).

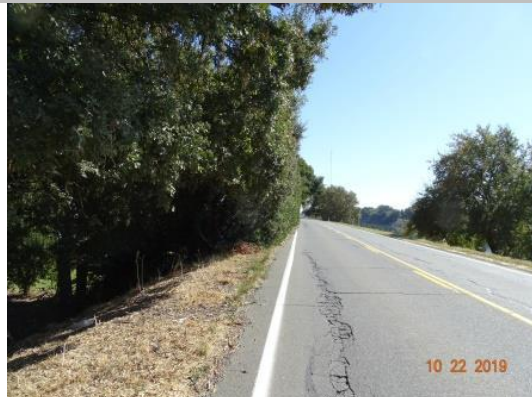
Photo 1 of 1 : SP\_2020\_RD0551\_175\_51\_20200304\_00075.jpg

View looking downstream at landscaping on the landside slope (Fall 2019).

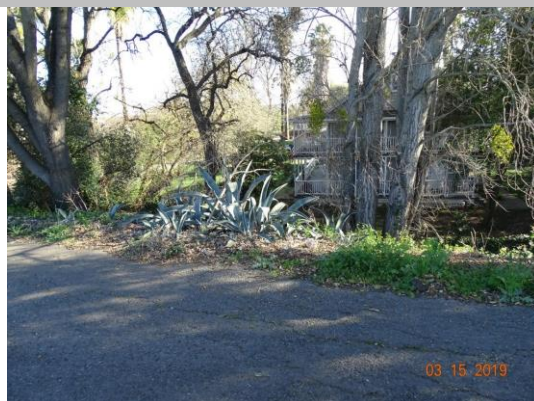
Photo 1 of 1 : SP\_2020\_RD0551\_175\_20\_20200304\_00005.jpg

LM Start	6.44	Rating **	M	Issue No.	20
LM End	6.44	Issue Type +	En	Location *	LS
Category	Earthen Levee			GPS Latitude/Longitude	
				Start	End
Item	Vegetation			38.262388 °	38.262388 °
				-121.522368 °	-121.522368 °
DWR ID	DWR_RD0551_01_s_2019_20				
Comment Code					
V6 : Landscaping					
Inspector Comment					
Cactus on the landside slope should be removed.

View of cactus on the landside shoulder (Spring 2019).
