**Flood Control Project Maintenance  
Levee Inspections  
LMA District Cover Sheet**

**Reclamation District No. 0551 Pearson**

**Flood Control Project Maintenance  
Levee Inspections**

**Levee Inspection Report By Mile - Spring 2021**

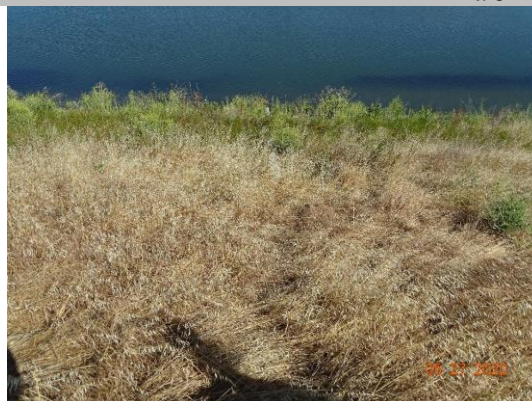
Photo 2 of 3 : UCIP\_SP\_2021\_57695\_85472.jpg

FS\_ID:57695  
DS\_ID:21971  
EP\_NO: 8664  
Repair Type: Non-Urgent  
Crossing Status: Found  
UCIP Comments: 05/27/2020 Record updated from No Action Needed to Non-Urgent. 8-inch pipe sleeved through 10-inch pipe. Installed new pump with gate valve and pressure booster, service pole with electric panel next to pumphouse. Abandoned pump and gate valve in pump house, abandoned 48-inch and 24-inch concrete standpipes at pump house on the LS toe. Unable to locate a permit authorizing modification. Need to have CVFPB review ABO and determine current owner. (O.Yakimov - DWR UCIP)  
FIELD\_STRUCT\_DESC: 8-inch pipe sleeved through 10-inch coated steel irrigation pipe through the levee, 5 feet below the crown. Pump with gate valve and pressure booster, service pole with electrical panel next to pumphouse on the landside slope. (Retention of irrigation pumping plant, centrifugal pump and gate valve in pump house, landside toe of the levee [HLM 0.05] authorized under Automatic Board Order (ABO) issued as Permit No. 8664, 1972 - Lincoln Chan).

Water-Side: View of levee slope

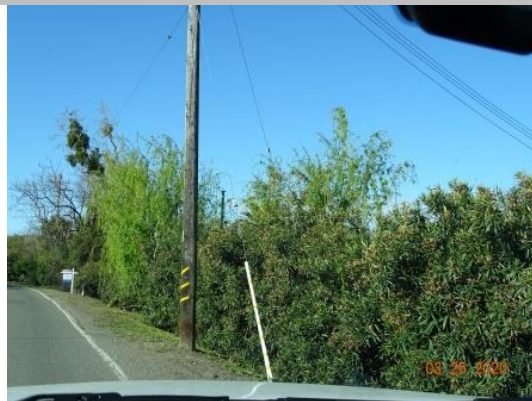
Photo 1 of 1 : SP\_2021\_RD0551\_175\_17\_20210301\_00004.jpg

View looking downstream of landscaping blocking view down waterside slope (Spring 2020).

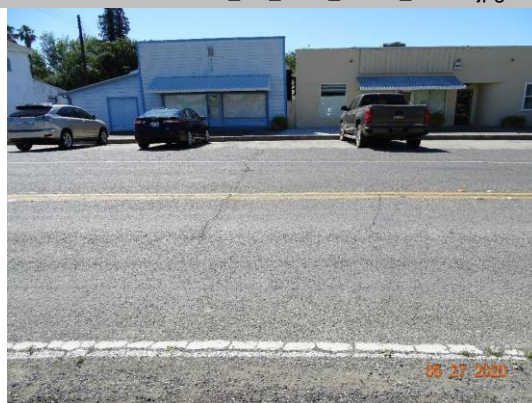
Photo 2 of 3 : UCIP\_SP\_2021\_60032\_87318.jpg

FS\_ID:60032  
DS\_ID:21982  
EP\_NO: 2759  
Repair Type: Non-Urgent  
Crossing Status: Found  
UCIP Comments: 05/27/2020 Record remains Non-Urgent.  
Unauthorized encroachment recorded in Levee Log prior to 2011.  
Unable to determine pipe material through the levee. PVC pipe is visible in a plastic box on waterside. (O.Yakimov - DWR UCIP)  
04/1-/2013 Unclear where exact crossing is located (W.Wylie - DWR UCIP)  
FIELD\_STRUCT\_DESC: [Courtland Boating Facilities] 1-inch steel water line through the levee, at an unknown depth. Ramp and boating facilities on the waterside (WS). Pipe visible under buildings at concrete foundation on the landside (LS). Water service connections for irrigation located on the WS slope. (Reference to existing 1-inch water pipe to be connected to the trailer made in Permit No. 2759, 1958 - Jack and Belva Swisley and Ed Hathaway).  
FS Date: 5/27/2020 3:05:40 PM

Land-Side: Stores on landside where pipe is crossing

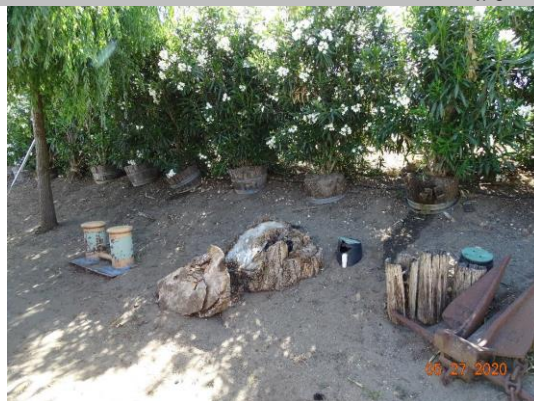
Photo 3 of 3 : UCIP\_SP\_2021\_60032\_87317.jpg

Land-Side: Overview of landside where PVC pipe is found

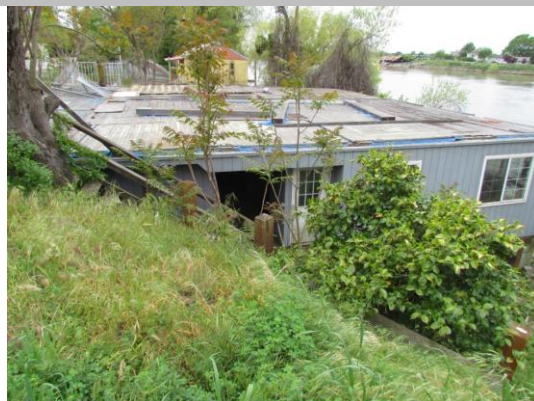
Photo 1 of 1 : SP\_2021\_RD0551\_175\_21\_20210301\_00006.jpg

LM Start	0.49	Rating **	M	Issue No.	21
LM End	0.49	Issue Type +	En	Location *	WS
Category	Earthen Levee			GPS Latitude/Longitude	
				Start	End
Item	Encroachments			38.331063 °	38.331063 °
				-121.570634 °	-121.570634 °
DWR ID	DWR_RD0551_01_s_2014_21				
Comment Code					
BU : Building					
Inspector Comment					
11750 River Road - The new land owner is working with the LMA trying to get CVFPB Permits for this project. No other work at this site. Waiting to hear from Enforcements.

Photo taken 4-06-2017. Building and steps have been there since at least January 2014. No work done, no permit issued.

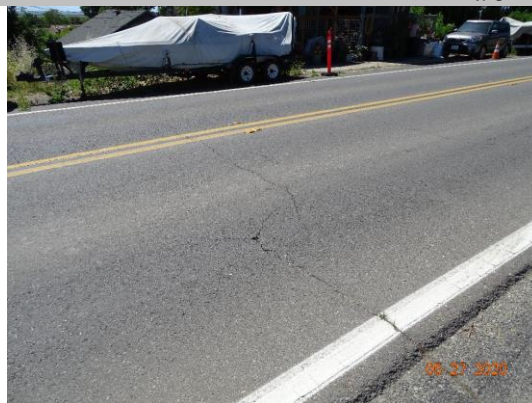
Photo 1 of 3 : UCIP\_SP\_2021\_60085\_87345.jpg

Comment Code						
Inspector Comment						
FS_ID:60085 DS_ID:21985 EP_NO: 6220 Repair Type: Non-Urgent Crossing Status: Found UCIP Comments: 05/27/2020 Record remains Non-Urgent. Two sinkholes on waterside levee slope that measure 18"x 12"x 6" deep found in pipe alignment. Crossing appears abandoned. Pipe is heavily rusted at riverbank. From conversation with adjacent property owner found out that pipe is located on easement to the property just across from the crossing and used to serve water for orchard on landside. (O.Yakimov - DWR UCIP) 04/10/2013 Pipe abandoned and should be removed. (W.Wylie - DWR UCIP) FIELD_STRUCT_DESC: 8-inch coated steel irrigation pipe through the levee, 6.1 feet below the crown. Pump on the waterside (WS) with slide gate and air vent. (8-inch pipe authorized under Permit No. 6220, 1968 - Robert U. Grant). [Additional Reference(s): DWR Levee Log, 2005 (HLM 0.71)]. FS Date: 5/27/2020 8:59:30 AM

Top of Levee: View of levee crown looking towards landside

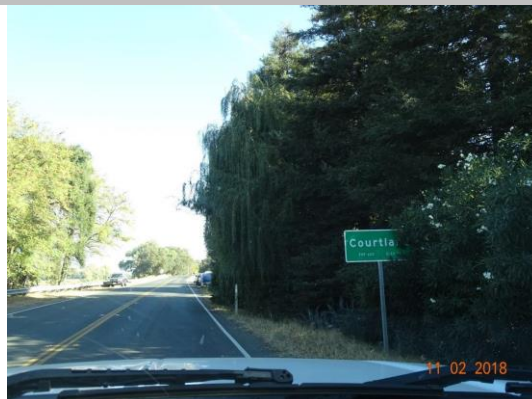
Photo 1 of 1 : SP\_2021\_RD0551\_175\_57\_20210301\_00023.jpg

View looking upstream at landscaping on the landside slope (November 2018).

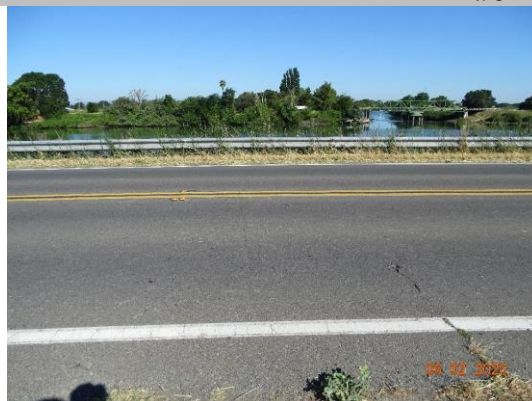
Photo 1 of 3 : UCIP\_SP\_2021\_60086\_87355.jpg

Comment Code					
Inspector Comment					
FS_ID:60086 DS_ID:21986 EP_NO: 701 Repair Type: Urgent Crossing Status: Found UCIP Comments: 06/02/2020 Record updated from Non-Urgent to Urgent. Through hole in pipe visible on landside slope, missing wall of pipe at riverbank. 2-foot diameter scour hole present around a hole in pipe on landside slope. 3-foot diameter and 3-inch deep depression of levee slope just above this hole. Crossing appears abandoned. (O.Yakimov - DWR UCIP) 04/10/2013 Pipe appears abandoned and should be done so properly. Good candidate for video inspection. (W.Wylie - DWR UCIP) FIELD_STRUCT_DESC: 14-inch steel irrigation pipe through the levee, 7.2 feet below the crown. Pump in pump house on the waterside (WS) slope. Service pole on the landside (LS) slope. 1-inch galvanized filler pipe, and a 2-inch electrical conduit at the same location. (16-inch pipe authorized under Permit No. 701, 1937 - American Trust Company). [Additional Reference(s): DWR Levee Log, 2005 (HLM 0.89). USACE Sacramento O&M Manual, Unit 111, May 1959, Revised 29 December 2016, (RM 33.91), listed as 14-inch pipe. USACE As-Built Drawing No. 06-13-1100, Sheet 12, upstream of 'L' 1348+33, January 1933]. FS Date: 6/2/2020 10:38:50 AM

Top of Levee: View of levee crown looking towards waterside

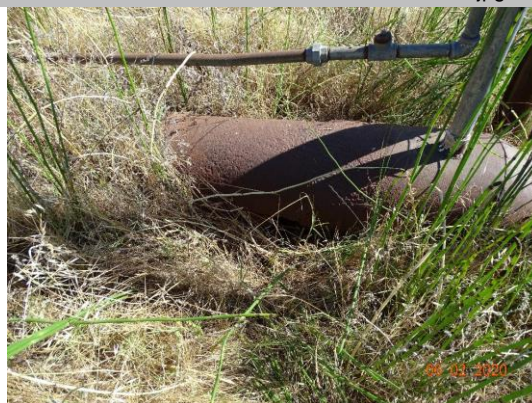
Photo 3 of 3 : UCIP\_SP\_2021\_60086\_87358.jpg

Land-Side: 1-inch filler line through levee connected to the pipe

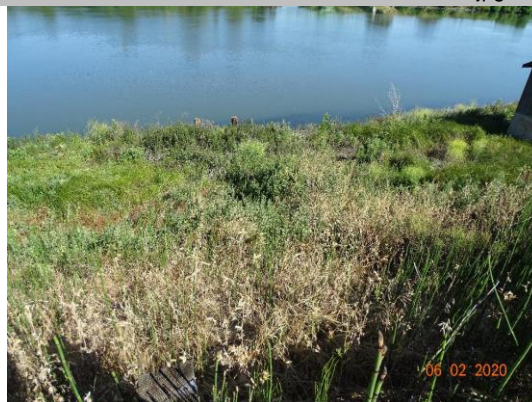
Photo 2 of 3 : UCIP\_SP\_2021\_60092\_87361.jpg

Comment Code						
Inspector Comment						
FS_ID:60092 DS_ID:21987 EP_NO: 793A Repair Type: Non-Urgent Crossing Status: Found UCIP Comments: 06/02/2020 Record updated from No Action Needed to Non-Urgent. Pump and screen filters installed on landside, capped old 12-inch pipe on landside slope next to the standpipe. Unable to find a permit authorizing modifications to this crossing. Two abandoned concrete standpipes on the landside slope and at the toe, abandoned pump piles at riverbank. Minor runoff erosion on waterside shoulder in pipe alignment. Pipe debris at riverbank. (O.Yakimov - DWR UCIP) FIELD_STRUCT_DESC: 8-inch steel irrigation pipe sleeved through a 12-inch pipe with annular space grouted 7.8 feet below the crown. Pump and pressure booster at the landside (LS) toe with switch panel and power pole. (12-inch pipe authorized under Permit No. 793, 1939 - Margaret H. Smith Estate). (Sleeving 8-inch pipe through existing 10-inch pipe and grouting annular space authorized under Permit No. 793A, 1974 - George W.G. Smith). [Additional Reference(s): DWR Levee Log, 2005 (HLM 0.90). USACE Sacramento O&M Manual, Unit 111, May 1959, Revised 29 December 2016, (RM 33.90), listed as 12-inch pipe]. FS Date: 6/2/2020 1:07:09 PM

Water-Side: View of levee slope looking from crown

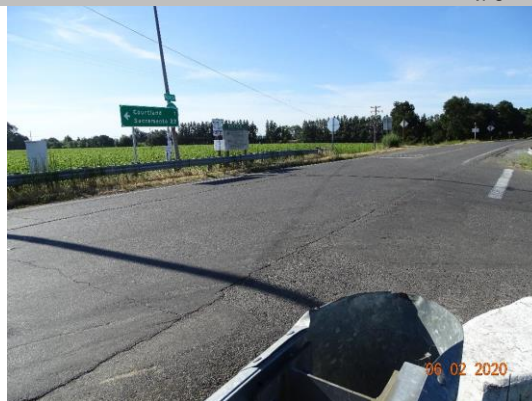
Photo 1 of 3 : UCIP\_SP\_2021\_60099\_87395.jpg

LM Start	1.43	Rating **	M	Issue No.	12	
LM End	1.43	Issue Type +	En	Location *		
Category	Supplemental			GPS Latitude/Longitude		
				Start		End
Item	DWR UCIP Field Study			38.318582 °	38.318582 °	
				-121.576498 °	-121.576498 °	
DWR ID	22972					
Comment Code						
Inspector Comment						
FS_ID:60099 DS_ID:22972 EP_NO: N/A Repair Type: Non-Urgent Crossing Status: Found UCIP Comments: 06/02/2020 Record updated from No Action Needed to Non-Urgent. No permit has been found authorizing this crossing through the levee. Conduit seems to cross intersection diagonally. (O.Yakimov - DWR UCIP)						
FIELD_STRUCT_DESC: 3-inch polyvinyl chloride (PVC) electrical conduit through the levee, 5 feet below the crown. Joint pole (JP) on the landside (LS) toe with a utility box on the LS shoulder. 2.5-inch steel conduit visible under bridge. FS Date: 6/2/2020 2:30:34 PM

Top of Levee: View of intersection where conduit crossing levee

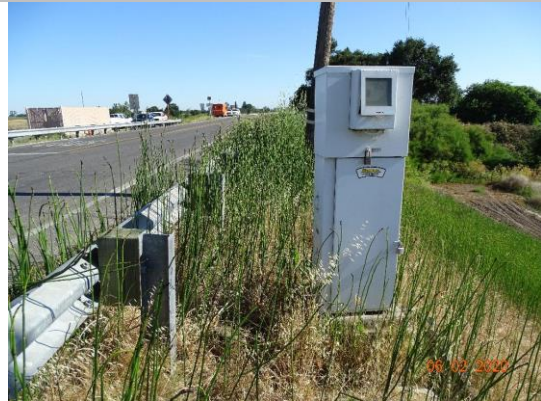
Photo 3 of 3 : UCIP\_SP\_2021\_60099\_87397.jpg

Land-Side: View of levee shoulder at the crossing

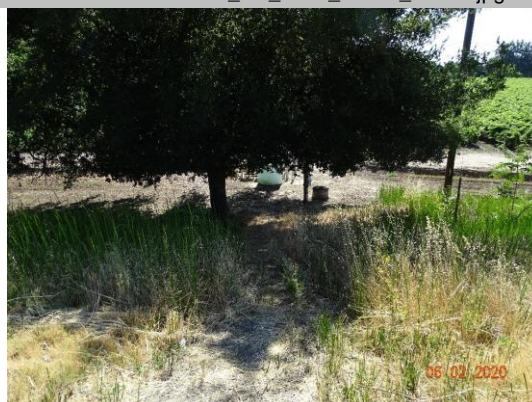
Photo 2 of 3 : UCIP\_SP\_2021\_60100\_87401.jpg

Comment Code						
Inspector Comment						
FS_ID:60100 DS_ID:21988 EP_NO: 11148 Repair Type: Non-Urgent Crossing Status: Found UCIP Comments: 06/02/2020 Record updated from No Action Needed to Non-Urgent. No permit has been identified authorizing pipe. Need to have CVFPB review ABO and determine current owner. No permit found authorizing sleeving 6-inch pipe through 10-inch pipe. Pump is running - minor leaks through pump sealing. (O.Yakimov - DWR UCIP) FIELD_STRUCT_DESC: 6-inch steel irrigation pipe sleeved through a 10-inch pipe, 6.8 feet below the crown. Pump in pump house on the waterside (WS) slope. Service pole on the landside (LS) slope. Filtration system installed on the LS toe. (10-inch pipe [HLM 1.51] authorized under Automatic Board Order (ABO) issued as Permit No. 11148, 1975 - M.C.C. Van Loben Sells). [Additional Reference(s): DWR Levee Log, 2005 (HLM 1.51). USACE Sacramento O&M Manual, Unit 111, May 1959, Revised 29 December 2016, (RM 33.29), listed as 10-inch pipe. USACE As-Built Drawing No. 06-13-1100, Sheet 12, near 'L' 1370+00, January 1933, listed as 10-inch pipe]. FS Date: 6/2/2020 3:12:27 PM

Land-Side: View of levee slope looking from crown

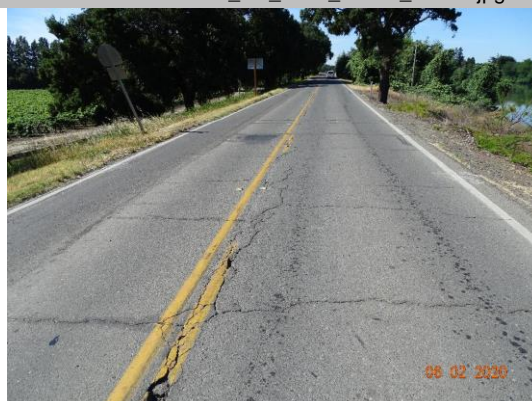
Photo 1 of 3 : UCIP\_SP\_2021\_60128\_87408.jpg

FS\_ID:60128  
 DS\_ID:22007  
 EP\_NO: 16640  
 Repair Type: Non-Urgent  
 Crossing Status: Found  
 UCIP Comments: 06/02/2020 Record updated from No Action Needed to Non-Urgent. Unable to locate a permit authorizing to sleeve 10-inch pipe through 12-inch pipe. (O.Yakimov - DWR UCIP)  
 FIELD\_STRUCT\_DESC: 10-inch coated steel irrigation pipe sleeved through a 12-inch pipe, 2 feet below the crown. Pump in pump house on the waterside (WS). Pipe discharges into a 6-foot by 10-foot concrete distribution box on the landside (LS) slope. (12-inch pipe authorized under Permit No. 16640, 1996 - Carel D. Van Loben Sels).  
 FS Date: 6/2/2020 9:21:00 AM

Top of Levee: View of levee crown looking downstream

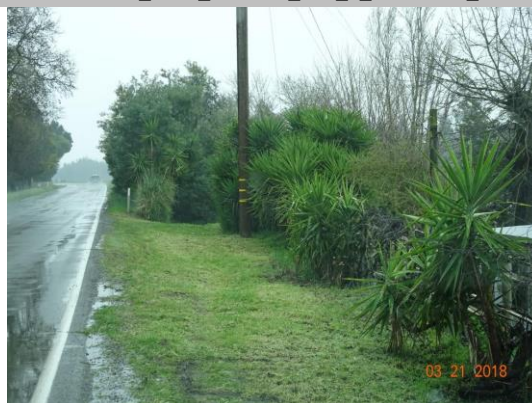
Photo 1 of 1 : SP\_2021\_RD0551\_175\_6\_20210301\_00003.jpg

View looking downstream at landscaping on the waterside shoulder (Spring 2018).

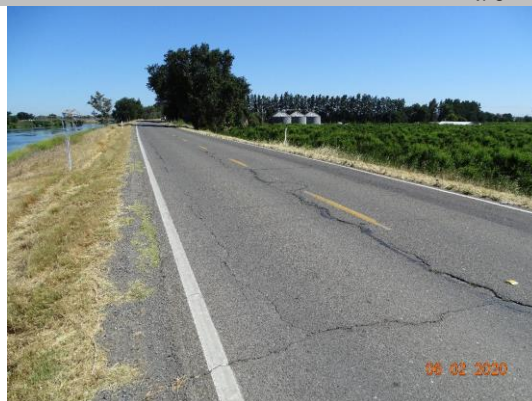
Photo 1 of 3 : UCIP\_SP\_2021\_60145\_87423.jpg

FS\_ID:60145  
DS\_ID:21990  
EP\_NO: 11145  
Repair Type: Non-Urgent  
Crossing Status: Found  
UCIP Comments: 06/02/2020 Record remains Non-Urgent. A portion on pipe on landside slope was replaced. Due to overgrown vegetation unable to locate connection of a replaced pipe segment to a pipe through the levee and evaluate levee slope condition. Pumphouse on waterside has been removed. Intake pipe at riverbank to the pump has been replaced, pipe debris left at riverbank. Unable to locate a permit for replacing the pipe segment on landside slope. No permit has been identified authorizing pipe through the levee. Need to have CVFPB review ABO and determine current owner. (O.Yakimov - DWR UCIP) Based on District notes from January 14, 2014, pump discharge pipe has been repaired. Pipe failing on LS slope causing erosion along pipe alignment. Pipe debris on both slopes should be removed as well.: As of 12/13/2013 District President noted that the landowner had made repairs to the LS slope leaks.: As of 12/17/2013 District submitted letter to landowner explaining UCIP report details including photos of the pipe problems

Top of Levee: View of levee crown looking upstream

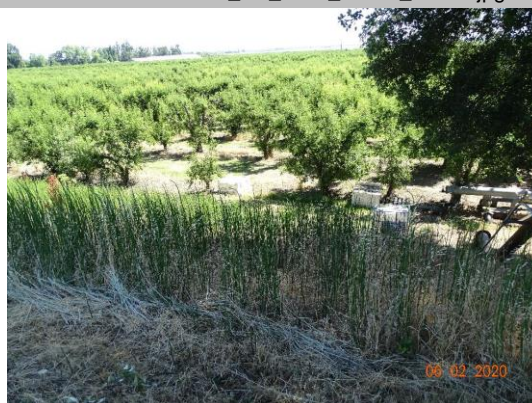
Photo 2 of 3 : UCIP\_SP\_2021\_60156\_87428.jpg

FS\_ID:60156  
DS\_ID:22040  
EP\_NO: 3676  
Repair Type: Non-Urgent  
Crossing Status: Not Found  
UCIP Comments: 06/02/2020 Record remains Non-Urgent. Crossing not found. Cut in road pavement is still visible. No permit has been identified authorizing original 12-inch pipe. (O.Yakimov - DWR UCIP) 04/10/2013 Fresh cut through pavement on crown indicates recent work on pipes at this location. Need to determine if pipe was removed or abandoned in place. (W.Wylie - DWR UCIP)  
FIELD\_STRUCT\_DESC: 8-inch coated steel irrigation pipe sleeved through a 12-inch pipe through the levee, 5 feet below the crown. Pump on platform on the waterside (WS). (Sleeving 8-inch pipe through existing 12-inch pipe authorized under Permit No. 3676, 1961 - Runyon and Dorsey). [Additional Reference(s): DWR Levee Log, 2005 (HLM 2.02). USACE Sacramento O&M Manual, Unit 111, May 1959, Revised 29 December 2016, (RM 32.78), listed as 10-inch pipe].

Land-Side: View of levee slope looking from crown

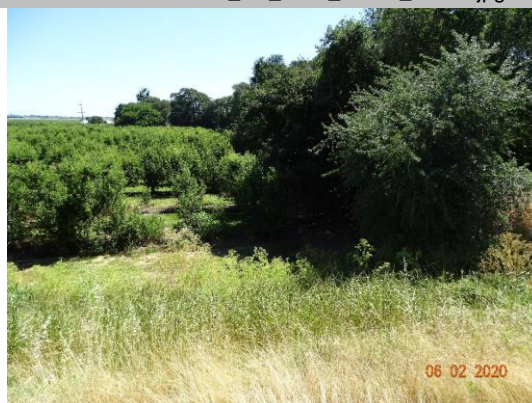
Photo 2 of 3 : UCIP\_SP\_2021\_60214\_87502.jpg

FS\_ID:60214  
DS\_ID:21992  
EP\_NO: N/A  
Repair Type: Non-Urgent  
Crossing Status: Not Found  
UCIP Comments: 06/02/2020 Record updated from No Action Needed to Non-Urgent. Crossing not found. Concrete retaining wall on waterside shoulder at this place. Need to confirm proper method of abandonment. No permit has been identified authorizing pipe. (O.Yakimov - DWR UCIP)  
FIELD\_STRUCT\_DESC: 4-inch pipe of an unknown material or purpose through the levee, 7.7 feet below the crown. Filled with concrete. Concrete headwall along the waterside (WS) shoulder may be a good indicator of pipe location. (Cat. IVA - Wheeler). [Additional Reference(s): DWR Levee Log, 2005 (HLM 2.24). USACE Sacramento O&M Manual, Unit 111, May 1959, Revised 29 December 2016, (RM 32.56), listed as 4-inch pipe. USACE As-Built Drawing No. 06-13-1100, Sheet 13, 'L' 1416+45, January 1933].  
FS Date: 6/2/2020 7:59:52 AM

Land-Side: View of levee slope looking from crown

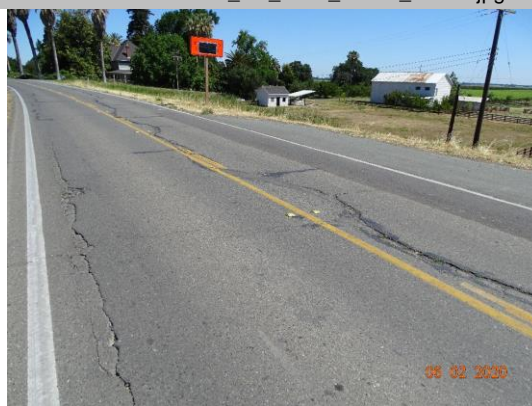
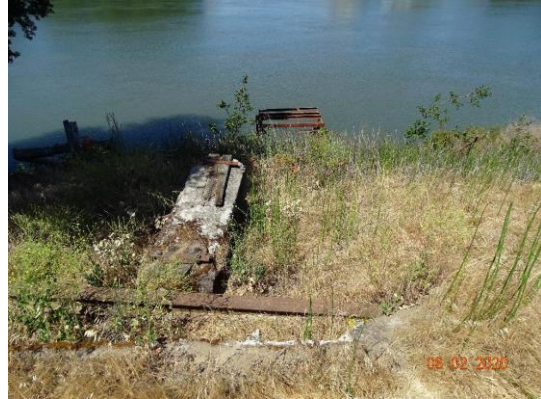
FS\_ID:60216  
DS\_ID:21993  
EP\_NO: 1248  
Repair Type: Non-Urgent  
Crossing Status: Indicator Found  
UCIP Comments: 06/02/2020 Record updated from No Action Needed to Non-Urgent. Crossing appears abandoned. Unable to locate a permit and confirm proper pipe abandonment. (O.Yakimov - DWR UCIP)

FIELD\_STRUCT\_DESC: 10-inch irrigation pipe of an unknown material through the levee, 5 feet below the crown. Concrete plug on the waterside (WS) end. Concrete headwall, electrical connection box, concrete abutment on WS slope. Steel pile pumping platform remains at the WS toe. No pump or other appurtenances found. (12-inch pipe authorized under Permit No. 1248, 1947 - Estate of Laura R. Dorsey). [Additional Reference(s): DWR Levee Log, 2005 (HLM 2.42). USACE As-Built Drawing No. 50-04-2983, Sheet 9, STA 1+45, March 1954, listed as 8-inch pipe].

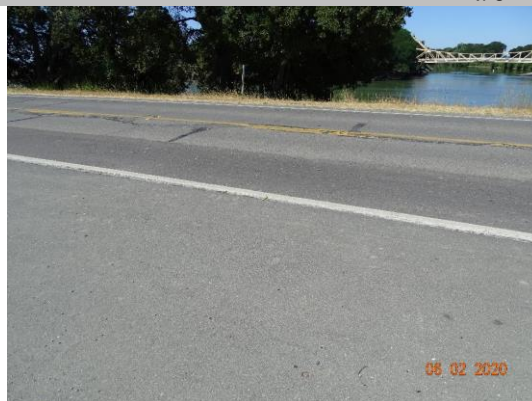
Photo 1 of 3 : UCIP\_SP\_2021\_60233\_87514.jpg

FS\_ID:60233  
DS\_ID:21994  
EP\_NO: 11141  
Repair Type: Non-Urgent  
Crossing Status: Found  
UCIP Comments: 06/02/2020 Record remains Non-Urgent. Field measured pipe through the levee to be 11-inch in diameter. 8-inch pipe sleeved through 11-inch pipe. Annular space between pipes seems to be grouted. Concrete standpipe at landside levee toe has been removed. Unable to locate a permit for modifications. No permit has been identified authorizing original pipe. Need to have CVFPB review ABO and determine current owner. (O.Yakimov - DWR UCIP)  
04/10/2013 Records indicate this pipe was abandoned, but it appears to be active. Verify status. (W.Wylie - DWR UCIP)  
FIELD\_STRUCT\_DESC: 8-inch steel irrigation pipe sleeved through 11-inch pipe through the levee, 8 feet below the crown. Slant pump on the waterside (WS) slope. Service pole on the landside (LS) slope with a 1.5-inch galvanized iron electrical conduit through the levee at the same location. This crossing replaces 12-inch pipe (see DSID 25637). (12-inch pipe authorized under Permit No. 747, 1938 - Runyon And Stephenson). (12-inch pipe [HLM 2.32] authorized under Automatic Board Order (ABO) issued as Permit No. 1975, 1975 - Adele Runyon, Et Al). [Additional Reference(s): DWR Levee Log, 2005 (HLM 2.42), listed as 12-inch pipe. USACE Sacramento O&M Manual, Unit 111, May 1959, Revised 29 December 2016, (RM 32.38), listed as 12-inch pipe. USACE As-Built Drawing No. 06-13-1100, Sheet 13, 'L' 1422+78, January 1933, listed as 12-inch pipe. USACE As-Built Drawing No. 50-04-2983, Sheet 9, STA 1+50, March 1954].

Top of Levee: View of levee crown looking towards waterside

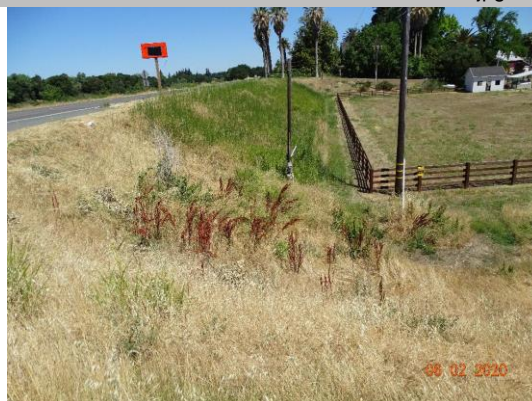
Photo 3 of 3 : UCIP\_SP\_2021\_60233\_87517.jpg

Land-Side: Overview of levee slope. Concrete standpipe is gone

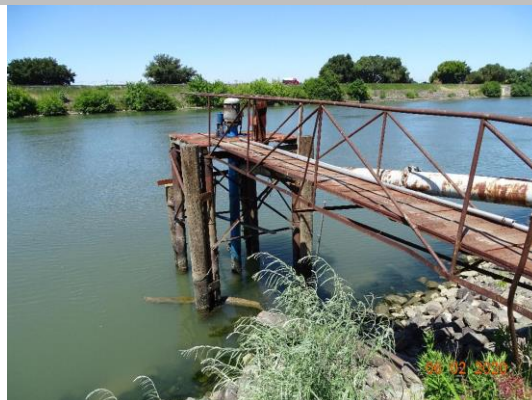
Photo 2 of 3 : UCIP\_SP\_2021\_60293\_87555.jpg

Water-Side: Pump on pile structure in river channel

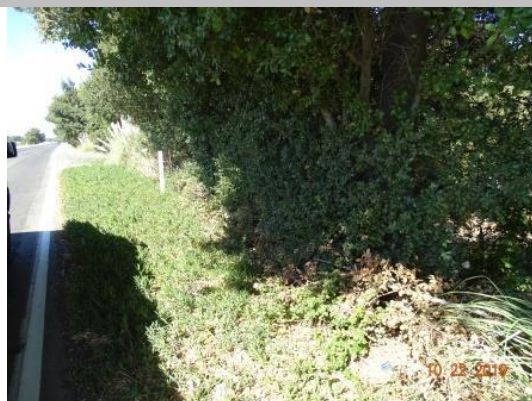
Photo 1 of 1 : SP\_2021\_RD0551\_175\_55\_20210301\_00021.jpg

View looking downstream at landscaping on the landside slope (Fall 2019).

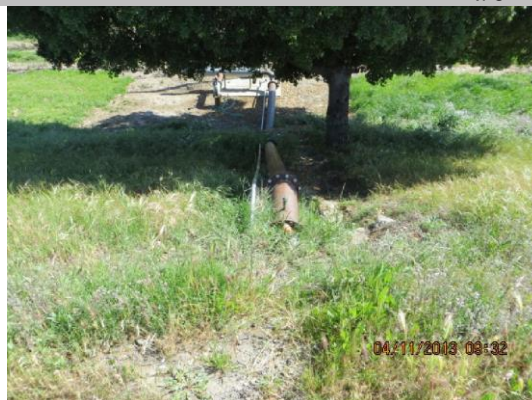
Photo 2 of 3 : UCIP\_SP\_2021\_60445\_19284.jpg

Pipe, air vent, siphon breaker, and electrical conduit on LS slope.

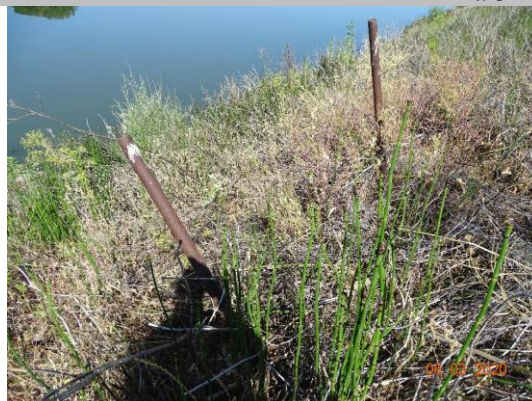
Photo 3 of 3 : UCIP\_SP\_2021\_60450\_87748.jpg

Water-Side: Two markers on waterside slope may indicate pipe alignment

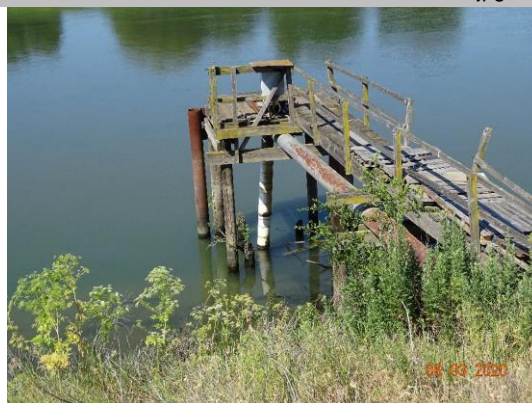
Photo 3 of 3 : UCIP\_SP\_2021\_60460\_87784.jpg

Water-Side: Pump on pile structure in channel. Wooden walkway is in bad shape

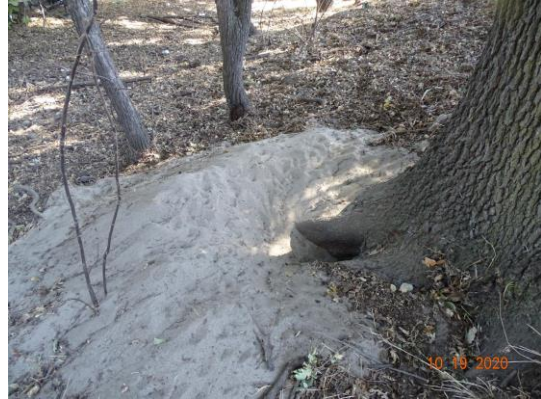
Photo 1 of 1 : SP\_2021\_RD0551\_175\_89\_20210301\_00035.jpg

View large animal hole in the landside slope (Fall 2020).

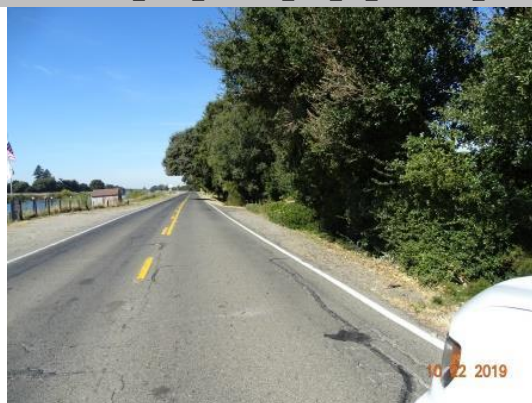
Photo 1 of 1 : SP\_2021\_RD0551\_175\_49\_20210301\_00016.jpg

View looking upstream at landscaping on the landside slope (Fall 2019).

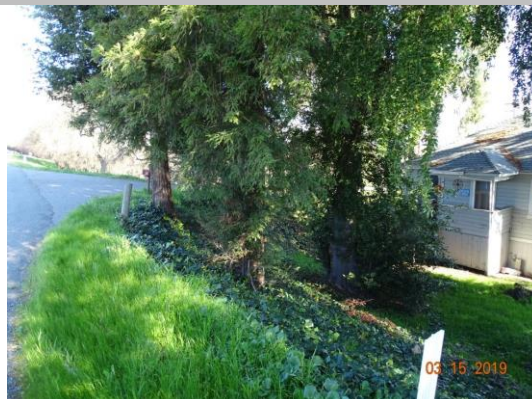
Photo 1 of 1 : SP\_2021\_RD0551\_175\_58\_20210301\_00024.jpg

View looking upstream at landscaping on the landside slope (Spring 2019).

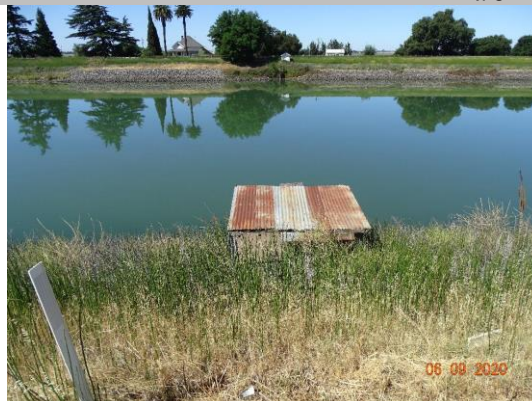
Photo 2 of 3 : UCIP\_SP\_2021\_60635\_87912.jpg

Water-Side: Dense vegetation on levee slope. View of pump house on the slope

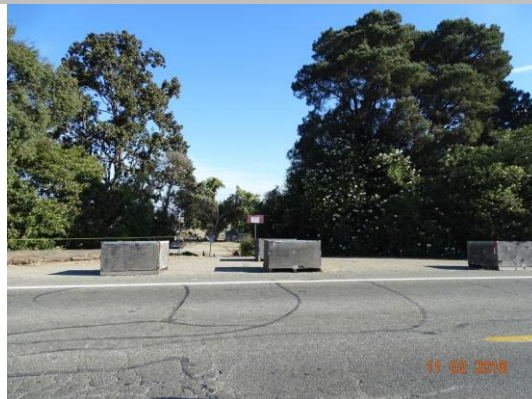
Photo 1 of 1 : SP\_2021\_RD0551\_175\_59\_20210301\_00025.jpg

View of boxes on the land side shoulder that landowner placed to block traffic from using driveway (November 2018).

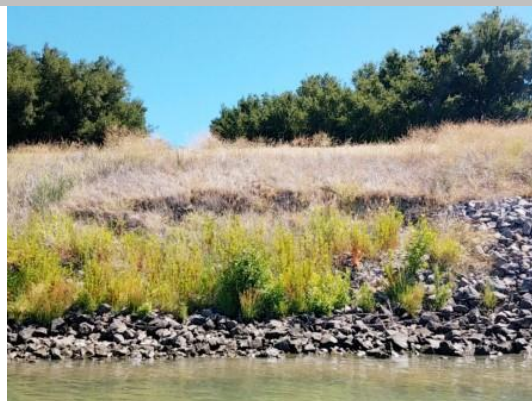
Photo 1 of 1 : SP\_2021\_RD0551\_175\_2\_20210301\_00002.jpg

View from the channel of erosion into the waterside prism (Summer 2020).

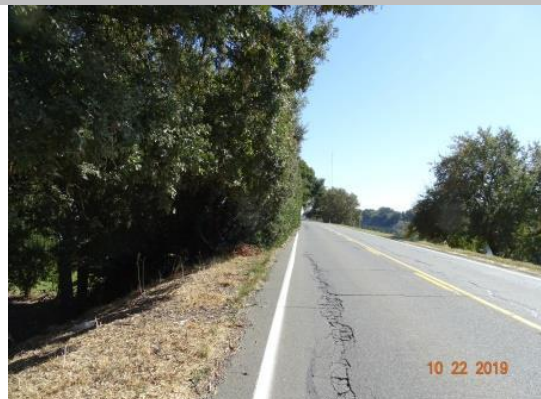
Photo 1 of 1 : SP\_2021\_RD0551\_175\_51\_20210301\_00018.jpg

View looking downstream at landscaping on the landside slope (Fall 2019).
