**Flood Control Project Maintenance
Levee Inspections
LMA District Cover Sheet**

Reclamation District No. 0551 Pearson

**Flood Control Project Maintenance
Levee Inspections
Unit Cover Sheet**

Waterway			Bank	Unit Miles
Unit No. 01 Sacramento River			Left	6.78
	Spring (March - May)	Summer (June - August)	(September - November) Fall	Winter (December - February)
Unit Maintenance Rating (Fall Only)				
Date of Inspection	3/10/2022 - 3/10/2022			
DWR Inspector	David Julian			
Accompanied By	Topper van Loben Sels RD 551

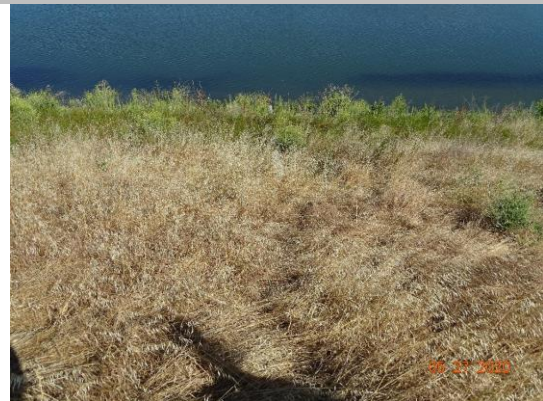
Photo 1 of 3 : UCIP_SP_2022_57695_85472.jpg

Comment Code						
Inspector Comment						
FS_ID:57695 DS_ID:21971 EP_NO: 8664 Repair Type: Non-Urgent Crossing Status: Found UCIP Comments: 05/27/2020 Record updated from No Action Needed to Non-Urgent. 8-inch pipe sleeved through 10-inch pipe. Installed new pump with gate valve and pressure booster, service pole with electric panel next to pumphouse. Abandoned pump and gate valve in pump house, abandoned 48-inch and 24-inch concrete standpipes at pump house on the LS toe. Unable to locate a permit authorizing modification. Need to have CVFPB review ABO and determine current owner. (O.Yakimov - DWR UCIP) FIELD_STRUCT_DESC: 8-inch pipe sleeved through 10-inch coated steel irrigation pipe through the levee, 5 feet below the crown. Pump with gate valve and pressure booster, service pole with electrical panel next to pumphouse on the landside slope. (Retention of irrigation pumping plant, centrifugal pump and gate valve in pump house, landside toe of the levee [HLM 0.05] authorized under Automatic Board Order (ABO) issued as Permit No. 8664, 1972 - Lincoln Chan). [Additional Reference(s): DWR Levee Log, 2005 (HLM 0.05). USACE Sacramento O&M Manual, Unit 111, May 1959, Revised 29 December 2016, (RM 34.75), listed as 10-inch pipe]. FS Date: 5/27/2020 10:13:34 AM

Water-Side: View of levee slope

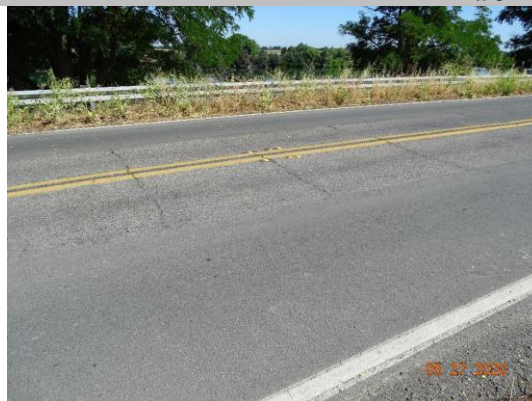
Photo 1 of 3 : UCIP_SP_2022_60001_87290.jpg

Comment Code						
Inspector Comment						
FS_ID:60001 DS_ID:21974 EP_NO: N/A Repair Type: Non-Urgent Crossing Status: Not Found UCIP Comments: 05/27/2020 Record updated from No Action Needed to Non-Urgent. Crossing not found. No permit has been identified authorizing pipe. (O.Yakimov - DWR UCIP) FIELD_STRUCT_DESC: 3-inch pipe of an unknown material or purpose through the levee, 9.3 feet below the crown. Gate valve on the waterside (WS) end. (Cat. IVA - Chan). [Additional Reference(s): DWR Levee Log, 2005 (HLM 0.31). USACE Sacramento O&M Manual, Unit 111, May 1959, Revised 29 December 2016, (RM 34.49), listed as 4-inch pipe]. FS Date: 5/27/2020 11:20:28 AM

Top of Levee: View of levee crown looking towards waterside

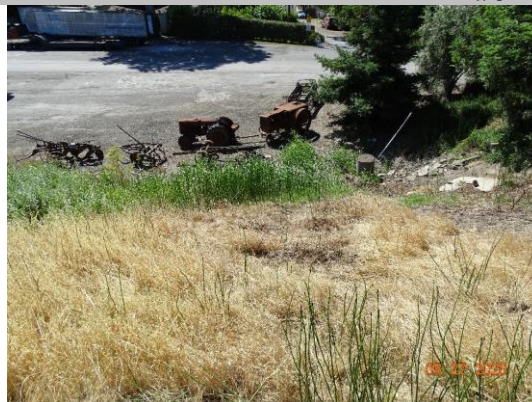
Photo 2 of 3 : UCIP_SP_2022_60001_87291.jpg

Land-Side: View of levee slope looking from crown

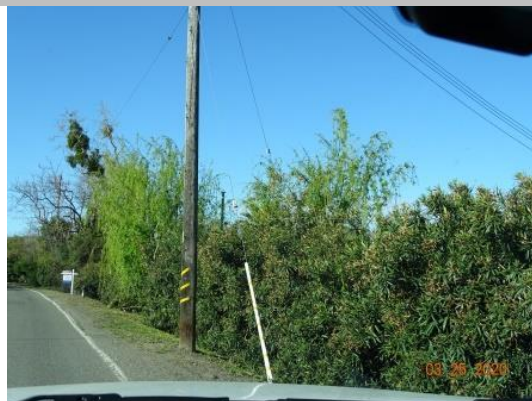
Photo 1 of 1 : SP_2022_RD0551_175_17_20220307_00004.jpg

View looking downstream of landscaping blocking view down waterside slope (Spring 2020).

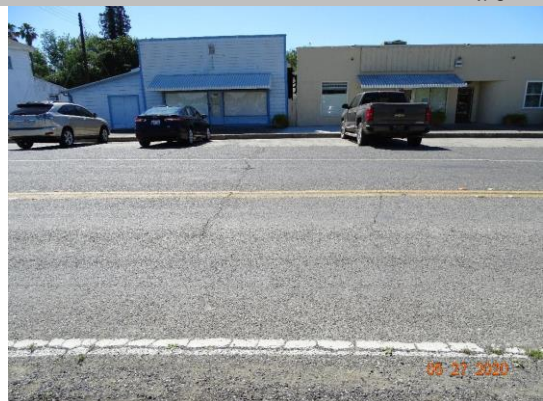
Photo 2 of 3 : UCIP_SP_2022_60032_87318.jpg

Comment Code						
Inspector Comment						
FS_ID:60032 DS_ID:21982 EP_NO: 2759 Repair Type: Non-Urgent Crossing Status: Found UCIP Comments: 05/27/2020 Record remains Non-Urgent. Unauthorized encroachment recorded in Levee Log prior to 2011. Unable to determine pipe material through the levee. PVC pipe is visible in a plastic box on waterside. (O.Yakimov - DWR UCIP) 04/1-/2013 Unclear where exact crossing is located (W.Wylie - DWR UCIP) FIELD_STRUCT_DESC: [Courtland Boating Facilities] 1-inch steel water line through the levee, at an unknown depth. Ramp and boating facilities on the waterside (WS). Pipe visible under buildings at concrete foundation on the landside (LS). Water service connections for irrigation located on the WS slope. (Reference to existing 1-inch water pipe to be connected to the trailer made in Permit No. 2759, 1958 - Jack and Belva Swisley and Ed Hathaway). FS Date: 5/27/2020 3:05:40 PM

Land-Side: Stores on landside where pipe is crossing

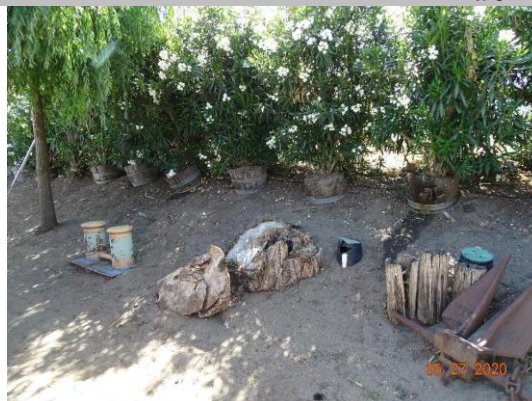
Photo 3 of 3 : UCIP_SP_2022_60032_87317.jpg

Land-Side: Overview of landside where PVC pipe is found

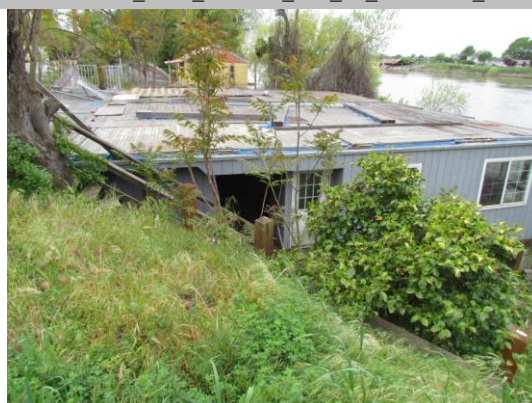
Photo 1 of 1 : SP_2022_RD0551_175_21_20220307_00006.jpg

Photo taken 4-06-2017. Building and steps have been there since at least January 2014. No work done, no permit issued.

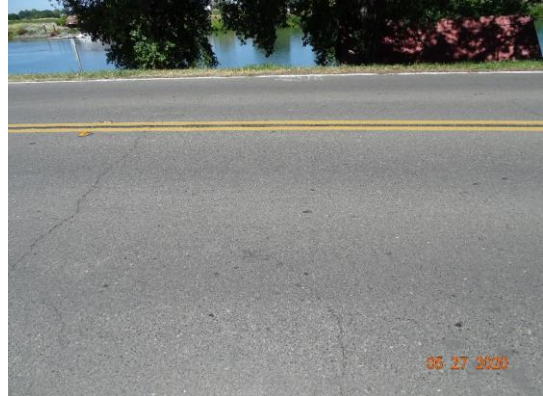
Photo 1 of 3 : UCIP_SP_2022_60080_87333.jpg

Comment Code						
Inspector Comment						
FS_ID:60080 DS_ID:21984 EP_NO: 3673 Repair Type: Non-Urgent Crossing Status: Not Found UCIP Comments: 05/27/2020 Record updated from No Action Needed to Non-Urgent. Crossing not found. A sign noticed during last inspection on opposite side of river is gone. Recommend owner to install communication line markers. (O.Yakimov - DWR UCIP) 04/10/2013 Sign on opposite side of river is a good indication of communication line location. (W.Wylie - DWR UCIP) FIELD_STRUCT_DESC: 2.5-inch steel telephone conduit through the levee and across the channel, 3 feet below the crown. (Armored submarine 2.5-inch steel conduit telephone cable authorized under Permit No. 3673, 1961 - Delta Telephone and Telegraph Company). [Additional Reference(s): DWR Levee Log, 2005 (HLM 0.60)]. FS Date: 5/27/2020 8:25:53 AM

Top of Levee: View of levee crown looking towards waterside

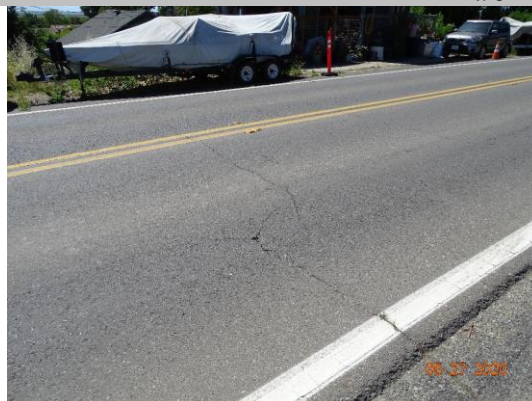
Photo 1 of 3 : UCIP_SP_2022_60085_87345.jpg

Comment Code						
Inspector Comment						
FS_ID:60085 DS_ID:21985 EP_NO: 6220 Repair Type: Non-Urgent Crossing Status: Found UCIP Comments: 05/27/2020 Record remains Non-Urgent. Two sinkholes on waterside levee slope that measure 18"x 12"x 6" deep found in pipe alignment. Crossing appears abandoned. Pipe is heavily rusted at riverbank. From conversation with adjacent property owner found out that pipe is located on easement to the property just across from the crossing and used to serve water for orchard on landside. (O.Yakimov - DWR UCIP) 04/10/2013 Pipe abandoned and should be removed. (W.Wylie - DWR UCIP) FIELD_STRUCT_DESC: 8-inch coated steel irrigation pipe through the levee, 6.1 feet below the crown. Pump on the waterside (WS) with slide gate and air vent. (8-inch pipe authorized under Permit No. 6220, 1968 - Robert U. Grant). [Additional Reference(s): DWR Levee Log, 2005 (HLM 0.71)]. FS Date: 5/27/2020 8:59:30 AM

Top of Levee: View of levee crown looking towards landside

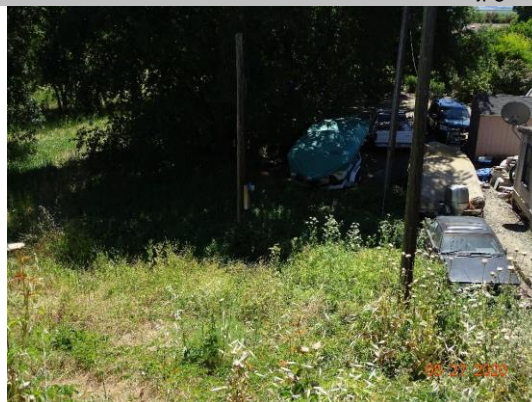
Photo 2 of 3 : UCIP_SP_2022_60085_87343.jpg

Land-Side: View of levee slope looking from crown

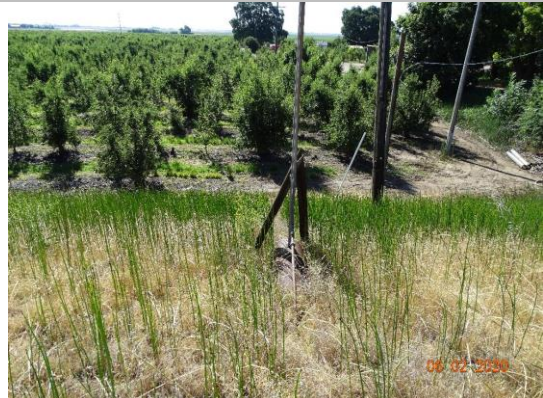
Photo 2 of 3 : UCIP_SP_2022_60086_87356.jpg

Comment Code					
Inspector Comment					
FS_ID:60086 DS_ID:21986 EP_NO: 701 Repair Type: Urgent Crossing Status: Found UCIP Comments: 06/02/2020 Record updated from Non-Urgent to Urgent. Through hole in pipe visible on landside slope, missing wall of pipe at riverbank. 2-foot diameter scour hole present around a hole in pipe on landside slope. 3-foot diameter and 3-inch deep depression of levee slope just above this hole. Crossing appears abandoned. (O.Yakimov - DWR UCIP) 04/10/2013 Pipe appears abandoned and should be done so properly. Good candidate for video inspection. (W.Wylie - DWR UCIP) FIELD_STRUCT_DESC: 14-inch steel irrigation pipe through the levee, 7.2 feet below the crown. Pump in pump house on the waterside (WS) slope. Service pole on the landside (LS) slope. 1-inch galvanized filler pipe, and a 2-inch electrical conduit at the same location. (16-inch pipe authorized under Permit No. 701, 1937 - American Trust Company). [Additional Reference(s): DWR Levee Log, 2005 (HLM 0.89). USACE Sacramento O&M Manual, Unit 111, May 1959, Revised 29 December 2016, (RM 33.91), listed as 14-inch pipe. USACE As-Built Drawing No. 06-13-1100, Sheet 12, upstream of 'L' 1348+33, January 1933]. FS Date: 6/2/2020 10:38:50 AM

Land-Side: View of levee slope looking from crown

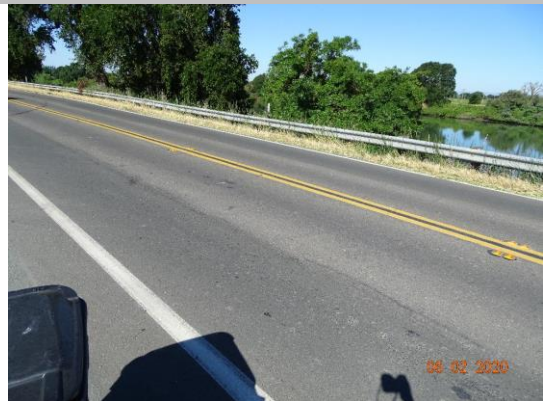
Photo 1 of 3 : UCIP_SP_2022_60092_87362.jpg

FS_ID:60092
DS_ID:21987
EP_NO: 793A
Repair Type: Non-Urgent
Crossing Status: Found
UCIP Comments: 06/02/2020 Record updated from No Action Needed to Non-Urgent. Pump and screen filters installed on landside, capped old 12-inch pipe on landside slope next to the standpipe. Unable to find a permit authorizing modifications to this crossing. Two abandoned concrete standpipes on the landside slope and at the toe, abandoned pump piles at riverbank. Minor runoff erosion on waterside shoulder in pipe alignment. Pipe debris at riverbank. (O.Yakimov - DWR UCIP)
FIELD_STRUCT_DESC: 8-inch steel irrigation pipe sleeved through a 12-inch pipe with annular space grouted 7.8 feet below the crown. Pump and pressure booster at the landside (LS) toe with switch panel and power pole. (12-inch pipe authorized under Permit No. 793, 1939 - Margaret H. Smith Estate). (Sleeving 8-inch pipe through existing 10-inch pipe and grouting annular space authorized under Permit No. 793A, 1974 - George W.G. Smith). [Additional Reference(s): DWR Levee Log, 2005 (HLM 0.90). USACE Sacramento O&M Manual, Unit 111, May 1959, Revised 29 December 2016, (RM 33.90), listed as 12-inch pipe].

Top of Levee: View of levee crown looking towards waterside

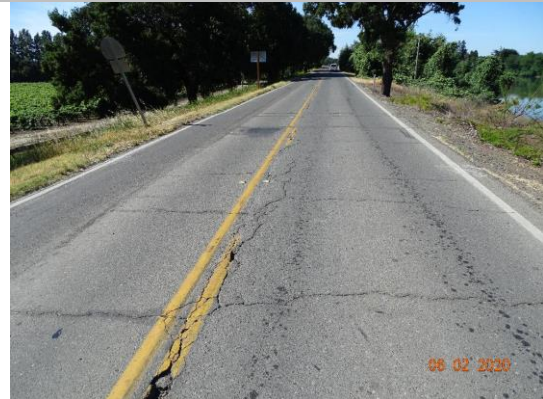
Photo 1 of 3 : UCIP_SP_2022_60100_87399.jpg

FS_ID:60100
DS_ID:21988
EP_NO: 11148
Repair Type: Non-Urgent
Crossing Status: Found
UCIP Comments: 06/02/2020 Record updated from No Action Needed to Non-Urgent. No permit has been identified authorizing pipe. Need to have CVFPB review ABO and determine current owner. No permit found authorizing sleeving 6-inch pipe through 10-inch pipe. Pump is running - minor leaks through pump sealing. (O.Yakimov - DWR UCIP)
FIELD_STRUCT_DESC: 6-inch steel irrigation pipe sleeved through a 10-inch pipe, 6.8 feet below the crown. Pump in pump house on the waterside (WS) slope. Service pole on the landside (LS) slope. Filtration system installed on the LS toe. (10-inch pipe [HLM 1.51] authorized under Automatic Board Order (ABO) issued as Permit No. 11148, 1975 - M.C.C. Van Loben Sells). [Additional Reference(s): DWR Levee Log, 2005 (HLM 1.51). USACE Sacramento O&M Manual, Unit 111, May 1959, Revised 29 December 2016, (RM 33.29), listed as 10-inch pipe. USACE As-Built Drawing No. 06-13-1100, Sheet 12, near 'L' 1370+00, January 1933, listed as 10-inch pipe].

Top of Levee: View of levee crown looking downstream

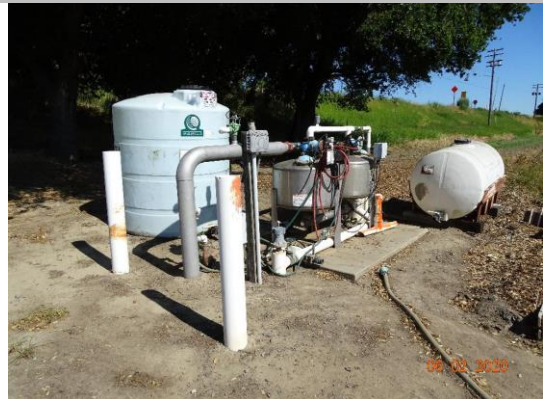
Photo 3 of 3 : UCIP_SP_2022_60100_87402.jpg

Land-Side: Filtering and mixing facility at levee toe. 6-inch pipe daylights here

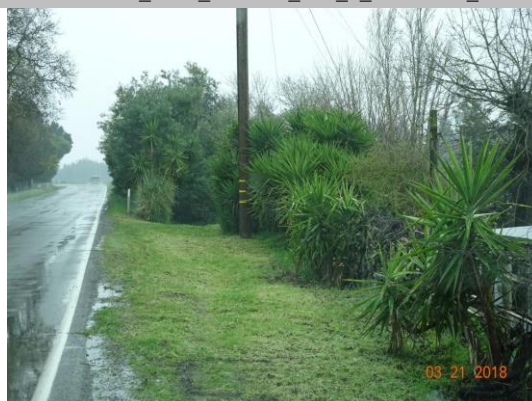
Photo 1 of 1 : SP_2022_RD0551_175_6_20220307_00003.jpg

View looking downstream at landscaping on the waterside shoulder (Spring 2018).

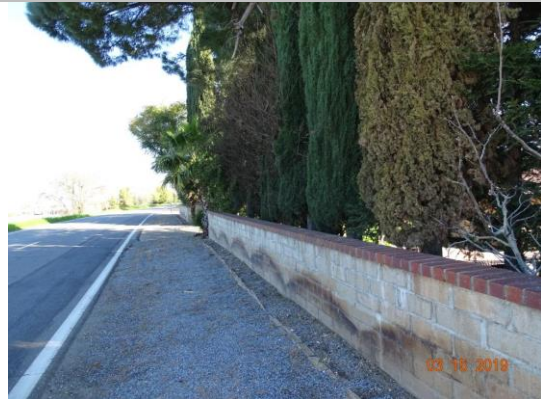
Photo 1 of 1 : SP_2022_RD0551_175_62_20220307_00026.jpg

View looking upstream at landscaping on the landside slope (Spring 2019).

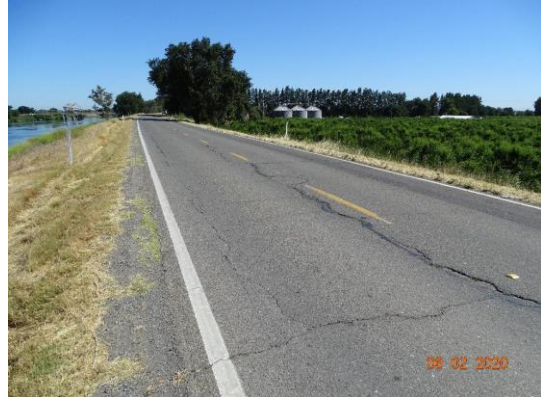
Photo 1 of 3 : UCIP_SP_2022_60145_87423.jpg

Comment Code					
Inspector Comment					
FS_ID:60145 DS_ID:21990 EP_NO: 11145 Repair Type: Non-Urgent Crossing Status: Found UCIP Comments: 06/02/2020 Record remains Non-Urgent. A portion on pipe on landside slope was replaced. Due to overgrown vegetation unable to locate connection of a replaced pipe segment to a pipe through the levee and evaluate levee slope condition. Pumphouse on waterside has been removed. Intake pipe at riverbank to the pump has been replaced, pipe debris left at riverbank. Unable to locate a permit for replacing the pipe segment on landside slope. No permit has been identified authorizing pipe through the levee. Need to have CVFPB review ABO and determine current owner. (O.Yakimov - DWR UCIP) Based on District notes from January 14, 2014, pump discharge pipe has been repaired. Pipe failing on LS slope causing erosion along pipe alignment. Pipe debris on both slopes should be removed as well.: As of 12/13/2013 District President noted that the landowner had made repairs to the LS slope leaks.: As of 12/17/2013 District submitted letter to landowner explaining UCIP report details including photos of the pipe problems FIELD_STRUCT_DESC: 10-inch irrigation pipe of an unknown material through the levee, 4.7 feet below the crown. Pump on concrete pad, butterfly valve, and U-shaped headwall on the waterside (WS) slope. 36-inch concrete riser on the landside (LS) toe. 1-inch electrical conduit at the same location. Service pole at the LS toe. (10-inch pipe [HLM 1.78] authorized under Automatic Board Order (ABO) issued as Permit No. 11145, 1975 - Horace D. & Lucile Towne). [Additional Reference(s): DWR Levee Log, 2005 (HLM 1.78). USACE Sacramento O&M Manual, Unit 111, May 1959, Revised 29 December 2016, (RM 33.02), listed as 8-inch pipe. USACE As-Built Drawing No. 06-13-1100, Sheet 13, RM 33, upstream of 'L' 1396+35, January 1933]. FS Date: 6/2/2020 11:15:34 AM

Top of Levee: View of levee crown looking upstream

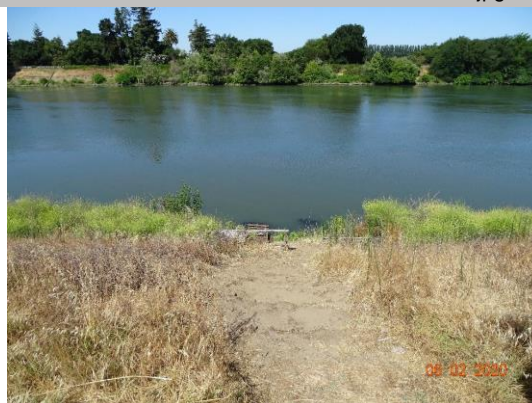
Photo 3 of 3 : UCIP_SP_2022_60145_87424.jpg

Water-Side: View of levee slope looking from crown

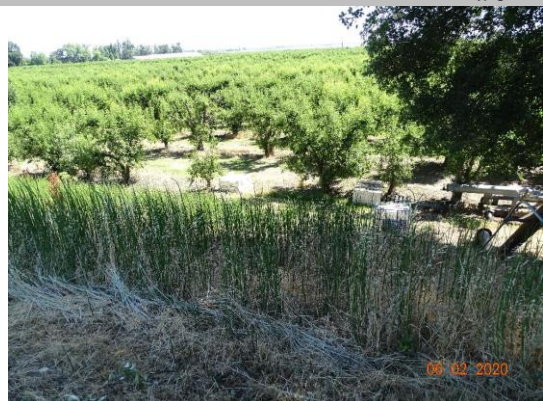
Photo 2 of 3 : UCIP_SP_2022_60156_87428.jpg

Comment Code						
Inspector Comment						
FS_ID:60156 DS_ID:22040 EP_NO: 3676 Repair Type: Non-Urgent Crossing Status: Not Found UCIP Comments: 06/02/2020 Record remains Non-Urgent. Crossing not found. Cut in road pavement is still visible. No permit has been identified authorizing original 12-inch pipe. (O.Yakimov - DWR UCIP) 04/10/2013 Fresh cut through pavement on crown indicates recent work on pipes at this location. Need to determine if pipe was removed or abandoned in place. (W.Wylie - DWR UCIP) FIELD_STRUCT_DESC: 8-inch coated steel irrigation pipe sleeved through a 12-inch pipe through the levee, 5 feet below the crown. Pump on platform on the waterside (WS). (Sleeving 8-inch pipe through existing 12-inch pipe authorized under Permit No. 3676, 1961 - Runyon and Dorsey). [Additional Reference(s): DWR Levee Log, 2005 (HLM 2.02). USACE Sacramento O&M Manual, Unit 111, May 1959, Revised 29 December 2016, (RM 32.78), listed as 10-inch pipe]. FS Date: 6/2/2020 1:33:33 PM

Land-Side: View of levee slope looking from crown

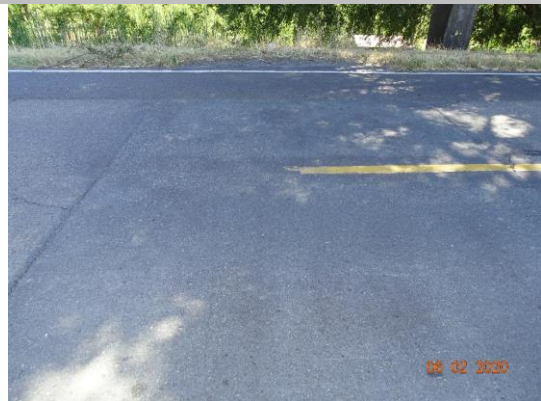
Photo 1 of 3 : UCIP_SP_2022_60178_87494.jpg

FS_ID:60178
DS_ID:21991
EP_NO: 6551
Repair Type: Non-Urgent
Crossing Status: Found
UCIP Comments: 06/02/2020 Record remains Non-Urgent. No permit has been identified authorizing original 14-inch pipe. Pipe was running, no leaks observed. (O.Yakimov - DWR UCIP)
04/10/2013 Rodent activity undermining pipe on LS slope. (W.Wylie - DWR UCIP)
FIELD_STRUCT_DESC: 10-inch steel irrigation pipe sleeved through 14-inch polyvinyl chloride (PVC) wrapped steel pipe through the levee, 3 feet below the crown. Butterfly valve on the waterside (WS) shoulder. 2-inch galvanized electrical conduit at the same location. Pump on pile structure on the WS toe. Screen filter and 2 additional pumps on the landside (LS) toe. (Sleeving 10-inch pipe through existing 16-inch pipe authorized under Permit No. 6551, 1969 - John D. Wheeler). [Additional Reference(s): DWR Levee Log, 2005 (HLM 2.02). USACE Sacramento O&M Manual, Unit 111, May 1959, Revised 29 December 2016, (RM 32.78), listed as 14-inch pipe]. USACE As-Built Drawing No. 06-13-1100, Sheet 13, near 'L' 1406+40, January 1933, listed as 14-inch pipe].

Top of Levee: View of levee crown looking towards landside. Cut in road pavement visible

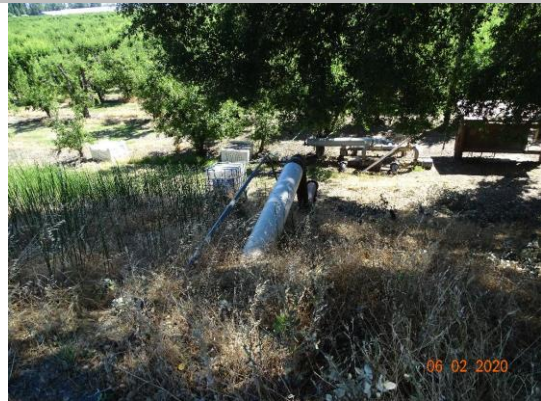
Photo 3 of 3 : UCIP_SP_2022_60178_87496.jpg

Land-Side: View of levee slope looking from crown

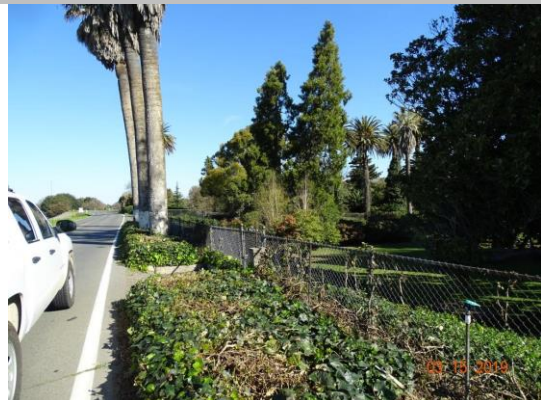
Photo 1 of 1 : SP_2022_RD0551_175_61_20220307_00025.jpg

View looking upstream at chainlink fence on the landside slope (Spring 2019).

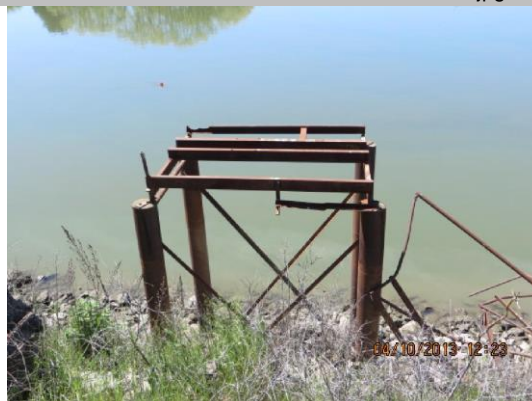
Photo 1 of 3 : UCIP_SP_2022_60216_19224.jpg

Steel pile platform remains at WS toe.

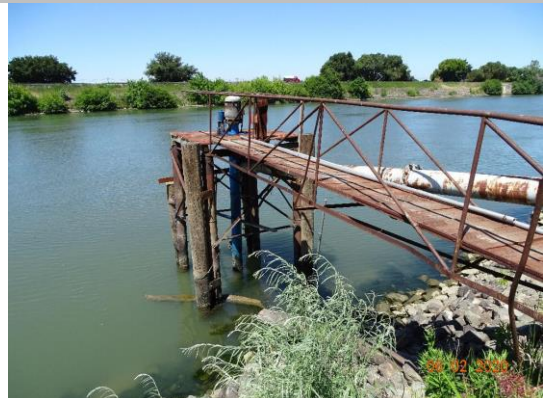
Photo 2 of 3 : UCIP_SP_2022_60293_87555.jpg

Water-Side: Pump on pile structure in river channel

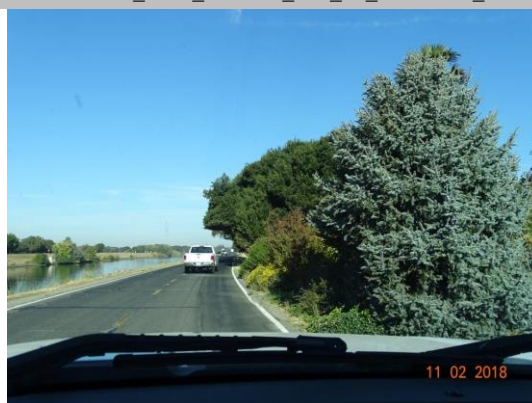
Photo 1 of 1 : SP_2022_RD0551_175_56_20220307_00020.jpg

View looking upstream at landscaping on the landside slope (November 2018).

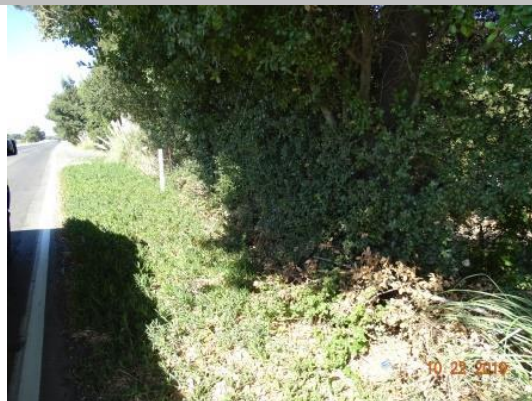
Photo 1 of 1 : SP_2022_RD0551_175_55_20220307_00019.jpg

View looking downstream at landscaping on the landside slope (Fall 2019).

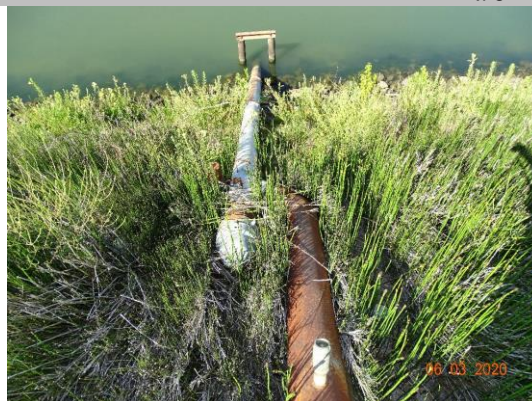
Photo 1 of 3 : UCIP_SP_2022_60391_87602.jpg

Water-Side: Pipe and slant pump on waterside levee slope

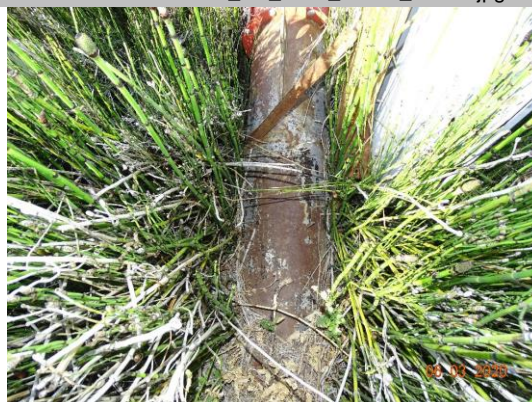
Photo 2 of 3 : UCIP_SP_2022_60391_87601.jpg

Water-Side: 12-inch pipe daylights on waterside slope

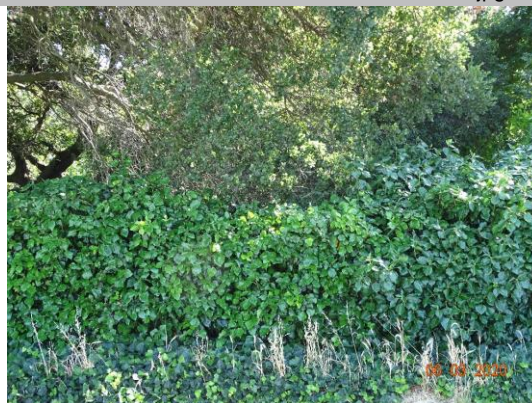
Photo 2 of 3 : UCIP_SP_2022_60444_87732.jpg

Land-Side: Landscaping on levee shoulder

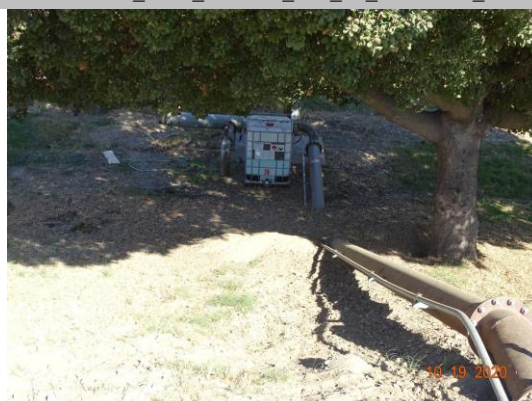
Photo 1 of 1 : SP_2022_RD0551_175_90_20220307_00033.jpg

View of large animal hole in the landside slope (Fall 2020).

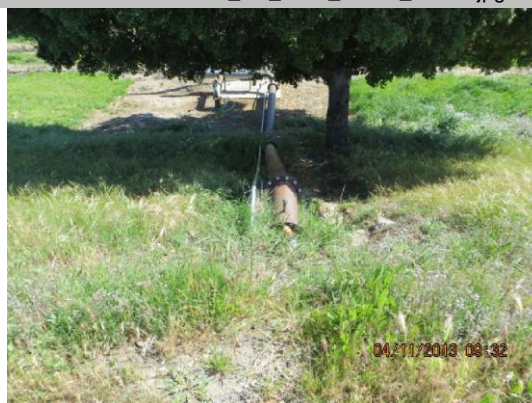
Photo 2 of 3 : UCIP_SP_2022_60445_19284.jpg

Pipe, air vent, siphon breaker, and electrical conduit on LS slope.

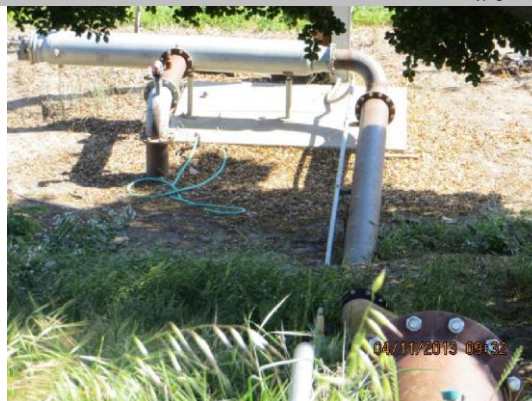
Photo 3 of 3 : UCIP_SP_2022_60445_19283.jpg

Pressure booster at LS toe.

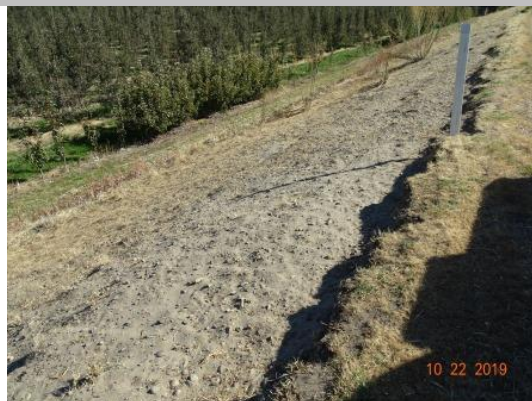
Photo 1 of 1 : SP_2022_RD0551_175_66_20220307_00029.jpg

View looking downstream at erosion due to goats on the landside slope (Fall 2019).

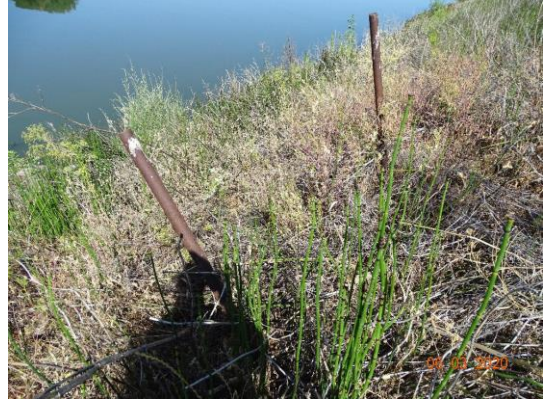
Photo 3 of 3 : UCIP_SP_2022_60450_87748.jpg

Water-Side: Two markers on waterside slope may indicate pipe alignment

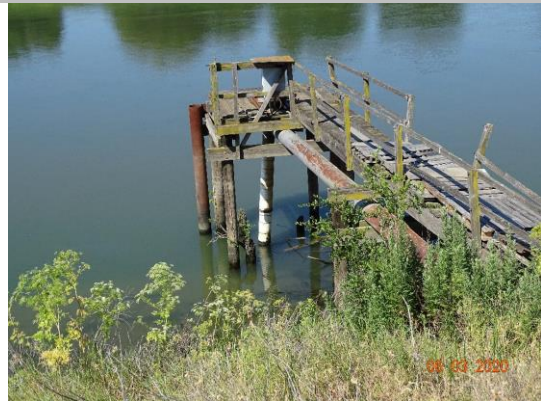
Photo 3 of 3 : UCIP_SP_2022_60460_87784.jpg

Water-Side: Pump on pile structure in channel. Wooden walkway is in bad shape

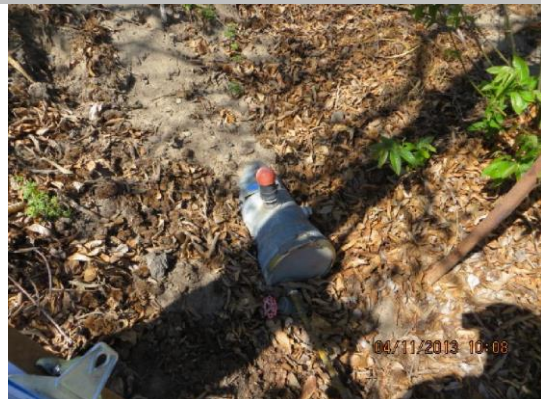
Photo 1 of 2 : UCIP_SP_2022_60558_19536.jpg

Siphon breaker and vent on pipe at LS toe.

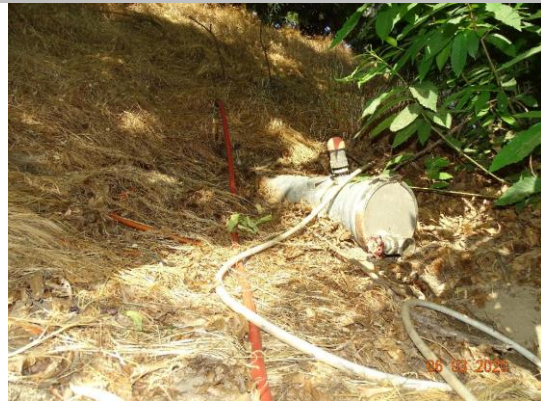
Photo 3 of 3 : UCIP_SP_2022_60578_87844.jpg

Land-Side: Pipe end with air vent at levee toe

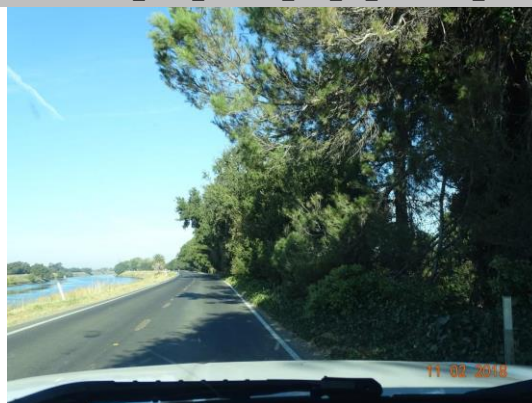
Photo 1 of 1 : SP_2022_RD0551_175_25_20220307_00008.jpg

View looking upstream at landscaping on the landside slope (November 2018).

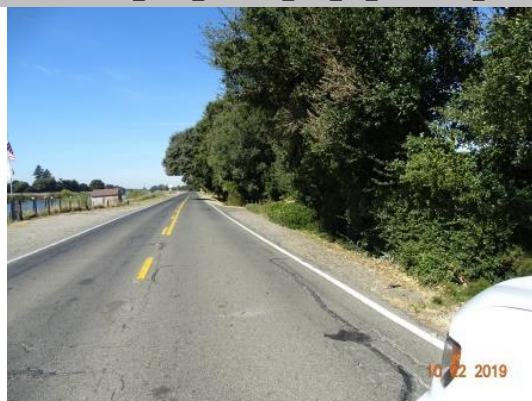
Photo 1 of 1 : SP_2022_RD0551_175_49_20220307_00015.jpg

View looking upstream at landscaping on the landside slope (Fall 2019).

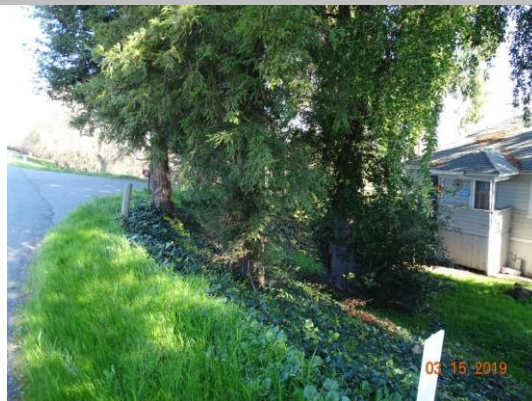
Photo 1 of 1 : SP_2022_RD0551_175_58_20220307_00022.jpg

View looking upstream at landscaping on the landside slope (Spring 2019).

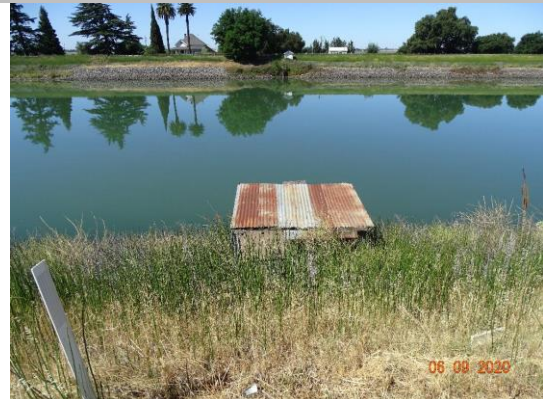
Photo 2 of 3 : UCIP_SP_2022_60635_87912.jpg

Water-Side: Dense vegetation on levee slope. View of pumphouse on the slope

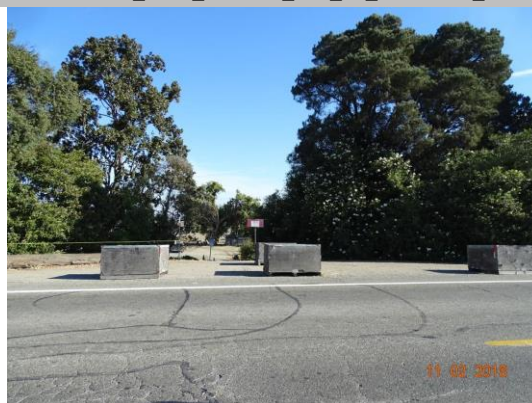
Photo 1 of 1 : SP_2022_RD0551_175_59_20220307_00023.jpg

View of boxes on the land side shoulder that landowner placed to block traffic from using driveway (November 2018).

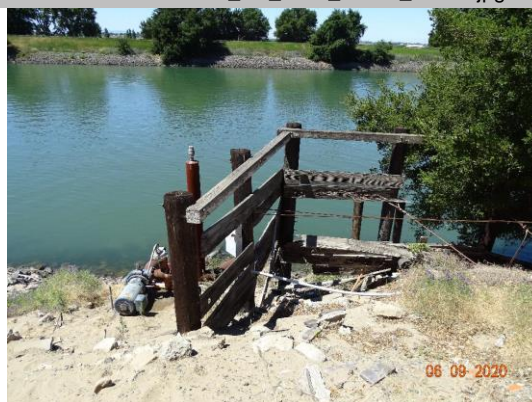
Photo 2 of 3 : UCIP_SP_2022_60643_87949.jpg

Water-Side: Electrical panel next to the pump on levee slope

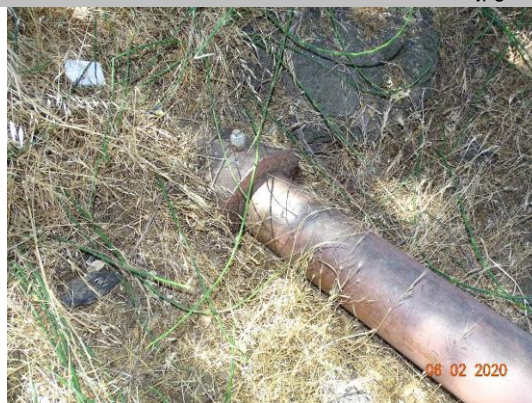
Photo 3 of 3 : UCIP_SP_2022_60701_87997.jpg

Land-Side: Pipe sleeved through 12-inch pipe visible on levee shoulder.
Grout filler plug on top of pipe
