**Flood Control Project Maintenance
Levee Inspections
LMA District Cover Sheet**

Reclamation District No. 0551 Pearson

**Flood Control Project Maintenance
Levee Inspections**

Levee Inspection Report By Mile - Spring 2023

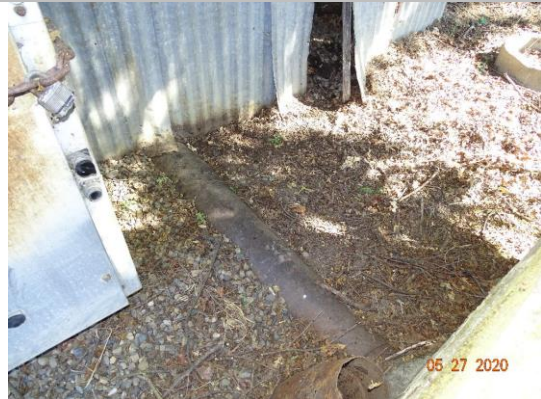
Photo 3 of 3 : UCIP_SP_2023_57695_85477.jpg

Land-Side: Abandoned 10-inch pipe between pumphouse and concrete standpipe

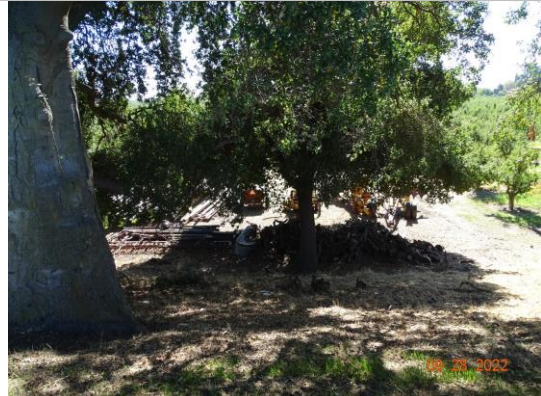
Photo 1 of 1 : SP_2023_RD0551_175_93_20230206_00039.jpg

LM Start	0.15	Rating **	U	Issue No.	93
LM End	0.15	Issue Type +	En	Location *	LS
Category	Earthen Levee			GPS Latitude/Longitude	
				Start	End
Item	Encroachments			38.334817 °	38.334817 °
				-121.566452 °	-121.566452 °
DWR ID	DWR_RD0551_01_f_2022_93				
Comment Code					
FW : Firewood					
Inspector Comment					
There is large pile of firewood and material along the LS toe.

View of the large woodpile and material on the LS toe (Fall 2022).

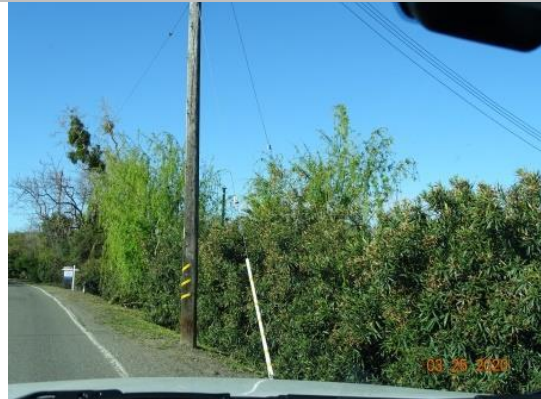
Photo 1 of 1 : SP_2023_RD0551_175_17_20230206_00004.jpg

View looking downstream of landscaping blocking view down waterside slope (Spring 2020).

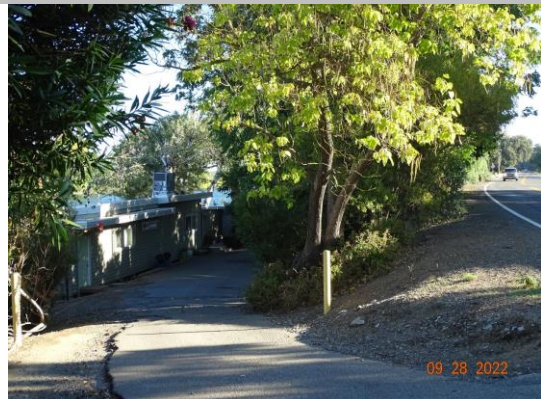
Photo 1 of 1 : SP_2023_RD0551_175_21_20230206_00006.jpg

LM Start	0.49	Rating **	M	Issue No.	21
LM End	0.49	Issue Type +	En	Location *	WS
Category	Earthen Levee			GPS Latitude/Longitude	
				Start	End
Item	Encroachments			38.331063°	38.331063°
				-121.570634°	-121.570634°
DWR ID	DWR_RD0551_01_s_2014_21				
Comment Code					
BU : Building					
Inspector Comment					
11750 River Road - The new land owner is working with the LMA trying to get CVFPB Permits for this project. No other work at this site. Waiting to hear from Enforcements.

View of the building on the WS toe (Fall 2022).

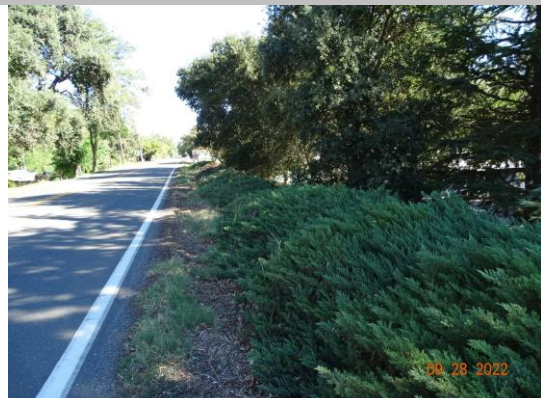
Photo 1 of 1 : SP_2023_RD0551_175_69_20230206_00030.jpg

LM Start	0.56	Rating **	M	Issue No.	69
LM End	0.59	Issue Type +	En	Location *	LS
Category	Earthen Levee			GPS Latitude/Longitude	
				Start	End
Item	Vegetation			38.330242°	38.329830°
				-121.571405°	-121.571725°
DWR ID	DWR_RD0551_01_f_2019_69				
Comment Code					
V6 : Landscaping					
Inspector Comment

View of the landscaping on the LS slope (Fall 2022).

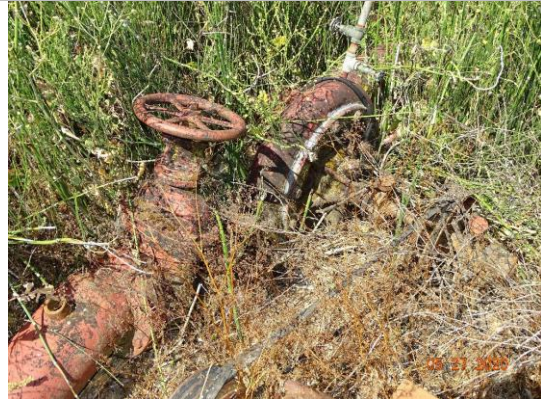
Photo 1 of 3 : UCIP_SP_2023_60085_87347.jpg

Comment Code						
Inspector Comment						
DS_ID:21985 FS_ID:60085 EP_NO: 6220 Repair Type: Non-Urgent EVAL Issue: 6, Levee Damage or Threat for Levee Damage Crossing Status: Found UCIP Comments: 05/27/2020 Record remains Non-Urgent. Two sinkholes on waterside levee slope that measure 18"x 12"x 6" deep found in pipe alignment. Crossing appears abandoned. Pipe is heavily rusted at riverbank. From conversation with adjacent property owner found out that pipe is located on easement to the property just across from the crossing and used to serve water for orchard on landside. (O.Yakimov - DWR UCIP) 04/10/2013 Pipe abandoned and should be removed. (W.Wylie - DWR UCIP) FIELD_STRUCT_DESC: 8-inch coated steel irrigation pipe through the levee, 6.1 feet below the crown. Pump on the waterside (WS) with slide gate and air vent. (8-inch pipe authorized under Permit No. 6220, 1968 - Robert U. Grant). [Additional Reference(s): DWR Levee Log, 2005 (HLM 0.71)]. FS Date: 5/27/2020 8:59:30 AM

Water-Side: Abandoned pipe, pump, and gate valve

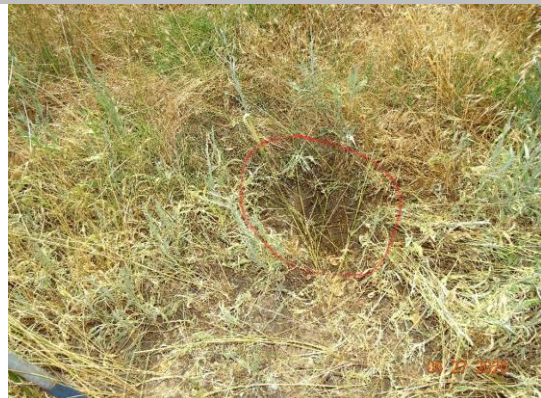
Photo 2 of 3 : UCIP_SP_2023_60085_87350.jpg

Water-Side: A sinkhole in pipe alignment measures 12"x 18"x 6" deep

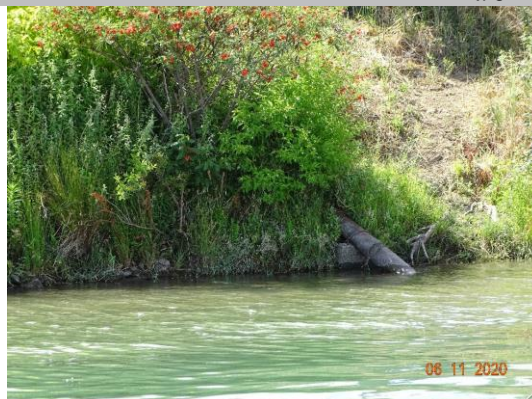
Photo 3 of 3 : UCIP_SP_2023_60085_87352.jpg

Water-Side: Heavily rusted pipe in riverbank

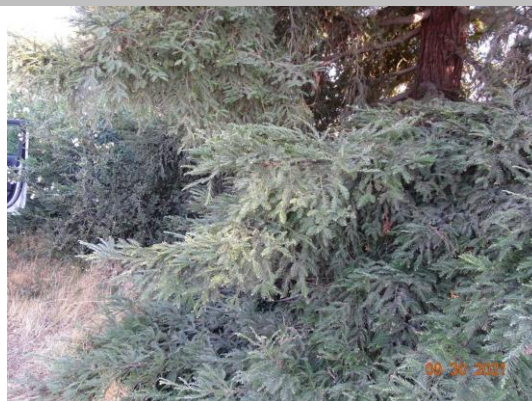
Photo 1 of 1 : SP_2023_RD0551_175_57_20230206_00022.jpg

LM Start	0.73	Rating **	U	Issue No.	57
LM End	0.76	Issue Type +	En	Location *	LS
Category	Earthen Levee			GPS Latitude/Longitude	
				Start	End
Item	Vegetation			38.328122°	38.327783°
				-121.573130°	-121.573362°
DWR ID	DWR_RD0551_01_f_2018_57				
Comment Code					
V6 : Landscaping					
Inspector Comment

View of thick landscaping on the landside slope (Fall 2021).

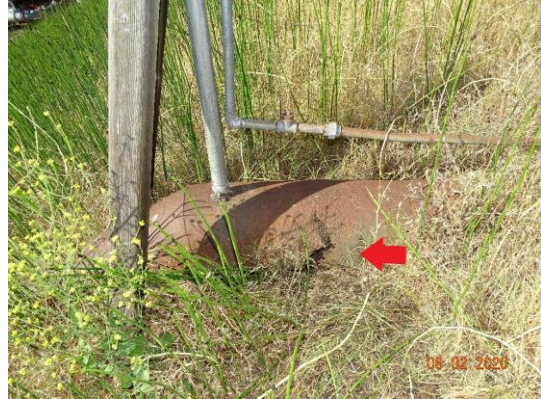
Photo 1 of 3 : UCIP_SP_2023_60086_87357.jpg

Comment Code					
Inspector Comment					
DS_ID:21986 FS_ID:60086 EP_NO: 701 Repair Type: Urgent EVAL Issue: 1, Pipe Integrity Crossing Status: Found UCIP Comments: 06/02/2020 Record updated from Non-Urgent to Urgent. Through hole in pipe visible on landside slope, missing wall of pipe at riverbank. 2-foot diameter scour hole present around a hole in pipe on landside slope. 3-foot diameter and 3-inch deep depression of levee slope just above this hole. Crossing appears abandoned. (O.Yakimov - DWR UCIP) 04/10/2013 Pipe appears abandoned and should be done so properly. Good candidate for video inspection. (W.Wylie - DWR UCIP) FIELD_STRUCT_DESC: 14-inch steel irrigation pipe through the levee, 7.2 feet below the crown. Pump in pump house on the waterside (WS) slope. Service pole on the landside (LS) slope. 1-inch galvanized filler pipe, and a 2-inch electrical conduit at the same location. (16-inch pipe authorized under Permit No. 701, 1937 - American Trust Company). [Additional Reference(s): DWR Levee Log, 2005 (HLM 0.89). USACE Sacramento O&M Manual, Unit 111, May 1959, Revised 29 December 2016, (RM 33.91), listed as 14-inch pipe. USACE As-Built Drawing No. 06-13-1100, Sheet 12, upstream of 'L' 1348+33, January 1933]. FS Date: 6/2/2020 10:38:50 AM

Land-Side: View of through hole in pipe on levee slope

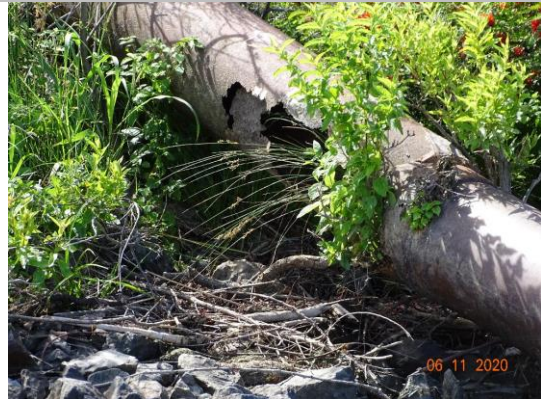
Photo 3 of 3 : UCIP_SP_2023_60086_87353.jpg

Water-Side: Missing wall of pipe at riverbank

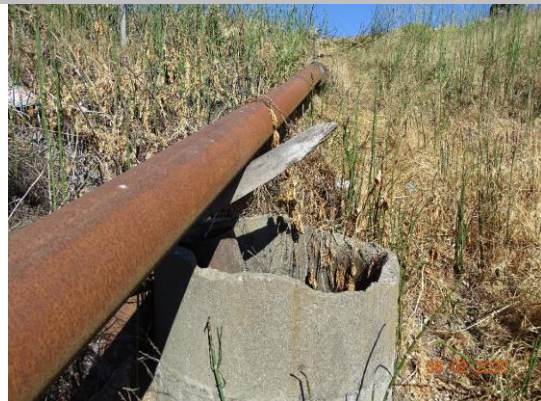
Photo 1 of 3 : UCIP_SP_2023_60092_87369.jpg

DS_ID:21987
 FS_ID:60092
 EP_NO: 793A
 Repair Type: Non-Urgent
 EVAL Issue: 10, Unauthorized Modification or Non-Compliant Permit
 Crossing Status: Found
 UCIP Comments: 06/02/2020 Record updated from No Action Needed to Non-Urgent. Pump and screen filters installed on landside, capped old 12-inch pipe on landside slope next to the standpipe. Unable to find a permit authorizing modifications to this crossing. Two abandoned concrete standpipes on the landside slope and at the toe, abandoned pump piles at riverbank. Minor runoff erosion on waterside shoulder in pipe alignment. Pipe debris at riverbank. (O.Yakimov - DWR UCIP)
 FIELD_STRUCT_DESC: 8-inch steel irrigation pipe sleeved through a 12-inch pipe with annular space grouted 7.8 feet below the crown. Pump and pressure booster at the landside (LS) toe with switch panel and power pole. (12-inch pipe authorized under Permit No. 793, 1939 - Margaret H. Smith Estate). (Sleeving 8-inch pipe through existing 10-inch pipe and grouting annular space authorized under Permit No. 793A, 1974 - George W.G. Smith). [Additional Reference(s): DWR Levee Log, 2005 (HLM 0.90). USACE Sacramento O&M Manual, Unit 111, May 1959, Revised 29 December 2016, (RM 33.90), listed as 12-inch pipe].

Land-Side: Levee slope, and abandoned concrete standpipe

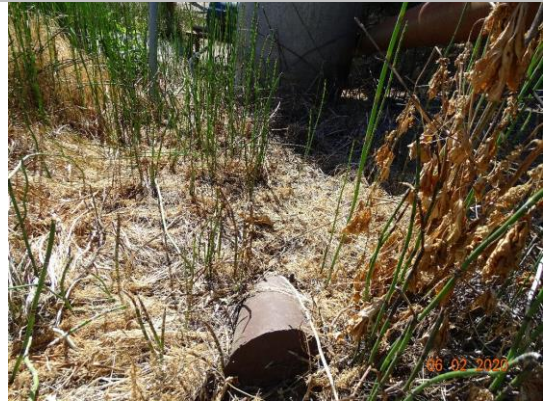
Photo 2 of 3 : UCIP_SP_2023_60092_87367.jpg

Land-Side: Capped old 12-inch pipe on levee slope

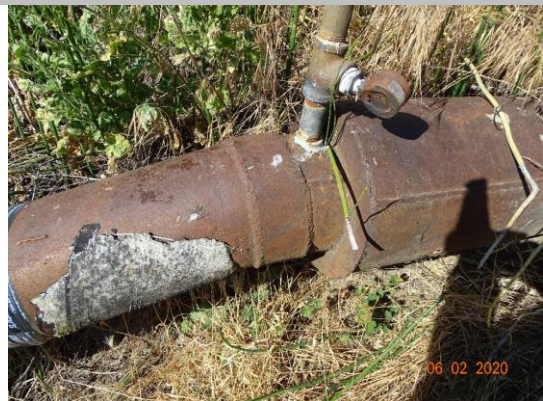
Photo 3 of 3 : UCIP_SP_2023_60092_87365.jpg

Land-Side: 8-inch pipe comes out of 12-inch pipe on levee slope

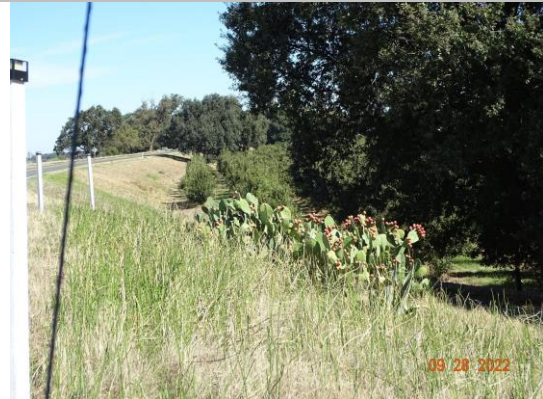
Photo 1 of 1 : SP_2023_RD0551_175_63_20230206_00028.jpg

View of the cactus on the LS slope (Fall 2022).

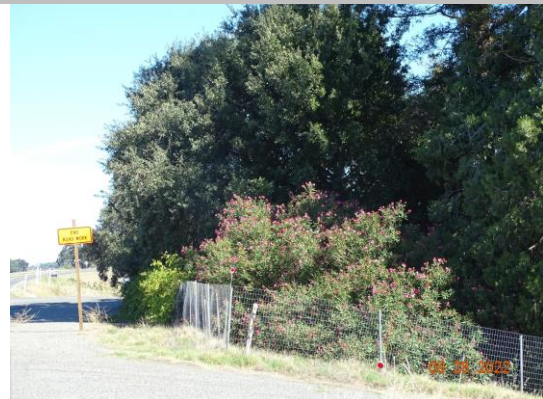
Photo 1 of 1 : SP_2023_RD0551_175_46_20230206_00012.jpg

View of the landscaping on the LS slope (Fall 2022).

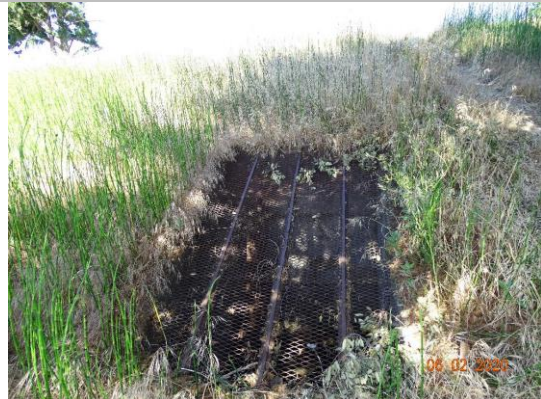
Photo 3 of 3 : UCIP_SP_2023_60128_87411.jpg

Land-Side: Concrete distribution box at levee toe covered with metal grate

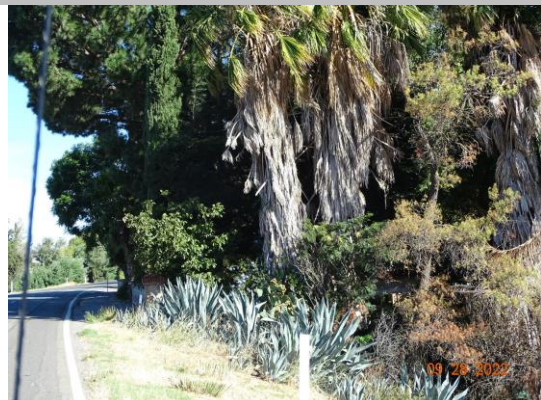
Photo 1 of 1 : SP_2023_RD0551_175_62_20230206_00027.jpg

View of the landscaping on the LS slope (Fall 2022).

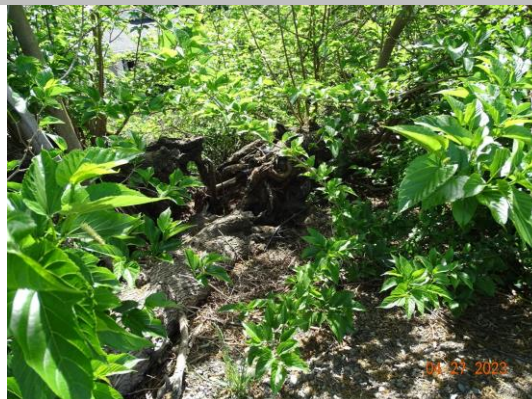
Photo 1 of 1 : SP_2023_RD0551_175_40_20230515_00112.jpg

View of the tree limb on the LS slope (Spring 2023).

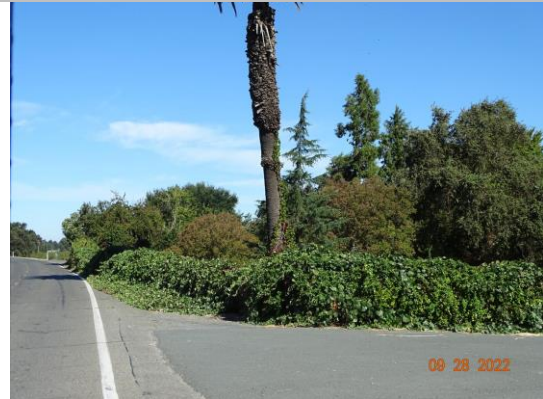
Photo 1 of 1 : SP_2023_RD0551_175_47_20230206_00013.jpg

View of the landscaping on the LS slope (Fall 2022).

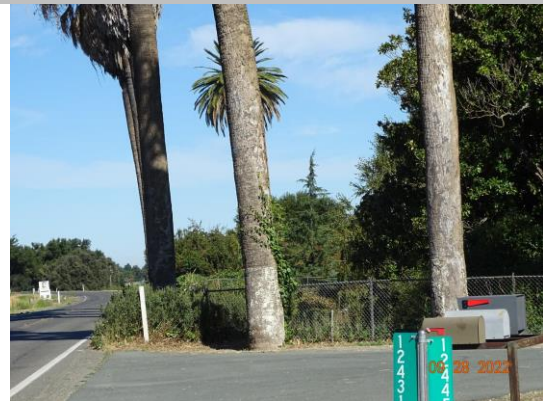
Photo 1 of 1 : SP_2023_RD0551_175_61_20230206_00026.jpg

View of the fence on the LS slope (Fall 2022).

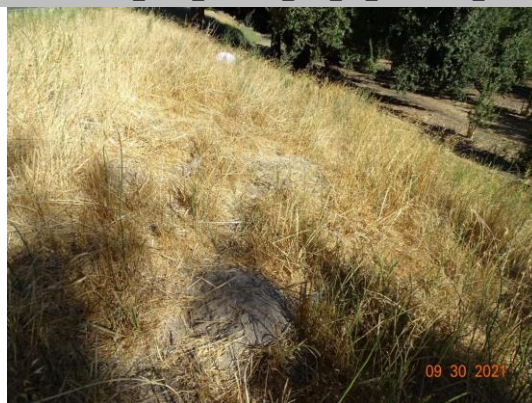
Photo 1 of 1 : SP_2023_RD0551_175_88_20230206_00034.jpg

View looking at multiple animal holes in the landside slope (Fall 2021).

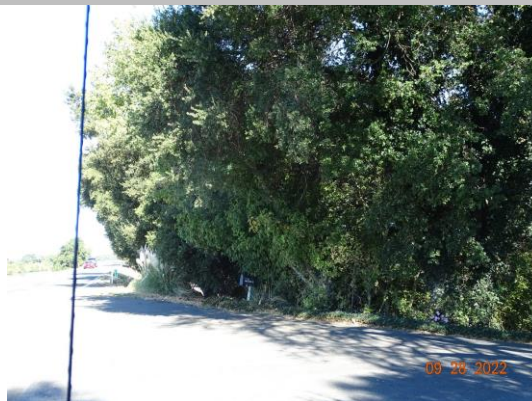
Photo 1 of 1 : SP_2023_RD0551_175_55_20230206_00020.jpg

View of the landscaping on the LS slope (Fall 2022).

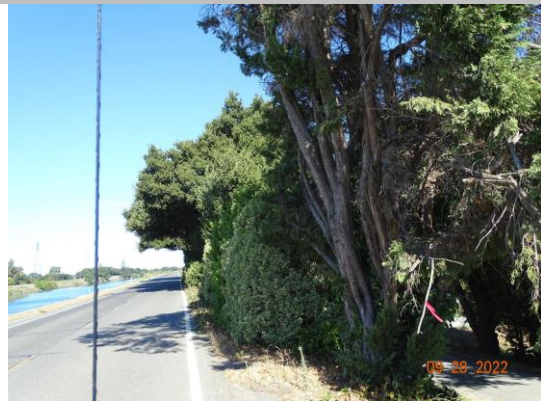
Photo 1 of 1 : SP_2023_RD0551_175_48_20230206_00014.jpg

View of the landscaping on the LS slope (Fall 2022).

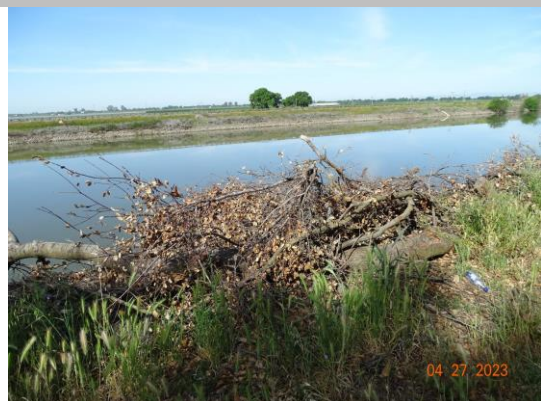
Photo 1 of 1 : SP_2023_RD0551_175_33_20230515_00106.jpg

View of the tree limb and branches on the WS slope (Spring 2023).

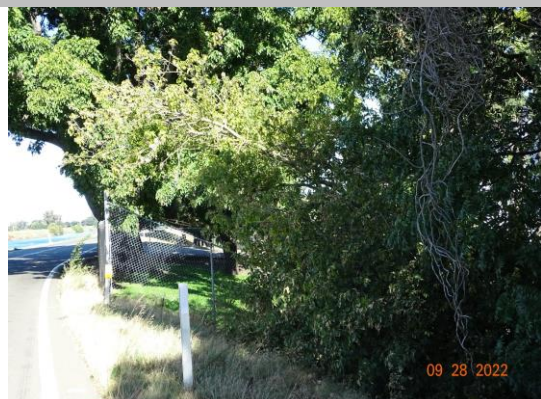
Photo 1 of 1 : SP_2023_RD0551_175_60_20230206_00025.jpg

View of the fence on the LS shoulder and slope (Fall 2022).

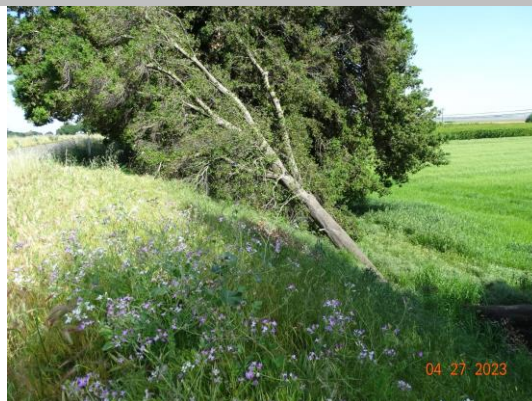
Photo 1 of 1 : SP_2023_RD0551_175_37_20230515_00109.jpg

View of the fallen tree on the LS slope (Spring 2023).

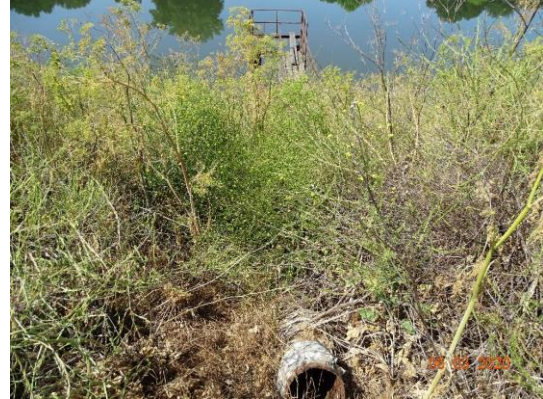
Photo 1 of 3 : UCIP_SP_2023_60620_87853.jpg

Water-Side: Pipe cut on levee slope

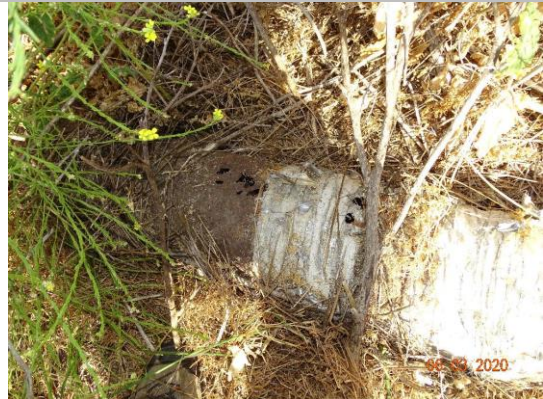
Photo 2 of 3 : UCIP_SP_2023_60620_87854.jpg

Water-Side: Through holes in pipe on levee slope

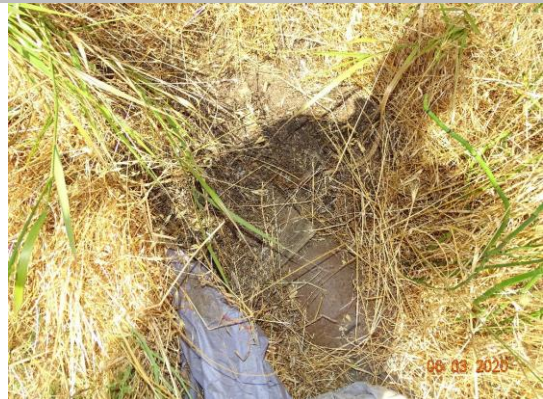
Photo 3 of 3 : UCIP_SP_2023_60620_87857.jpg

Land-Side: Pipe daylights on levee slope. Slope depression found at this location measures 8' x 9' x 2' deep

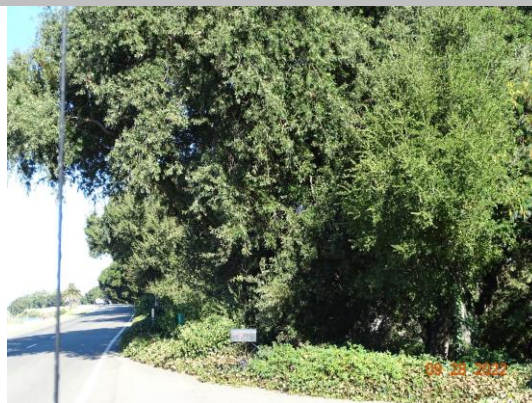
Photo 1 of 1 : SP_2023_RD0551_175_25_20230206_00008.jpg

View of the landscaping on the LS slope (Fall 2022).

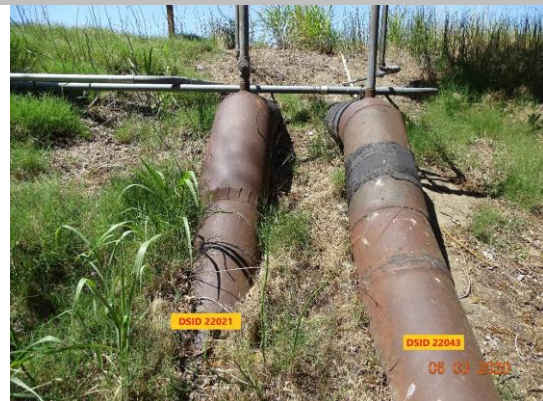
Photo 3 of 3 : UCIP_SP_2023_77178_87879.jpg

Land-Side: View of pipe at levee toe

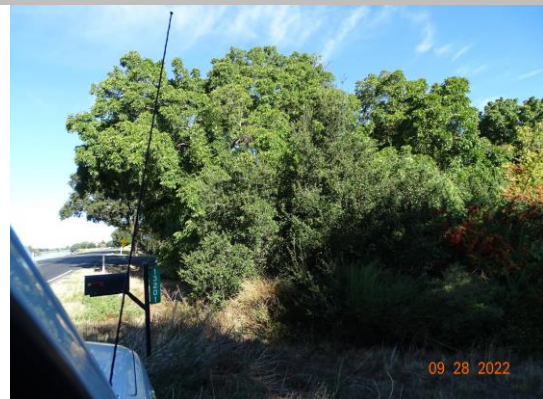
Photo 1 of 1 : SP_2023_RD0551_175_44_20230206_00011.jpg

View of the landscaping on the LS slope (Fall 2022).

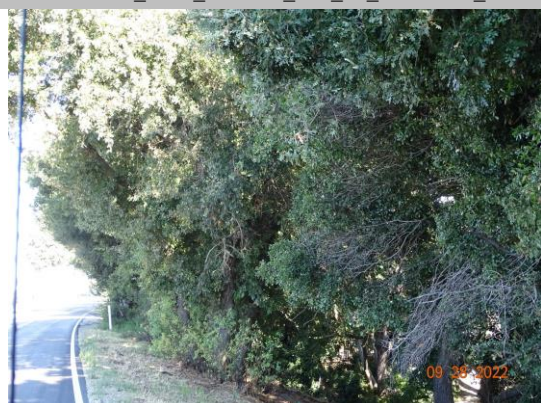
Photo 1 of 1 : SP_2023_RD0551_175_49_20230206_00015.jpg

View of the landscaping on the LS slope (Fall 2022).

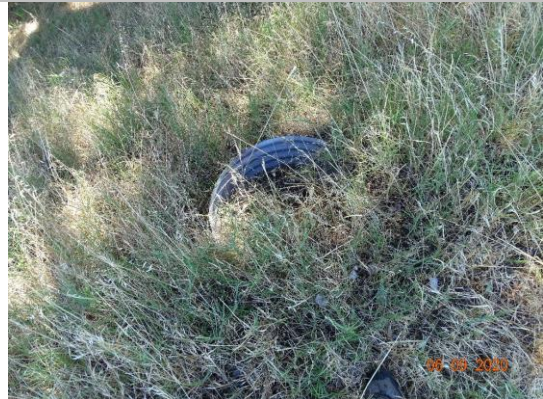
Photo 2 of 3 : UCIP_SP_2023_60630_87901.jpg

Land-Side: Uncovered 24-inch CMP riser on levee slope

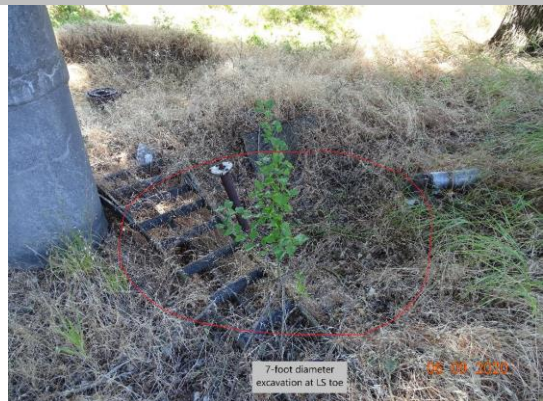
Photo 3 of 3 : UCIP_SP_2023_60630_87904.jpg

Land-Side: 7-foot diameter and 1-foot deep excavation at levee toe

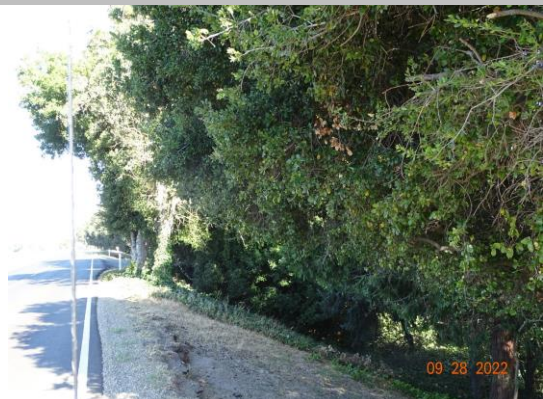
Photo 1 of 1 : SP_2023_RD0551_175_58_20230206_00023.jpg

View of the landscaping on the LS slope (Fall 2022).

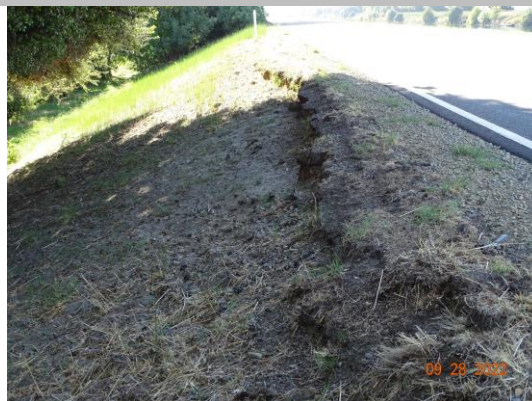
Photo 1 of 1 : SP_2023_RD0551_175_86_20230206_00032.jpg

View of the slope instability on the LS slope (Fall 2022).

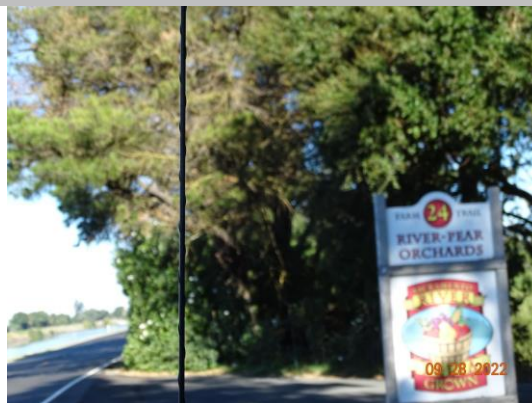
Photo 1 of 1 : SP_2023_RD0551_175_24_20230206_00007.jpg

View of the landscaping on the LS slope (Fall 2022).

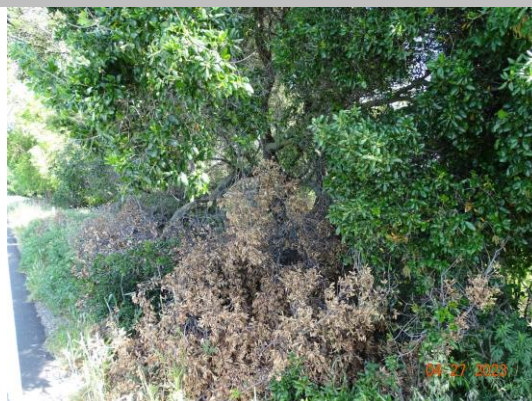
Photo 1 of 1 : SP_2023_RD0551_175_36_20230515_00108.jpg

View of the fallen tree on the LS slope (Spring 2023).

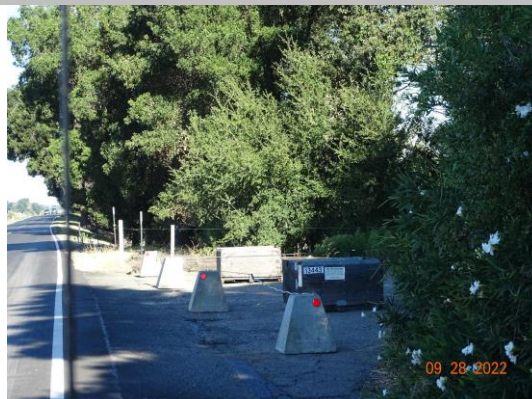
Photo 1 of 1 : SP_2023_RD0551_175_59_20230206_00024.jpg

View of the concrete blocks on the LS shoulder (Fall 2022).

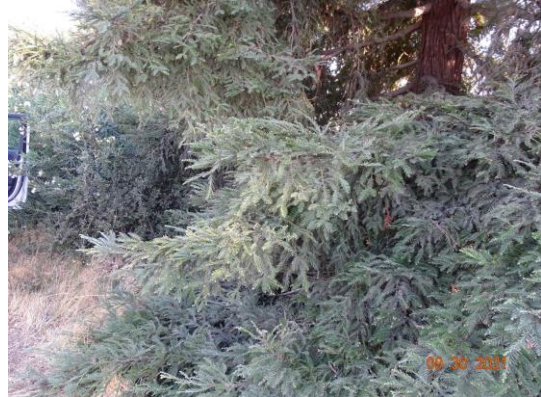
Photo 1 of 1 : SP_2023_RD0551_175_91_20230206_00037.jpg

View of landscaping on the landside slope (Fall 2021).

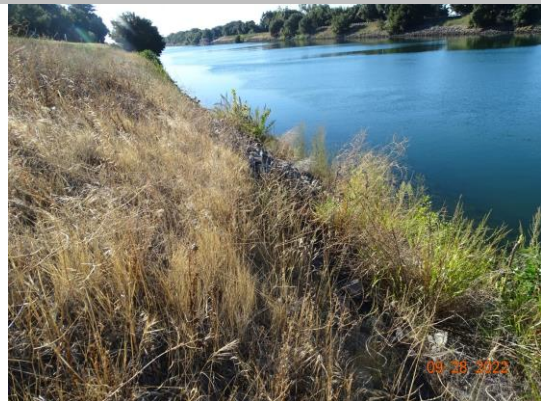
Photo 1 of 2 : SP_2023_RD0551_175_2_20230206_00001.jpg

View of the erosion on the WS slope (Fall 2022).

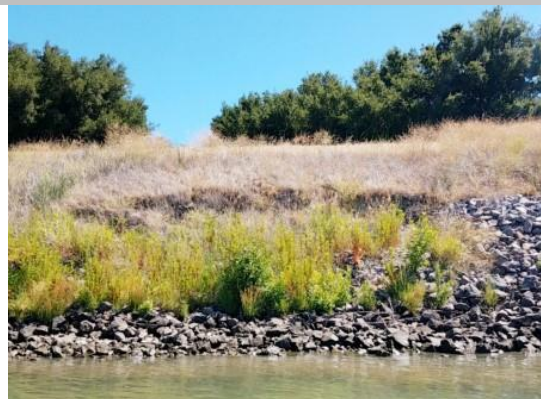
Photo 2 of 2 : SP_2023_RD0551_175_2_20230206_00002.jpg

View from the channel of erosion into the waterside prism (Summer 2020).

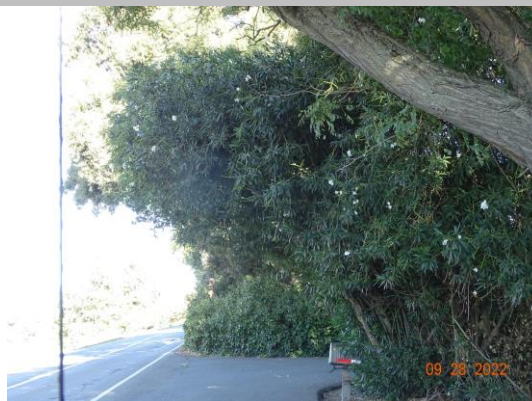
Photo 1 of 1 : SP_2023_RD0551_175_51_20230206_00016.jpg

View of the landscaping on the LS shoulder and slope (Fall 2022).

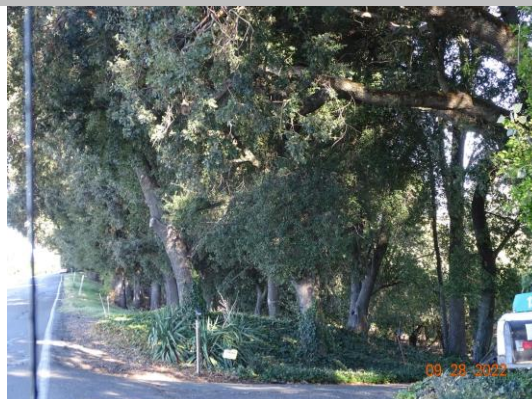
Photo 1 of 1 : SP_2023_RD0551_175_20_20230206_00005.jpg

View of the cactus and other landscaping on the LS slope (Fall 2022).

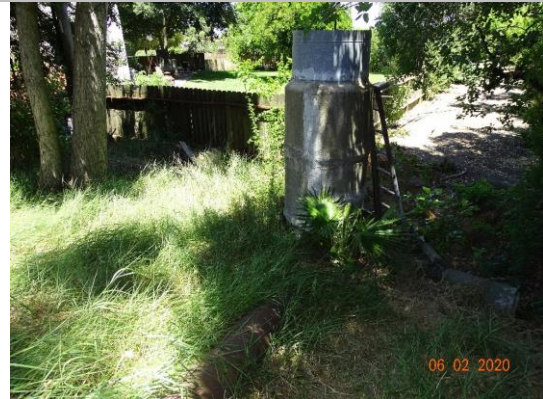
Photo 3 of 3 : UCIP_SP_2023_60696_87980.jpg

Land-Side: Concrete standpipe height raised with a metal sheet
