Flood Control Project Maintenance
Levee Inspections
LMA District Cover Sheet

Reclamation District No. 0551 Pearson

Levee Inspection Report By Mile - Spring 2024

Waterway	Bank	Unit Miles	Inspection Start/End	Inspector
Unit No. 01 Sacramento River	Left	1.83	03/11/2024 03/11/2024	Gregg McMillon

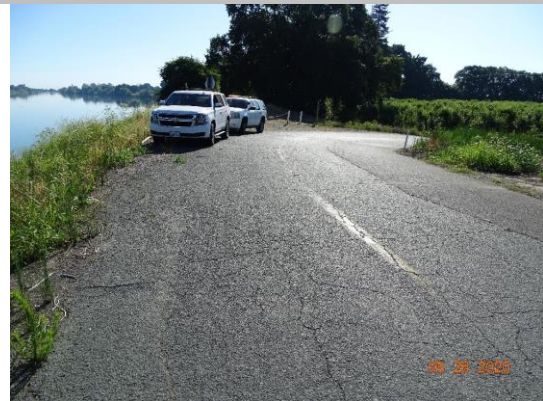
Photo 1 of 3 : UCIP_SP_2024_57010_84335.jpg

Comment Code						
Inspector Comment						
DS_ID:18848 FS_ID:57010 EP_NO: 11221 Repair Type: Urgent EVAL Issue: 1, Pipe Integrity Crossing Status: Found UCIP Comments: 05/26/2020 Record updated to Urgent. Through holes in pipe on LS slope. Open end of electrical conduit without wires at LS toe next to abandoned service pole. These two could pose flood risk to landside. 14-inch to 12-inch pipe welded connection on LS shoulder. Ruined pile structure at riverbank, missing pump. Abandoned service pole at LS toe. Crossing appears abandoned. Need to have CVFPB review ABO and determine current owner. Coordinates of crossing have been updated. (O.Yakimov - DWR UCIP) FIELD_STRUCT_DESC: 14-inch irrigation discharge pipe of an unknown material through the levee, invert elevation 4.2 feet below the crown, 2-inch steel electrical conduit at same location. Pump on a pile structure in the river. Wooden stairs and walkway to the pump. 42-inch concrete standpipe and service pole at landside toe. (14-inch pipe [HLM 0.18] authorized under Automatic Board Order (ABO) issued as Permit No. 11221, 1975 - Greene and Hemly, Inc). [Additional Reference(s): DWR Levee Log, 2005 (HLM 0.18). USACE As-Built Drawing No. 50-04-2983, Sheet 14, RM 36.5, March 1954, listed as 12-inch pipe]. FS Date: 5/26/2020 9:45:18 AM

Top of Levee: View of levee crown looking upstream

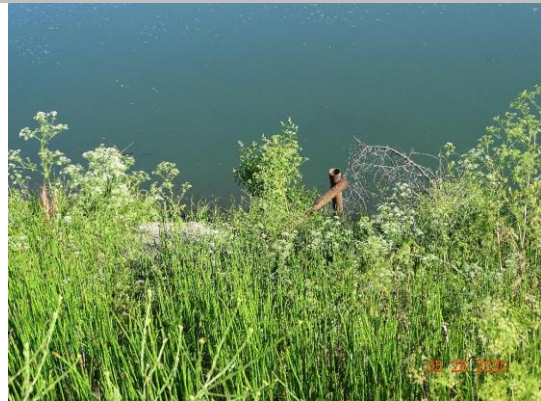
Photo 3 of 3 : UCIP_SP_2024_57010_84337.jpg

Water-Side: Signs of ruined pile structure on levee slope

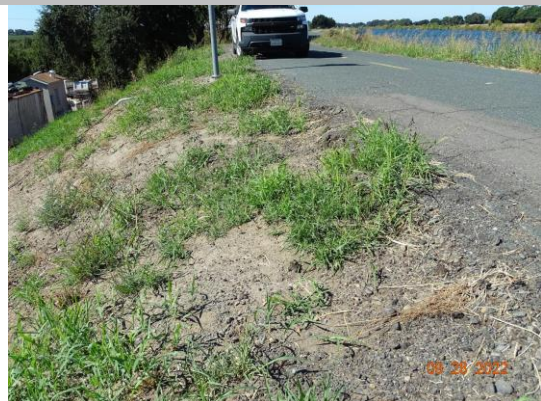
Photo 1 of 1 : SP_2024_RD0755_177_10_20240301_00001.jpg

LM Start	0.21	Rating **	M	Issue No.	10
LM End	0.21	Issue Type +	Ma	Location *	LS
Category	Earthen Levee			GPS Latitude/Longitude	
				Start	End
Item	Slope Stability			38.346428°	38.346428°
				-121.539400°	-121.539400°
DWR ID	DWR_RD0755_01_s_2019_10				
Comment Code					
S1 : Repair slope instability.					
Inspector Comment					
There is a 2" separation between roadway and levee on the landside shoulder.

View of the small slip on the LS shoulder (Fall 2022).

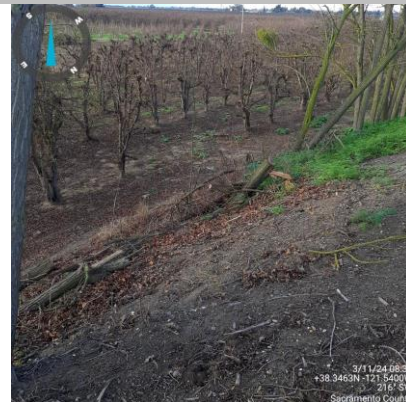
Photo 1 of 1 : SP_2024_RD0755_177_3_20240311_00012.jpg

View of fallen tree limbs on the LS slope. (Spring 2024)

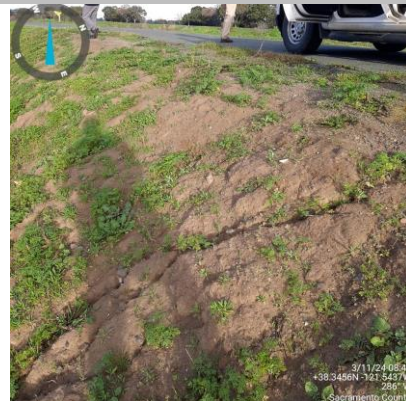
Photo 1 of 1 : SP_2024_RD0755_177_5_20240311_00013.jpg

LM Start	0.46	Rating **	A/W	Issue No.	5
LM End	0.46	Issue Type +	Ma	Location *	LS
Category	Earthen Levee			GPS Latitude/Longitude	
				Start	End
Item	Erosion / Rills			38.345672°	38.345672°
				-121.543734°	-121.543734°
DWR ID	DWR_RD0755_01_s_2024_5				
Comment Code					
E5 : Schedule repair of rills prior to the next inspection.					
Inspector Comment					
Erosion rills on the LS slope should be monitored.

Monitor erosion on LS slope. (Spring 2024)

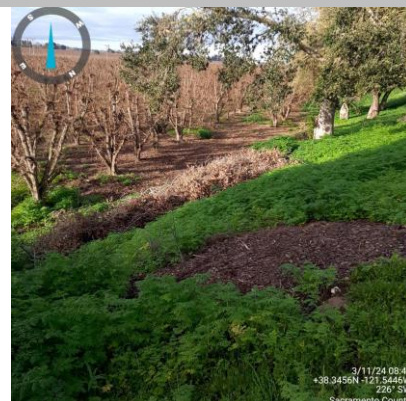
Photo 1 of 1 : SP_2024_RD0755_177_6_20240311_00014.jpg

LM Start	0.51	Rating **	M	Issue No.	6
LM End	0.51	Issue Type +	En	Location *	LS
Category	Earthen Levee			GPS Latitude/Longitude	
				Start	End
Item	Encroachments			38.345667°	38.345667°
				-121.544726°	-121.544726°
DWR ID	DWR_RD0755_01_s_2024_6				
Comment Code					
PR : Prunings					
Inspector Comment					
Pruning pile to be removed on the LS slope.

View of pruning pile on the LS slope. (Spring 2024)

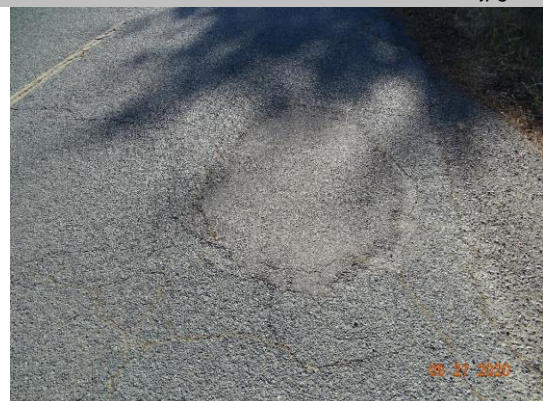
Photo 2 of 3 : UCIP_SP_2024_57080_84493.jpg

DS_ID:18855
FS_ID:57080
EP_NO: 11225
Repair Type: Urgent
EVAL Issue: 1, Pipe Integrity
Crossing Status: Found
UCIP Comments: 05/27/2020 Record updated from Non-Urgent to Urgent. Through holes in pipe on waterside slope, sinkhole on WS shoulder measures 3'x3'x1'. Erosion continues to levee crown - road pavement. Asphalt patch repair on the crown. Knocked down service pole with electric box on LS slope. Crossing appears abandoned. Need to have CVFPB review ABO and determine current owner. (O.Yakimov - DWR UCIP)
08/06/2013 Abandoned pipe and pump. Service pole, power box lying on LS slope.
FIELD_STRUCT_DESC: 10-inch irrigation discharge pipe of an unknown material and a 1-inch electrical conduit through the levee, invert elevation 5.6 feet below the crown. Pump on a pile structure with a walkway to the pump. Abandoned service pole on the landside (LS) slope. (10-inch pipe [HLM 0.94] authorized under Automatic Board Order (ABO) issued as Permit No. 11225, 1975 - Helen D. Wilson). [Additional Reference(s): DWR Levee Log, 2005 (HLM 0.94). USACE Sacramento O&M Manual, Unit 111, May 1959, Revised 29 December 2016, (RM 35.66), listed as 10-inch pipe. USACE As-Built Drawing No. 50-04-2983, Sheet 13, downstream of Station 515+00, March 1954].

Top of Levee: Patch in road pavement within pipe alignment

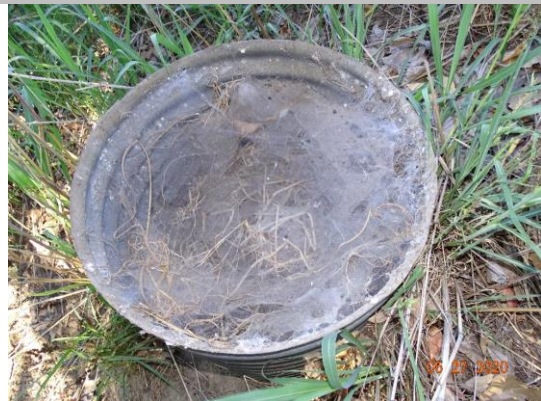
Photo 1 of 3 : UCIP_SP_2024_57083_84526.jpg

Comment Code						
Inspector Comment						
DS_ID:18857 FS_ID:57083 EP_NO: 11219 Repair Type: Urgent EVAL Issue: 2a, Levee Integrity Crossing Status: Found UCIP Comments: 05/27/2020 Record updated from Non-Urgent to Urgent. Unauthorized 8'x3'x3' excavation between pump house and WS levee slope was observed. Excavation exposes 8-inch pipe cut-off that was welded to a 6-inch pipe going towards pump house. Pump is running, minor water leaks from pump in pump house observed. CMP riser on LS shoulder is filled with soil and debris. No permit has been identified authorizing pipe. (O.Yakimov - DWR UCIP) 08/06/2013 requires cleaning of siphon breaker box. FIELD_STRUCT_DESC: 8-inch irrigation discharge pipe of an unknown material through the levee, invert elevation 5.7 feet below the crown. Siphon breaker in a 26-inch corrugated metal pipe (CMP) riser on the landside (LS) shoulder. Power pole on the LS. Pump and power box in a pump house on the waterside (WS) slope. Electrical conduit through the levee at the same location. (8-inch pipe [HLM 1.13] authorized under Automatic Board Order (ABO) issued as Permit No. 11219, 1975 - David J. Jr and Bonnie Elliott). [Additional Reference(s): DWR Levee Log, 2005 (HLM 1.13). USACE Sacramento O&M Manual, Unit 111, May 1959, Revised 29 December 2016, (RM 35.47), listed as 8-inch pipe]. FS Date: 5/27/2020 9:09:23 AM

Land-Side: Soil and debris inside of CMP riser

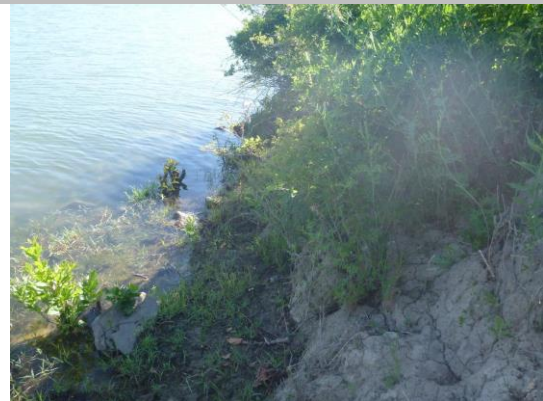
Photo 1 of 1 : SP_2024_RD0755_177_22_20240301_00004.jpg

LM Start	1.23	Rating **	A/W	Issue No.	22
LM End	1.29	Issue Type +	Ma	Location *	WS
Category	Earthen Levee			GPS Latitude/Longitude	
				Start	End
Item	Erosion / Bank Caving			38.342992°	38.342633°
				-121.557572°	-121.558622°
DWR ID	LMA-155				
Comment Code					
E1 : Note and monitor erosion site.					
Inspector Comment					
This was a 2017 Storm Damage site. Damage consists of erosion of the lower waterside levee slope and bank approximately 322 feet in length. Site ID No:328 Site Designation:LMA-155 6/18/2020 Field Notes: Erosion is into berm and not prism.

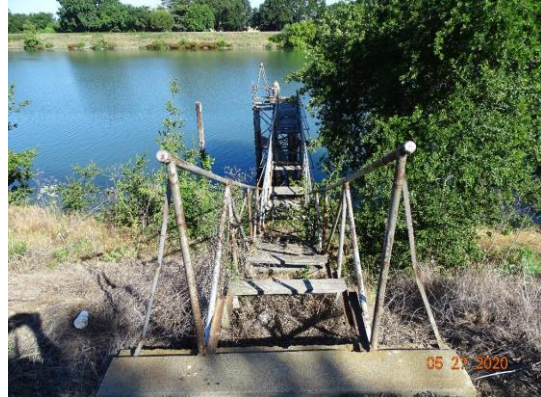
Photo 1 of 3 : UCIP_SP_2024_57084_84534.jpg

DS_ID:18858
FS_ID:57084
EP_NO: 11219
Repair Type: Non-Urgent
EVAL Issue: 10, Unauthorized Modification or Non-Compliant Permit
Crossing Status: Found
UCIP Comments: 05/27/2020 Record remains Non-Urgent. 14-inch supply pipe segment on waterside cut off between closure device and levee shoulder and replaced with 12-inch pipe from WS shoulder to riverbank. Pump house with a pump at LS toe was built. 8-inch pipe daylights in this pump house. Pump on pile structure in the river and walkway to the pump have been abandoned. 2-inch electrical conduit through the levee has open end with no wires on LS shoulder - should be abandoned properly. Need to have CVFPB review ABO and determine current owner. (O.Yakimov - DWR UCIP)
08/06/2013 Pump and walkway seem abandoned.- Power line is not connected with pump.- A pump house like structure found on LS levee toe.
FIELD_STRUCT_DESC: 14-inch irrigation discharge pipe of an unknown material through the levee, invert elevation 8.5 feet below the crown. Pump house at landside levee toe. Siphon breaker and power pole on the landside (LS) slope. 2-inch electrical conduit through the levee at the same location. Pump on pile structure in the river and walkway to the pump have been abandoned. (14-inch pipe [HLM 1.65] authorized under Automatic Board Order (ABO) issued as Permit No. 11219, 1975 - David J. Jr and Bonnie Elliott). [Additional Reference(s): DWR Levee Log, 2005 (HLM 1.65). USACE Sacramento O&M Manual, Unit 111, May 1959, Revised 29 December 2016, (RM35.02), 14-inch pipe referenced in RD0551. USACE As-Built Drawing No. 50-4-2983, Sheet 11, page 15, March 1954. USACE As-Built Drawing No. 06-13-1100, Sheet 12, near 'L' 1283+75, January 1933].

Water-Side: View of levee slope looking from crown. Abandoned pipe on waterside

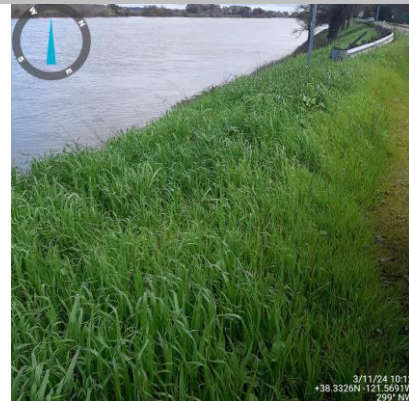
Photo 1 of 1 : SP_2024_RD0551_175_37_20240318_00127.jpg

View of tall grass on the WS slope. (Spring 2024)

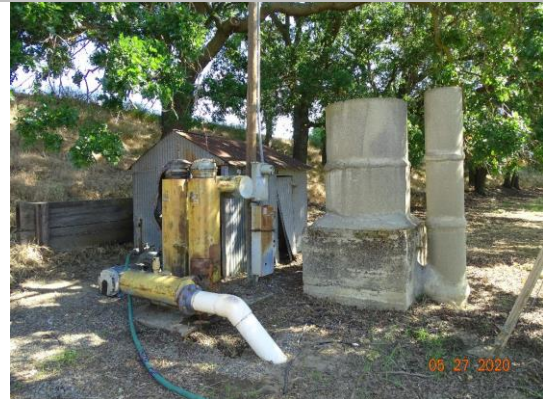
Photo 1 of 3 : UCIP_SP_2024_57695_85475.jpg

Comment Code					
Inspector Comment					
DS_ID:21971 FS_ID:57695 EP_NO: 8664 Repair Type: Non-Urgent EVAL Issue: 10, Unauthorized Modification or Non-Compliant Permit Crossing Status: Found UCIP Comments: 05/27/2020 Record updated from No Action Needed to Non-Urgent. 8-inch pipe sleeved through 10-inch pipe. Installed new pump with gate valve and pressure booster, service pole with electric panel next to pumphouse. Abandoned pump and gate valve in pump house, abandoned 48-inch and 24-inch concrete standpipes at pump house on the LS toe. Unable to locate a permit authorizing modification. Need to have CVFPB review ABO and determine current owner. (O.Yakimov - DWR UCIP) FIELD_STRUCT_DESC: 8-inch pipe sleeved through 10-inch coated steel irrigation pipe through the levee, 5 feet below the crown. Pump with gate valve and pressure booster, service pole with electrical panel next to pumphouse on the landside slope. (Retention of irrigation pumping plant, centrifugal pump and gate valve in pump house, landside toe of the levee [HLM 0.05] authorized under Automatic Board Order (ABO) issued as Permit No. 8664, 1972 - Lincoln Chan). [Additional Reference(s): DWR Levee Log, 2005 (HLM 0.05). USACE Sacramento O&M Manual, Unit 111, May 1959, Revised 29 December 2016, (RM 34.75), listed as 10-inch pipe]. FS Date: 5/27/2020 10:13:34 AM

Land-Side: Abandoned concrete standpipes

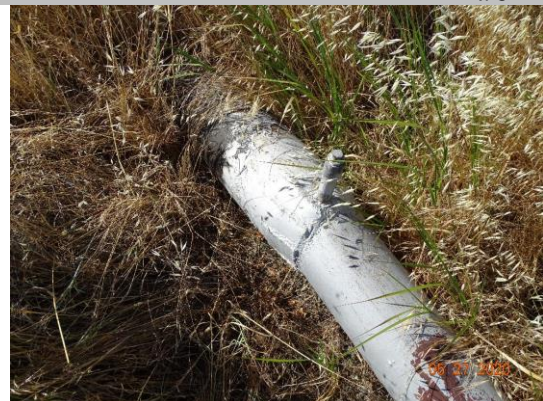
Photo 2 of 3 : UCIP_SP_2024_57695_85479.jpg

Water-Side: 10-inch to 8-inch pipe welded connection

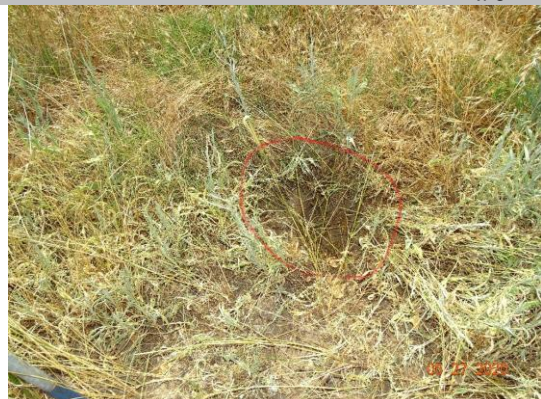
Photo 2 of 3 : UCIP_SP_2024_60085_87350.jpg

Water-Side: A sinkhole in pipe alignment measures 12"x 18"x 6" deep

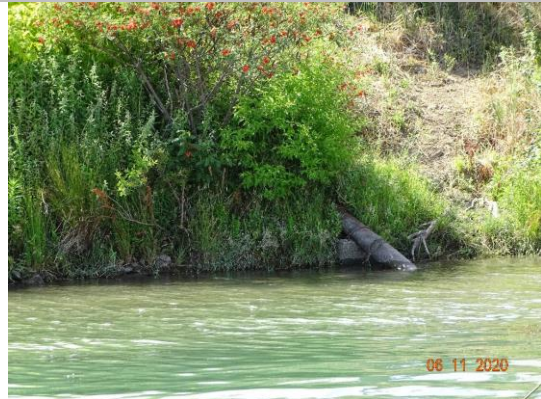
Photo 3 of 3 : UCIP_SP_2024_60085_87352.jpg

Water-Side: Heavily rusted pipe in riverbank

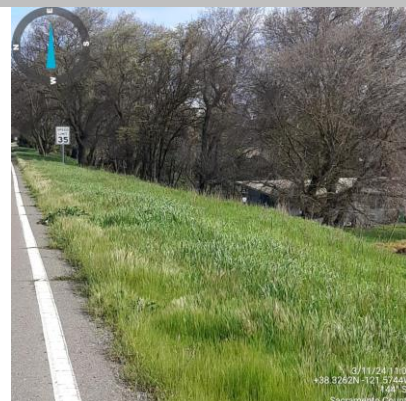
Photo 1 of 1 : SP_2024_RD0551_175_79_20240314_00108.jpg

View of tall grass on the LS slope. (Spring 2024)

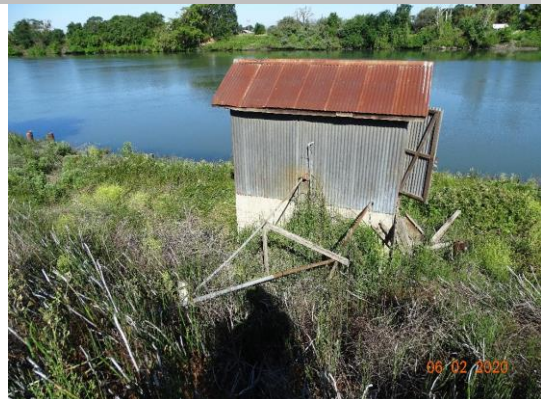
Photo 2 of 3 : UCIP_SP_2024_60086_87359.jpg

Water-Side: Abandoned pumphouse on levee slope

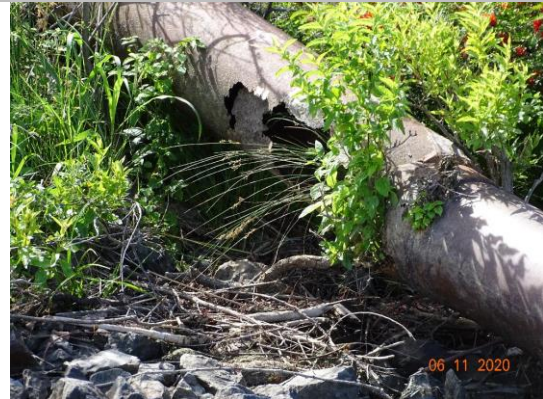
Photo 3 of 3 : UCIP_SP_2024_60086_87353.jpg

Water-Side: Missing wall of pipe at riverbank

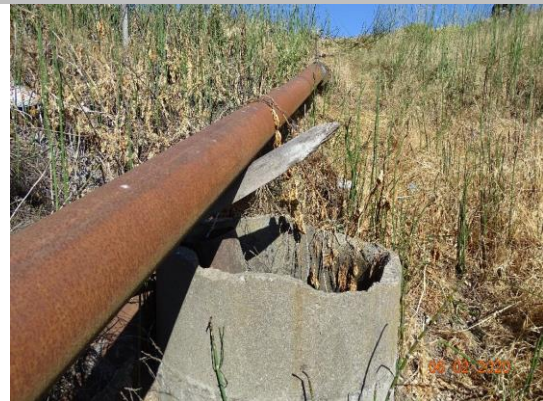
Photo 1 of 3 : UCIP_SP_2024_60092_87369.jpg

Land-Side: Levee slope, and abandoned concrete standpipe

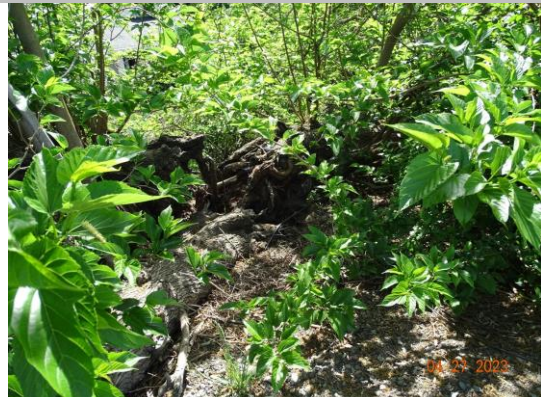
Photo 1 of 1 : SP_2024_RD0551_175_40_20240301_00010.jpg

View of the tree limb on the LS slope (Spring 2023).

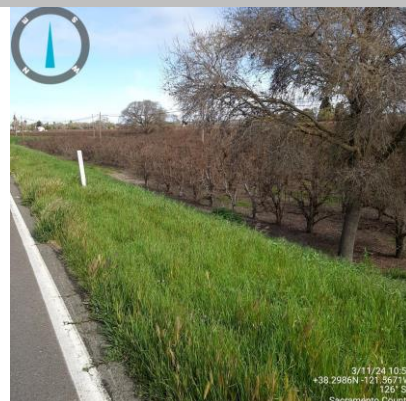
Photo 1 of 1 : SP_2024_RD0551_175_75_20240314_00112.jpg

View of tall grass on the LS slope. (Spring 2024)

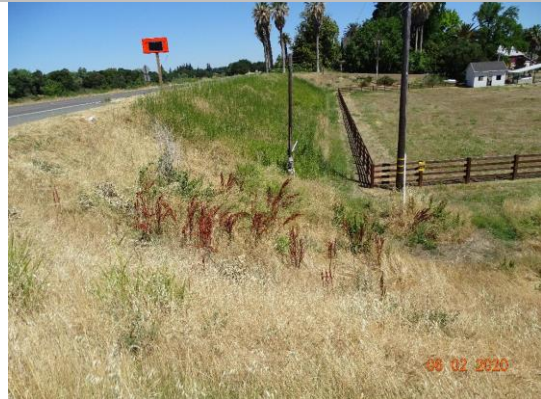
Photo 1 of 3 : UCIP_SP_2024_60233_87517.jpg

Land-Side: Overview of levee slope. Concrete standpipe is gone

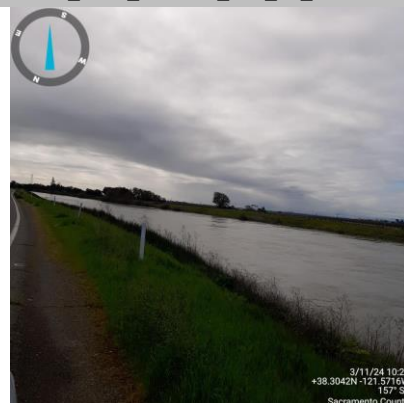
Photo 1 of 1 : SP_2024_RD0551_175_43_20240311_00104.jpg

View of tall grass on WS slope. (Spring 2024)

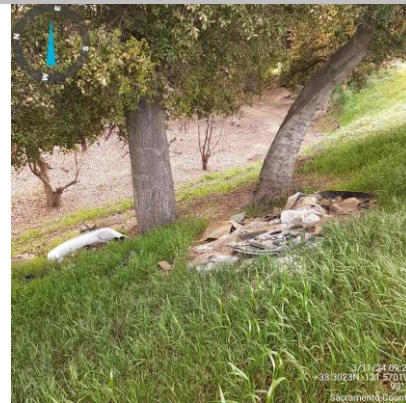
Photo 1 of 1 : SP_2024_RD0551_175_36_20240314_00113.jpg

View of garbage and car debris on the LS slope. (Spring 2024)

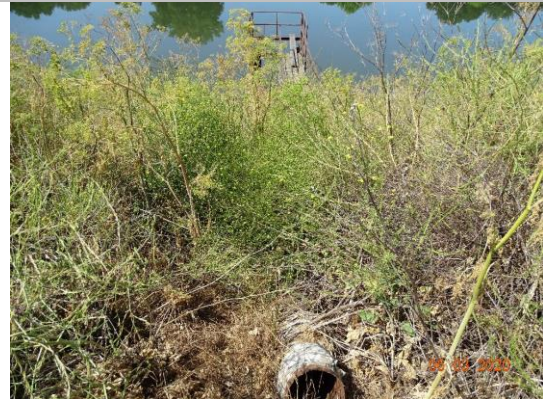
Photo 1 of 3 : UCIP_SP_2024_60620_87853.jpg

Water-Side: Pipe cut on levee slope

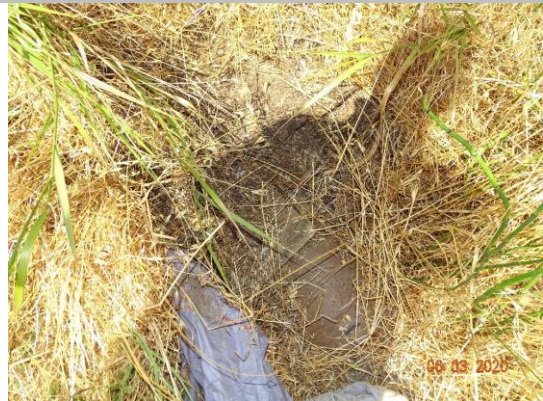
Photo 3 of 3 : UCIP_SP_2024_60620_87857.jpg

Land-Side: Pipe daylights on levee slope. Slope depression found at this location measures 8' x 9' x 2' deep

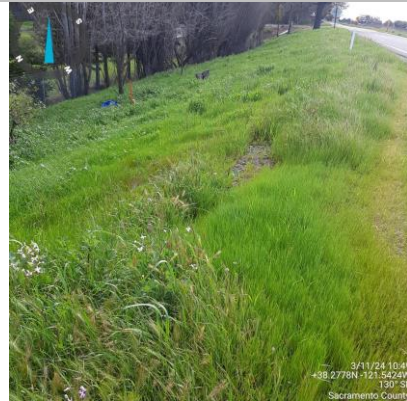
Photo 1 of 1 : SP_2024_RD0551_175_68_20240314_00125.jpg

View of tall grass on the LS slope. (Spring 2024)

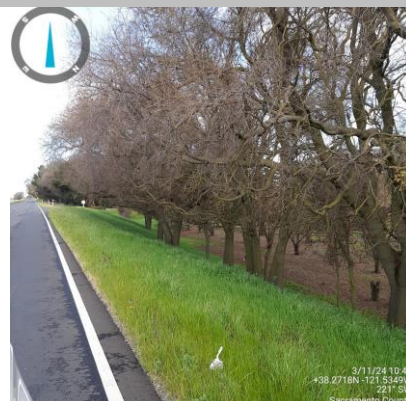
Photo 1 of 1 : SP_2024_RD0551_175_67_20240314_00119.jpg

View of tall grass on the LS slope. (Spring 2024)

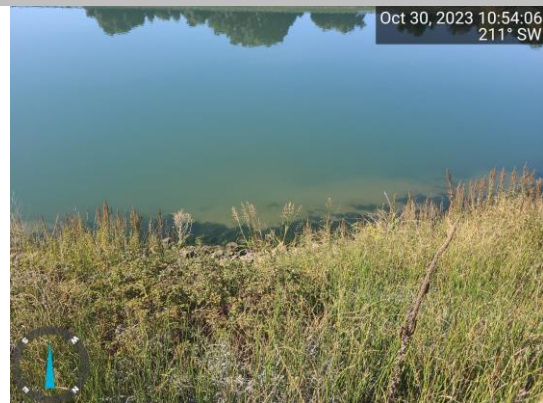
Photo 1 of 2 : SP_2024_RD0551_175_2_20240301_00001.jpg

View of the erosion on the WS slope (Fall 2023).

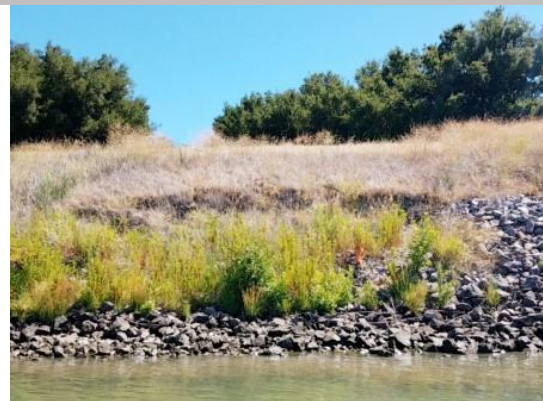
Photo 2 of 2 : SP_2024_RD0551_175_2_20240301_00002.jpg

View from the channel of erosion into the waterside prism (Summer 2020).

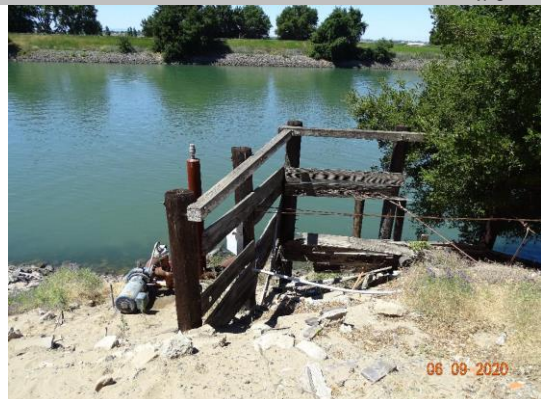
Photo 2 of 3 : UCIP_SP_2024_60650_87923.jpg

Water-Side: Abandoned pile structure on levee slope and in channel

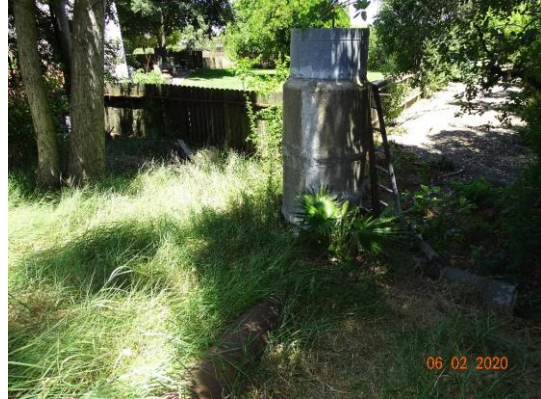
Photo 3 of 3 : UCIP_SP_2024_60696_87980.jpg

Land-Side: Concrete standpipe height raised with a metal sheet
