**Flood Control Project Maintenance  
Levee Inspections**

**Fall 2013 Levee Maintenance Deficiency Summary Report**

**Levee Inspection Report By Mile - Fall 2013**

**Reclamation District No. 0554 Walnut Grove**

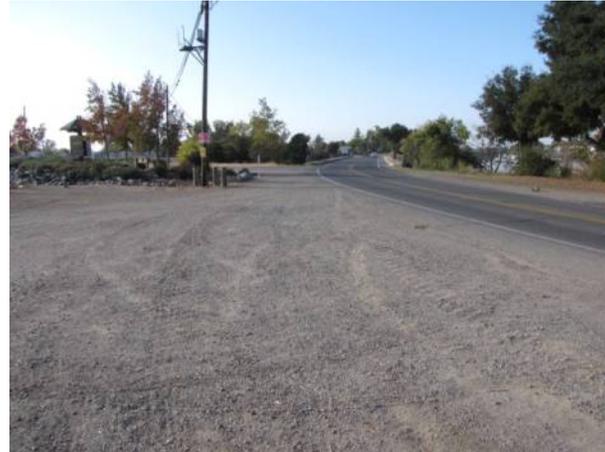
Levee Mile Report Line	4
Start Levee Mile	0.00
End Levee Mile	0.00
Location	Land Side
Category	Earthen Levee
Item	Vegetation
RD 554 Looking downstream from levee mile 0.00 landside slope, Delta cross canal bridge in background. Photo taken 10-29-2013.	
phillips_f_20131029_670.JPG

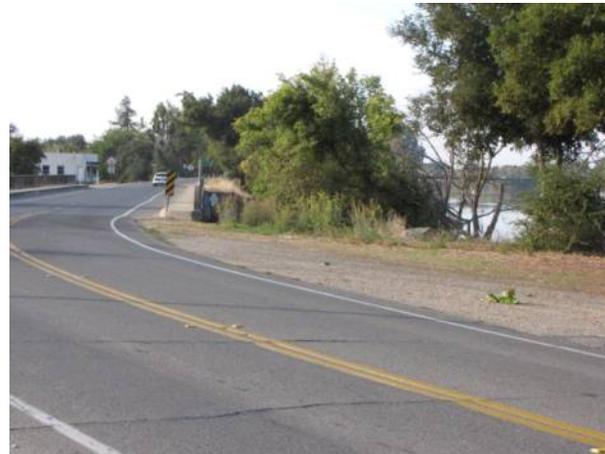
5	0.12	0.12	Earthen Levee	Vegetation	WS Ma	V2 : Remove the wild growth other than native grasses from the levee slopes. Inspector Comments: Vegetation present beyond the bridge crossing on the water side levee slopes. Should be maintained.	38.247774 ° -121.509817 °	38.247774 ° -121.509817 °	12 Y
							DWR ID: DWR_RD0554_01_f_2013_12		
6	0.25	0.34	Supplemental	USACE Erosion Survey	WS Ma	Inspector Comments: 2009 - Tension cracks on road on top of levee. Erosion into the levee slope and mass failure. 2012: No observed change. [2012 Site ID: SAC_27-0_L]	38.246222 ° -121.510878 °	38.245017 ° -121.511740 °	2 Y
							DWR ID:		
7	0.28	0.34	Earthen Levee	Vegetation	WS Ma	V2 : Remove the wild growth other than native grasses from the levee slopes.	38.245724 ° -121.510987 °	38.244974 ° -121.511540 °	1
							DWR ID: DWR_RD0554_01_f_2013_1		
8	0.32	0.32	Earthen Levee	Encroachments	WS Ma	TR : Tree or limb	38.245152 ° -121.511435 °	38.245152 ° -121.511435 °	7

Levee Mile Report Line	5
Start Levee Mile	0.12
End Levee Mile	0.12
Location	Water Side
Category	Earthen Levee
Item	Vegetation
RD 554 Standing at levee mile 0.12 landward looking across River Road at water side levee slope downstream. The Delta Cross Canal bridge crossing in back ground. Photo taken 10-29-2013.	
phillips_f_20131029_671.JPG
