**Flood Control Project Maintenance
Levee Inspections**
LMA District Cover Sheet
Spring 2014 Levee Inspection Results

Reclamation District No. 0554 Walnut Grove

Levee Inspection Report By Mile - Spring 2014

Waterway		Bank	Unit Miles	Inspection Start/End	Inspector
Unit No. 01 Sacramento River		Left	1.09	05/06/2014 05/06/2014	Herman Phillips

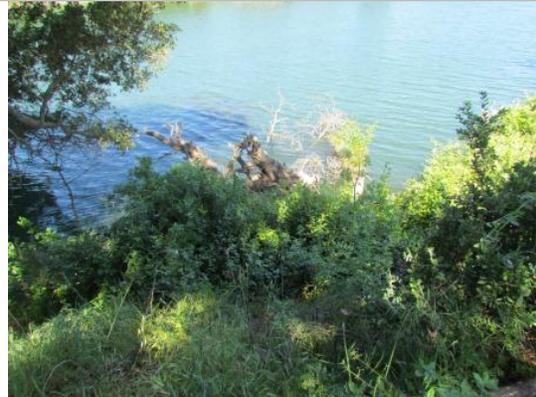
Photo 1 of 1 : phillips_s_20140506_05835.jpg

LM Start	0.09	Rating **	U	Issue No.	11
LM End	0.09	Issue Type +	Ma	Location *	WS
Category	Earthen Levee			GPS Latitude/Longitude	
				Start	End
Item	Erosion / Bank Caving			38.248262 °	38.248262 °
				-121.509901 °	-121.509901 °
DWR ID	DWR_RD0554_01_s_2014_11				
Action/Comments					
Note and monitor erosion site. Inspector Comments: This is not a new erosion site, repairs are needed. One tree has fallen into the Sac River at the erosion site. There are many more trees at that same location.

Erosion at waterside toe. Tree fallen at erosion site. Photo taken 06-05-2014.

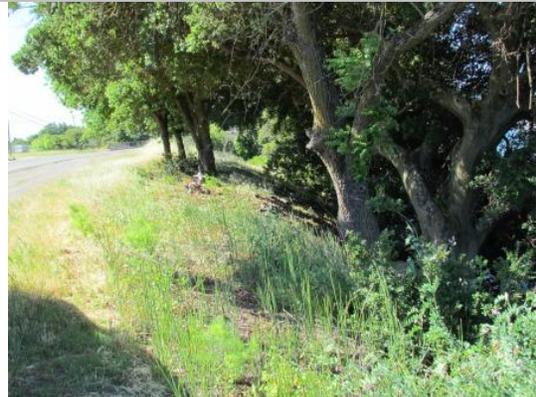
Photo 1 of 1 : phillips_s_20140506_05837.jpg

LM Start	0.12	Rating **	M	Issue No.	12
LM End	0.12	Issue Type +	Ma	Location *	WS
Category	Earthen Levee			GPS Latitude/Longitude	
				Start	End
Item	Vegetation			38.247774 °	38.247774 °
				-121.509817 °	-121.509817 °
DWR ID	DWR_RD0554_01_f_2013_12				
Action/Comments					
Remove the wild growth other than native grasses from the levee slopes. Inspector Comments: Vegetation present beyond the bridge crossing on the water side levee slopes. Should be maintained.

Looking downstream from waterside slope of RD 554. Photo taken 06-05-2014.

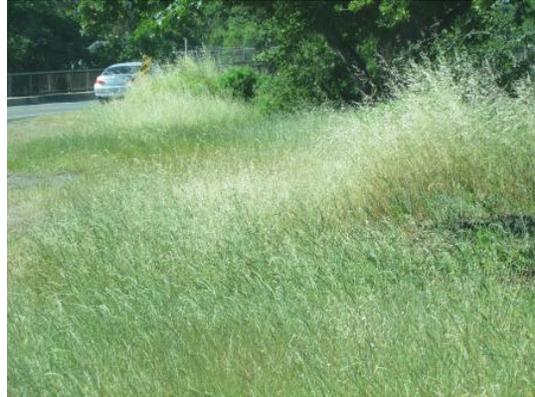
Photo 1 of 1 : phillips_s_20140506_05836.jpg

LM Start	0.15	Rating **	U	Issue No.	14
LM End	1.04	Issue Type +	Ma	Location *	WS
Category	Earthen Levee			GPS Latitude/Longitude	
				Start	End
Item	Vegetation			38.247405 °	38.237626 °
				-121.509946 °	-121.516910 °
DWR ID	DWR_RD0554_01_s_2014_14				
Action/Comments					
Control annual grass and weeds on the levee slopes and easements.

Weeds taller than 2-foot along the waterside levee slope. Photo taken 06-05-2014.

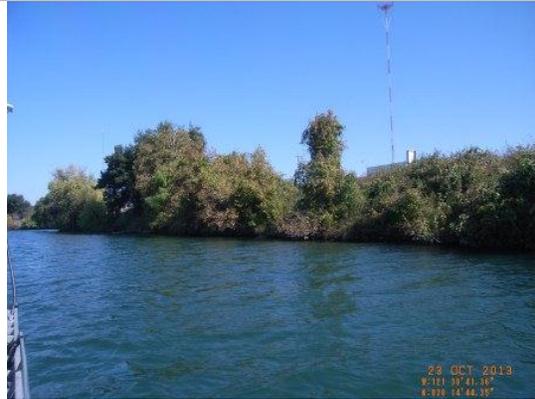
Photo 1 of 2 : USACE2013A_SAC_27-0_L_6.jpg

LM Start	0.25	Rating **	M	Issue No.	2
LM End	0.34	Issue Type +	Ma	Location *	WS
Category	Supplemental			GPS Latitude/Longitude	
				Start	End
Item	USACE Erosion Survey			38.246222 °	38.245017 °
				-121.510878 °	-121.511740 °
DWR ID					
Action/Comments					
Inspector Comments: 2009 - Tension cracks on road on top of levee. Erosion into the levee slope and mass failure. 2013: Short vertical sections at bank toe. [2013 Site ID: SAC_27-0_L]

USACE 2013 Photo #1

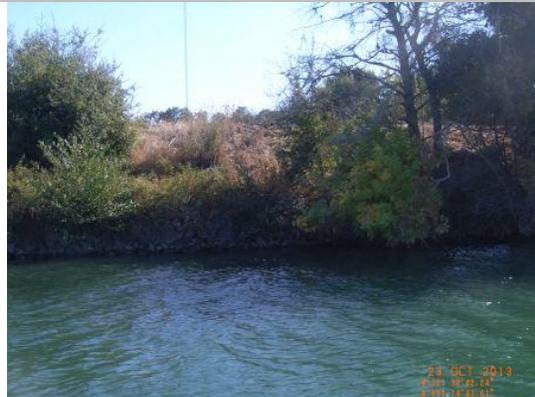
Photo 2 of 2 : USACE2013A_SAC_27-0_L_8.jpg

LM Start	0.25	Rating **	M	Issue No.	2 (cont)
LM End	0.34	Issue Type +	Ma	Location *	WS

USACE 2013 Photo #2

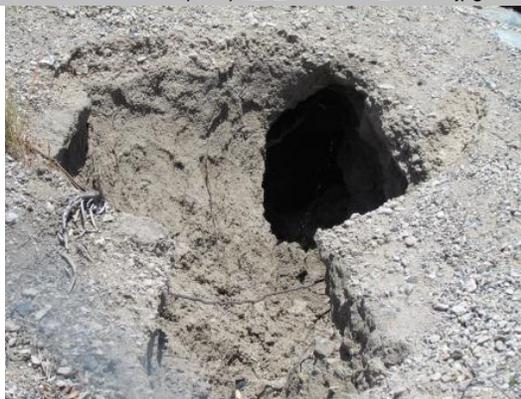
Photo 1 of 2 : phillips_s_20140506_05840.jpg

LM Start	0.30	Rating **	U	Issue No.	13
LM End	0.30	Issue Type +	Ma	Location *	LS
Category	Earthen Levee		GPS Latitude/Longitude		
			Start	End	
Item	Erosion / Bank Caving		38.245389 °	38.245389 °	
			-121.511085 °	-121.511085 °	
DWR ID	DWR_RD0554_01_s_2014_13				
Action/Comments					
Schedule repair of erosion site prior to the next inspection. Inspector Comments: This erosion along the slope need to be repaired before rainy season, it will only get worse.

Bank caving along the landward levee slope. Photo taken 06-05-2014.

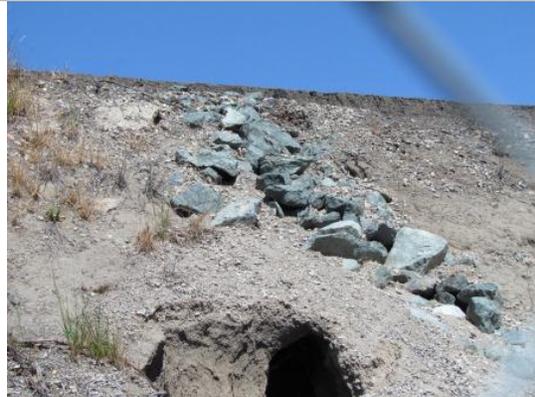
Photo 2 of 2 : phillips_s_20140506_05841.jpg

LM Start	0.30	Rating **	U	Issue No.	13 (cont)
LM End	0.30	Issue Type +	Ma	Location *	LS
Category	Earthen Levee		GPS Latitude/Longitude		
			Start	End	
Item	Erosion / Bank Caving		38.245389 °	38.245389 °	
			-121.511085 °	-121.511085 °	
DWR ID	DWR_RD0554_01_s_2014_13				
Action/Comments					
Schedule repair of erosion site prior to the next inspection. Inspector Comments: This erosion along the slope need to be repaired before rainy season, it will only get worse.

Another view of the issue. Photo taken 06-05-2014.

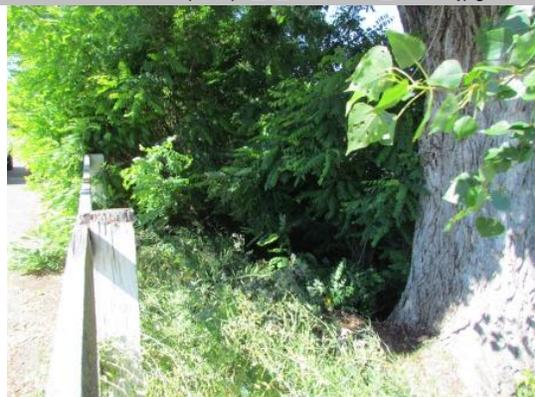
Photo 1 of 1 : phillips_s_20140506_05838.jpg

LM Start	0.63	Rating **	U	Issue No.	18
LM End	0.75	Issue Type +	Ma	Location *	WS
Category	Earthen Levee		GPS Latitude/Longitude		
			Start	End	
Item	Trim / Thin Trees		38.241547 °	38.240129 °	
			-121.514617 °	-121.515973 °	
DWR ID	DWR_RD0554_01_s_2014_18				
Action/Comments					
Thin trees to allow visibility of the ground and room to flood fight.

Wooded tree growth along waterward shoulder and slope. Photo taken 06-05-2014.

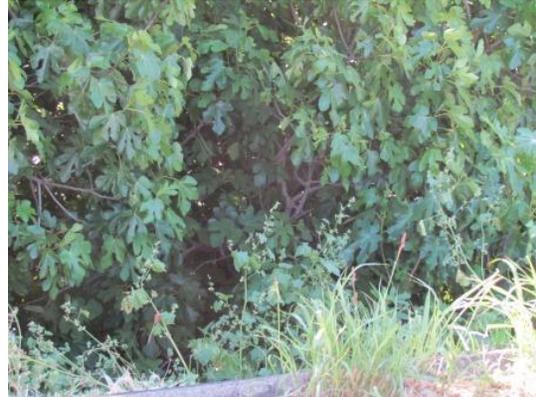
Photo 1 of 1 : phillips_s_20140506_05839.jpg

LM Start	0.75	Rating **	U	Issue No.	20
LM End	0.79	Issue Type +	Ma	Location *	LS
Category	Earthen Levee		GPS Latitude/Longitude		
			Start	End	
Item	Trim / Thin Trees		38.240128 °	38.239630 °	
			-121.515974 °	-121.516418 °	
DWR ID	DWR_RD0554_01_s_2014_20				
Action/Comments					
Thin trees to allow visibility of the ground and room to flood fight.

Wooded tree growth on landward levee slope and shoulders. Photo taken 06-05-2014.

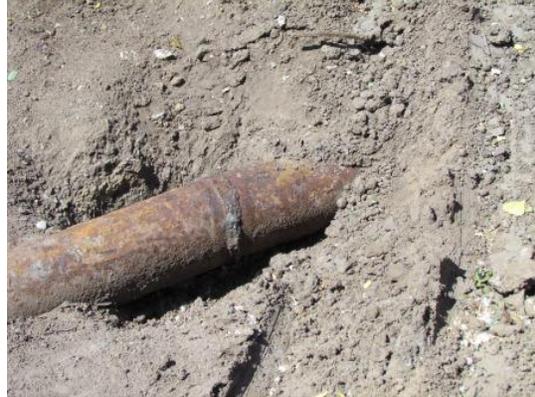
Photo 1 of 3 : phillips_s_20140506_05842.jpg

LM Start	1.09	Rating **	U	Issue No.	16
LM End	1.09	Issue Type +	En	Location *	LS
Category	Earthen Levee			GPS Latitude/Longitude	
				Start	End
Item	Encroachments			38.235422 °	38.235422 °
				-121.517233 °	-121.517233 °
DWR ID	DWR_RD0554_01_s_2014_16				
Action/Comments					
Pipe Inspector Comments: Unauthorized pipe repair done without CVFPB Permit.

Uncovered pipe section on the landward toe levee mile 1.09. Photo taken 06-05-2014.

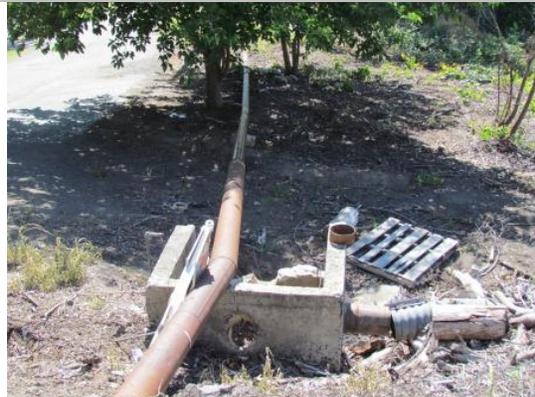
Photo 2 of 3 : phillips_s_20140506_05843.jpg

LM Start	1.09	Rating **	U	Issue No.	16 (cont)
LM End	1.09	Issue Type +	En	Location *	LS

Another view of the unauthorized pipe repair viewed from landside shoulder. 06-05-2014.

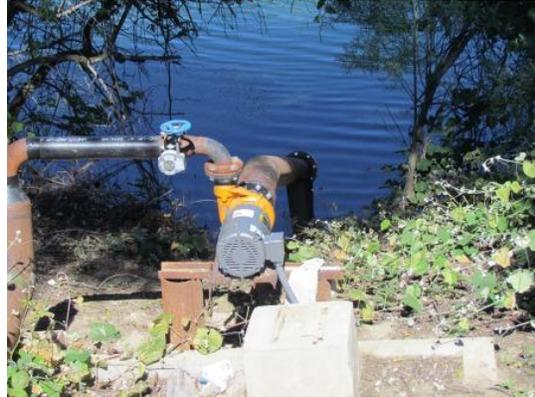
Photo 3 of 3 : phillips_s_20140506_05844.jpg

LM Start	1.09	Rating **	U	Issue No.	16 (cont)
LM End	1.09	Issue Type +	En	Location *	LS
Category	Earthen Levee			GPS Latitude/Longitude	
				Start	End
Item	Encroachments			38.235422 °	38.235422 °
				-121.517233 °	-121.517233 °
DWR ID	DWR_RD0554_01_s_2014_16				
Action/Comments					
Pipe

Waterside view of the unauthorized pipe repair, new pump shown in picture. Photo taken 06-05-2014.
