**Flood Control Project Maintenance
Levee Inspections**

Maintenance Issue Types Only, Levee Inspection Report By Mile - Fall 2014

Reclamation District No. 0554 Walnut Grove

Waterway	Bank	Unit Miles	Inspection Start/End	Inspector
Unit No. 01 Sacramento River	Left	1.13	10/22/2014 10/22/2014	Herman Phillips

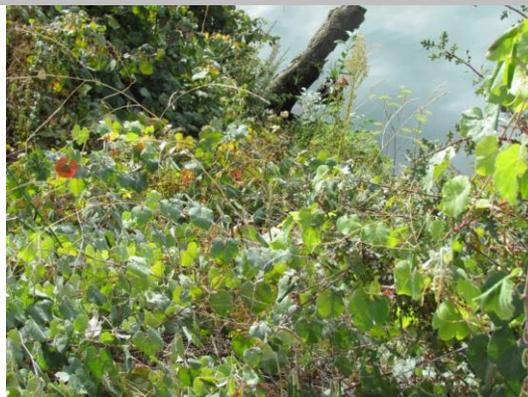
Photo 1 of 1 : FA_2014_RD0554_176_11_20141125_00012.jpg

LM Start	0.09	Rating **	U	Issue No.	11
LM End	0.09	Issue Type +	Ma	Location *	WS
Category	Earthen Levee		GPS Latitude/Longitude		
			Start	End	
Item	Erosion / Bank Caving		38.248262 °	38.248262 °	
			-121.509901 °	-121.509901 °	
DWR ID	DWR_RD0554_01_s_2014_11				
Action/Comments					
Note and monitor erosion site. Inspector Comments: This is not a new erosion site, repairs are needed. One tree has fallen into the Sac River at the erosion site. There are many more trees at that same location.

Erosion on waterside toe dead tree fallen at erosion site.

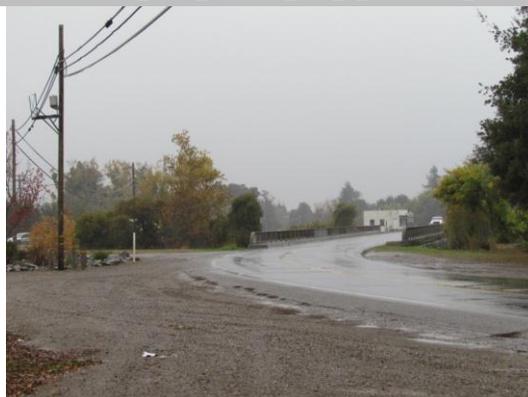
Photo 1 of 1 : FA_2014_RD0554_176_8_20141125_00014.jpg

LM Start	0.12	Rating **	M	Issue No.	8
LM End	0.12	Issue Type +	Ma	Location *	LS
Category	Earthen Levee		GPS Latitude/Longitude		
			Start	End	
Item	Vegetation		38.247774 °	38.247774 °	
			-121.509820 °	-121.509820 °	
DWR ID	DWR_RD0554_01_f_2014_8				
Action/Comments					
Control annual grass and weeds on the levee slopes and easements. Inspector Comments: Looking downstream from the landside shoulder of RD 554.

Looking downstream from Levee mile 0.12 landside of RD 554.

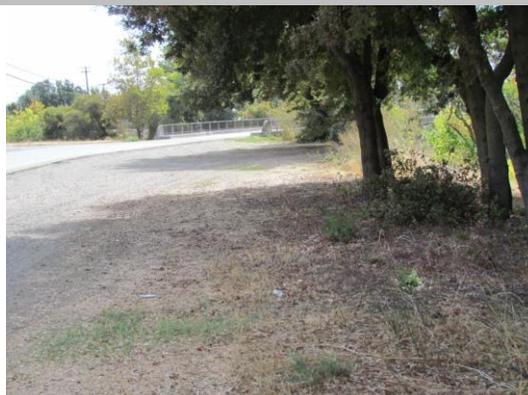
Photo 1 of 1 : FA_2014_RD0554_176_12_20141125_00013.jpg

LM Start	0.12	Rating **	M	Issue No.	12
LM End	0.12	Issue Type +	Ma	Location *	WS
Category	Earthen Levee		GPS Latitude/Longitude		
			Start	End	
Item	Vegetation		38.247774 °	38.247774 °	
			-121.509817 °	-121.509817 °	
DWR ID	DWR_RD0554_01_f_2013_12				
Action/Comments					
Remove the wild growth other than native grasses from the levee slopes. Inspector Comments: Vegetation present beyond the bridge crossing on the water side levee slopes. Should be maintained.

Looking downstream from the waterside shoulder RD 554.

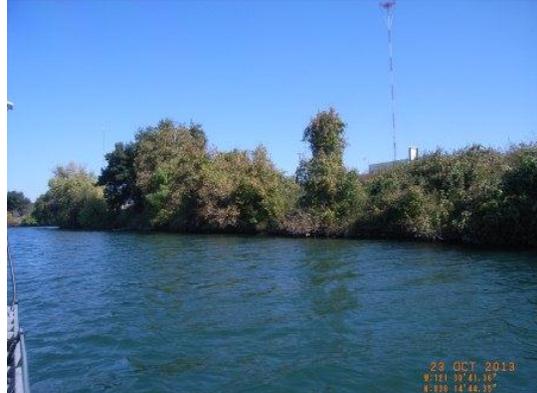
Photo 1 of 2 : FA_2014_RD0554_176_2_20141008_00001.jpg

LM Start	0.25	Rating **	M	Issue No.	2
LM End	0.34	Issue Type +	Ma	Location *	WS
Category	Supplemental		GPS Latitude/Longitude		
			Start	End	
Item	USACE Erosion Survey		38.246222 °	38.245017 °	
			-121.510878 °	-121.511740 °	
DWR ID	DWR_RD0554_01_f_2014_2				
Action/Comments					
Inspector Comments: 2009 - Tension cracks on road on top of levee. Erosion into the levee slope and mass failure. 2013: Short vertical sections at bank toe. [2013 Site ID: SAC_27-0_L]

USACE 2013 Photo #1

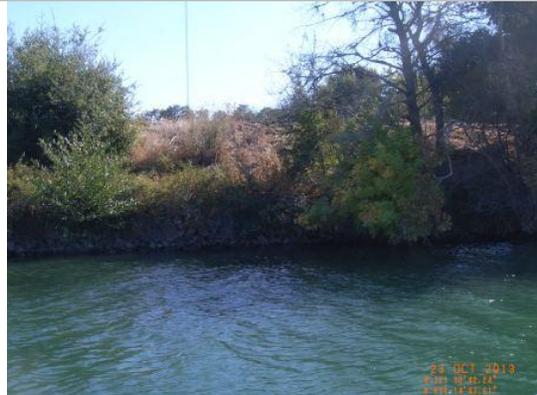
Photo 2 of 2 : FA_2014_RD0554_176_2_20141008_00002.jpg

LM Start	0.25	Rating **	M	Issue No.	2 (cont)
LM End	0.34	Issue Type +	Ma	Location *	WS

USACE 2013 Photo #2

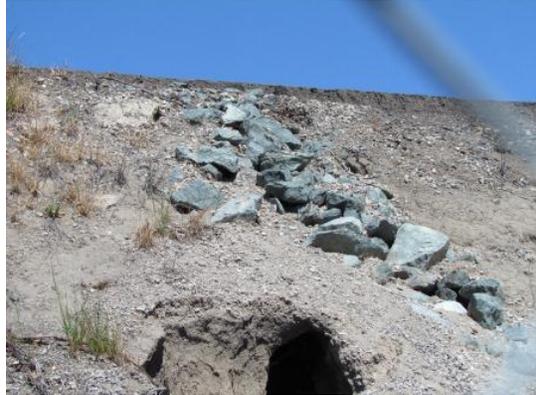
Photo 1 of 2 : FA_2014_RD0554_176_13_20141008_00005.jpg

LM Start	0.30	Rating **	U	Issue No.	13
LM End	0.30	Issue Type +	Ma	Location *	N/A
Category	Earthen Levee		GPS Latitude/Longitude		
			Start	End	
Item	Erosion / Bank Caving		38.245389 °	38.245389 °	
			-121.511085 °	-121.511085 °	
DWR ID	DWR_RD0554_01_s_2014_13				
Action/Comments					
Schedule repair of erosion site prior to the next inspection. Inspector Comments: This erosion along the slope need to be repaired before rainy season, it will only get worse.

Another view of the issue. Photo taken 06-05-2014. No new photo no change, no repairs to issue.

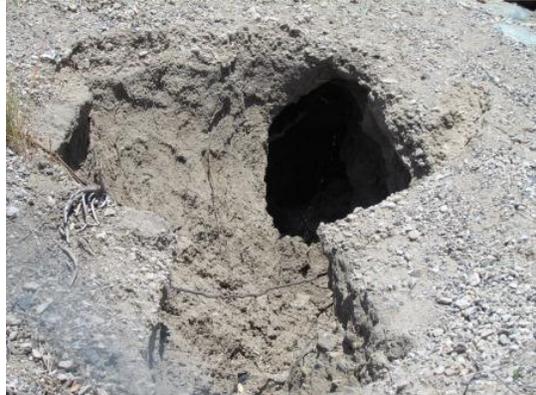
Photo 2 of 2 : FA_2014_RD0554_176_13_20141008_00006.jpg

LM Start	0.30	Rating **	U	Issue No.	13 (cont)
LM End	0.30	Issue Type +	Ma	Location *	N/A

Bank caving along the landward levee slope. Photo taken 06-05-2014. No new photo, no change to this issue prior to fall inspection 2014.

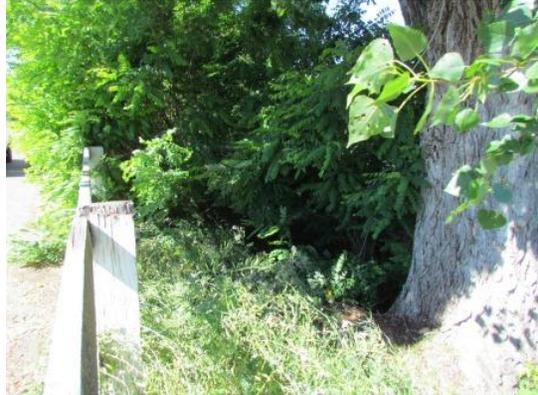
Photo 1 of 1 : FA_2014_RD0554_176_18_20141008_00010.jpg

LM Start	0.63	Rating **	U	Issue No.	18
LM End	0.75	Issue Type +	Ma	Location *	WS
Category	Earthen Levee		GPS Latitude/Longitude		
			Start	End	
Item	Trim / Thin Trees		38.241547 °	38.240129 °	
			-121.514617 °	-121.515973 °	
DWR ID	DWR_RD0554_01_s_2014_18				
Action/Comments					
Thin trees to allow visibility of the ground and room to flood fight. Inspector Comments: No new photo taken Fall 2014. No change at this location.

Wooded tree growth along waterward shoulder and slope. Photo taken 06-05-2014. No new photo taken Fall 2014.

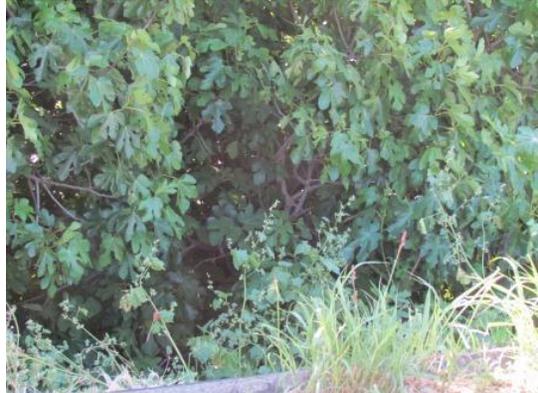
Photo 1 of 1 : FA_2014_RD0554_176_20_20141008_00011.jpg

LM Start	0.75	Rating **	U	Issue No.	20
LM End	0.79	Issue Type +	Ma	Location *	LS
Category	Earthen Levee		GPS Latitude/Longitude		
			Start	End	
Item	Trim / Thin Trees		38.240128 °	38.239630 °	
			-121.515974 °	-121.516418 °	
DWR ID	DWR_RD0554_01_s_2014_20				
Action/Comments					
Thin trees to allow visibility of the ground and room to flood fight. Inspector Comments: No new photo for this issue Fall inspection 2014.

Wooded tree growth on landward levee slope and shoulders. Photo taken 06-05-2014. No new photo, no change to location during Fall inspection.
