**Flood Control Project Maintenance
Levee Inspections**

Maintenance Issue Types Only, Levee Inspection Report By Mile - Fall 2015

Reclamation District No. 0554 Walnut Grove

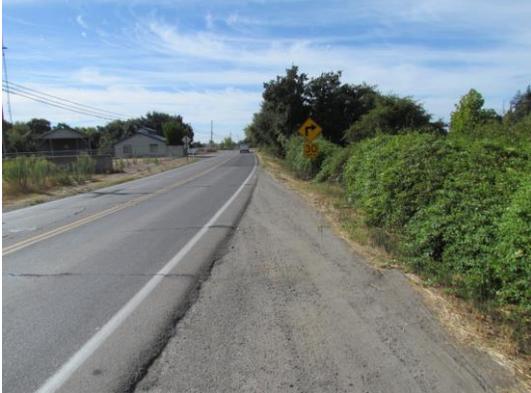
Photo 1 of 1 : FA_2015_RD0554_176_32_20150924_00012.jpg

| Control annual grass and weeds on the levee slopes and easements. Inspector Comments: This section on the waterside has growth covering the fence at levee mile 0.05. The District has scheduled a crew to do some spraying next week 9-29-2015. | | | | | |

RD 554 levee mile 0.05 waterside slope.

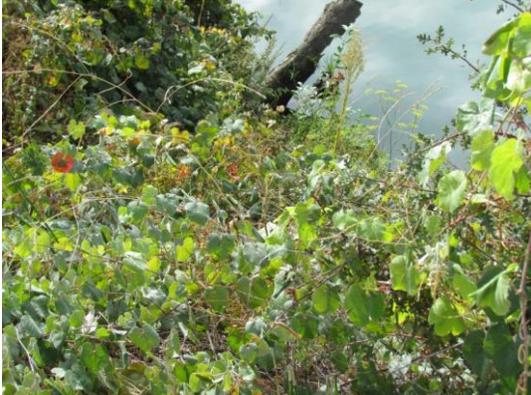
Photo 1 of 1 : FA_2015_RD0554_176_11_20150915_00003.jpg

| Note and monitor erosion site. Inspector Comments: This is not a new erosion site, repairs are needed. One tree has fallen into the Sac River at the erosion site. This site can be seen better from the river by boat. The wild grapes blocks the view from the waterside shoulder looking down the slope. | | | | | |

Erosion on waterside toe dead tree fallen at erosion site.

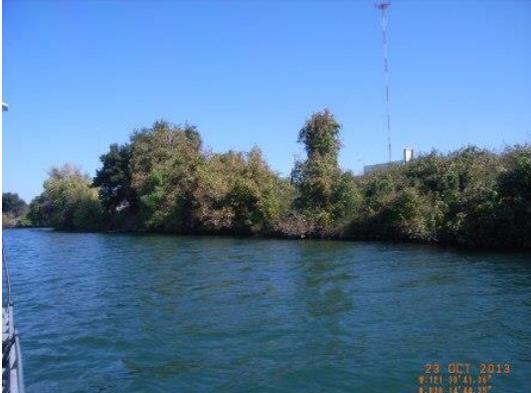
Photo 1 of 2 : USACE2013A_SAC_27-0_L_6.jpg

| Inspector Comments: 2009 - Tension cracks on road on top of levee. Erosion into the levee slope and mass failure. 2013 - Short vertical sections at bank toe. 2015: No observed changes. [2015 Site ID: SAC_27-0_L] | | | | | |

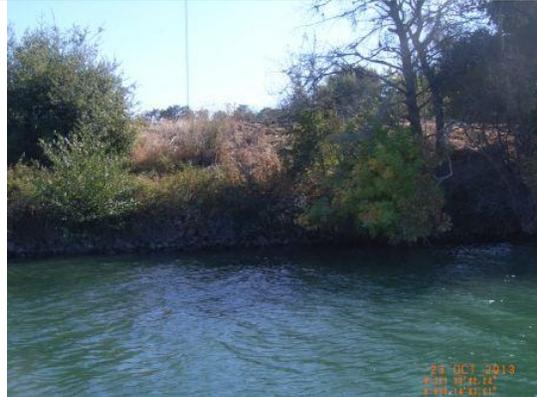
Photo 2 of 2 : USACE2013A_SAC_27-0_L_8.jpg

| Inspector Comments: 2009 - Tension cracks on road on top of levee. Erosion into the levee slope and mass failure. 2013 - Short vertical sections at bank toe. 2015: No observed changes. [2015 Site ID: SAC_27-0_L] | | | | | |

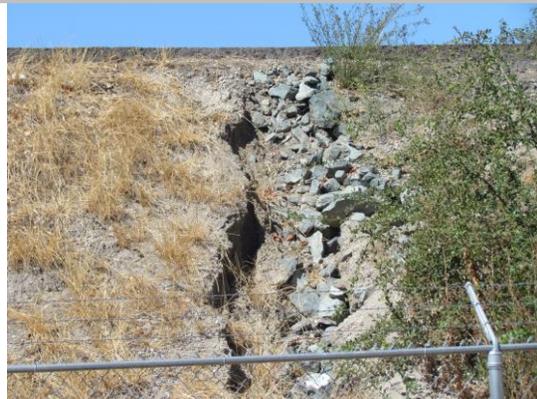
Photo 1 of 1 : FA_2015_RD0554_176_13_20150928_00015.jpg

This erosion along the landside levee slope is not new, it was reported two years ago.

| Schedule repair of erosion site prior to the next inspection. Inspector Comments: The District has scheduled repairs this season. | | | | | |

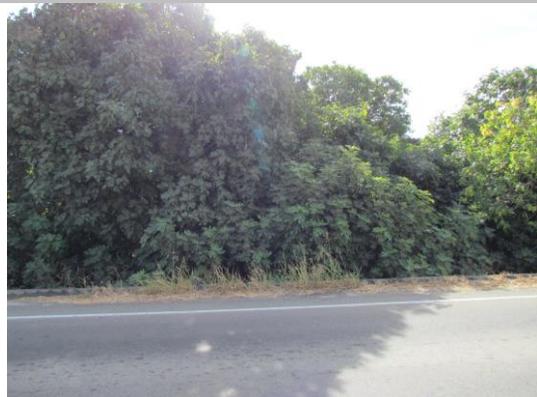
Photo 1 of 1 : FA_2015_RD0554_176_20_20150924_00013.jpg

Woody tree growth on the landside shoulder and slope.

| Thin trees to allow visibility of the ground and room to flood fight. Inspector Comments: Woody growth of trees has blocked the view of this levee section. | | | | | |
