**Flood Control Project Maintenance
Levee Inspections**

Maintenance Issue Types Only, Levee Inspection Report By Mile - Fall 2016

Reclamation District No. 0554 Walnut Grove

Waterway	Bank	Unit Miles	Inspection Start/End	Inspector
Unit No. 01 Sacramento River	Left	1.13	09/21/2016 09/21/2016	Herman Phillips

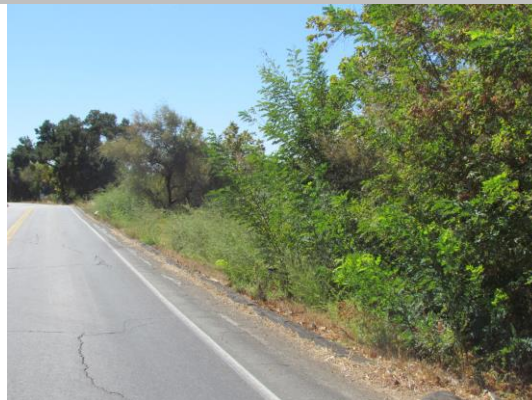
Photo 1 of 1 : FA_2016_RD0554_176_31_20160921_00052.jpg

LM Start	0.08	Rating **	U	Issue No.	31
LM End	0.30	Issue Type +	Ma	Location *	WS
Category	Earthen Levee			GPS Latitude/Longitude	
				Start	End
Item	Vegetation			38.248638 °	38.245697 °
				-121.509872 °	-121.511022 °
DWR ID	DWR_RD0554_01_f_2016_31				
Comment Code					
V2 : Remove the wild growth other than native grasses from the levee slopes.					
Inspector Comment					
Remove the wild growth from the levee slope along the waterside levee section.

Looking downstream waterside levee slope from levee mile 0.08-0.30.

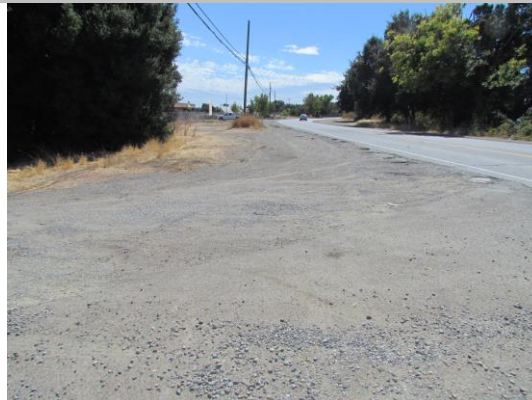
Photo 1 of 1 : FA_2016_RD0554_176_10_20160921_00056.jpg

LM Start	0.08	Rating **	A	Issue No.	10
LM End	0.88	Issue Type +	Ma	Location *	LS
Category	Earthen Levee			GPS Latitude/Longitude	
				Start	End
Item	Vegetation			38.248638 °	38.238600 °
				-121.509872 °	-121.517010 °
DWR ID	DWR_RD0554_01_f_2016_10				
Comment Code					
V1 : Control annual grass and weeds on the levee slopes and easements.					
Inspector Comment					
No unwanted vegetation along this section of levee.

Looking downstream of the landside levee slope of RD 554.

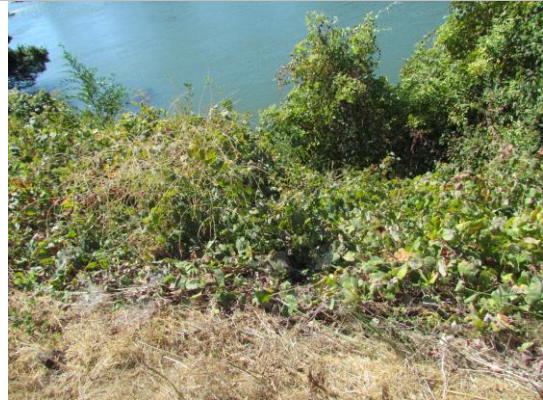
Photo 1 of 1 : FA_2016_RD0554_176_11_20160926_00057.jpg

LM Start	0.10	Rating **	U	Issue No.	11
LM End	0.10	Issue Type +	Ma	Location *	WS
Category	Earthen Levee			GPS Latitude/Longitude	
				Start	End
Item	Erosion / Bank Caving			38.248262 °	38.248262 °
				-121.509901 °	-121.509901 °
DWR ID	DWR_RD0554_01_s_2014_11				
Comment Code					
E1 : Note and monitor erosion site.					
Inspector Comment					
This is not a new erosion site, repairs are needed. One tree has fallen into the Sac River at the erosion site. This site can be seen better from the river by boat. The wild grapes blocks the view from the waterside shoulder looking down the slope.

RD 554 Waterside levee slope looking downstream.

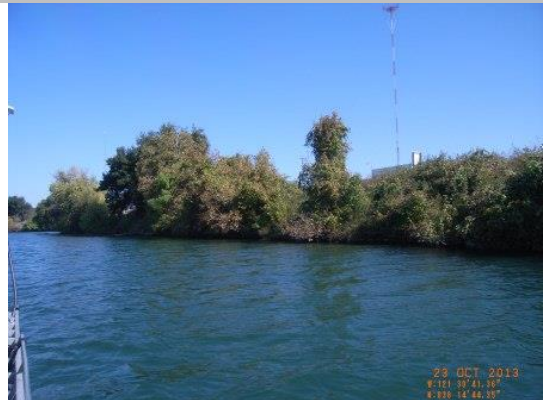
Photo 1 of 2 : FA_2016_RD0554_176_1_20160919_00001.jpg

LM Start	0.26	Rating **	M	Issue No.	1
LM End	0.36	Issue Type +	Ma	Location *	WS
Category	Supplemental			GPS Latitude/Longitude	
				Start	End
Item	2015 USACE Erosion Survey, DRAFT			38.246222 °	38.245017 °
				-121.510878 °	-121.511740 °
DWR ID	DWR_RD0554_01_f_2016_1				
Comment Code					
Inspector Comment					
2009 - Tension cracks on road on top of levee. Erosion into the levee slope and mass failure. 2013 - Short vertical sections at bank toe. 2015: No observed changes. [2015 Site ID: SAC_27-0_L]

USACE 2013 Photo #1

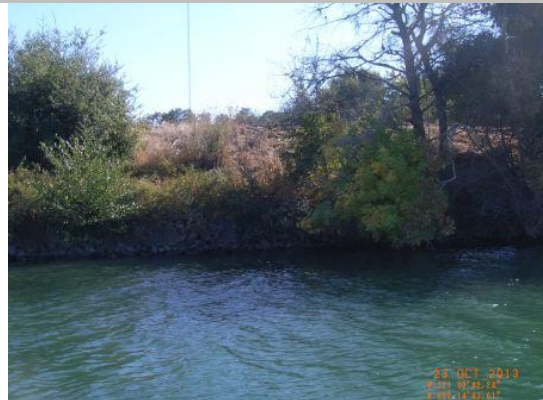
Photo 2 of 2 : FA_2016_RD0554_176_1_20160919_00002.jpg

USACE 2013 Photo #2

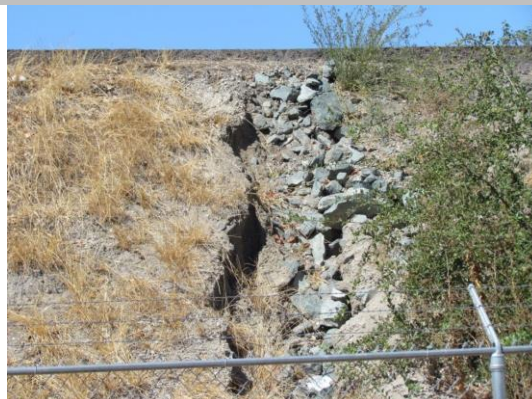
Photo 1 of 2 : FA_2016_RD0554_176_13_20160919_00004.jpg

LM Start	0.32	Rating **	U	Issue No.	13
LM End	0.32	Issue Type +	Ma	Location *	LS
Category	Earthen Levee			GPS Latitude/Longitude	
				Start	End
Item	Erosion / Bank Caving			38.245389 °	38.245389 °
				-121.511085 °	-121.511085 °
DWR ID	DWR_RD0554_01_s_2014_13				
Comment Code					
E2 : Schedule repair of erosion site prior to the next inspection.					
Inspector Comment					
This erosion isn't repaired to date. Needs repairing.

This erosion along the landside levee slope is not new, it was reported two years ago.

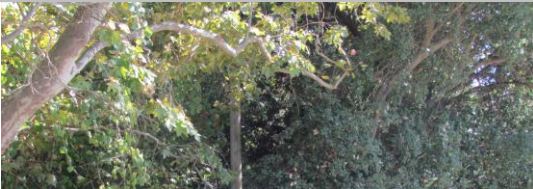
Photo 1 of 1 : FA_2016_RD0554_176_33_20160928_00059.jpg

RD 554 Levee mile 0.77-0.87 waterside slope.

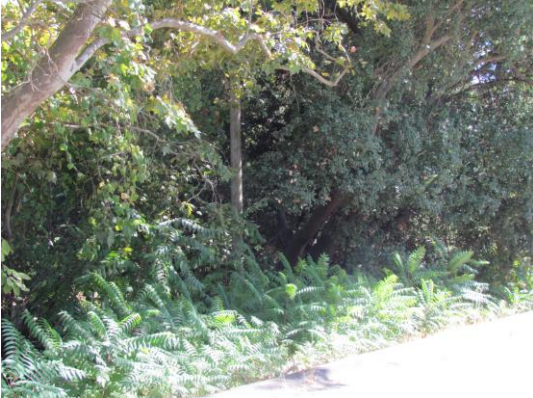
Photo 1 of 1 : FA_2016_RD0554_176_30_20160921_00053.jpg

Looking downstream landside levee mile 0.88-0.93.
