**Flood Control Project Maintenance  
Levee Inspections**

## Maintenance Issue Types Only, Levee Inspection Report By Mile - Fall 2017

### Reclamation District No. 0554 Walnut Grove

Waterway	Bank	Unit Miles	Inspection Start/End	Inspector
Unit No. 01 Sacramento River	Left	1.13	10/18/2017 10/18/2017	Keith Millard

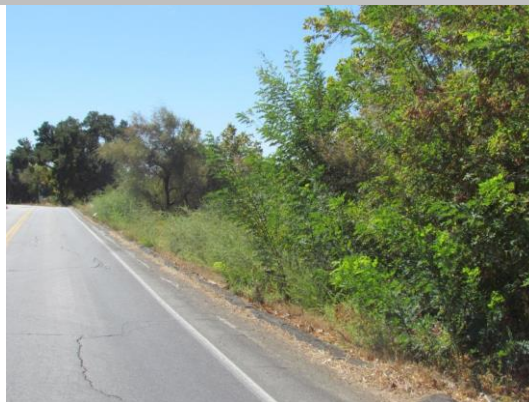
Photo 1 of 1 : FA\_2017\_RD0554\_176\_31\_20171002\_00007.jpg

LM Start	<b>0.02</b>	Rating **	U	Issue No.	<b>31</b>
LM End	<b>0.17</b>	Issue Type +	Ma	Location *	WS
Category	Earthen Levee		GPS Latitude/Longitude		
			Start	End	
Item	Vegetation		38.249449 °	38.247375 °	
			-121.510017 °	-121.509990 °	
DWR ID	DWR_RD0554_01_f_2016_31				
Comment Code					
V2 : Remove the wild growth other than native grasses from the levee slopes.					
Inspector Comment					
Remove/reduce wild growth on the waterside to 20 feet from the crown.

Looking downstream waterside levee slope from levee mile 0.08-0.30.

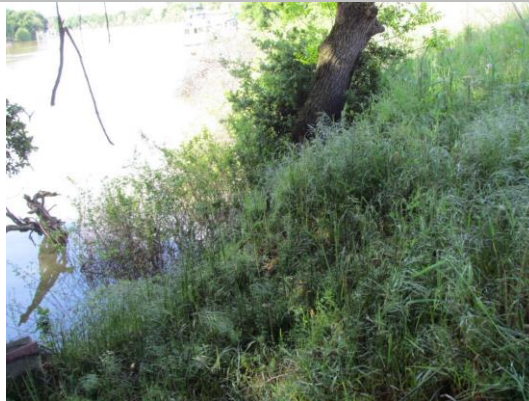
Photo 1 of 1 : FA\_2017\_RD0554\_176\_11\_20171002\_00003.jpg

LM Start	0.10	Rating **	U	Issue No.	11
LM End	0.10	Issue Type +	Ma	Location *	WS
Category	Earthen Levee			GPS Latitude/Longitude	
				Start	End
Item	Erosion / Bank Caving			38.248262 °	38.248262 °
				-121.509901 °	-121.509901 °
DWR ID	DWR_RD0554_01_s_2014_11				
Comment Code					
E1 : Note and monitor erosion site.					
Inspector Comment					
This is not a new erosion site, repairs are needed. One tree has fallen into the Sac River at the erosion site. This site can be seen better from the river by boat. The wild grapes blocks the view from the waterside shoulder looking down the slope.

RD 554 Waterside levee slope erosion into the bank, the wild vegetation growth blocks the view.

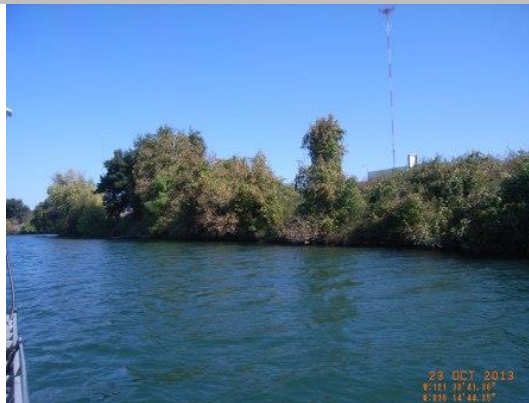
Photo 1 of 2 : FA\_2017\_RD0554\_176\_1\_20171002\_00001.jpg

LM Start	0.26	Rating **	M	Issue No.	1
LM End	0.36	Issue Type +	Ma	Location *	WS
Category	Supplemental			GPS Latitude/Longitude	
				Start	End
Item	2015 USACE Erosion Survey, DRAFT			38.246222 °	38.245017 °
				-121.510878 °	-121.511740 °
DWR ID	DWR_RD0554_01_f_2016_1				
Comment Code					
Inspector Comment					
2009 - Tension cracks on road on top of levee. Erosion into the levee slope and mass failure. 2013 - Short vertical sections at bank toe. 2015: No observed changes. [2015 Site ID: SAC_27-0_L]

USACE 2013 Photo #1

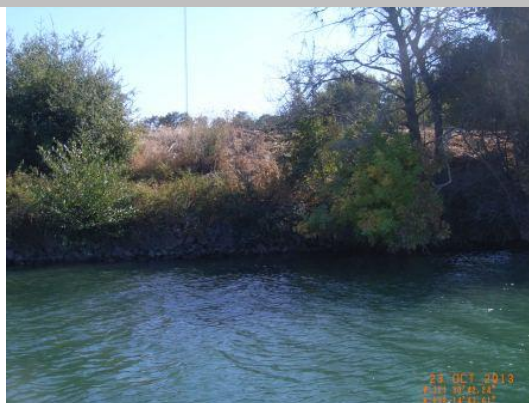
Photo 2 of 2 : FA\_2017\_RD0554\_176\_1\_20171002\_00002.jpg

USACE 2013 Photo #2

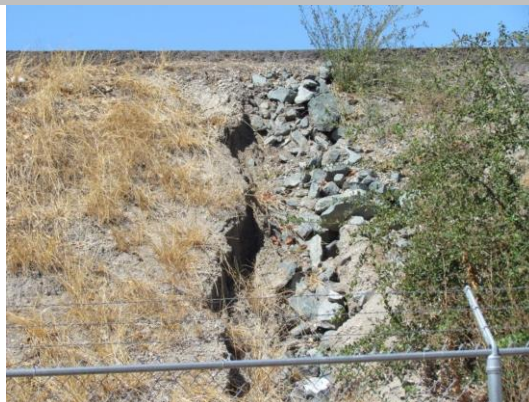
Photo 1 of 3 : FA\_2017\_RD0554\_176\_13\_20171002\_00004.jpg

LM Start	0.32	Rating **	U	Issue No.	13
LM End	0.32	Issue Type +	Ma	Location *	LS
Category	Earthen Levee			GPS Latitude/Longitude	
				Start	End
Item	Erosion / Bank Caving			38.245389 °	38.245389 °
				-121.511085 °	-121.511085 °
DWR ID	DWR_RD0554_01_s_2014_13				
Comment Code					
E2 : Schedule repair of erosion site prior to the next inspection.					
Inspector Comment					
This erosion isn't repaired to date. Large bush growing in eroded gully. Needs repairing.

This erosion along the landside levee slope is not new, it was reported two years ago.

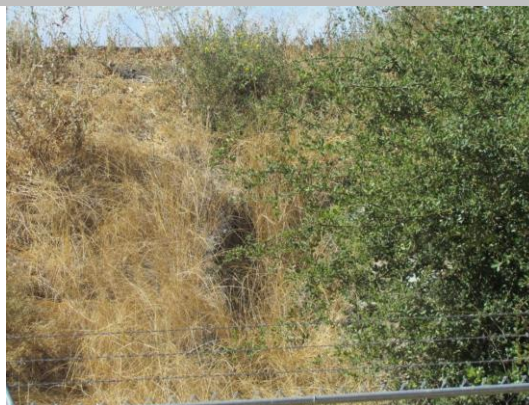
Photo 2 of 3 : FA\_2017\_RD0554\_176\_13\_20171002\_00005.jpg

LM Start	0.32	Rating **	U	Issue No.	13 (cont)	
LM End	0.32	Issue Type +	Ma	Location *	LS	
Category	Earthen Levee			GPS Latitude/Longitude		
				Start		End
Item	Erosion / Bank Caving			38.245389 °		38.245389 °
				-121.511085 °		-121.511085 °
DWR ID	DWR_RD0554_01_s_2014_13					
Comment Code						
E2 : Schedule repair of erosion site prior to the next inspection.						
Inspector Comment						
This erosion isn't repaired to date. Large bush growing in eroded gully. Needs repairing.

This erosion site along the landside slope levee 0.32 has been reported and has not been repaired.

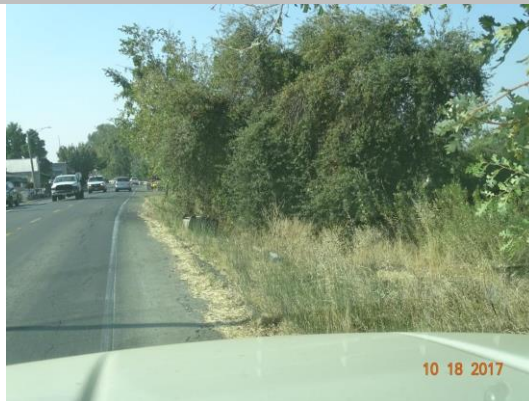
Photo 1 of 1 : FA\_2017\_RD0554\_176\_32\_20171020\_00057.jpg

LM Start	0.45	Rating **	U	Issue No.	32
LM End	0.49	Issue Type +	Ma	Location *	WS
Category	Earthen Levee			GPS Latitude/Longitude	
				Start	End
Item	Vegetation			38.243818 °	38.243389 °
				-121.512459 °	-121.512919 °
DWR ID	DWR_RD0554_01_f_2017_32				
Comment Code					
V2 : Remove the wild growth other than native grasses from the levee slopes.					
Inspector Comment					
Waterside vegetation should be cleared to 20 feet from crown for inspection and access.

Waterside vegetation should be cleared to 20 feet from crown for inspection and access.

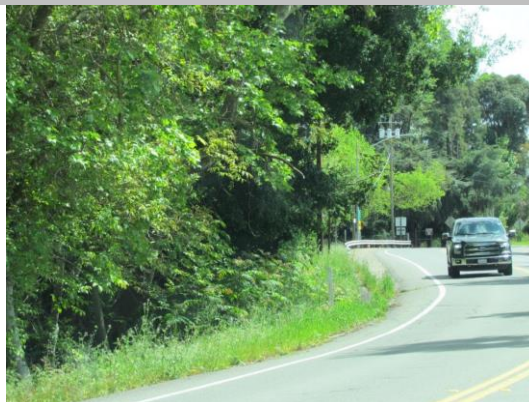
Photo 1 of 1 : FA\_2017\_RD0554\_176\_30\_20171002\_00006.jpg

LM Start	0.88	Rating **	U	Issue No.	30
LM End	0.95	Issue Type +	Ma	Location *	LS
Category	Earthen Levee			GPS Latitude/Longitude	
				Start	End
Item	Trim / Thin Trees			38.238680 °	38.237638 °
				-121.517010 °	-121.516871 °
DWR ID	DWR_RD0554_01_f_2016_30				
Comment Code					
T1 : Trim trees to at least five feet above ground level.					
Inspector Comment					
These trees along this stretch of levee need to be trimmed from ground up 5.0 feet so the slope can be seen.

Looking downstream at the wild growth on the landside levee slope.

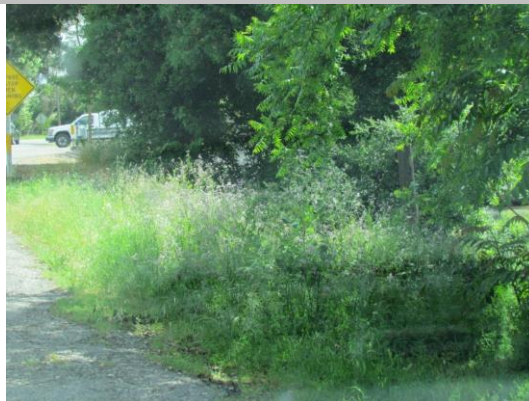
Photo 1 of 1 : FA\_2017\_RD0554\_176\_37\_20171002\_00009.jpg

LM Start	1.00	Rating **	U	Issue No.	37
LM End	1.13	Issue Type +	Ma	Location *	WS
Category	Earthen Levee			GPS Latitude/Longitude	
				Start	End
Item	Vegetation			38.236991 °	38.235232 °
				-121.516812 °	-121.517341 °
DWR ID	DWR_RD0554_01_s_2017_37				
Comment Code					
V2 : Remove the wild growth other than native grasses from the levee slopes.					
Inspector Comment					
Thin out the trees and remove the wild growth blocking view of the levee section.

Looking downstream from levee mile 0.93 waterside slope blocking the view of the levee slope.
