**Flood Control Project Maintenance
Levee Inspections**

Maintenance Issue Types Only, Levee Inspection Report By Mile - Fall 2019

Reclamation District No. 0554 Walnut Grove

Waterway	Bank	Unit Miles	Inspection Start/End	Inspector
Unit No. 01 Sacramento River	Left	1.13	10/22/2019 10/22/2019	David Julian

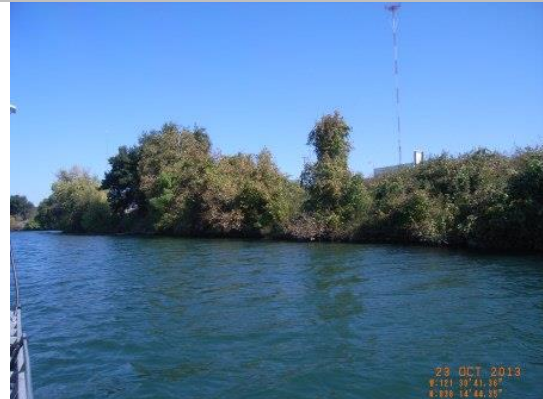
Photo 1 of 2 : FA_2019_RD0554_176_24_20190826_00005.jpg

LM Start	0.26	Rating **	M	Issue No.	24
LM End	0.36	Issue Type +	Ma	Location *	WS
Category	Supplemental			GPS Latitude/Longitude	
				Start	End
Item	2017 USACE Erosion Survey			38.246222°	38.245017°
				-121.510878°	-121.511740°
DWR ID	DWR_RD0554_01_f_2018_24				
Comment Code					
Inspector Comment					
2017 Site ID: SAC 27.0 L					
Status: Eroding					
2017 Field Notes: Minor new erosion at toe.					
Site History: 2009 - Tension cracks on road on top of levee. Erosion into the levee slope and mass failure. 2013 - Short vertical sections at bank toe.

USACE 2013 Photo #1

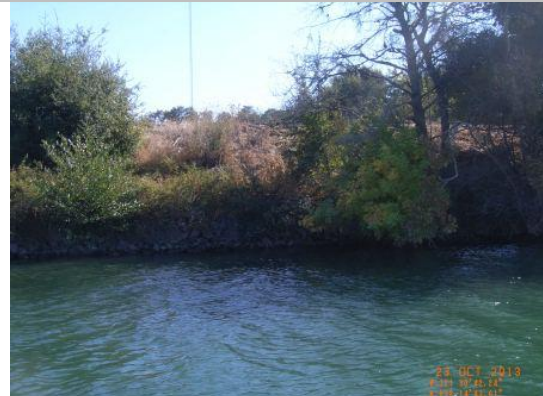
Photo 2 of 2 : FA_2019_RD0554_176_24_20190826_00006.jpg

USACE 2013 Photo #2

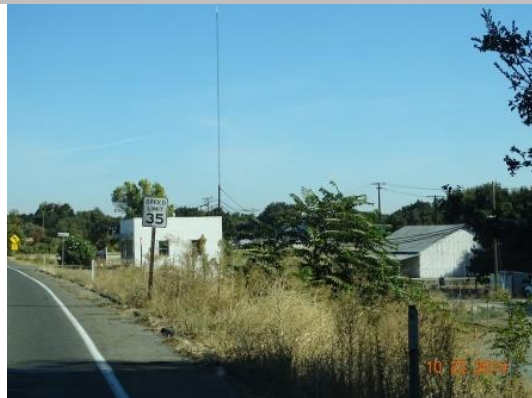
Photo 1 of 1 : FA_2019_RD0554_176_51_20191024_00083.jpg

View looking upstream at thick vegetation on the landside slope (Fall 2019).

LM Start	0.31	Rating **	U	Issue No.	51
LM End	0.35	Issue Type +	Ma	Location *	LS
Category	Earthen Levee			GPS Latitude/Longitude	
				Start	End
Item	Vegetation			38.245515 °	38.244950 °
				-121.511083 °	-121.511493 °
DWR ID	DWR_RD0554_01_f_2019_51				
Comment Code					
V2 : Remove the wild growth other than native grasses from the levee slopes.					
Inspector Comment

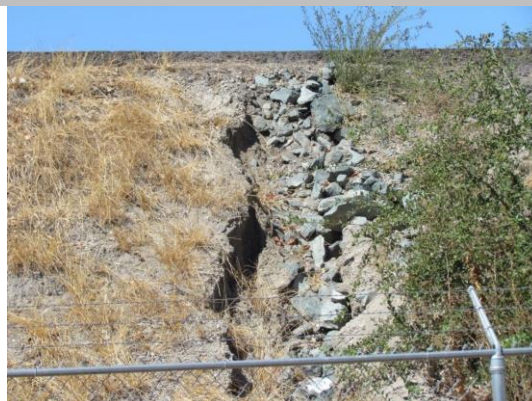
Photo 1 of 3 : FA_2019_RD0554_176_13_20190826_00002.jpg

This erosion along the landside levee slope is not new, it was reported two years ago.

LM Start	0.32	Rating **	U	Issue No.	13
LM End	0.32	Issue Type +	Ma	Location *	LS
Category	Earthen Levee			GPS Latitude/Longitude	
				Start	End
Item	Erosion / Bank Caving			38.245389 °	38.245389 °
				-121.511085 °	-121.511085 °
DWR ID	DWR_RD0554_01_s_2014_13				
Comment Code					
E2 : Schedule repair of erosion site prior to the next inspection.					
Inspector Comment					
This erosion isn't repaired to date. Large bush growing in eroded gully. Needs repairing.

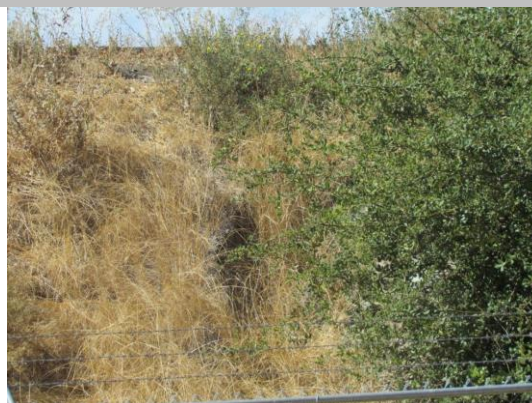
Photo 2 of 3 : FA_2019_RD0554_176_13_20190826_00003.jpg

This erosion site along the landside slope levee 0.32 has been reported and has not been repaired.
