**Flood Control Project Maintenance
Levee Inspections**

Maintenance Issue Types Only, Levee Inspection Report By Mile - Fall 2020

Reclamation District No. 0554 Walnut Grove

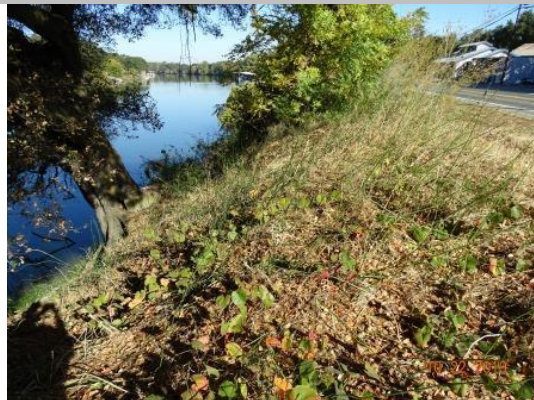
Photo 1 of 1 : FA_2020_RD0554_176_11_20201009_00001.jpg

| Item | Erosion / Bank Caving | | | 38.248262 ° | 38.248262 ° |
| This is not a new erosion site, repairs are needed. One tree has fallen into the Sac River at the erosion site. This site can be seen better from the river by boat. The wild grapes block the view from the waterside shoulder looking down the slope. Rated as M because it is an oversized levee section. | | | | | |

View looking upstream at erosion site on the waterside (Fall 2019).

| E2 : Schedule repair of erosion site prior to the next inspection. | | | | | |

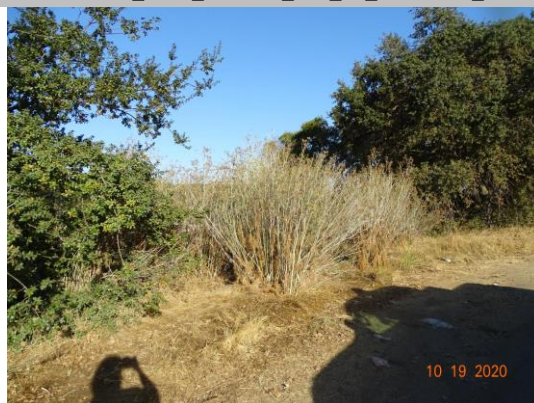
Photo 1 of 1 : FA_2020_RD0554_176_31_20201019_00104.jpg

| Item | Vegetation | | | 38.247615 ° | 38.247615 ° |

View of vegetation on the waterside slope (Fall 2020).

| V2 : Remove the wild growth other than native grasses from the levee slopes. | | | | | |

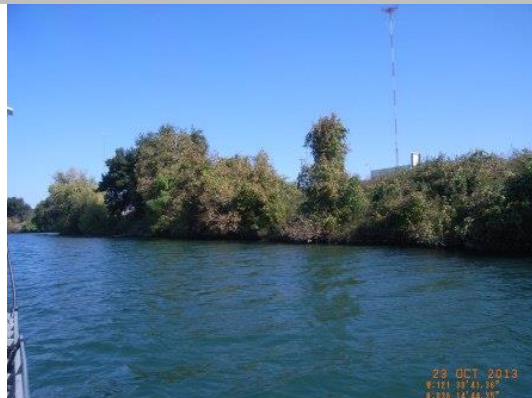
Photo 1 of 2 : FA_2020_RD0554_176_24_20201009_00003.jpg

| 2017 Field Notes: Minor new erosion at toe. | | | | | |
| Site History: 2009 - Tension cracks on road on top of levee. Erosion into the levee slope and mass failure. 2013 - Short vertical sections at bank toe. | | | | | |

USACE 2013 Photo #1

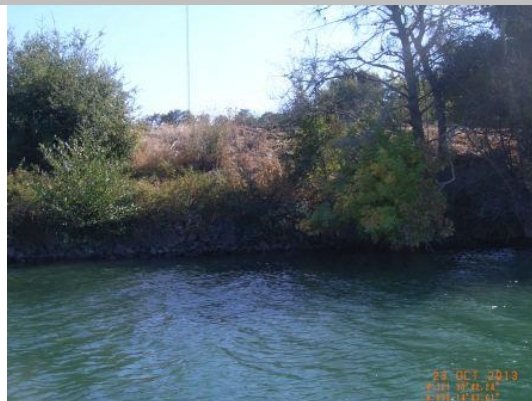
Photo 2 of 2 : FA_2020_RD0554_176_24_20201009_00004.jpg

USACE 2013 Photo #2

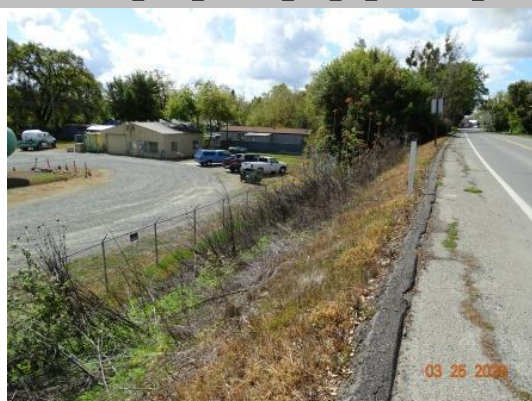
Photo 1 of 1 : FA_2020_RD0554_176_51_20201009_00019.jpg

| Item | Vegetation | | | 38.245515 ° | 38.244950 ° |

View looking downstream at vegetation on the landside slope (Spring 2020).

| V2 : Remove the wild growth other than native grasses from the levee slopes. | | | | | |

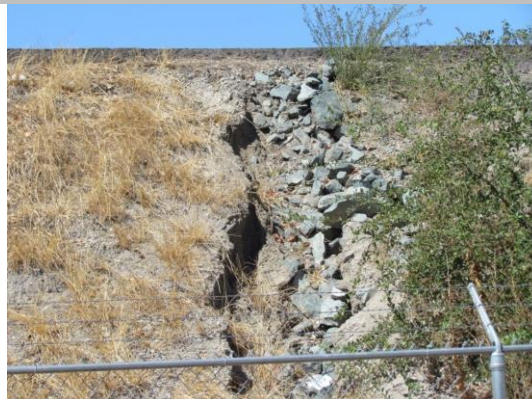
Photo 1 of 1 : FA_2020_RD0554_176_13_20201009_00002.jpg

| This erosion isn't repaired to date. Large bush growing in eroded gully. Needs repairing. | | | | | |

View of eroded gully on the landside slope.

| E2 : Schedule repair of erosion site prior to the next inspection. | | | | | |

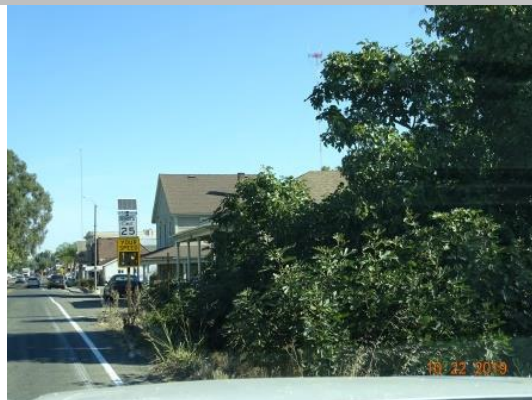
Photo 1 of 1 : FA_2020_RD0554_176_49_20201009_00017.jpg

| Item | Trim / Thin Trees | | | 38.239587 ° | 38.239587 ° |

View looking upstream at thick trees on the landside slope (Fall 2019).

| T2 : Thin trees to allow visibility of the ground and room to flood fight. | | | | | |

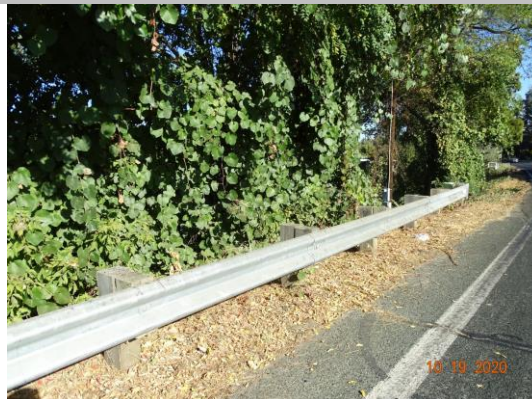
Photo 1 of 1 : FA_2020_RD0554_176_60_20201019_00106.jpg

| Item | Vegetation | | | 38.236027 ° | 38.235262 ° |

View of thick vegetation on the waterside slope (Fall 2020).

| V2 : Remove the wild growth other than native grasses from the levee slopes. | | | | | |
