**Flood Control Project Maintenance
Levee Inspections**

Maintenance Issue Types Only, Levee Inspection Report By Mile - Fall 2021

Reclamation District No. 0554 Walnut Grove

Waterway	Bank	Unit Miles	Inspection Start/End	Inspector
Unit No. 01 Sacramento River	Left	1.13	09/30/2021 09/30/2021	David Julian

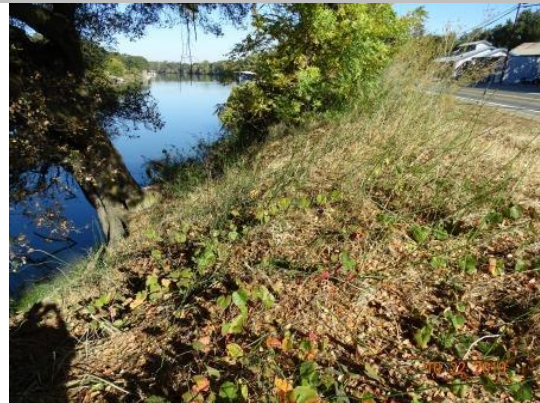
Photo 1 of 1 : FA_2021_RD0554_176_11_20210830_00001.jpg

LM Start	0.10	Rating **	M	Issue No.	11
LM End	0.10	Issue Type +	Ma	Location *	WS
Category	Earthen Levee			GPS Latitude/Longitude	
				Start	End
Item	Erosion / Bank Caving			38.248262 °	38.248262 °
				-121.509901 °	-121.509901 °
DWR ID	DWR_RD0554_01_s_2014_11				
Comment Code					
E2 : Schedule repair of erosion site prior to the next inspection.					
Inspector Comment					
This is not a new erosion site, repairs are needed. One tree has fallen into the Sac River at the erosion site. This site can be seen better from the river by boat. The wild grapes block the view from the waterside shoulder looking down the slope. Rated as M because it is an oversized levee section.

View looking upstream at erosion site on the waterside (Fall 2019).

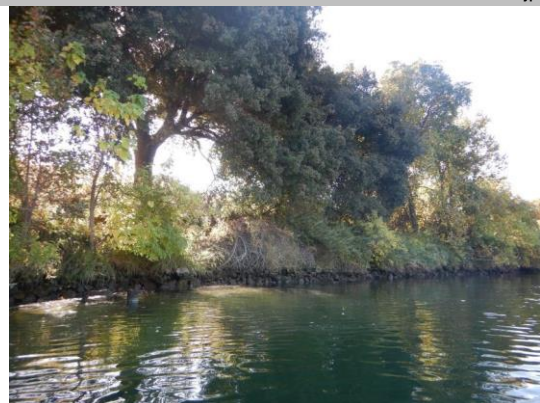
Photo 1 of 2 : FA_2021_RD0554_176_24_20211218_3.jpg

LM Start	0.26	Rating **	M	Issue No.	24
LM End	0.36	Issue Type +	Ma	Location *	WS
Category	Supplemental			GPS Latitude/Longitude	
				Start	End
Item	2018 USACE Erosion Survey			38.246222 °	38.245017 °
				-121.510878 °	-121.511740 °
DWR ID					
Comment Code					
Inspector Comment					
2018 Site ID: SAC 27.0 L Status: Eroding 2018 Field Notes: No observed change. Site History: 2009 - Tension cracks on road on top of levee. Erosion into the levee slope and mass failure. 2013 - Short vertical sections at bank toe. 2017 - Minor new erosion at toe.

USACE 2018 Erosion Photo #1

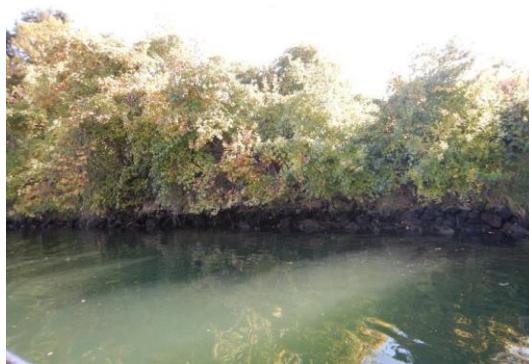
Photo 2 of 2 : FA_2021_RD0554_176_24_20211218_4.jpg

LM Start	0.26	Rating **	M	Issue No.	24 (cont)
LM End	0.36	Issue Type +	Ma	Location *	WS
Category	Supplemental			GPS Latitude/Longitude	
				Start	End
Item	2018 USACE Erosion Survey			38.246222 °	38.245017 °
				-121.510878 °	-121.511740 °
DWR ID

USACE 2018 Erosion Photo #2

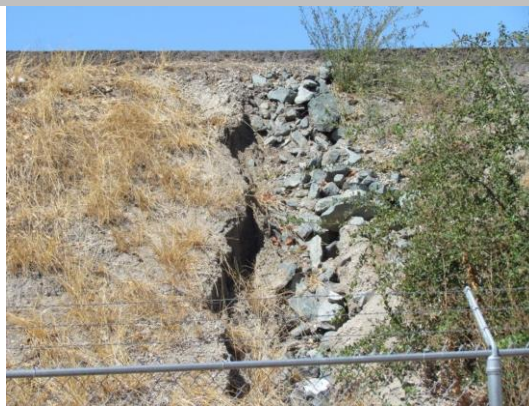
Photo 1 of 1 : FA_2021_RD0554_176_13_20210830_00002.jpg

LM Start	0.32	Rating **	U	Issue No.	13
LM End	0.32	Issue Type +	Ma	Location *	LS
Category	Earthen Levee			GPS Latitude/Longitude	
				Start	End
Item	Erosion / Bank Caving			38.245389 °	38.245389 °
				-121.511085 °	-121.511085 °
DWR ID	DWR_RD0554_01_s_2014_13

This erosion isn't repaired to date. Large bush growing in eroded gully. Needs repairing.

View of eroded gully on the landside slope.

E2 : Schedule repair of erosion site prior to the next inspection.

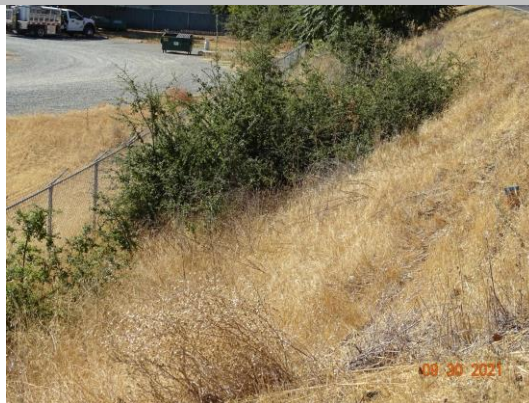
Photo 1 of 1 : FA_2021_RD0554_176_56_20211001_00099.jpg

LM Start	0.32	Rating **	U	Issue No.	56
LM End	0.32	Issue Type +	Ma	Location *	LS
Category	Earthen Levee			GPS Latitude/Longitude	
				Start	End
Item	Vegetation			38.245388 °	38.245388 °
				-121.511211 °	-121.511211 °
DWR ID	DWR_RD0554_01 f _ 2021_56

View looking downstream at vegetation on the landside slope (Fall 2021).

V2 : Remove the wild growth other than native grasses from the levee slopes.

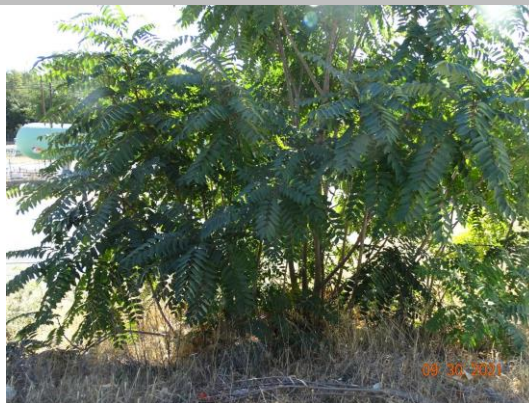
Photo 1 of 1 : FA_2021_RD0554_176_55_20211001_00100.jpg

LM Start	0.34	Rating **	U	Issue No.	55
LM End	0.34	Issue Type +	Ma	Location *	LS
Category	Earthen Levee			GPS Latitude/Longitude	
				Start	End
Item	Vegetation			38.245140 °	38.245140 °
				-121.511350 °	-121.511350 °
DWR ID	DWR_RD0554_01_f_2021_55				
Comment Code					
V7 : Trees / Woody Vegetation					
Inspector Comment					
Remove tree of heaven before it gets further established.

View of tree of heaven on the landside slope (Fall 2021).

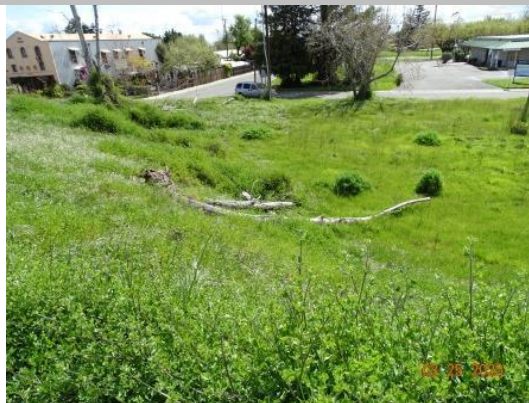
Photo 1 of 1 : FA_2021_RD0554_176_54_20210830_00015.jpg

LM Start	0.65	Rating **	M	Issue No.	54
LM End	0.65	Issue Type +	Ma	Location *	LS
Category	Earthen Levee			GPS Latitude/Longitude	
				Start	End
Item	Encroachments			38.241411 °	38.241411 °
				-121.514636 °	-121.514636 °
DWR ID	DWR_RD0554_01_s_2020_54				
Comment Code					
TR : Tree or limb					
Inspector Comment					
Remove tree limb from landside slope.

View of large tree limb on the landside slope (Spring 2020).

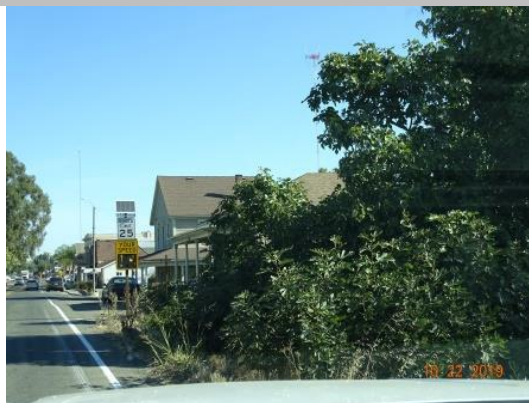
Photo 1 of 1 : FA_2021_RD0554_176_49_20210830_00013.jpg

LM Start	0.81	Rating **	U	Issue No.	49
LM End	0.81	Issue Type +	Ma	Location *	LS
Category	Earthen Levee			GPS Latitude/Longitude	
				Start	End
Item	Trim / Thin Trees			38.239587 °	38.239587 °
				-121.516353 °	-121.516353 °
DWR ID	DWR_RD0554_01_f_2019_49				
Comment Code					
T2 : Thin trees to allow visibility of the ground and room to flood fight.					
Inspector Comment

View looking upstream at thick trees on the landside slope (Fall 2019).

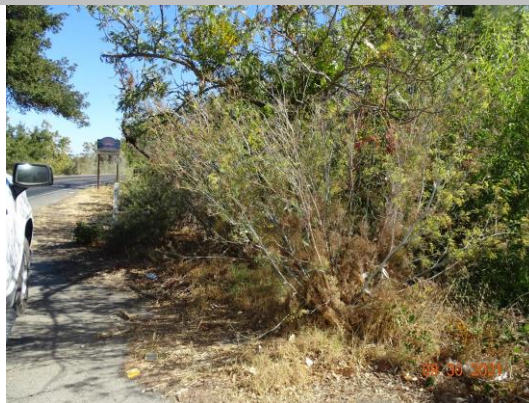
Photo 1 of 1 : FA_2021_RD0554_176_52_20211001_00101.jpg

LM Start	0.86	Rating **	U	Issue No.	52
LM End	0.86	Issue Type +	Ma	Location *	LS
Category	Earthen Levee			GPS Latitude/Longitude	
				Start	End
Item	Vegetation			38.239015 °	38.239015 °
				-121.516802 °	-121.516802 °
DWR ID	DWR_RD0554_01_f_2021_52				
Comment Code					
V2 : Remove the wild growth other than native grasses from the levee slopes.					
Inspector Comment

View looking upstream at vegetation on the landside slope (Fall 2021).

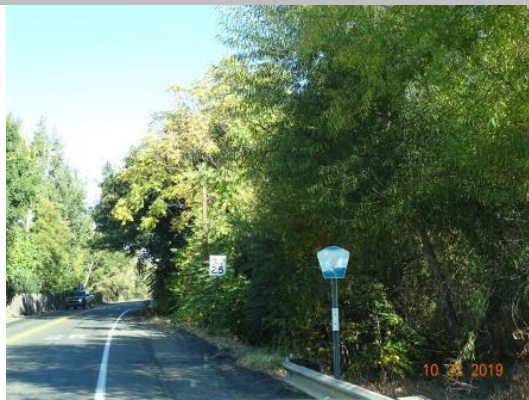
Photo 1 of 1 : FA_2021_RD0554_176_30_20210830_00009.jpg

LM Start	0.90	Rating **	U	Issue No.	30
LM End	0.96	Issue Type +	Ma	Location *	LS
Category	Earthen Levee			GPS Latitude/Longitude	
				Start	End
Item	Trim / Thin Trees			38.238396 °	38.237604 °
				-121.516938 °	-121.516774 °
DWR ID	DWR_RD0554_01_f_2016_30				
Comment Code					
T1 : Trim trees to at least five feet above ground level.					
Inspector Comment

View looking upstream at thick trees on the landside slope (Fall 2019).

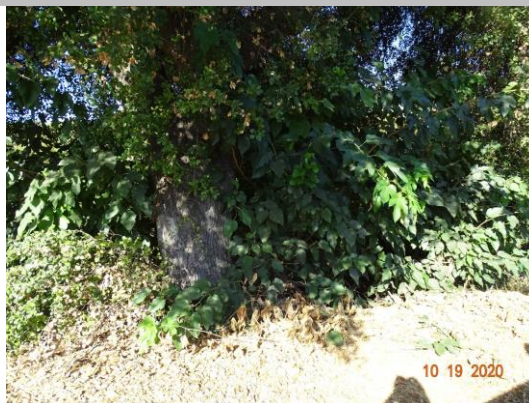
Photo 1 of 1 : FA_2021_RD0554_176_59_20210830_00017.jpg

LM Start	0.95	Rating **	U	Issue No.	59
LM End	0.95	Issue Type +	Ma	Location *	WS
Category	Earthen Levee			GPS Latitude/Longitude	
				Start	End
Item	Trim / Thin Trees			38.237632 °	38.237632 °
				-121.516880 °	-121.516880 °
DWR ID	DWR_RD0554_01_f_2020_59				
Comment Code					
T2 : Thin trees to allow visibility of the ground and room to flood fight.					
Inspector Comment

View of thick trees on the waterside slope (Fall 2020).

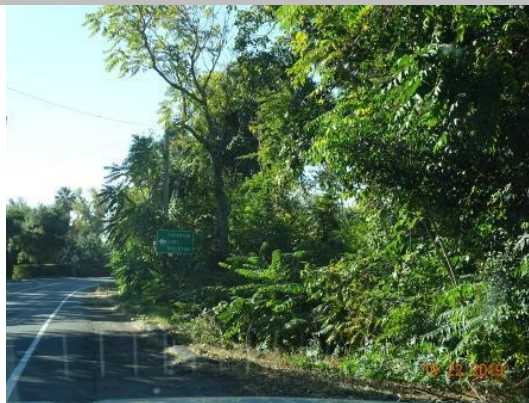
Photo 1 of 1 : FA_2021_RD0554_176_37_20210830_00012.jpg

LM Start	1.00	Rating **	U	Issue No.	37
LM End	1.05	Issue Type +	Ma	Location *	WS
Category	Earthen Levee			GPS Latitude/Longitude	
				Start	End
Item	Trim / Thin Trees			38.236991 °	38.236287 °
				-121.516812 °	-121.516864 °
DWR ID	DWR_RD0554_01_f_2019_37				
Comment Code					
T2 : Thin trees to allow visibility of the ground and room to flood fight.					
Inspector Comment

View of looking downstream at thick trees on the waterside slope (Fall 2019).

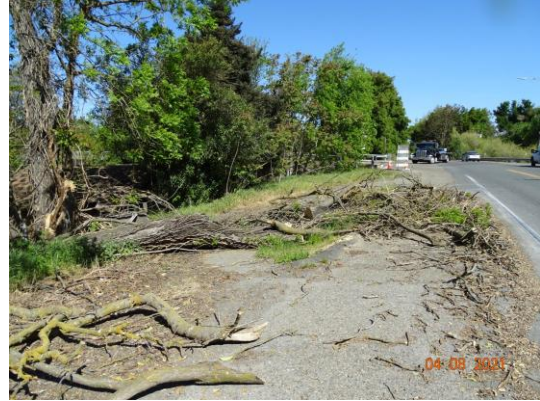
Photo 1 of 1 : FA_2021_RD0554_176_62_20210830_00018.jpg

LM Start	1.00	Rating **	U	Issue No.	62
LM End	1.00	Issue Type +	Ma	Location *	WS
Category	Earthen Levee			GPS Latitude/Longitude	
				Start	End
Item	Encroachments			38.236961 °	38.236961 °
				-121.516823 °	-121.516823 °
DWR ID	DWR_RD0554_01_s_2021_62				
Comment Code					
TR : Tree or limb					
Inspector Comment					
Remove fallen tree on waterside shoulder.

View of fallen tree on the waterside shoulder (Spring 2021).
