**Flood Control Project Maintenance
Levee Inspections**

Maintenance Issue Types Only, Levee Inspection Report By Mile - Fall 2022

Reclamation District No. 0554 Walnut Grove

Waterway	Bank	Unit Miles	Inspection Start/End	Inspector
Unit No. 01 Sacramento River	Left	1.13	10/11/2022 10/11/2022	Saskia Donovan

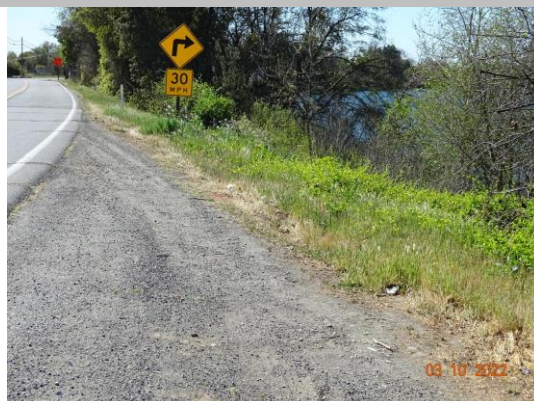
Photo 1 of 1 : FA_2022_RD0554_176_51_20220831_00013.jpg

LM Start	0.02	Rating **	M	Issue No.	51
LM End	0.17	Issue Type +	Ma	Location *	WS
Category	Earthen Levee			GPS Latitude/Longitude	
				Start	End
Item	Vegetation			38.249496 °	38.247351 °
				-121.510033 °	-121.509983 °
DWR ID	DWR_RD0554_01_s_2022_51				
Comment Code					
V2 : Remove the wild growth and woody vegetation other than native grasses from the levee slopes.					
Inspector Comment

View looking downstream at vegetation on the top of the waterside slope (Spring 2022).

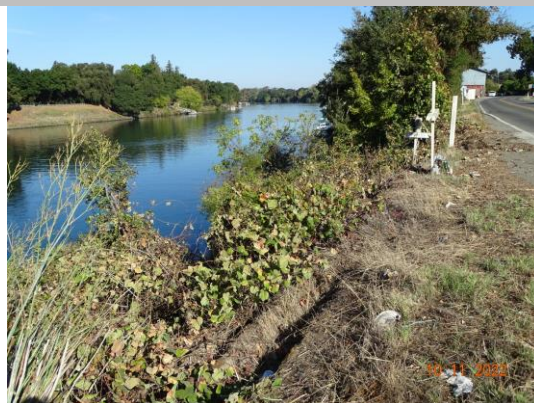
Photo 1 of 1 : FA_2022_RD0554_176_11_20221101_00104.jpg

LM Start	0.10	Rating **	M	Issue No.	11
LM End	0.10	Issue Type +	Ma	Location *	WS
Category	Earthen Levee			GPS Latitude/Longitude	
				Start	End
Item	Erosion / Bank Caving			38.248262 °	38.248262 °
				-121.509901 °	-121.509901 °
DWR ID	DWR_RD0554_01_s_2014_11				
Comment Code					
E2 : Schedule repair of erosion site prior to the next inspection.					
Inspector Comment					
This is not a new erosion site, repairs are needed. One tree has fallen into the Sac River at the erosion site. This site can be seen better from the river by boat. The wild grapes block the view from the waterside shoulder looking down the slope. Rated as M because it is an oversized levee section.

View of the erosion on the WS slope (Fall 2022).

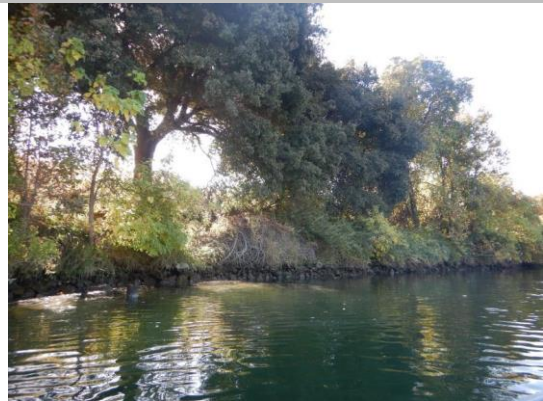
Photo 1 of 2 : FA_2022_RD0554_176_24_20220831_00003.jpg

LM Start	0.26	Rating **	M	Issue No.	24
LM End	0.36	Issue Type +	Ma	Location *	WS
Category	Supplemental			GPS Latitude/Longitude	
				Start	End
Item	2018 USACE Erosion Survey			38.246222 °	38.245017 °
				-121.510878 °	-121.511740 °
DWR ID	DWR_RD0554_01_s_2022_24				
Comment Code					
Inspector Comment					
2018 Site ID: SAC 27.0 L					
Status: Eroding					
2018 Field Notes: No observed change.					
Site History: 2009 - Tension cracks on road on top of levee. Erosion into the levee slope and mass failure. 2013 - Short vertical sections at bank toe. 2017 - Minor new erosion at toe.

USACE 2018 Erosion Photo #1

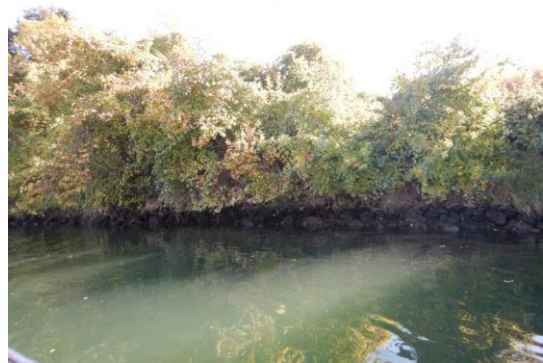
Photo 2 of 2 : FA_2022_RD0554_176_24_20220831_00004.jpg

LM Start	0.26	Rating **	M	Issue No.	24 (cont)
LM End	0.36	Issue Type +	Ma	Location *	WS

USACE 2018 Erosion Photo #2

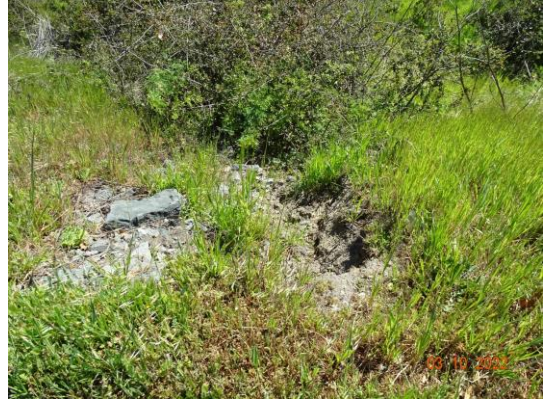
Photo 1 of 1 : FA_2022_RD0554_176_13_20220831_00002.jpg

LM Start	0.32	Rating **	U	Issue No.	13
LM End	0.32	Issue Type +	Ma	Location *	LS
Category	Earthen Levee			GPS Latitude/Longitude	
				Start	End
Item	Erosion / Rills			38.245389 °	38.245389 °
				-121.511085 °	-121.511085 °
DWR ID	DWR_RD0554_01_s_2014_13				
Comment Code					
E5 : Schedule repair of rills prior to the next inspection.					
Inspector Comment					
There is a large bush growing in the eroded gully. This site is in need of repairing. It has gotten worse since Fall 2021.

View looking down eroded gully in the landside slope (Spring 2022).

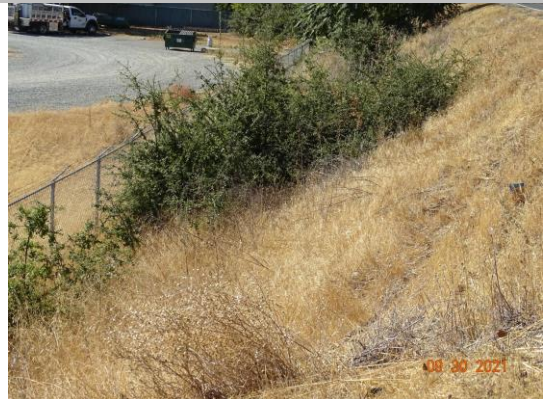
Photo 1 of 1 : FA_2022_RD0554_176_56_20220831_00017.jpg

LM Start	0.32	Rating **	U	Issue No.	56
LM End	0.32	Issue Type +	Ma	Location *	LS
Category	Earthen Levee			GPS Latitude/Longitude	
				Start	End
Item	Vegetation			38.245388 °	38.245388 °
				-121.511211 °	-121.511211 °
DWR ID	DWR_RD0554_01_f _ 2021_56				
Comment Code					
V2 : Remove the wild growth and woody vegetation other than native grasses from the levee slopes.					
Inspector Comment

View looking downstream at vegetation on the landside slope (Fall 2021).

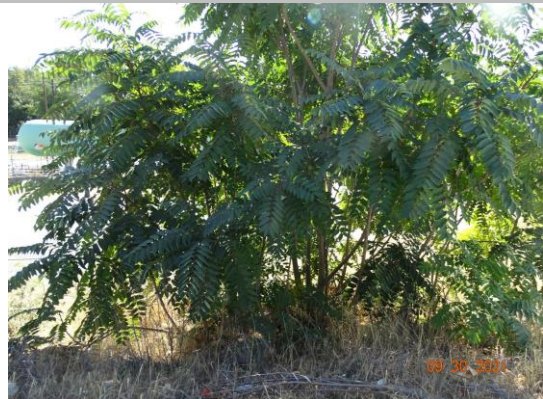
Photo 1 of 1 : FA_2022_RD0554_176_55_20220831_00016.jpg

LM Start	0.34	Rating **	U	Issue No.	55
LM End	0.34	Issue Type +	Ma	Location *	LS
Category	Earthen Levee			GPS Latitude/Longitude	
				Start	End
Item	Trim / Thin Trees			38.245140 °	38.245140 °
				-121.511350 °	-121.511350 °
DWR ID	DWR_RD0554_01_f_2021_55				
Comment Code					
T1 : Trim and thin trees to at least five feet above ground level to allow visibility of the ground and room to flood fight.					
Inspector Comment					
Remove Tree of Heaven before it gets further established.

View of Tree of Heaven on the landside slope (Fall 2021).

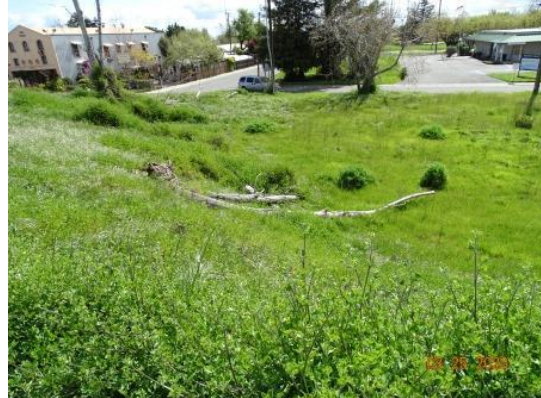
Photo 1 of 1 : FA_2022_RD0554_176_54_20220831_00015.jpg

LM Start	0.65	Rating **	M	Issue No.	54
LM End	0.65	Issue Type +	Ma	Location *	LS
Category	Earthen Levee			GPS Latitude/Longitude	
				Start	End
Item	Trim / Thin Trees			38.241411 °	38.241411 °
				-121.514636 °	-121.514636 °
DWR ID	DWR_RD0554_01_s_2020_54				
Comment Code					
T2 : Tree or limb.					
Inspector Comment					
Remove tree limb from landside slope.

View of large tree limb on the landside slope (Spring 2020).

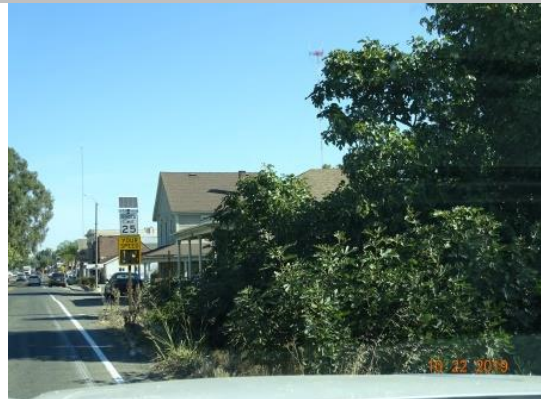
Photo 1 of 1 : FA_2022_RD0554_176_49_20220831_00012.jpg

LM Start	0.81	Rating **	U	Issue No.	49
LM End	0.81	Issue Type +	Ma	Location *	LS
Category	Earthen Levee			GPS Latitude/Longitude	
				Start	End
Item	Trim / Thin Trees			38.239587 °	38.239587 °
				-121.516353 °	-121.516353 °
DWR ID	DWR_RD0554_01_f_2019_49				
Comment Code					
T1 : Trim and thin trees to at least five feet above ground level to allow visibility of the ground and room to flood fight.					
Inspector Comment

View looking upstream at thick trees on the landside slope (Fall 2019).

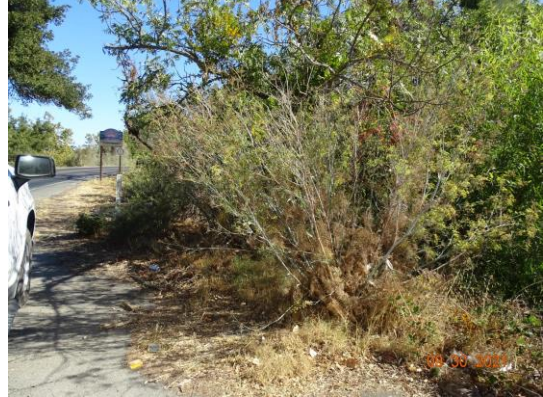
Photo 1 of 1 : FA_2022_RD0554_176_52_20220831_00014.jpg

LM Start	0.86	Rating **	U	Issue No.	52
LM End	0.86	Issue Type +	Ma	Location *	LS
Category	Earthen Levee			GPS Latitude/Longitude	
				Start	End
Item	Vegetation			38.239015 °	38.239015 °
				-121.516802 °	-121.516802 °
DWR ID	DWR_RD0554_01_f _ 2021_52				
Comment Code					
V2 : Remove the wild growth and woody vegetation other than native grasses from the levee slopes.					
Inspector Comment

View looking upstream at vegetation on the landside slope (Fall 2021).

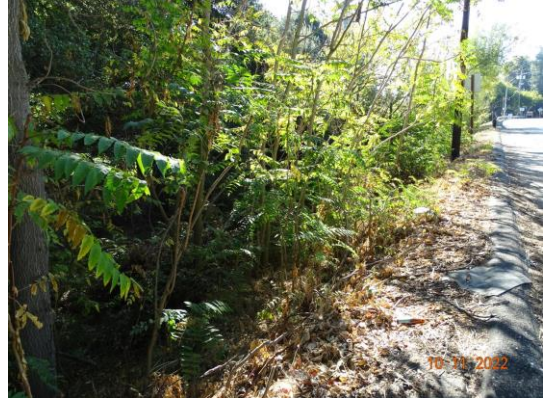
Photo 1 of 1 : FA_2022_RD0554_176_30_20221101_00106.jpg

LM Start	0.90	Rating **	U	Issue No.	30
LM End	0.96	Issue Type +	Ma	Location *	LS
Category	Earthen Levee			GPS Latitude/Longitude	
				Start	End
Item	Trim / Thin Trees			38.238396 °	38.237604 °
				-121.516938 °	-121.516774 °
DWR ID	DWR_RD0554_01_f _ 2016_30				
Comment Code					
T1 : Trim and thin trees to at least five feet above ground level to allow visibility of the ground and room to flood fight.					
Inspector Comment

View of dense vegetation on the LS slope (Fall 2022).

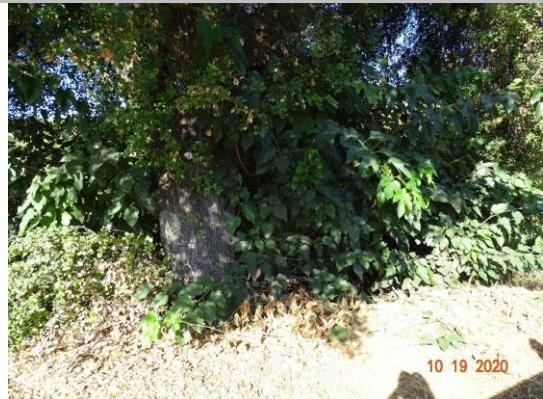
Photo 1 of 1 : FA_2022_RD0554_176_59_20220831_00019.jpg

LM Start	0.95	Rating **	U	Issue No.	59
LM End	0.95	Issue Type +	Ma	Location *	WS
Category	Earthen Levee			GPS Latitude/Longitude	
				Start	End
Item	Trim / Thin Trees			38.237632 °	38.237632 °
				-121.516880 °	-121.516880 °
DWR ID	DWR_RD0554_01_f_2020_59				
Comment Code					
T1 : Trim and thin trees to at least five feet above ground level to allow visibility of the ground and room to flood fight.					
Inspector Comment

View of thick trees on the waterside slope (Fall 2020).

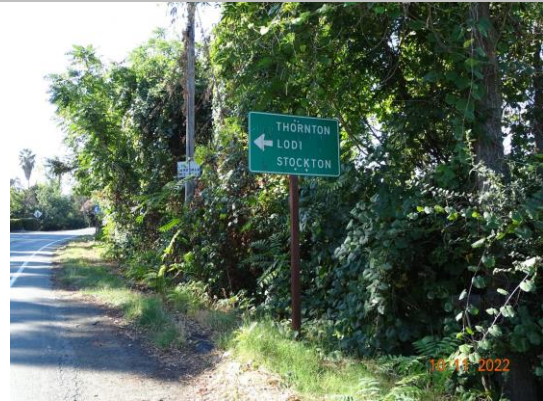
Photo 1 of 1 : FA_2022_RD0554_176_37_20221101_00108.jpg

LM Start	1.00	Rating **	U	Issue No.	37
LM End	1.05	Issue Type +	Ma	Location *	WS
Category	Earthen Levee			GPS Latitude/Longitude	
				Start	End
Item	Trim / Thin Trees			38.236991 °	38.236287 °
				-121.516812 °	-121.516864 °
DWR ID	DWR_RD0554_01_f_2019_37				
Comment Code					
T1 : Trim and thin trees to at least five feet above ground level to allow visibility of the ground and room to flood fight.					
Inspector Comment

View of the vegetation on the WS slope (Fall 2022).
