**Flood Control Project Maintenance
Levee Inspections**

Maintenance Issue Types Only, Levee Inspection Report By Mile - Fall 2023

Reclamation District No. 0554 Walnut Grove

Waterway	Bank	Unit Miles	Inspection Start/End	Inspector
Unit No. 01 Sacramento River	Left	1.13	10/30/2023 10/30/2023	Brooks Weisser

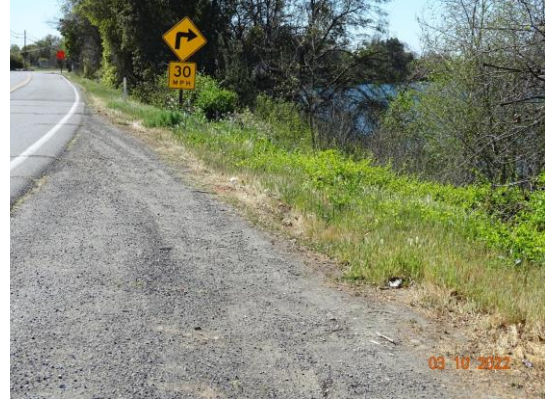
Photo 1 of 1 : FA_2023_RD0554_176_51_20231030_00014.jpg

LM Start	0.02	Rating **	M	Issue No.	51
LM End	0.17	Issue Type +	Ma	Location *	WS
Category	Earthen Levee			GPS Latitude/Longitude	
				Start	End
Item	Vegetation			38.249496°	38.247351°
				-121.510033°	-121.509983°
DWR ID	DWR_RD0554_01_s_2022_51				
Comment Code					
V2 : Remove the wild growth and woody vegetation other than native grasses from the levee slopes.					
Inspector Comment

View looking downstream at vegetation on the top of the waterside slope (Spring 2022).

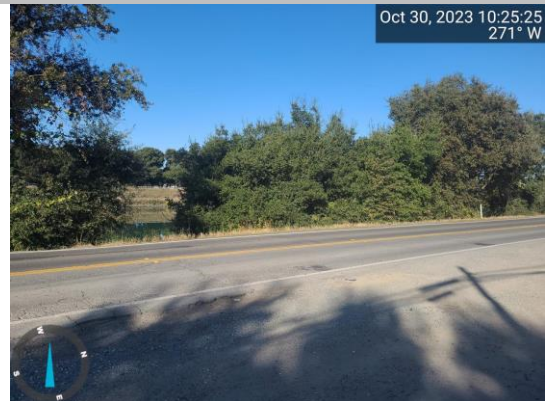
Photo 1 of 1 : FA_2023_RD0554_176_58_20231101_00027.jpg

LM Start	0.07	Rating **	M	Issue No.	58
LM End	0.07	Issue Type +	Ma	Location *	WS
Category	Earthen Levee			GPS Latitude/Longitude	
				Start	End
Item	Trim / Thin Trees			38.248783°	38.248783°
				-121.509977°	-121.509977°
DWR ID	DWR_RD0554_01_s_2021_58				
Comment Code					
T1 : Trim and thin trees to at least five feet above ground level to allow visibility of the ground and room to flood fight.					
Inspector Comment					
Low hanging trees on the waterside slope need to be trimmed up at least 5 feet for visibility.

View of low hanging trees on the waterside slope (Fall 2023).

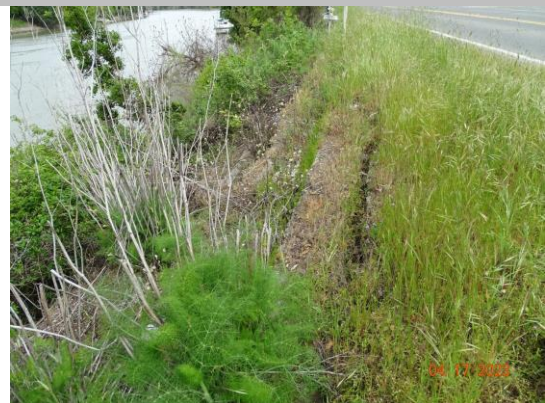
Photo 1 of 1 : FA_2023_RD0554_176_11_20231030_00002.jpg

LM Start	0.10	Rating **	M	Issue No.	11
LM End	0.10	Issue Type +	Ma	Location *	WS
Category	Earthen Levee			GPS Latitude/Longitude	
				Start	End
Item	Erosion / Bank Caving			38.248262°	38.248262°
				-121.509901°	-121.509901°
DWR ID	DWR_RD0554_01_s_2014_11				
Comment Code					
E2 : Schedule repair of erosion site prior to the next inspection.					
Inspector Comment					
This is not a new erosion site, repairs are needed. One tree has fallen into the Sac River at the erosion site. This site can be seen better from the river by boat. The wild grapes block the view from the waterside shoulder looking down the slope. Rated as M because it is an oversized levee section.

View of the erosion on the WS slope (Spring 2023).

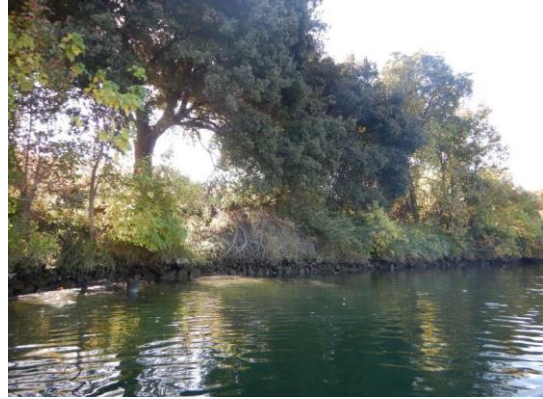
Photo 1 of 2 : FA_2023_RD0554_176_24_20231030_00004.jpg

LM Start	0.26	Rating **	M	Issue No.	24
LM End	0.36	Issue Type +	Ma	Location *	WS
Category	Supplemental			GPS Latitude/Longitude	
				Start	End
Item	2018 USACE Erosion Survey			38.246222°	38.245017°
				-121.510878°	-121.511740°
DWR ID	DWR_RD0554_01_s_2022_24				
Comment Code					
Inspector Comment					
2018 Site ID: SAC 27.0 L					
Status: Eroding					
2018 Field Notes: No observed change.					
Site History: 2009 - Tension cracks on road on top of levee. Erosion into the levee slope and mass failure. 2013 - Short vertical sections at bank toe. 2017 - Minor new erosion at toe.

USACE 2018 Erosion Photo #1

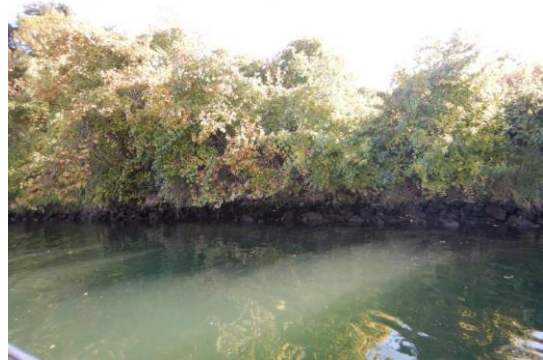
Photo 2 of 2 : FA_2023_RD0554_176_24_20231030_00005.jpg

LM Start	0.26	Rating **	M	Issue No.	24 (cont)
LM End	0.36	Issue Type +	Ma	Location *	WS

USACE 2018 Erosion Photo #2

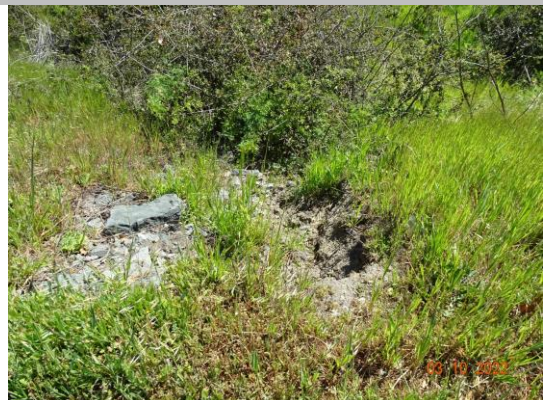
Photo 1 of 1 : FA_2023_RD0554_176_13_20231030_00003.jpg

LM Start	0.32	Rating **	U	Issue No.	13
LM End	0.32	Issue Type +	Ma	Location *	LS
Category	Earthen Levee			GPS Latitude/Longitude	
				Start	End
Item	Erosion / Rills			38.245389°	38.245389°
				-121.511085°	-121.511085°
DWR ID	DWR_RD0554_01_s_2014_13				
Comment Code					
E5 : Schedule repair of rills prior to the next inspection.					
Inspector Comment					
There is a large bush growing in the eroded gully. This site is in need of repairing. It has gotten worse since Fall 2021.

View looking down eroded gully in the landside slope (Spring 2022).

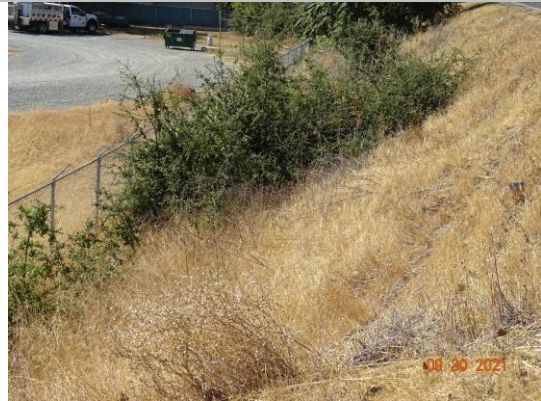
Photo 1 of 1 : FA_2023_RD0554_176_56_20231030_00018.jpg

LM Start	0.32	Rating **	U	Issue No.	56
LM End	0.32	Issue Type +	Ma	Location *	LS
Category	Earthen Levee			GPS Latitude/Longitude	
				Start	End
Item	Vegetation			38.245388°	38.245388°
				-121.511211°	-121.511211°
DWR ID	DWR_RD0554_01_f _ 2021_56				
Comment Code					
V2 : Remove the wild growth and woody vegetation other than native grasses from the levee slopes.					
Inspector Comment

View looking downstream at vegetation on the landside slope (Fall 2021).

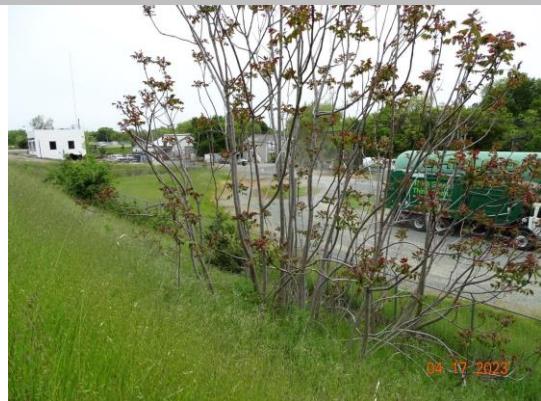
Photo 1 of 1 : FA_2023_RD0554_176_55_20231030_00017.jpg

LM Start	0.34	Rating **	M	Issue No.	55
LM End	0.34	Issue Type +	Ma	Location *	LS
Category	Earthen Levee			GPS Latitude/Longitude	
				Start	End
Item	Trim / Thin Trees			38.245140°	38.245140°
				-121.511350°	-121.511350°
DWR ID	DWR_RD0554_01_f_2021_55				
Comment Code					
T1 : Trim and thin trees to at least five feet above ground level to allow visibility of the ground and room to flood fight.					
Inspector Comment					
Remove Tree of Heaven before it gets further established. Spring 2023: The tree was trimmed but more work is needed.

View of the tree on the LS slope (Spring 2023).

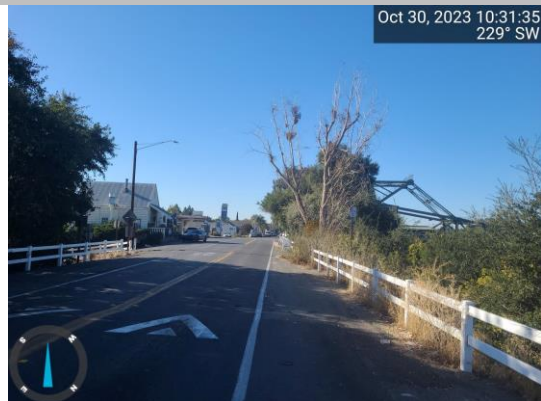
Photo 1 of 1 : FA_2023_RD0554_176_46_20231101_00028.jpg

LM Start	0.59	Rating **	M	Issue No.	46
LM End	0.59	Issue Type +	Ma	Location *	WS
Category	Earthen Levee			GPS Latitude/Longitude	
				Start	End
Item	Trim / Thin Trees			38.242125°	38.242125°
				-121.514080°	-121.514080°
DWR ID	DWR_RD0554_01_f_2019_46				
Comment Code					
T1 : Trim and thin trees to at least five feet above ground level to allow visibility of the ground and room to flood fight.					
Inspector Comment					
Low hanging trees on the waterside slope need to be trimmed up at least 5 feet for visibility.

View of low hanging trees on the waterside slope (Fall 2023).

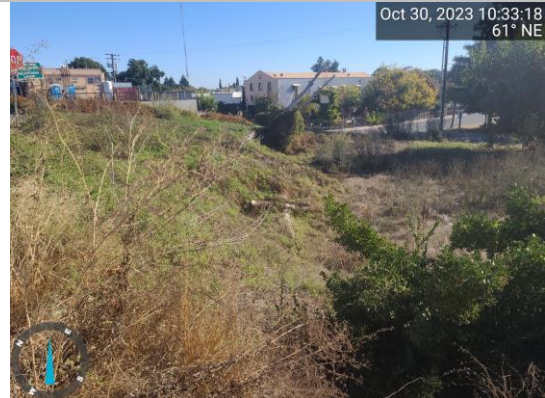
Photo 1 of 1 : FA_2023_RD0554_176_54_20231101_00029.jpg

LM Start	0.65	Rating **	M	Issue No.	54
LM End	0.65	Issue Type +	Ma	Location *	LS
Category	Earthen Levee			GPS Latitude/Longitude	
				Start	End
Item	Trim / Thin Trees			38.241411°	38.241411°
				-121.514636°	-121.514636°
DWR ID	DWR_RD0554_01_s_2020_54				
Comment Code					
T2 : Tree or limb.					
Inspector Comment					
Remove tree limb from landside slope.

View of large tree limb on the landside slope (Fall 2023).

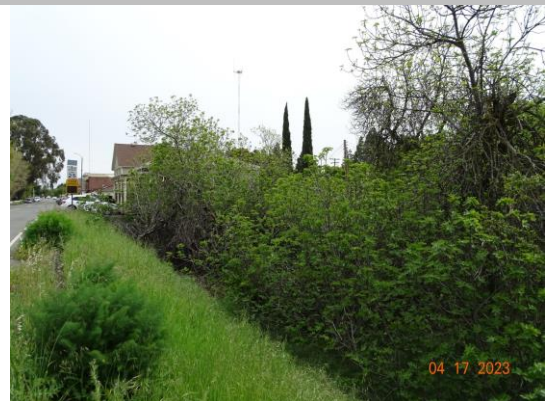
Photo 1 of 1 : FA_2023_RD0554_176_49_20231030_00013.jpg

LM Start	0.81	Rating **	U	Issue No.	49
LM End	0.81	Issue Type +	Ma	Location *	LS
Category	Earthen Levee			GPS Latitude/Longitude	
				Start	End
Item	Trim / Thin Trees			38.239587°	38.239587°
				-121.516353°	-121.516353°
DWR ID	DWR_RD0554_01_f_2019_49				
Comment Code					
T1 : Trim and thin trees to at least five feet above ground level to allow visibility of the ground and room to flood fight.					
Inspector Comment

View of the trees on the LS slope (Spring 2023).

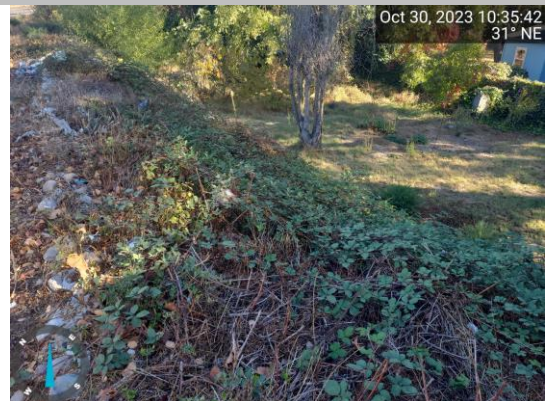
Photo 1 of 1 : FA_2023_RD0554_176_52_20231101_00030.jpg

LM Start	0.86	Rating **	U	Issue No.	52
LM End	0.86	Issue Type +	Ma	Location *	LS
Category	Earthen Levee			GPS Latitude/Longitude	
				Start	End
Item	Vegetation			38.239015°	38.239015°
				-121.516802°	-121.516802°
DWR ID	DWR_RD0554_01_f_2021_52				
Comment Code					
V2 : Remove the wild growth and woody vegetation other than native grasses from the levee slopes.					
Inspector Comment

View looking upstream at vegetation on the landside slope (Fall 2023).

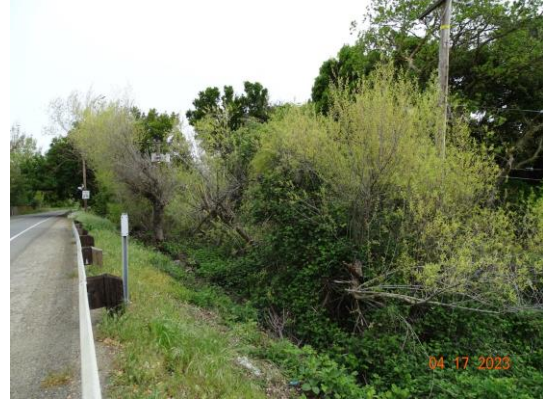
Photo 1 of 1 : FA_2023_RD0554_176_30_20231030_00010.jpg

LM Start	0.90	Rating **	U	Issue No.	30
LM End	0.96	Issue Type +	Ma	Location *	LS
Category	Earthen Levee			GPS Latitude/Longitude	
				Start	End
Item	Trim / Thin Trees			38.238396°	38.237604°
				-121.516938°	-121.516774°
DWR ID	DWR_RD0554_01_f_2016_30				
Comment Code					
T1 : Trim and thin trees to at least five feet above ground level to allow visibility of the ground and room to flood fight.					
Inspector Comment

View of the trees on the LS slope (Spring 2023).

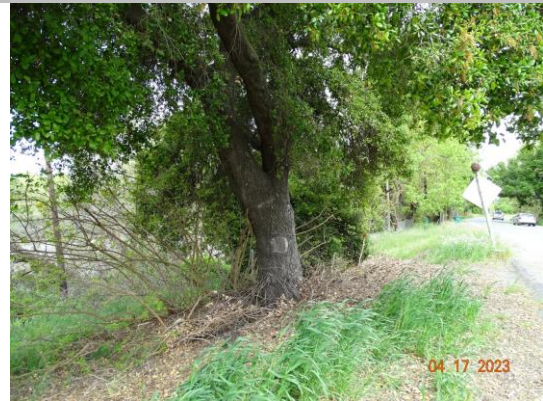
Photo 1 of 1 : FA_2023_RD0554_176_59_20231030_00020.jpg

LM Start	0.95	Rating **	M	Issue No.	59
LM End	0.95	Issue Type +	Ma	Location *	WS
Category	Earthen Levee			GPS Latitude/Longitude	
				Start	End
Item	Trim / Thin Trees			38.237632°	38.237632°
				-121.516880°	-121.516880°
DWR ID	DWR_RD0554_01_f_2020_59				
Comment Code					
T1 : Trim and thin trees to at least five feet above ground level to allow visibility of the ground and room to flood fight.					
Inspector Comment					
The trees have been trimmed but more work is needed.

View of the trees on the WS slope (Spring 2023).

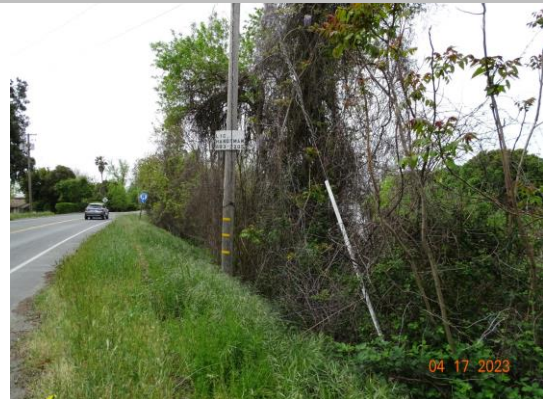
Photo 1 of 1 : FA_2023_RD0554_176_37_20231030_00012.jpg

LM Start	1.03	Rating **	U	Issue No.	37
LM End	1.03	Issue Type +	Ma	Location *	WS
Category	Earthen Levee			GPS Latitude/Longitude	
				Start	End
Item	Trim / Thin Trees			38.236518°	38.236518°
				-121.516771°	-121.516771°
DWR ID	DWR_RD0554_01_f_2019_37				
Comment Code					
T1 : Trim and thin trees to at least five feet above ground level to allow visibility of the ground and room to flood fight.					
Inspector Comment

View of the trees on the WS slope (Spring 2023).
