**Flood Control Project Maintenance
Levee Inspections**

Maintenance Issue Types Only, Levee Inspection Report By Mile - Fall 2024

Reclamation District No. 0554 Walnut Grove

Waterway	Bank	Unit Miles	Inspection Start/End	Inspector
Unit No. 01 Sacramento River	Left	1.13	10/22/2024 10/22/2024	Gregg McMillon

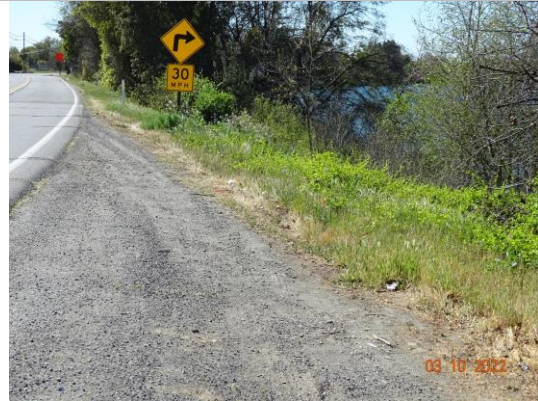
Photo 1 of 1 : FA_2024_RD0554_176_51_20241001_00016.jpg

LM Start	0.02	Rating **	M	Issue No.	51
LM End	0.17	Issue Type +	Ma	Location *	WS
Category	Earthen Levee			GPS Latitude/Longitude	
				Start	End
Item	Vegetation			38.249496°	38.247351°
				-121.510033°	-121.509983°
DWR ID	DWR_RD0554_01_s_2022_51				
Comment Code					
V2 : Remove the wild growth and woody vegetation other than native grasses from the levee slopes.					
Inspector Comment

View looking downstream at vegetation on the top of the waterside slope (Spring 2022).

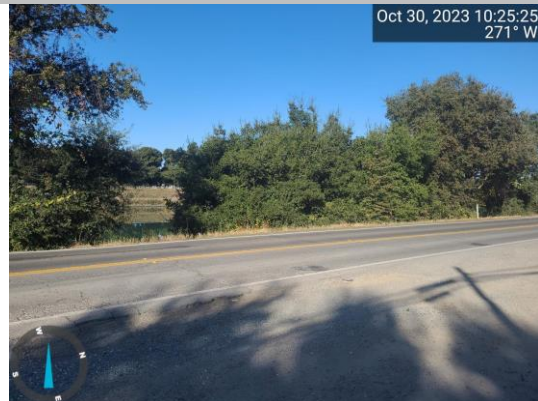
Photo 1 of 1 : FA_2024_RD0554_176_58_20241001_00020.jpg

LM Start	0.07	Rating **	M	Issue No.	58
LM End	0.07	Issue Type +	Ma	Location *	WS
Category	Earthen Levee			GPS Latitude/Longitude	
				Start	End
Item	Trim / Thin Trees			38.248783°	38.248783°
				-121.509977°	-121.509977°
DWR ID	DWR_RD0554_01_s_2021_58				
Comment Code					
T1 : Trim and thin trees to at least five feet above ground level to allow visibility of the ground and room to flood fight.					
Inspector Comment					
Low hanging trees on the waterside slope need to be trimmed up at least 5 feet for visibility.

View of low hanging trees on the waterside slope (Fall 2023).

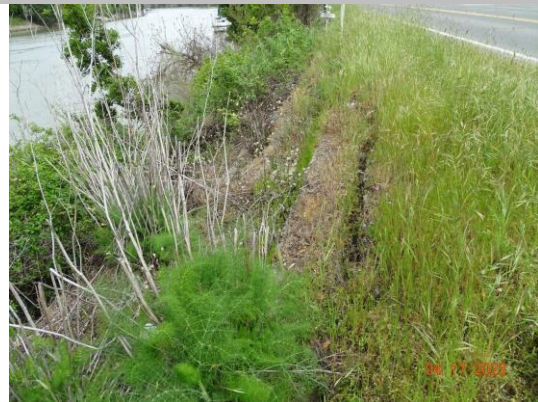
Photo 1 of 1 : FA_2024_RD0554_176_11_20241001_00003.jpg

LM Start	0.10	Rating **	M	Issue No.	11
LM End	0.10	Issue Type +	Ma	Location *	WS
Category	Earthen Levee			GPS Latitude/Longitude	
				Start	End
Item	Erosion / Bank Caving			38.248262°	38.248262°
				-121.509901°	-121.509901°
DWR ID	DWR_RD0554_01_s_2014_11				
Comment Code					
E2 : Schedule repair of erosion site prior to the next inspection.					
Inspector Comment					
This is not a new erosion site, repairs are needed. One tree has fallen into the Sac River at the erosion site. This site can be seen better from the river by boat. The wild grapes block the view from the waterside shoulder looking down the slope. Rated as M because it is an oversized levee section.

View of the erosion on the WS slope (Spring 2023).

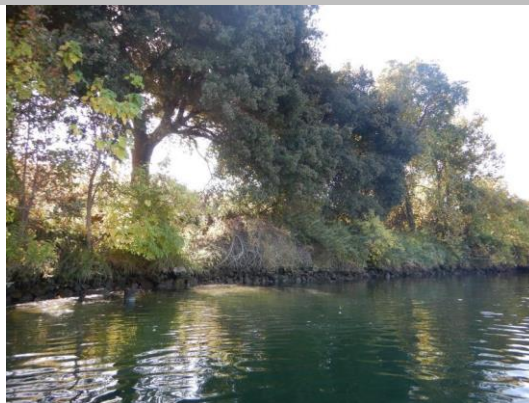
Photo 1 of 2 : FA_2024_RD0554_176_24_20241001_00005.jpg

LM Start	0.26	Rating **	M	Issue No.	24
LM End	0.36	Issue Type +	Ma	Location *	WS
Category	Supplemental			GPS Latitude/Longitude	
				Start	End
Item	2018 USACE Erosion Survey			38.246222°	38.245017°
				-121.510878°	-121.511740°
DWR ID	DWR_RD0554_01_s _ 2022_24				
Comment Code					
Inspector Comment					
2018 Site ID: SAC 27.0 L					
Status: Eroding					
2018 Field Notes: No observed change.					
Site History: 2009 - Tension cracks on road on top of levee. Erosion into the levee slope and mass failure. 2013 - Short vertical sections at bank toe. 2017 - Minor new erosion at toe.

USACE 2018 Erosion Photo #1

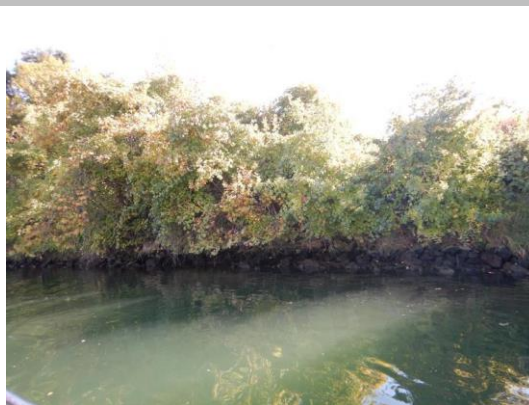
Photo 2 of 2 : FA_2024_RD0554_176_24_20241001_00006.jpg

USACE 2018 Erosion Photo #2

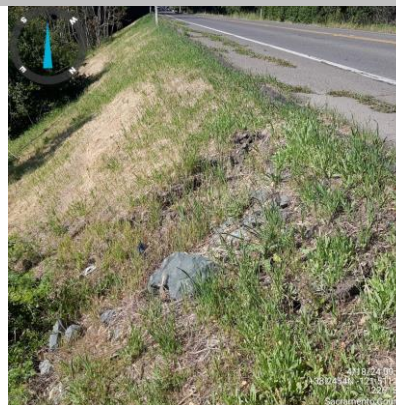
Photo 1 of 1 : FA_2024_RD0554_176_13_20241001_00004.jpg

LM Start	0.32	Rating **	U	Issue No.	13
LM End	0.32	Issue Type +	Ma	Location *	LS
Category	Earthen Levee			GPS Latitude/Longitude	
				Start	End
Item	Erosion / Rills			38.245389°	38.245389°
				-121.511085°	-121.511085°
DWR ID	DWR_RD0554_01_s _ 2014_13				
Comment Code					
E5 : Schedule repair of rills prior to the next inspection.					
Inspector Comment					
There is a large bush growing in the eroded gully. This site is in need of repairing. It has gotten worse since Fall 2021.

View looking down eroded gully in the LS slope. (Spring 2024)

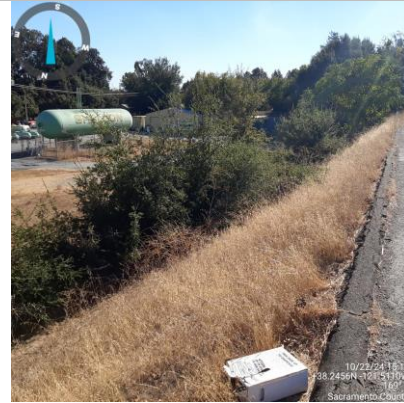
Photo 1 of 1 : FA_2024_RD0554_176_56_20241023_00026.jpg

LM Start	0.32	Rating **	U	Issue No.	56
LM End	0.32	Issue Type +	Ma	Location *	LS
Category	Earthen Levee			GPS Latitude/Longitude	
				Start	End
Item	Vegetation			38.245388°	38.245388°
				-121.511211°	-121.511211°
DWR ID	DWR_RD0554_01_f_2021_56				
Comment Code					
V2 : Remove the wild growth and woody vegetation other than native grasses from the levee slopes.					
Inspector Comment

View looking downstream at vegetation on the landside slope. (Fall 2024)

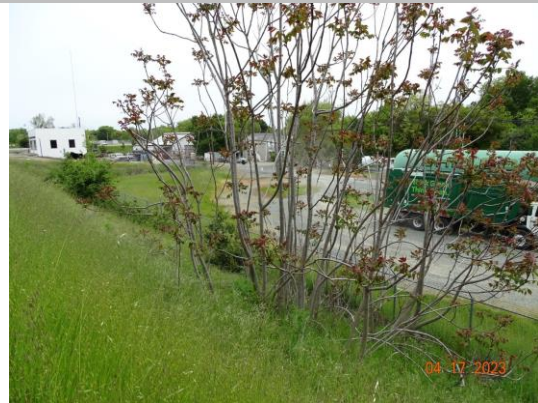
Photo 1 of 1 : FA_2024_RD0554_176_55_20241001_00017.jpg

LM Start	0.34	Rating **	M	Issue No.	55
LM End	0.34	Issue Type +	Ma	Location *	LS
Category	Earthen Levee			GPS Latitude/Longitude	
				Start	End
Item	Trim / Thin Trees			38.245140°	38.245140°
				-121.511350°	-121.511350°
DWR ID	DWR_RD0554_01_f_2021_55				
Comment Code					
T1 : Trim and thin trees to at least five feet above ground level to allow visibility of the ground and room to flood fight.					
Inspector Comment					
Remove Tree of Heaven before it gets further established.

View of the tree on the LS slope (Spring 2023).

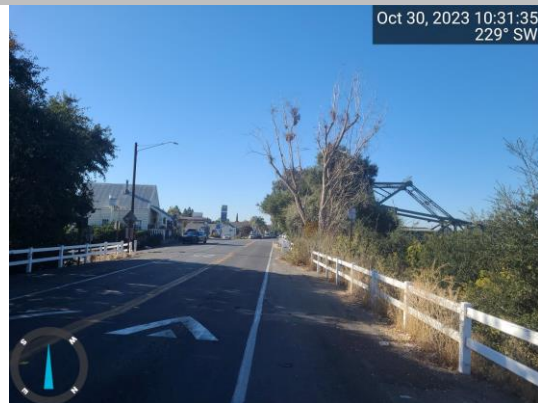
Photo 1 of 1 : FA_2024_RD0554_176_46_20241001_00014.jpg

LM Start	0.59	Rating **	M	Issue No.	46
LM End	0.59	Issue Type +	Ma	Location *	WS
Category	Earthen Levee			GPS Latitude/Longitude	
				Start	End
Item	Trim / Thin Trees			38.242125°	38.242125°
				-121.514080°	-121.514080°
DWR ID	DWR_RD0554_01_f_2019_46				
Comment Code					
T1 : Trim and thin trees to at least five feet above ground level to allow visibility of the ground and room to flood fight.					
Inspector Comment					
Low hanging trees on the waterside slope need to be trimmed up at least 5 feet for visibility.

View of low hanging trees on the waterside slope (Fall 2023).

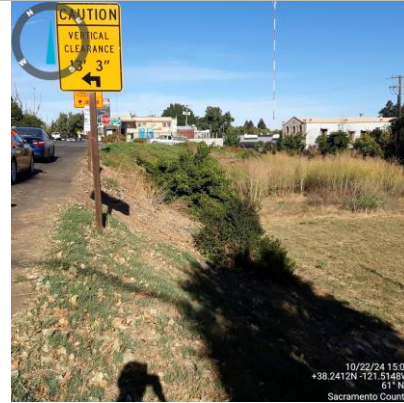
Photo 1 of 1 : FA_2024_RD0554_176_5_20241023_00027.jpg

LM Start	0.66	Rating **	M	Issue No.	5
LM End	0.66	Issue Type +	Ma	Location *	LS
Category	Earthen Levee			GPS Latitude/Longitude	
				Start	End
Item	Vegetation			38.241317°	38.241317°
				-121.514794°	-121.514794°
DWR ID	DWR_RD0554_01_s_2024_5				
Comment Code					
V2 : Remove the wild growth and woody vegetation other than native grasses from the levee slopes.					
Inspector Comment					
Vegetation has been trimmed, additional trimming of the large shrubs on the landside slope is needed.

View of shrubs on the landside slope. (Fall 2024)

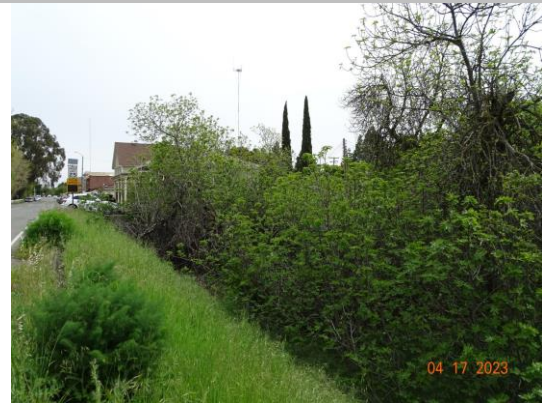
Photo 1 of 1 : FA_2024_RD0554_176_49_20241001_00015.jpg

LM Start	0.81	Rating **	U	Issue No.	49
LM End	0.83	Issue Type +	Ma	Location *	LS
Category	Earthen Levee			GPS Latitude/Longitude	
				Start	End
Item	Trim / Thin Trees			38.239587°	38.239344°
				-121.516353°	-121.516563°
DWR ID	DWR_RD0554_01_f_2019_49				
Comment Code					
T1 : Trim and thin trees to at least five feet above ground level to allow visibility of the ground and room to flood fight.					
Inspector Comment

View of the trees on the LS slope (Spring 2023).

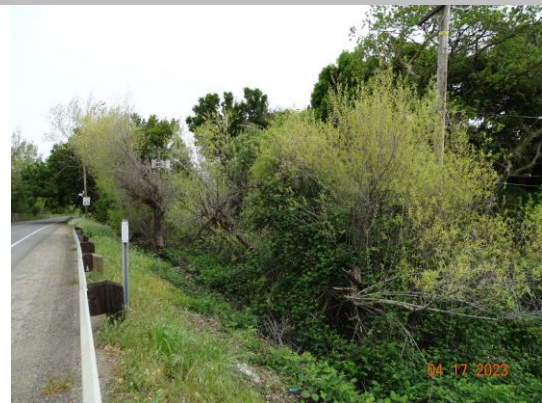
Photo 1 of 1 : FA_2024_RD0554_176_30_20241001_00011.jpg

LM Start	0.90	Rating **	U	Issue No.	30
LM End	0.96	Issue Type +	Ma	Location *	LS
Category	Earthen Levee			GPS Latitude/Longitude	
				Start	End
Item	Trim / Thin Trees			38.238396°	38.237604°
				-121.516938°	-121.516774°
DWR ID	DWR_RD0554_01_f_2016_30				
Comment Code					
T1 : Trim and thin trees to at least five feet above ground level to allow visibility of the ground and room to flood fight.					
Inspector Comment

View of the trees on the LS slope (Spring 2023).

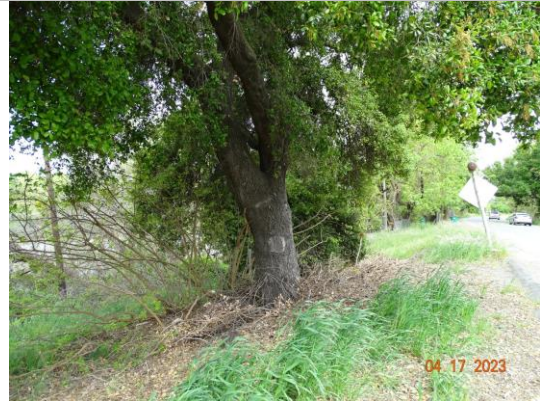
Photo 1 of 1 : FA_2024_RD0554_176_59_20241001_00021.jpg

LM Start	0.95	Rating **	M	Issue No.	59
LM End	0.95	Issue Type +	Ma	Location *	WS
Category	Earthen Levee			GPS Latitude/Longitude	
				Start	End
Item	Trim / Thin Trees			38.237632°	38.237632°
				-121.516880°	-121.516880°
DWR ID	DWR_RD0554_01_f_2020_59				
Comment Code					
T1 : Trim and thin trees to at least five feet above ground level to allow visibility of the ground and room to flood fight.					
Inspector Comment					
The trees have been trimmed but more work is needed.

View of the trees on the WS slope (Spring 2023).

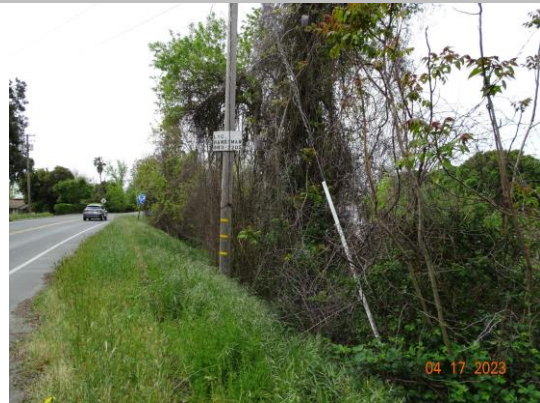
Photo 1 of 1 : FA_2024_RD0554_176_37_20241001_00013.jpg

LM Start	1.03	Rating **	U	Issue No.	37
LM End	1.03	Issue Type +	Ma	Location *	WS
Category	Earthen Levee			GPS Latitude/Longitude	
				Start	End
Item	Trim / Thin Trees			38.236518°	38.236518°
				-121.516771°	-121.516771°
DWR ID	DWR_RD0554_01_f_2019_37				
Comment Code					
T1 : Trim and thin trees to at least five feet above ground level to allow visibility of the ground and room to flood fight.					
Inspector Comment

View of the trees on the WS slope (Spring 2023).
