**Flood Control Project Maintenance  
Levee Inspections**

**Maintenance Issue Types Only, Levee Inspection Report By Mile - Spring 2015**

**Reclamation District No. 0554 Walnut Grove**

Waterway	Bank	Unit Miles	Inspection Start/End	Inspector
Unit No. 01 Sacramento River	Left	1.13	04/29/2015 04/29/2015	Herman Phillips

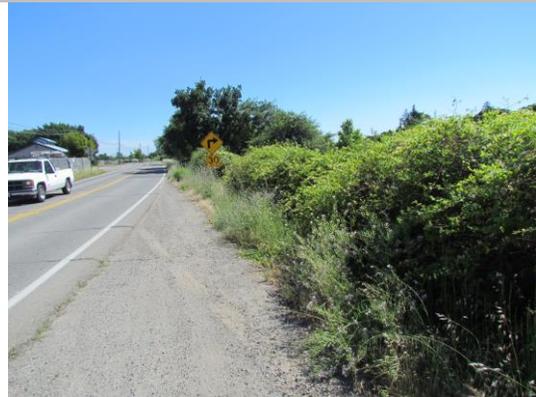
Photo 1 of 1 : SP\_2015\_RD0554\_176\_127\_20150603\_00139.jpg

LM Start	<b>0.03</b>	Rating **	U	Issue No.	<b>127</b>
LM End	<b>0.13</b>	Issue Type +	Ma	Location *	WS
Category	Earthen Levee			GPS Latitude/Longitude	
				Start	End
Item	Vegetation			38.249393 °	38.247823 °
				-121.510040 °	-121.509945 °
DWR ID	DWR_RD0554_01_s_2015_127				
Action/Comments					
Remove the wild growth other than native grasses from the levee slopes.

View looking downstream from the waterside shoulder.

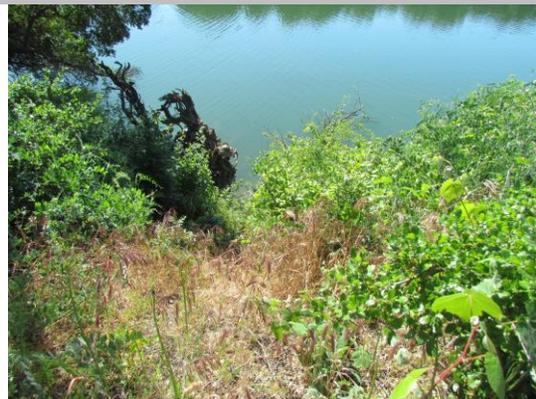
Photo 1 of 1 : SP\_2015\_RD0554\_176\_11\_20150603\_00138.jpg

LM Start	<b>0.10</b>	Rating **	U	Issue No.	<b>11</b>
LM End	<b>0.10</b>	Issue Type +	Ma	Location *	WS
Category	Earthen Levee			GPS Latitude/Longitude	
				Start	End
Item	Erosion / Bank Caving			38.248262 °	38.248262 °
				-121.509901 °	-121.509901 °
DWR ID	DWR_RD0554_01_s_2014_11				
Action/Comments					
Note and monitor erosion site. Inspector Comments: This is not a new erosion site, repairs are needed. One tree has fallen into the Sacramento River at the erosion site.

Erosion on waterside toe.

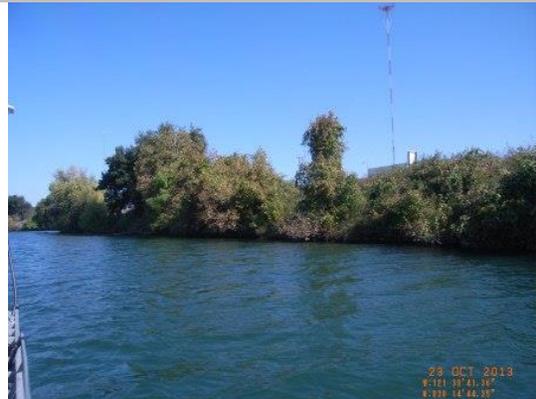
Photo 1 of 2 : SP\_2015\_RD0554\_176\_2\_20150312\_00001.jpg

LM Start	<b>0.26</b>	Rating **	M	Issue No.	<b>2</b>
LM End	<b>0.36</b>	Issue Type +	Ma	Location *	WS
Category	Supplemental		GPS Latitude/Longitude		
			Start	End	
Item	USACE Erosion Survey		38.246222 °	38.245017 °	
			-121.510878 °	-121.511740 °	
DWR ID	DWR_RD0554_01_f_2014_2				
Action/Comments					
Inspector Comments: 2009 - Tension cracks on road on top of levee. Erosion into the levee slope and mass failure. 2013: Short vertical sections at bank toe. [2013 Site ID: SAC_27-0_L]

USACE 2013 Photo #1

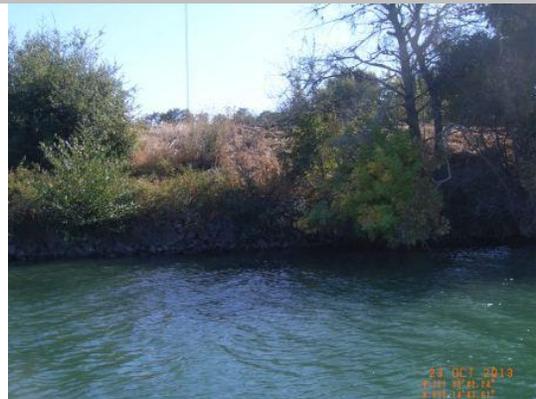
Photo 2 of 2 : SP\_2015\_RD0554\_176\_2\_20150312\_00002.jpg

LM Start	<b>0.26</b>	Rating **	M	Issue No.	<b>2 (cont)</b>
LM End	<b>0.36</b>	Issue Type +	Ma	Location *	WS

USACE 2013 Photo #2

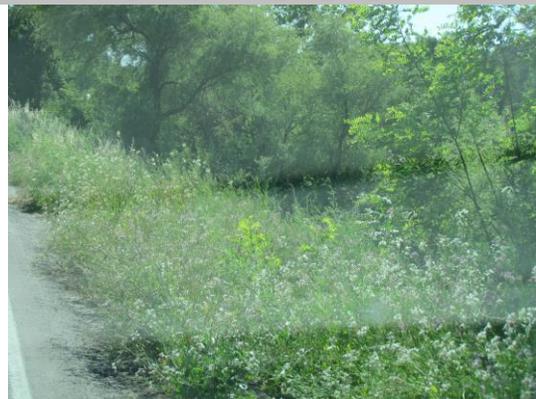
Photo 1 of 1 : SP\_2015\_RD0554\_176\_134\_20150603\_00141.jpg

LM Start	<b>0.77</b>	Rating **	U	Issue No.	<b>134</b>
LM End	<b>0.84</b>	Issue Type +	Ma	Location *	WS
Category	Earthen Levee		GPS Latitude/Longitude		
			Start	End	
Item	Vegetation		38.240033 °	38.239227 °	
			-121.515998 °	-121.516745 °	
DWR ID	DWR_RD0554_01_s_2015_134				
Action/Comments					
Control annual grass and weeds on the levee slopes and easements. Inspector Comments: Control the unacceptable weeds on the waterside slope.

View looking downstream at the waterside slope.
