**Flood Control Project Maintenance
Levee Inspections**

Fall 2009 Levee Maintenance Deficiency Summary Report

Sacramento River Basin

Reclamation District No. 0556 Upper Andrus

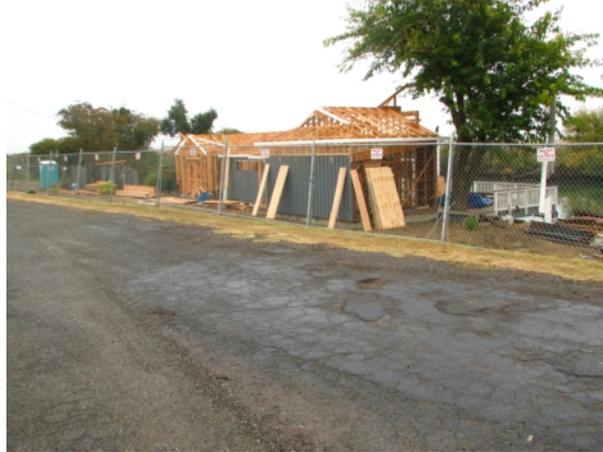
phillips_20091215_25.jpg

Levee Mile Report Line	57
Start Levee Mile	3.94
End Levee Mile	4.05
Location	Water Side
Category	Earthen Levee
Item	Encroachments

This house has been remodeled without a Reclamation Permit. At this time 12-09 this house has been complete and listed for sale.
