**Flood Control Project Maintenance  
Levee Inspections**

**Fall 2011 Levee Maintenance Deficiency Summary Report**

**Sacramento River Basin**

**Reclamation District No. 0556 Upper Andrus**

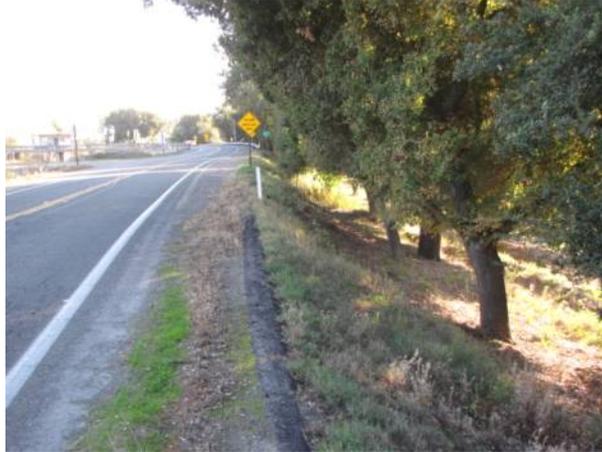
Levee Mile Report Line	1
Start Levee Mile	0.00
End Levee Mile	0.00
Location	Land Side
Category	Earthen Levee
Item	Vegetation
Standing on land side looking downstream from levee mile 0.00 Unit 1 RD 556. Photo taken 11-17-2010	
phillips_f_20110929_172.jpg

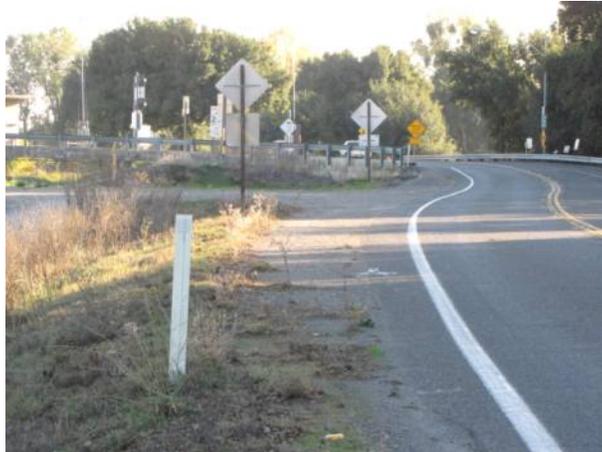
Levee Mile Report Line	2
Start Levee Mile	0.00
End Levee Mile	0.00
Location	Water Side
Category	Earthen Levee
Item	Vegetation
Standing on water side from levee mile 0.00 looking downstream of RD 556 Unit 1. Photo taken 11-17-2010.	
phillips_f_20110929_173.jpg

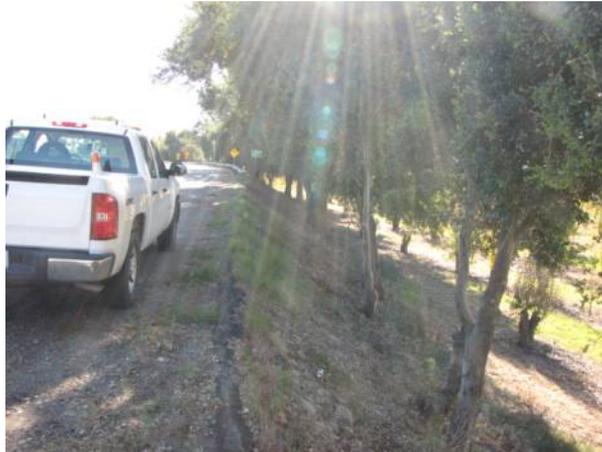
Levee Mile Report Line	3
Start Levee Mile	0.07
End Levee Mile	0.07
Location	Land Side
Category	Earthen Levee
Item	Vegetation
Looking downstream from levee mile 0.07. Photo taken 11-16-2011	
phillips_f_20111128_063.jpg

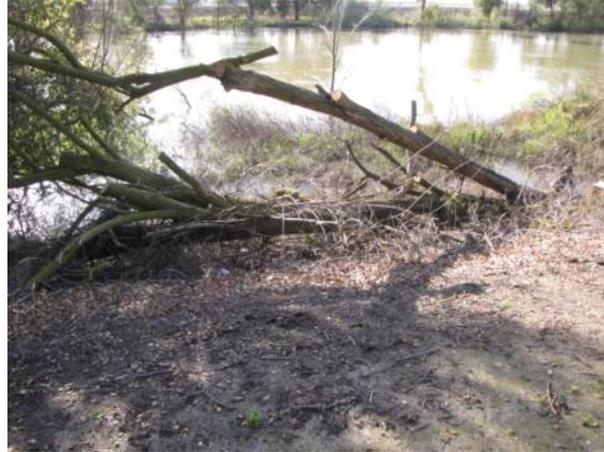
Levee Mile Report Line	5
Start Levee Mile	0.42
End Levee Mile	0.42
Location	Water Side
Category	Earthen Levee
Item	Encroachments
Looking downstream from levee mile 0.42 two fallen trees on waterward slope. Photo taken 3-29-2011	
phillips_f_20110929_176.jpg

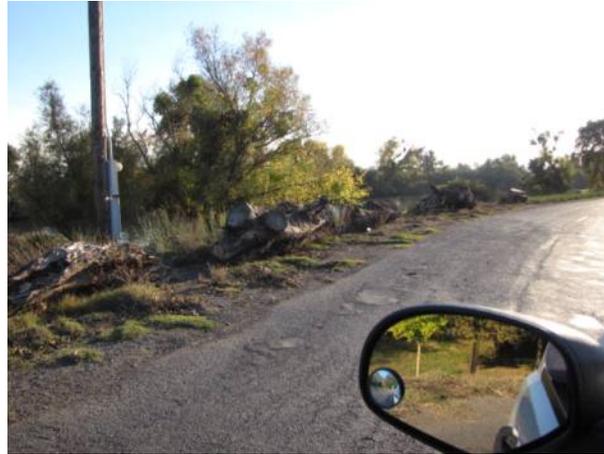
Levee Mile Report Line	12
Start Levee Mile	1.55
End Levee Mile	1.57
Location	Water Side
Category	Earthen Levee
Item	Encroachments
Standing on land side from levee mile 1.55 looking at water side shoulder unauthorized dumping of cut up trees has been placed on levee section to levee mile 1.57. District needs to remove this encroachment from the levee section. Photo taken 11-17-2010	
phillips_f_20110929_174.jpg

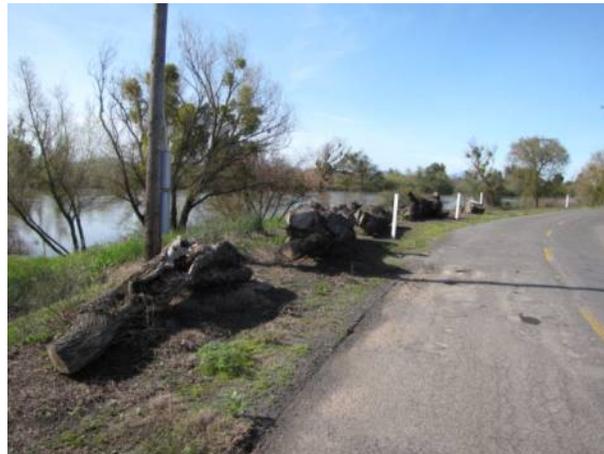
Levee Mile Report Line	12
Start Levee Mile	1.55
End Levee Mile	1.57
Location	Water Side
Category	Earthen Levee
Item	Encroachments
The land owner stated that he would have these trees removed from levee section next month (April). Photo taken 3-29-2011.	
phillips_f_20110929_175.jpg

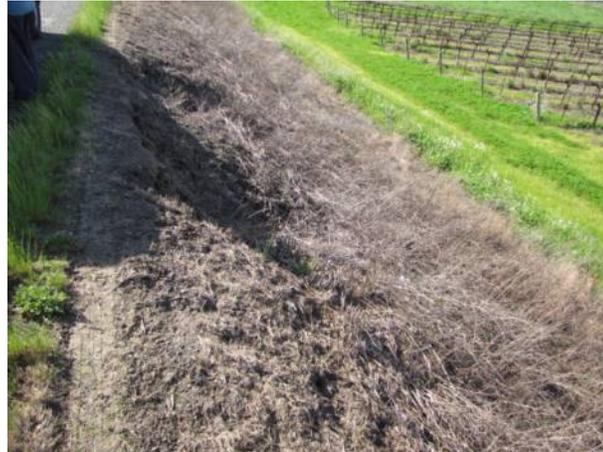
Levee Mile Report Line	17
Start Levee Mile	2.32
End Levee Mile	2.32
Location	Land Side
Category	Earthen Levee
Item	Erosion / Bank Caving
Looking at new erosion site levee mile 2.32 landside slope UNIT # 1 RD 556. Photo taken 3-29-2011.	
phillips_f_20110929_179.jpg

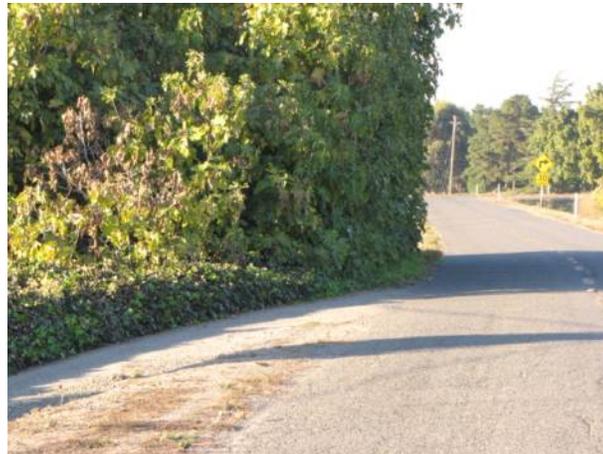
Levee Mile Report Line	18
Start Levee Mile	2.32
End Levee Mile	2.34
Location	Land Side
Category	Earthen Levee
Item	Trim / Thin Trees
Standing on waterside of Unit 1 RD 556 from levee miles 2.34 looking back upstream to levee 2.32 unauthorized tree growth remains on levee section. Phot taken 11-17-2010	
phillips_f_20110929_180.jpg

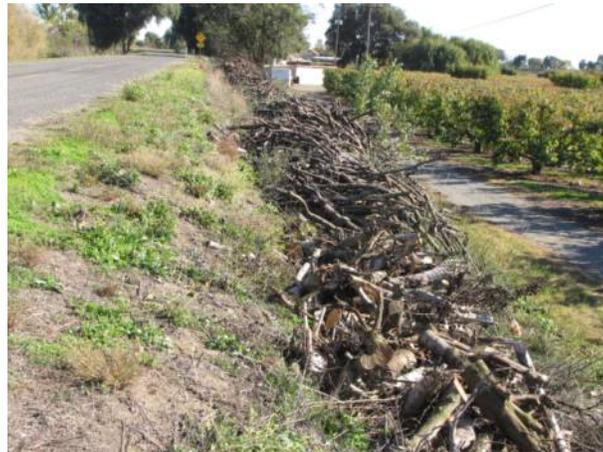
Levee Mile Report Line	23
Start Levee Mile	2.44
End Levee Mile	2.62
Location	Land Side
Category	Earthen Levee
Item	Encroachments
Levee mile 2.44 to levee mile 2.62 fire wood placed on landside slope and toe of levee section. Photo taken 11-16-2011.	
phillips_f_20111128_064.jpg

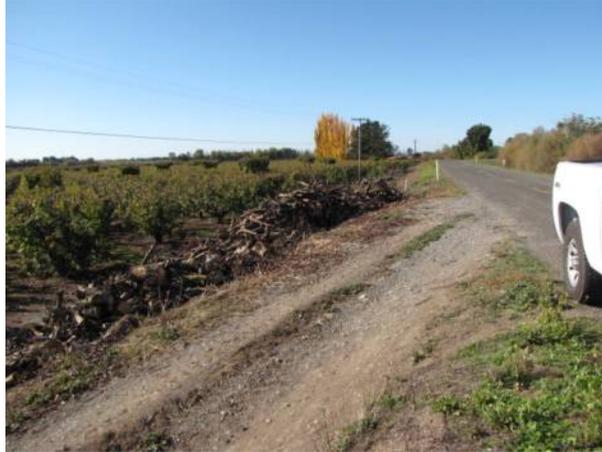
Levee Mile Report Line	23
Start Levee Mile	2.44
End Levee Mile	2.62
Location	Land Side
Category	Earthen Levee
Item	Encroachments
<p>Standing at levee mile 2.62 looking upstream landside at the downstream end of the firewood pile. Photo taken 11-16-2011.</p>	
<p>phillips_f_20111128_066.jpg</p>

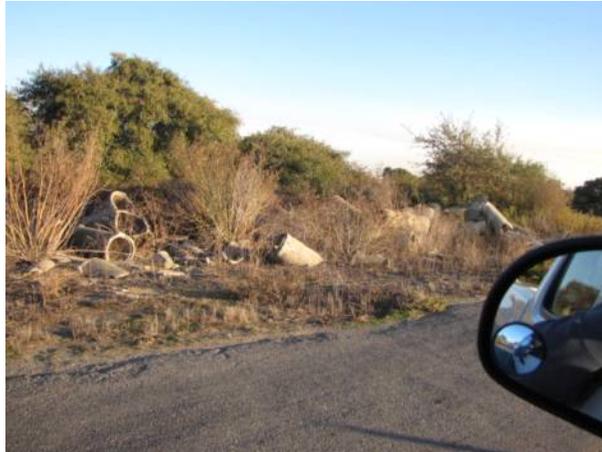
Levee Mile Report Line	34
Start Levee Mile	3.44
End Levee Mile	3.46
Location	Water Side
Category	Earthen Levee
Item	Encroachments
<p>Unit 1 RD 556 Unauthorized dumping of concrete pipe and blocks of water side shoulder and berm. Photo taken 11-17-2010 (Unsatisfactory).</p>	
<p>phillips_f_20110929_181.jpg</p>

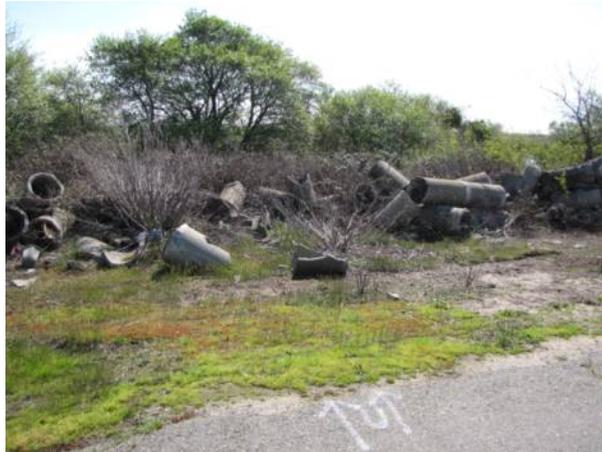
Levee Mile Report Line	34
Start Levee Mile	3.44
End Levee Mile	3.46
Location	Water Side
Category	Earthen Levee
Item	Encroachments
<p>This pipe continue to be on waterward side of RD 556 Unit 1. New photo taken 3-29-2011. Unsatisfactory.</p>	
<p>phillips_f_20110929_182.jpg</p>

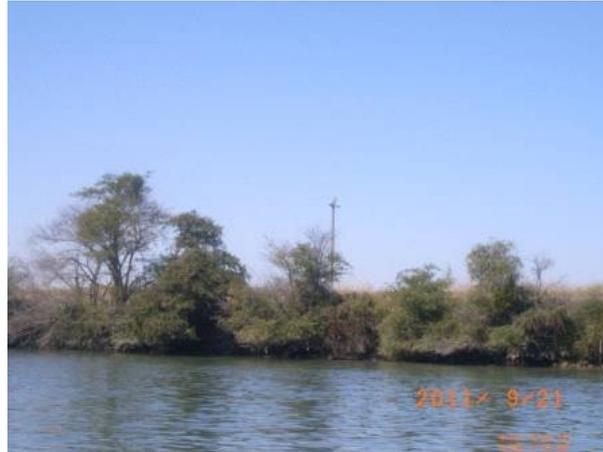
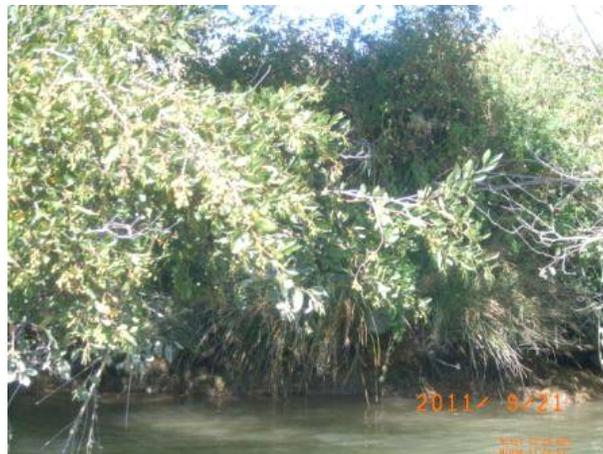
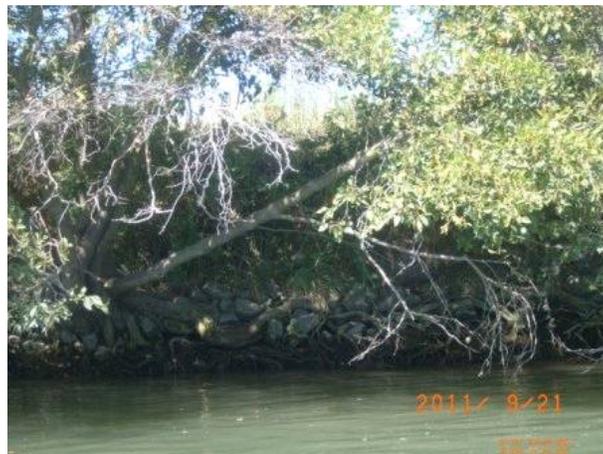
LMIR No.	Levee Mile		Category	Item	* Location	** Rating	Action/Comment	GPS Latitude/Longitude		Issue No. Photo
	Start	End						Start	End	
37	3.94	4.05	Earthen Levee	Encroachments	WS	CO	Buildings Inspector Comments: There is a remodeling of a home here The owner is Dona Blower.	38.201475 ° -121.542832 °	38.200617 ° -121.544530 °	86
38	4.01	4.15	Earthen Levee	Vegetation	LS	M	Remove the wild growth other than native grasses from the levee slopes.	38.200930 ° -121.543990 °	38.199552 ° -121.545590 °	58
39	4.95	5.22	Supplemental	USACE Erosion Survey	WS	M	Inspector Comments: 1997 - Toe damaged rock. 1999 - One pocket filled with gravel. 2000 - Eroding beach with some biotech rolls and stakes; some gravel on slope. 2001 - Staked, low fascine walls at bankline. 2005 - Stone revetment in between pockets. 2006 - New rock on upper slope behind brush boxes at the upstream end, Stone is sliding off the hard toe. 2011: No observed change. [2011 Site ID: GEO_7-0_R]	38.189775 ° -121.557729 °	38.188121 ° -121.559413 °	19 Y

Levee Mile Report Line	39
Start Levee Mile	4.95
End Levee Mile	5.22
Location	Water Side
Category	Supplemental
Item	USACE Erosion Survey
USACE 2011 Photo #1	
USACE2011_GEO_7-0_R_1.jpg

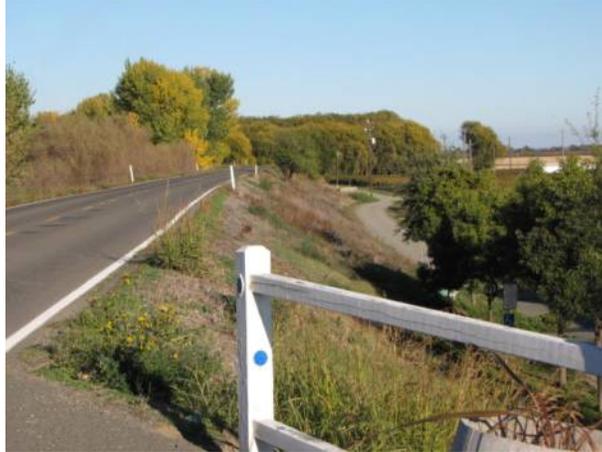
Levee Mile Report Line	1
Start Levee Mile	0.00
End Levee Mile	0.00
Location	Land Side
Category	Earthen Levee
Item	Vegetation
Looking downstream from levee mile 0.00 unit 2 looking from landward slope. Photo taken 11-16-2011.	
phillips_f_20111128_067.jpg

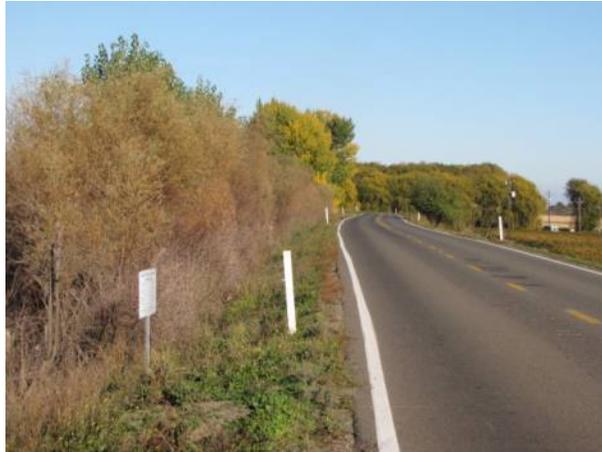
Levee Mile Report Line	2
Start Levee Mile	0.00
End Levee Mile	0.00
Location	Water Side
Category	Earthen Levee
Item	Vegetation
Standing on the waterward side for levee mile 0.00 looking ownstream. Photo taken 11-16-2011.	
phillips_f_20111128_068.jpg

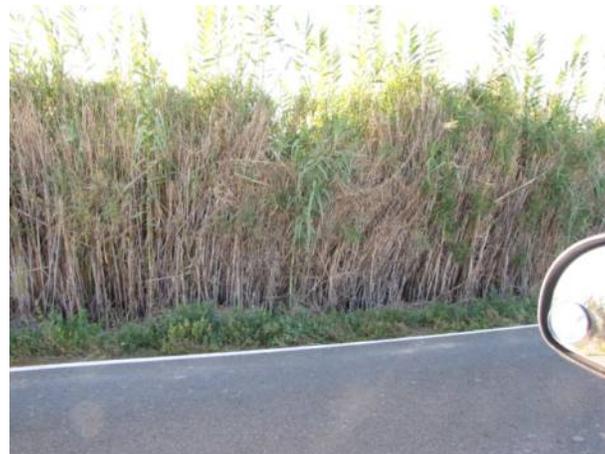
4	1.03	1.04	Earthen Levee	Vegetation	WS	U	Remove the wild growth other than native grasses from the levee slopes.	38.238524 ° -121.536808 °	38.238566 ° -121.536984 °	24 Y
5	1.08	1.11	Supplemental	USACE Erosion Survey	WS	M	Inspector Comments: 1997 - Rock is in poor condition and has failed in many places. Scallops in berm with remnants of old rock in the toe area. 2005 - Brush boxes present. 2011: No observed change. [2011 Site ID: SAC_25-2_L]	38.239006 ° -121.537765 °	38.239265 ° -121.538845 °	26 Y
6	1.45	1.45	Earthen Levee	Vegetation	WS	U	Remove the wild growth other than native grasses from the levee slopes.	38.240118 ° -121.544255 °	38.240118 ° -121.544255 °	19 Y
7	1.45	1.53	Supplemental	USACE Erosion Survey	WS	M	Inspector Comments: 1997 - Slow erosion of the berm at the waterline; bench below water. 2005 - Brush boxes present. 2010 - Minor new erosion. 2011: No observed change. [2011 Site ID: SAC_24-8_L]	38.240401 ° -121.544106 °	38.240772 ° -121.546791 °	27 Y

Levee Mile Report Line	4
Start Levee Mile	1.03
End Levee Mile	1.04
Location	Water Side
Category	Earthen Levee
Item	Vegetation
Waterside levee mile 1.03 to levee mile 1.04 RD 556 Unit 2. Photo taken 11-16-2011.	
phillips_f_20111128_072.jpg

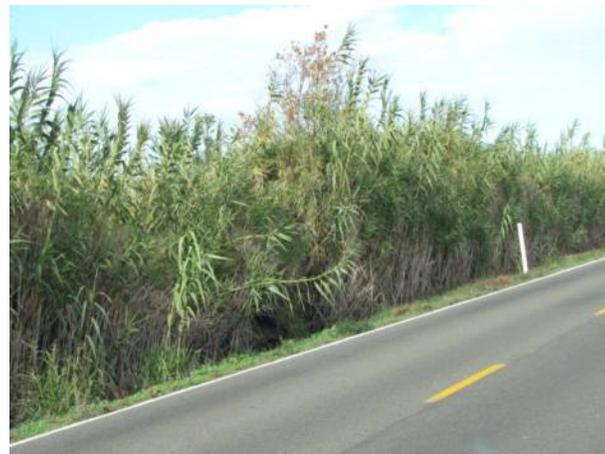
Levee Mile Report Line	6
Start Levee Mile	1.45
End Levee Mile	1.45
Location	Water Side
Category	Earthen Levee
Item	Vegetation
Waterside levee mile 1.45 Unit 2 RD 556. Photo taken 11-16-2011.	
phillips_f_20111128_071.jpg

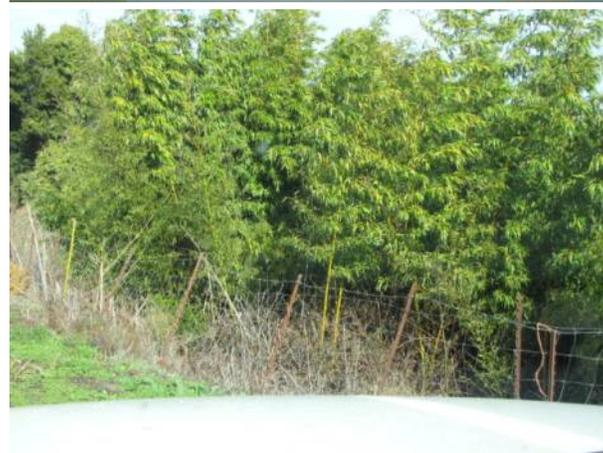
Levee Mile Report Line	8
Start Levee Mile	1.50
End Levee Mile	1.50
Location	Land Side
Category	Earthen Levee
Item	Vegetation
Looking downstream from levee mile 1.50. Photo taken 11-16-2011	
phillips_f_20111128_070.jpg

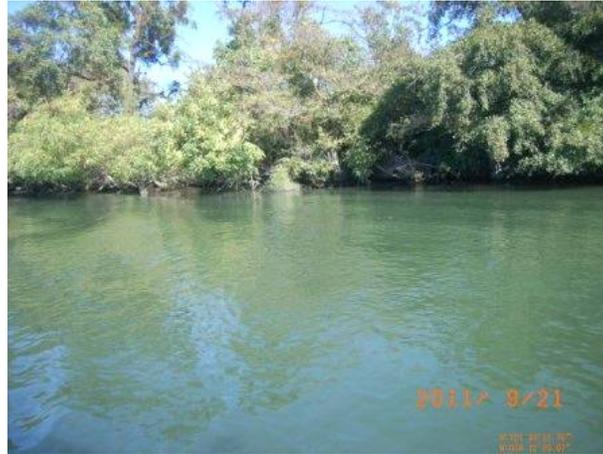
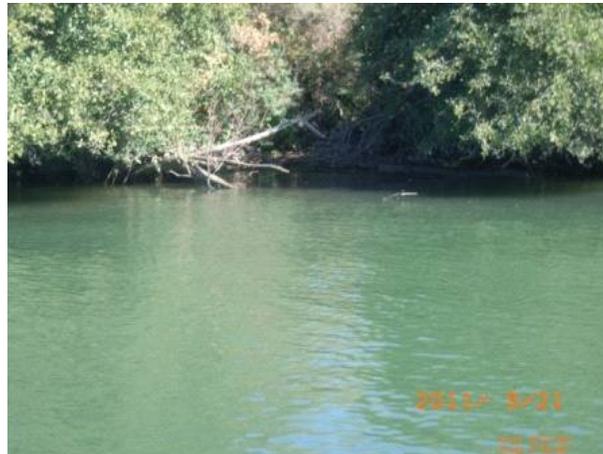
Levee Mile Report Line	27
Start Levee Mile	4.73
End Levee Mile	4.73
Location	Water Side
Category	Supplemental
Item	USACE Erosion Survey
USACE 2011 Photo #1	
USACE2011_SAC_21-5_L_1.jpg

LMIR No.	Levee Mile		Category	Item	Location *	Rating **	Action/Comment	GPS Latitude/Longitude		Issue No. Photo
	Start	End						Start	End	
27	4.73	4.73	Supplemental	USACE Erosion Survey	WS	M	Inspector Comments: 1999 - Downstream 140 ft repaired with rock. 2010 - Lots of woody debris, but no changes to site. 2011: No observed change. [2011 Site ID: SAC_21-5_L]	38.200225 ° -121.557749 °	38.200646 ° -121.557606 °	34 Y
28	4.74	4.85	Earthen Levee	Encroachments	WS	PO	Fences	38.202250 ° -121.556892 °	38.200597 ° -121.557203 °	39
29	4.80	4.92	Earthen Levee	Vegetation	LS	M	Remove the wild growth other than native grasses from the levee slopes.	38.201362 ° -121.557077 °	38.199558 ° -121.557603 °	5
30	4.82	4.95	Earthen Levee	Vegetation	WS	M	Remove the wild growth other than native grasses from the levee slopes.	38.200676 ° -121.557136 °	38.199025 ° -121.557923 °	11
31	5.01	5.07	Earthen Levee	Vegetation	LS	M	Remove the wild growth other than native grasses from the levee slopes.	38.198403 ° -121.558263 °	38.197618 ° -121.558800 °	4
