**Flood Control Project Maintenance
Levee Inspections**

**Fall 2010 Levee Maintenance Deficiency Summary Report
Overall LMA & Unit Ratings, including USACE Erosion Survey**

Reclamation District No. 0556 Upper Andrus

Levee Inspection Report By Mile - Fall 2010

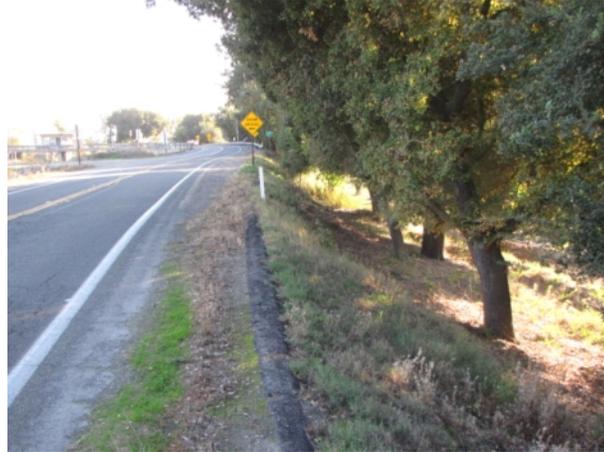
Levee Mile Report Line	1
Start Levee Mile	0.00
End Levee Mile	0.00
Location	Land Side
Category	Earthen Levee
Item	Vegetation
Standing on land side looking downstream from levee mile 0.00 Unit 1 RD 556. Photo taken 11-17-2010	
phillips_f_20101129_337.jpg

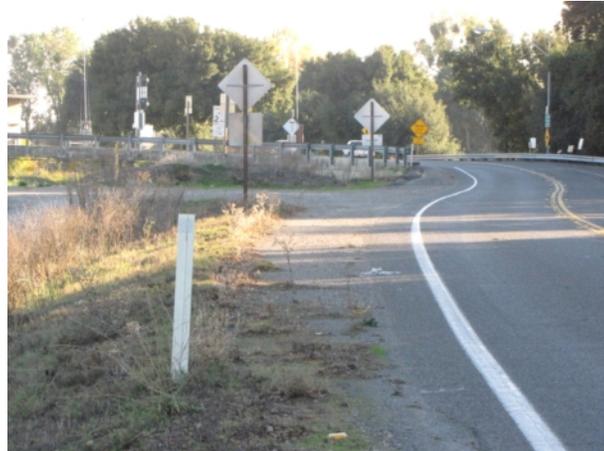
Levee Mile Report Line	2
Start Levee Mile	0.00
End Levee Mile	0.00
Location	Water Side
Category	Earthen Levee
Item	Vegetation
Standing on water side from levee mile 0.00 looking downstream of RD 556 Unit 1. Photo taken 11-17-2010.	
phillips_f_20101129_338.jpg

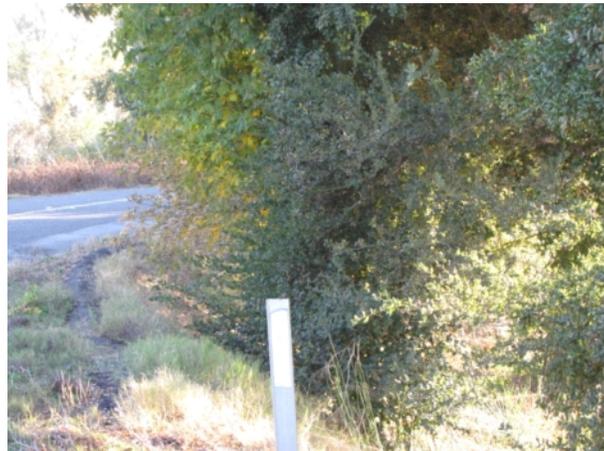
Levee Mile Report Line	4
Start Levee Mile	0.17
End Levee Mile	0.26
Location	Land Side
Category	Earthen Levee
Item	Trim / Thin Trees
Looking downstream from levee mile 0.17 unsatisfactory growth on landside slope. Photo taken 11-17-2010	
phillips_f_20101129_336.jpg

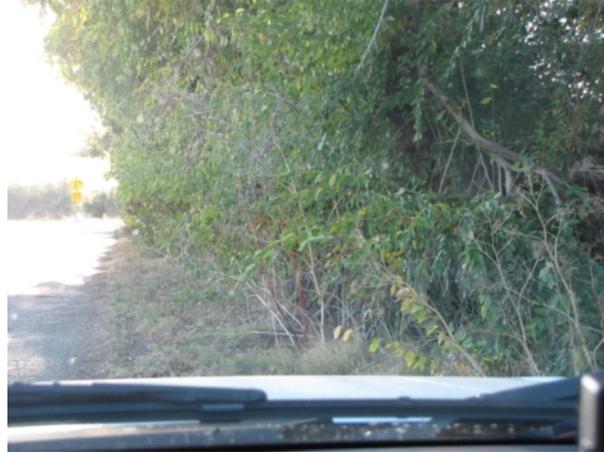
Levee Mile Report Line	8
Start Levee Mile	0.90
End Levee Mile	0.91
Location	Land Side
Category	Earthen Levee
Item	Trim / Thin Trees
<p>Standing on landside from levee mile 0.90 looking downstream to levee mile 0.91 unsatisfactory wild growth on shoulder and slope of Unit 1 RD 556</p>	
<p>phillips_f_20101129_340.jpg</p>

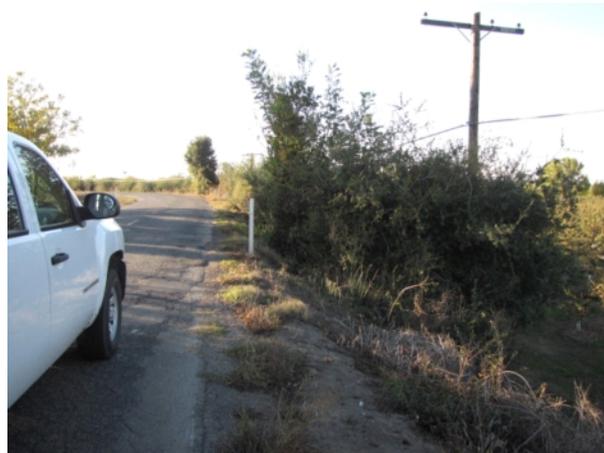
Levee Mile Report Line	10
Start Levee Mile	1.20
End Levee Mile	1.31
Location	Land Side
Category	Earthen Levee
Item	Trim / Thin Trees
<p>Standing on landside from levee mile 1.20 looking downstream at wild growth on landside shoulder and slope of Unit 1 RD 556. Photo taken 11-17-2010</p>	
<p>phillips_f_20101129_341.jpg</p>

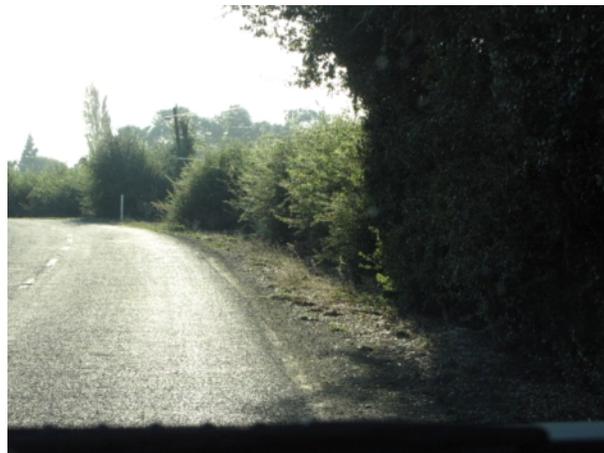
Levee Mile Report Line	13
Start Levee Mile	1.32
End Levee Mile	1.42
Location	Land Side
Category	Earthen Levee
Item	Trim / Thin Trees
<p>Standing on landside Unit 1 RD 556 from levee mile 1.32 looking downstream to levee mile 1.42 unsatisfactory growth remains on levee section. Photo taken 11-17-2010</p>	
<p>phillips_f_20101129_342.jpg</p>

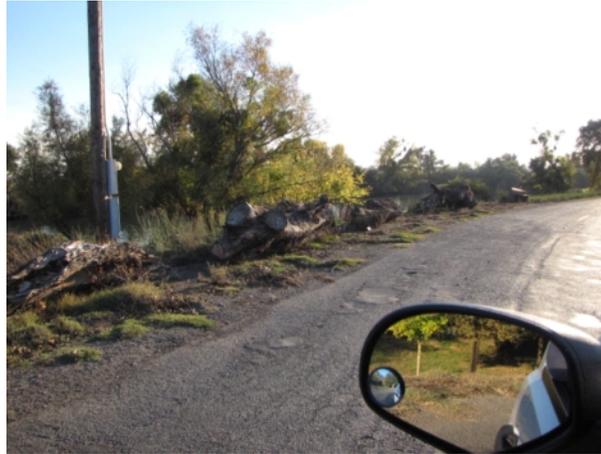
Levee Mile Report Line	15
Start Levee Mile	1.55
End Levee Mile	1.57
Location	Water Side
Category	Earthen Levee
Item	Encroachments

Standing on land side from levee mile 1.55 looking at water side shoulder unauthorized dumping of cut up trees has been placed on levee section to levee mile 1.57. District need to remove this encroachment from the levee section. Photo taken 11-17-2010

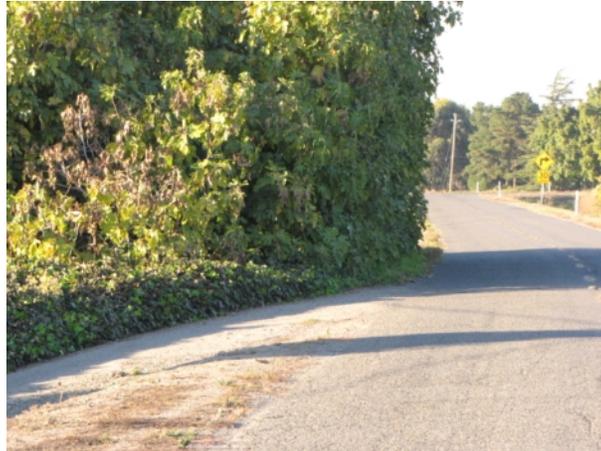
Levee Mile Report Line	22
Start Levee Mile	2.32
End Levee Mile	2.34
Location	Land Side
Category	Earthen Levee
Item	Trim / Thin Trees

Standing on waterside of Unit 1 RD 556 from levee miles 2.34 looking back upstream to levee 2.32 unauthorized tree growth remains on levee section. Photo taken 11-17-2010

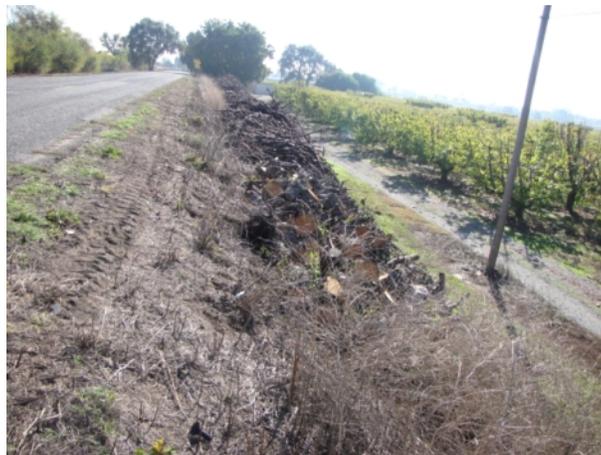
Levee Mile Report Line	27
Start Levee Mile	2.60
End Levee Mile	2.65
Location	Land Side
Category	Earthen Levee
Item	Encroachments

RD 556 Unit 1 standing on land side from levee mile 2.60 looking down stream to levee mile 2.65 unauthorized placement of fire wood on the slope and toe of levee section. District is to contact landowner and have it removed. Photo taken 11-16-2010.

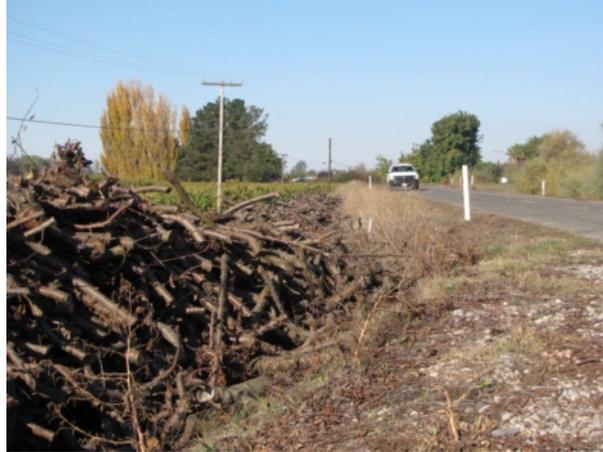
Levee Mile Report Line	27
Start Levee Mile	2.60
End Levee Mile	2.65
Location	Land Side
Category	Earthen Levee
Item	Encroachments
<p>Standing on land side levee mile 2.65 looking back up stream to levee mile 2.60 view from down stream end of encroachment. Photo taken 11-16-2010</p>	
<p>phillips_f_20101130_351.jpg</p>

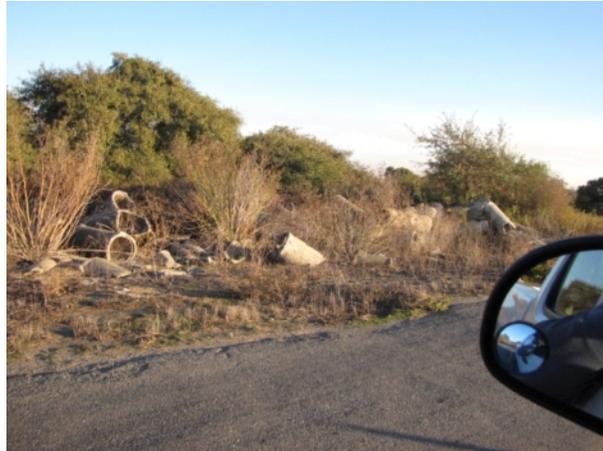
Levee Mile Report Line	46
Start Levee Mile	3.44
End Levee Mile	3.46
Location	Water Side
Category	Earthen Levee
Item	Encroachments
<p>Unit 1 RD 556 Un authorized dumping of concrete pipe and blocks of water side shoulder and berm. Photo taken 11-17-2010 (Unsatisfactory).</p>	
<p>phillips_f_20101129_347.jpg</p>

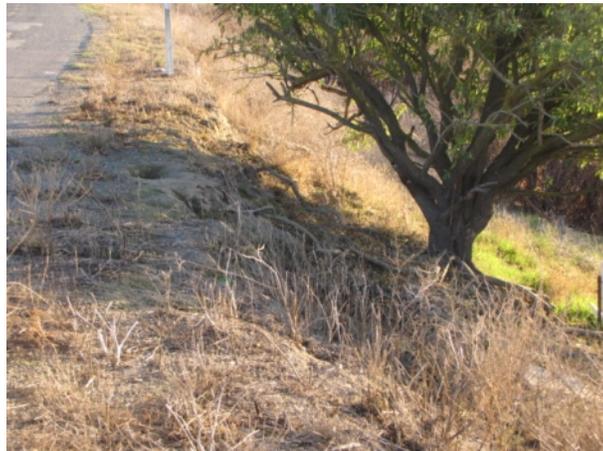
Levee Mile Report Line	47
Start Levee Mile	3.50
End Levee Mile	3.75
Location	Land Side
Category	Earthen Levee
Item	Slope Stability
<p>This section of levee unit 1 RD 556 levee mile 3.50 to levee mile 3.75 was damaged by the Land owner's livestock (goats) that never was repaired. Photo taken 11-17-2010</p>	
<p>phillips_f_20101129_346.jpg</p>

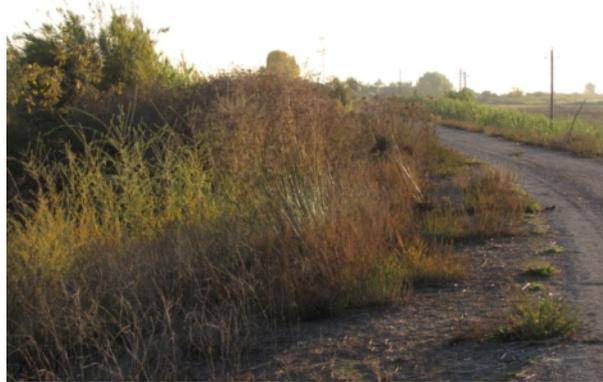
Levee Mile Report Line	57
Start Levee Mile	4.07
End Levee Mile	5.45
Location	Water Side
Category	Earthen Levee
Item	Vegetation
<p>Standing on water side shoulder looking downstream at unsatisfactory growth on levee section levee mile 4.07 to 5.45. Photo taken 11-17-2010</p>	
<p>phillips_f_20101129_348.jpg</p>

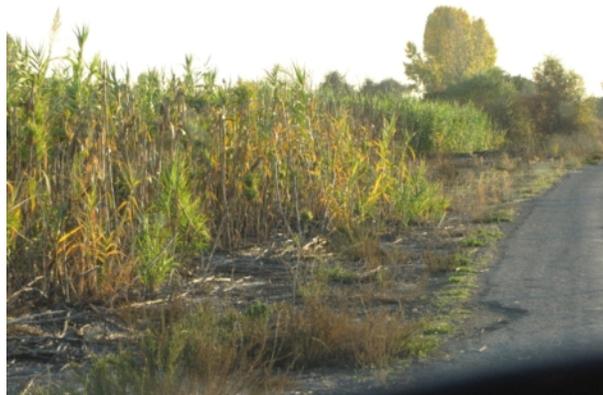
Levee Mile Report Line	59
Start Levee Mile	4.15
End Levee Mile	4.16
Location	Water Side
Category	Earthen Levee
Item	Vegetation
<p>Unsatisfactory growth of bambo on water side section Unit 1 RD 556 Levee mile 4.15 looking down stream to levee mile 4.16. Tthis section was burned however the new growth has come back. Photo taken 11-17-2010</p>	
<p>phillips_f_20101129_349.jpg</p>

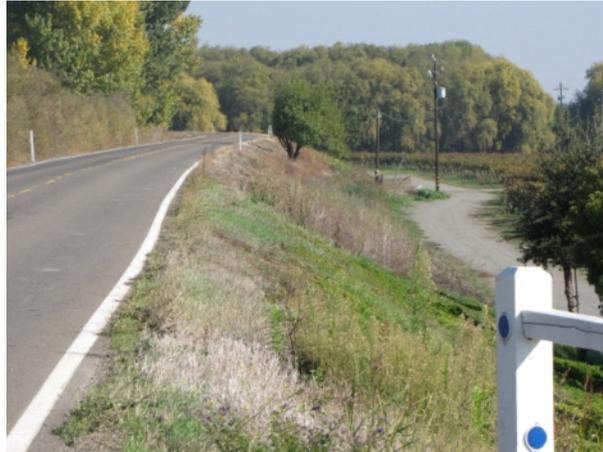
Levee Mile Report Line	1
Start Levee Mile	0.00
End Levee Mile	0.00
Location	Land Side
Category	Earthen Levee
Item	Vegetation
<p>Standing on levee mile 0.00 of RD 556 Unit 2 looking down stream of landside. Photo taken 11-16-2010</p>	
<p>phillips_f_20101130_352.jpg</p>

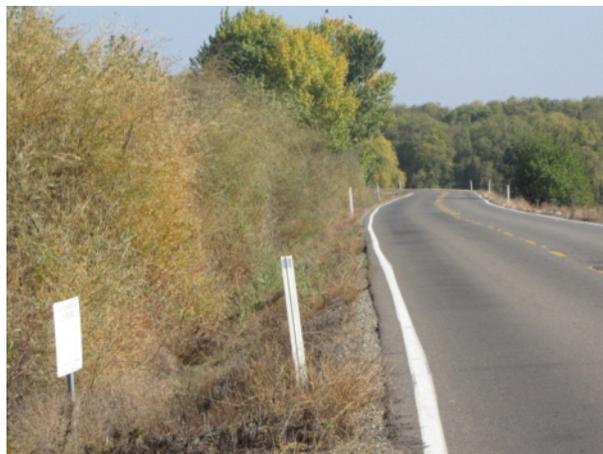
Levee Mile Report Line	2
Start Levee Mile	0.00
End Levee Mile	0.00
Location	Water Side
Category	Earthen Levee
Item	Vegetation
<p>Standing on water side of levee mile 0.00 Unit 2 of RD 556 looking downstream. This photo taken 11-16-2010. Levee mile 0.00 there is a Veg. site in view of this shot.</p>	
<p>phillips_f_20101130_353.jpg</p>
