**Flood Control Project Maintenance
Levee Inspections**

Fall 2012 Levee Maintenance Deficiency Summary Report

Reclamation District No. 0556 Upper Andrus

Levee Inspection Report By Mile - Fall 2012

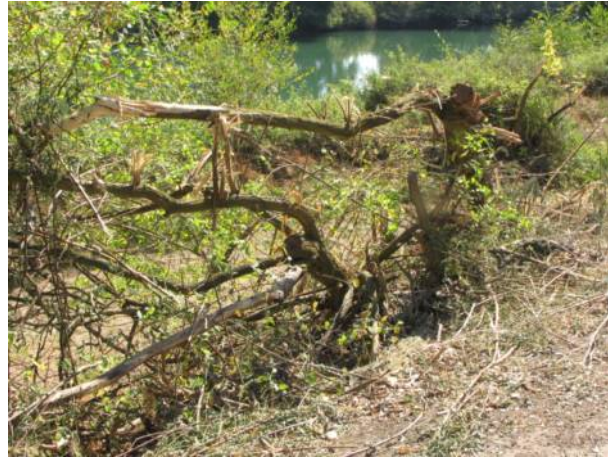
Levee Mile Report Line	7
Start Levee Mile	0.42
End Levee Mile	0.42
Location	Water Side
Category	Earthen Levee
Item	Encroachments

Waterside RD 556 Unit 1 levee mile 0.42, this tree fell down last year on the waterside slope in 2011. As of fall 2012 it hasn't been removed. Photo taken 10-20-2012.

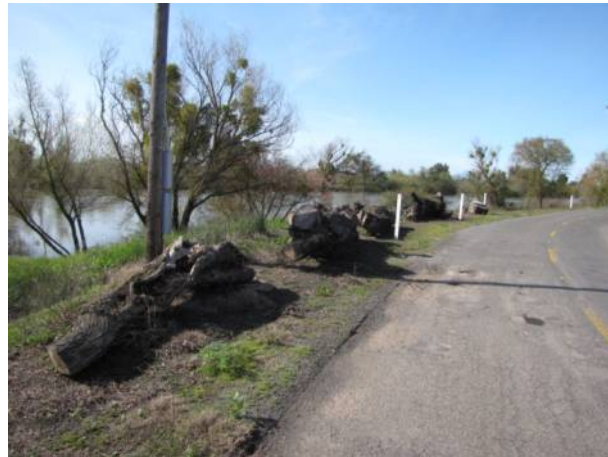
Levee Mile Report Line	20
Start Levee Mile	1.55
End Levee Mile	1.57
Location	Water Side
Category	Earthen Levee
Item	Encroachments

The land owner stated that he would have these trees removed from levee section next month (April). Photo taken 3-29-2011. 10-02-2012 The cut up tree has not been removed from waterward levee shoulder.

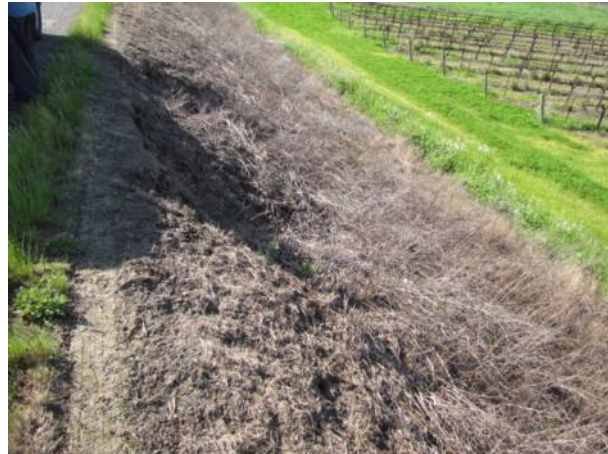
Levee Mile Report Line	26
Start Levee Mile	2.32
End Levee Mile	2.32
Location	Land Side
Category	Earthen Levee
Item	Erosion / Bank Caving

Looking at new erosion site levee mile 2.32 landside slope along Unit 1 of RD 556. Photo taken 3-29-2011.

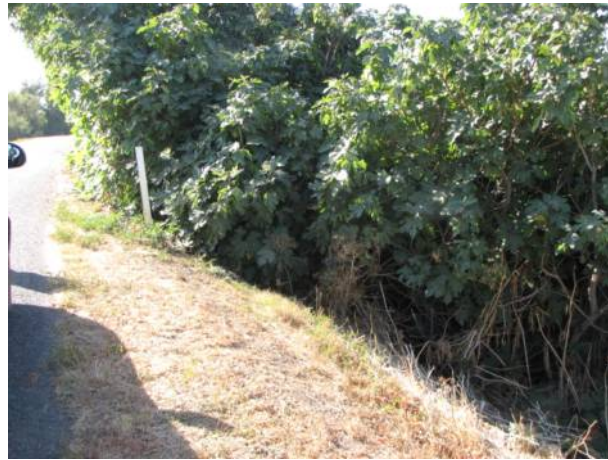
Levee Mile Report Line	27
Start Levee Mile	2.32
End Levee Mile	2.34
Location	Land Side
Category	Earthen Levee
Item	Trim / Thin Trees

RD 556 levee mile 2.35 looking downstream land side shoulder and slope, these figs block visibility of levee section. Photo taken 10-02-2012.

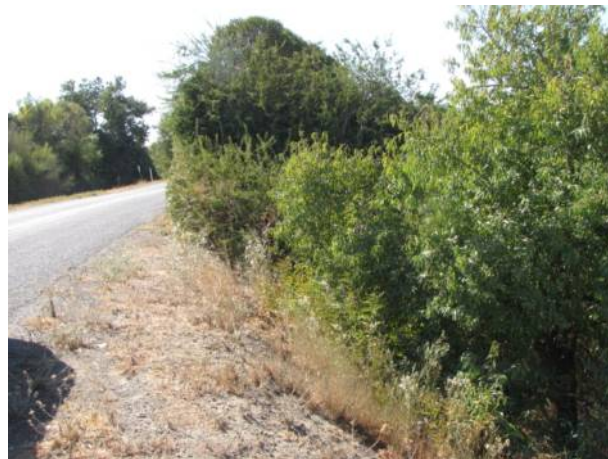
Levee Mile Report Line	29
Start Levee Mile	2.42
End Levee Mile	2.46
Location	Land Side
Category	Earthen Levee
Item	Vegetation

RD 556 Unit 1 at levee mile 2.42 looking downstream landward unsatisfactory wild growth. Photo taken 10-02-2012.

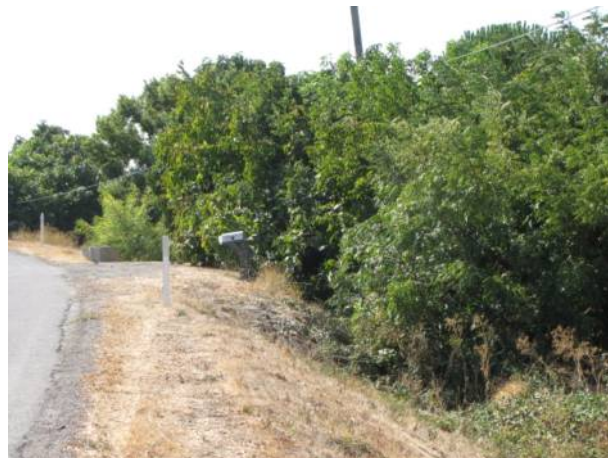
Levee Mile Report Line	48
Start Levee Mile	3.26
End Levee Mile	3.26
Location	Land Side
Category	Earthen Levee
Item	Trim / Thin Trees

RD 556 Unit 1 at levee mile 3.26. Unsatisfactory wild growth blocking visibility of levee section. Photo taken 10-02-2012.

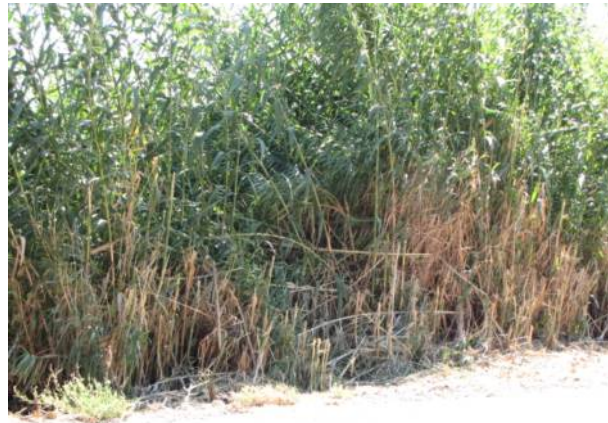
View of vegetation on the waterward slope.

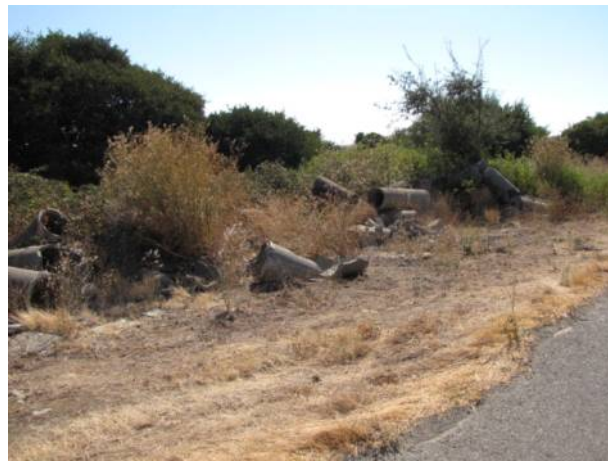
Levee Mile Report Line	53
Start Levee Mile	3.44
End Levee Mile	3.46
Location	Water Side
Category	Earthen Levee
Item	Encroachments

RD 556 Unit 1, unauthorized discarded concrete pipe on waterside berm. Photo taken 10-02-2012. This pipe should be removed from the levee section.

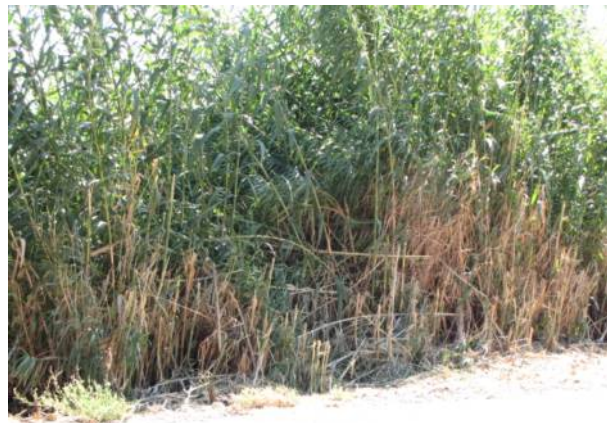
Levee Mile Report Line	9
Start Levee Mile	1.03
End Levee Mile	1.04
Location	Water Side
Category	Earthen Levee
Item	Vegetation

RD 556, wild growth on the waterside shoulder blocks visibility. Photo taken 10-02-2012.

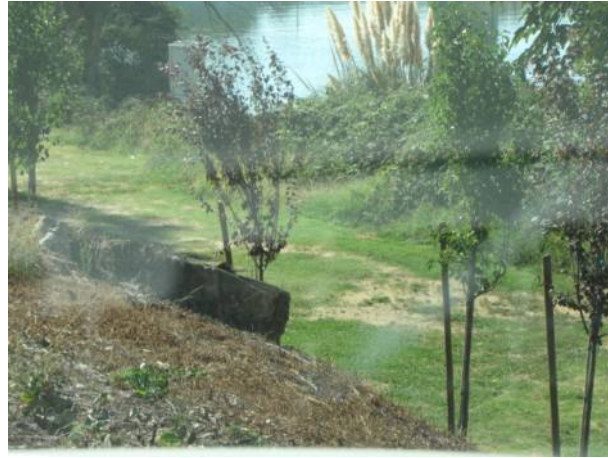
RD 556, unauthorized tree planting on waterward toe. Photo taken 10-02-2012.

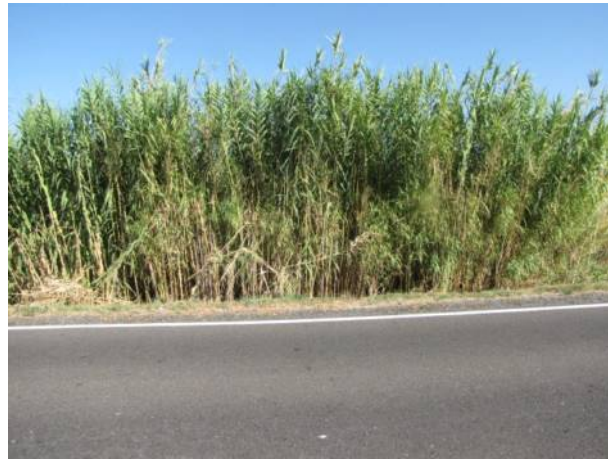
Levee Mile Report Line	17
Start Levee Mile	2.38
End Levee Mile	2.73
Location	Land Side
Category	Earthen Levee
Item	Vegetation

RD 556, bamboo on L/S slopes. Photo taken 10-2-2012.

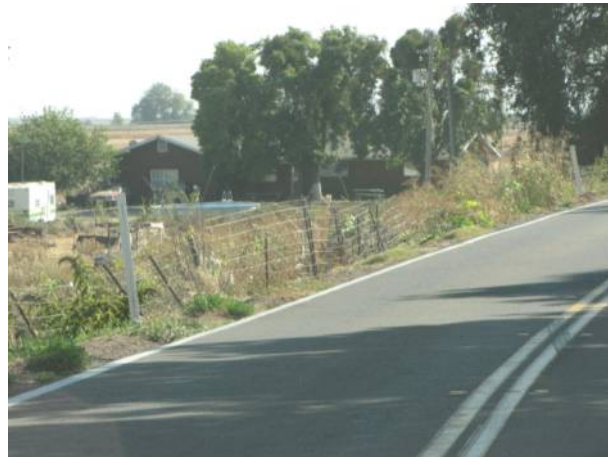
Levee Mile Report Line	38
Start Levee Mile	4.59
End Levee Mile	5.25
Location	Land Side
Category	Earthen Levee
Item	Encroachments

RD 556, unauthorized fence on L/S shoulder. Photo taken 10-02-2012.

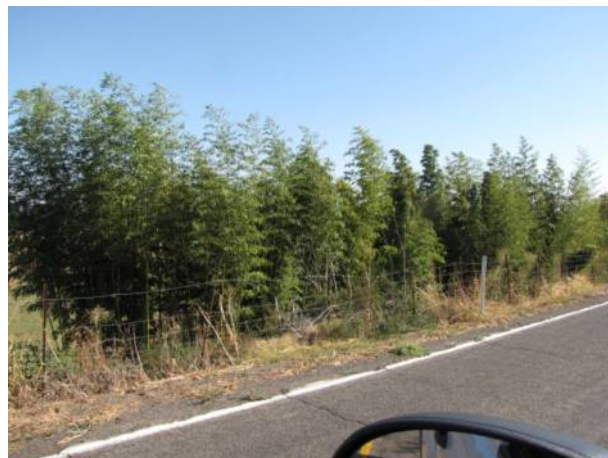
Levee Mile Report Line	41
Start Levee Mile	4.72
End Levee Mile	4.90
Location	Land Side
Category	Earthen Levee
Item	Vegetation

RD 556, wild wooded growth on L/S shoulder blocking view of levee. Photo taken 10-02-2012.

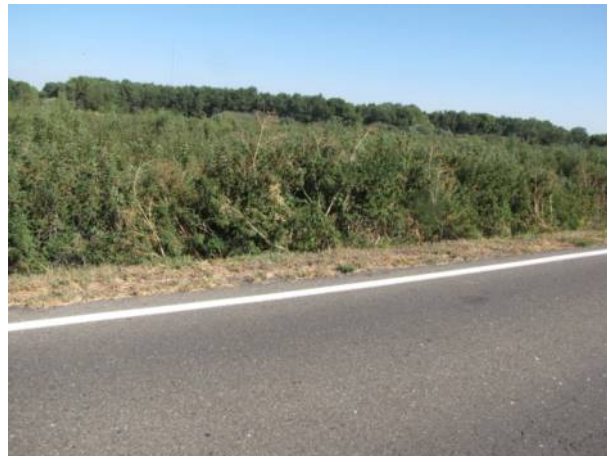
Levee Mile Report Line	47
Start Levee Mile	4.93
End Levee Mile	5.09
Location	Land Side
Category	Earthen Levee
Item	Vegetation

RD 556, wild wooded growth on L/S sholder blocking visibility. Photo taken 10-02-2012.

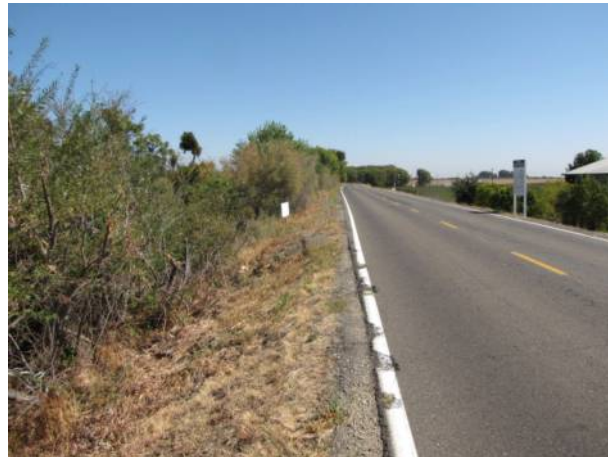
Levee Mile Report Line	58
Start Levee Mile	5.72
End Levee Mile	5.72
Location	Water Side
Category	Earthen Levee
Item	Vegetation

RD 556, looking upstream from levee mile 5.72 waterside. Photo taken 10-02-2012.
