**Flood Control Project Maintenance
Levee Inspections**

Fall 2013 Levee Maintenance Deficiency Summary Report

Reclamation District No. 0556 Upper Andrus

Levee Inspection Report By Mile - Fall 2013

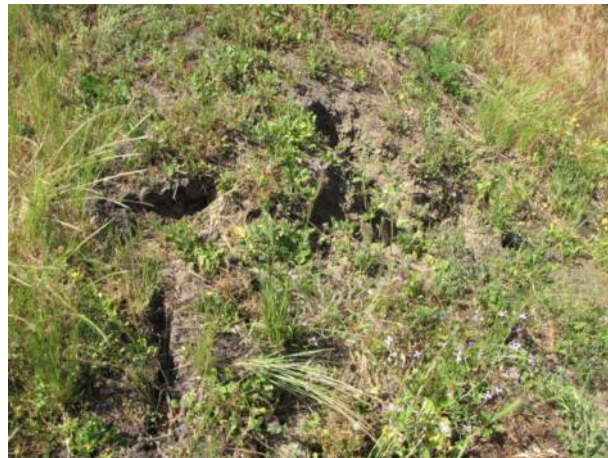
Levee Mile Report Line	67
Start Levee Mile	3.26
End Levee Mile	3.26
Location	Land Side
Category	Earthen Levee
Item	Animal Control

This damage was caused by gophers in levee slope. Photo taken 4-25-2013.

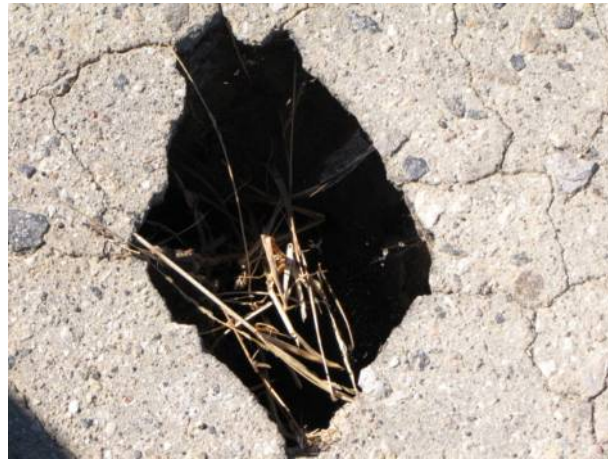
Levee Mile Report Line	78
Start Levee Mile	4.05
End Levee Mile	4.05
Location	Crown
Category	Earthen Levee
Item	Animal Control

This rodent hole is in the levee crown roadway and goes down some 3-4 feet deep. Repairs are needed before rainwater gets inside causing more problems. Status: unsatisfactory.
