**Flood Control Project Maintenance
Levee Inspections**

Fall 2014 Levee Maintenance Deficiency Summary Report

Sacramento River Basin

Reclamation District No. 0556 Upper Andrus

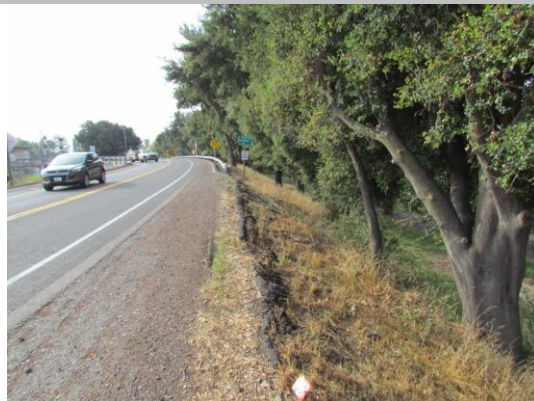
Photo 1 of 1 : FA_2014_RD0556_18_26_20141113_00014.jpg

Looking downstream from levee mile 0.21 at tall weeds on landside slope.

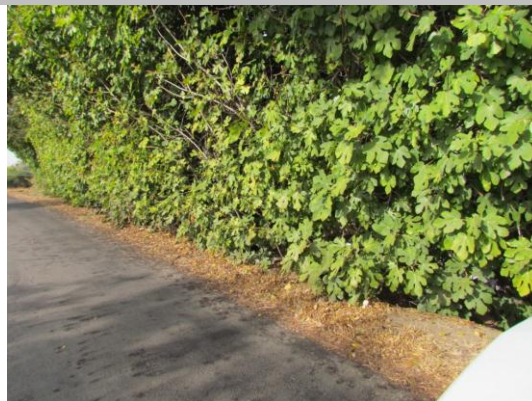
Photo 1 of 1 : FA_2014_RD0556_18_376_20141113_00017.jpg

Remove unwanted fig trees present on the landside slope.

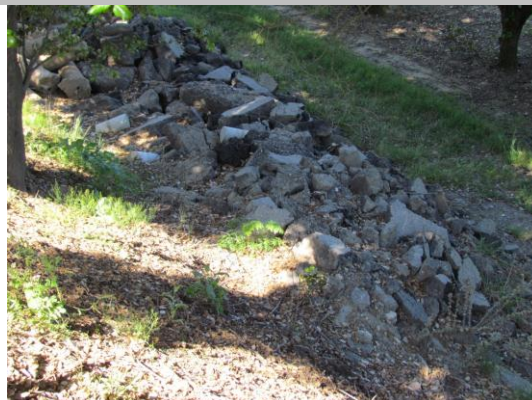
Photo 1 of 1 : FA_2014_RD0556_18_27_20141030_00005.jpg

Unauthorized asphalt dumping on the levee toe. No new photo taken; during the fall inspection 2014 this issue was still there.

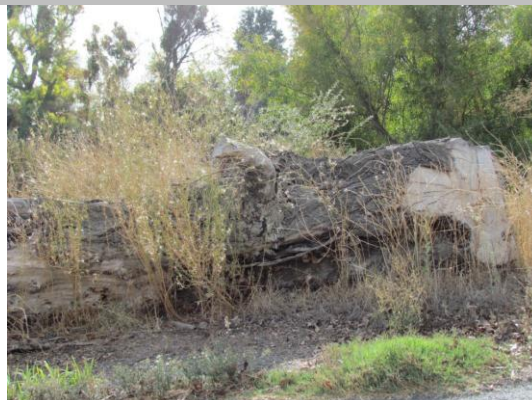
Photo 1 of 1 : FA_2014_RD0556_18_9_20141113_00018.jpg

Unwanted cut up tree sections remains on the waterward slope, landowner sits on the Reclamation Board for RD 556.

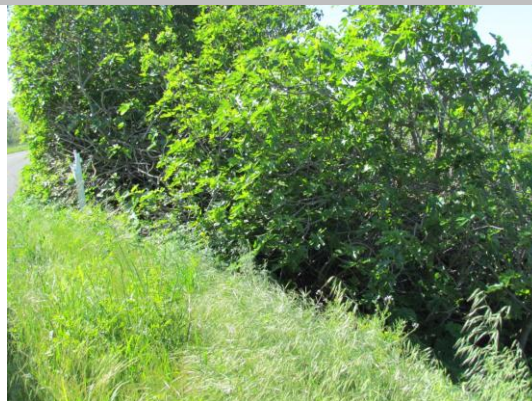
Photo 1 of 1 : FA_2014_RD0556_18_24_20141030_00004.jpg

Unsatisfactory woody tree growth and tall weeds along the shoulder, slope and toe landward.

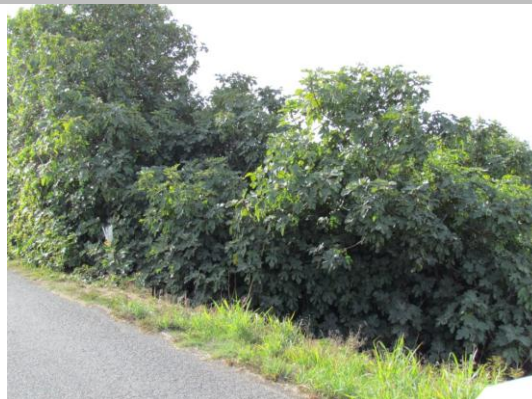
Photo 1 of 1 : FA_2014_RD0556_18_47_20141113_00022.jpg

Unsatisfactory tree growth completely blocking visibility of the levee section at this location.

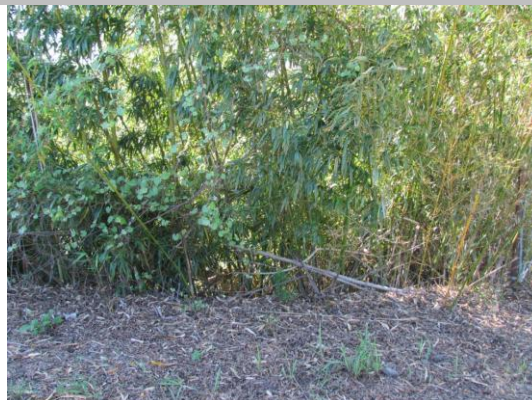
Photo 1 of 1 : FA_2014_RD0556_18_390_20141030_00010.jpg

Unsatisfactory growth of bambo on the landside slope and toe.

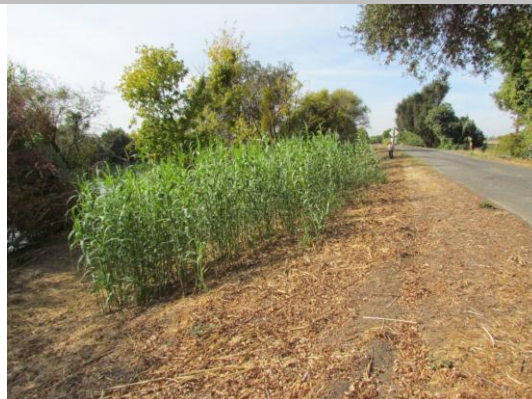
Photo 1 of 1 : FA_2014_RD0556_18_64_20141113_00021.jpg

Waterside levee mile 3-12 to 3.14: young patch of arundo growing.

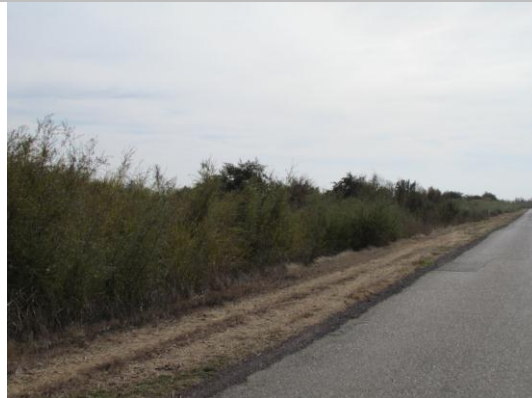
Photo 1 of 1 : FA_2014_RD0556_18_68_20141113_00024.jpg

Unwanted woody tree growth view of slope and toe waterward.

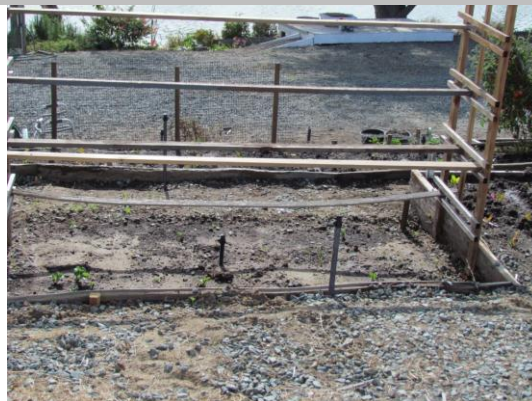
Photo 1 of 2 : FA_2014_RD0556_18_70_20141113_00025.jpg

Landowner has dug into waterward slope and placed planterboxes.

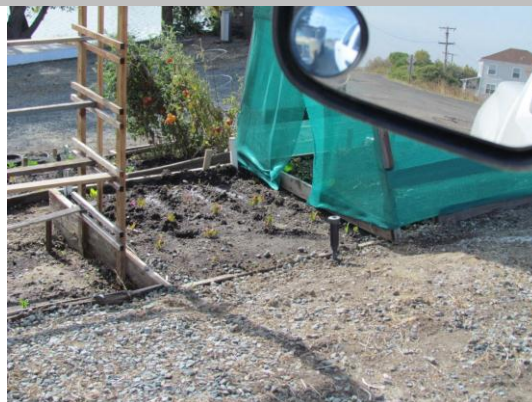
Photo 2 of 2 : FA_2014_RD0556_18_70_20141113_00026.jpg

Continue placement of unauthorized planter boxes into levee slope waterside.

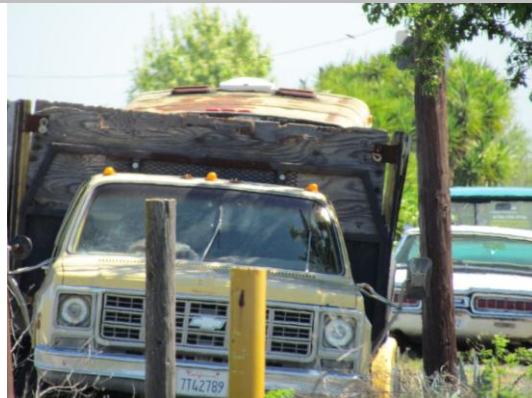
Photo 1 of 2 : FA_2014_RD0556_18_4_20141030_00001.jpg

LM Start	4.01	Rating **	U	Issue No.	4
LM End	4.04	Issue Type +	En	Location *	WS
Category	Earthen Levee			GPS Latitude/Longitude	
				Start	End
Item	Encroachments			38.201028 °	38.200801 °
				-121.543930 °	-121.544400 °
DWR ID	DWR_RD0556_01_s_2014_4				
Action/Comments					
Abandoned vehicles Inspector Comments: The levee is used to store vehicles at this location. There are lots of issues going on at this location, storing vehicles just happens to be one of them. Notice of violation needs to be issued to landowner.

Several vehicles using the water side shoulder as parking/storage.

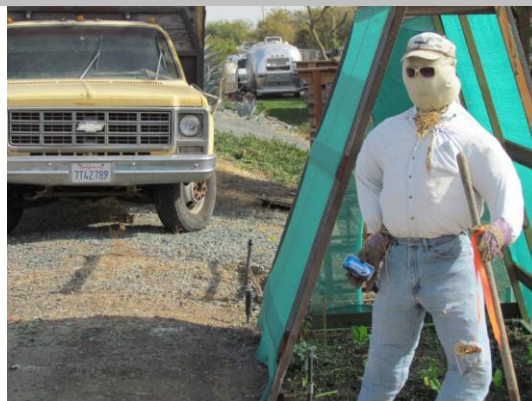
Photo 2 of 2 : FA_2014_RD0556_18_4_20141113_00023.jpg

LM Start	4.01	Rating **	U	Issue No.	4 (cont)	
LM End	4.04	Issue Type +	En	Location *	WS	
Category	Earthen Levee			GPS Latitude/Longitude		
				Start		End
Item	Encroachments			38.201028 °		38.200801 °
				-121.543930 °		-121.544400 °
DWR ID	DWR_RD0556_01_s_2014_4					
Action/Comments						
Abandoned vehicles Inspector Comments: The levee is used to store vehicles at this location. There are lots of issues going on at this location, storing vehicles just happens to be one of them. Notice of violation needs to be issued to landowner.

Unauthorized storage of vehicles and various other items stored at this location.

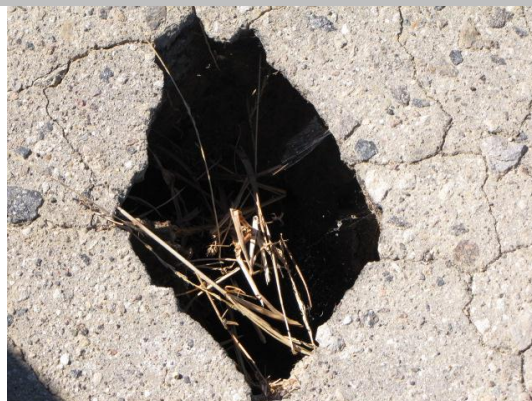
Photo 1 of 1 : FA_2014_RD0556_18_69_20141030_00008.jpg

This rodent hole is in the levee crown roadway and goes down some 3-4 feet deep. Repairs are needed before rainwater get inside causing more problems. Status: unsatisfactory. There was no new photo taken of this site during the inspection of 4-2014. No new photo taken; this hole has not been backfilled.

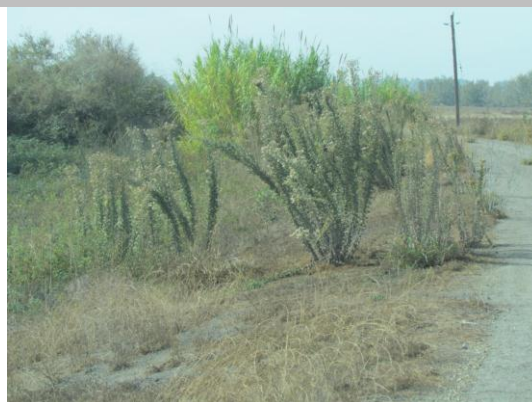
Photo 1 of 1 : FA_2014_RD0556_18_67_20141113_00029.jpg

Unwanted tall weeds along with *Arundo* present on the waterside slope.

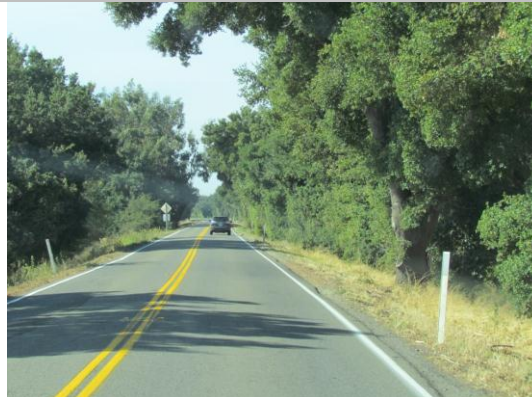
Photo 1 of 1 : FA_2014_RD0556_19_82_20141113_00027.jpg

Standing at levee mile 0.00 looking downstream both slope covered with wild growth.

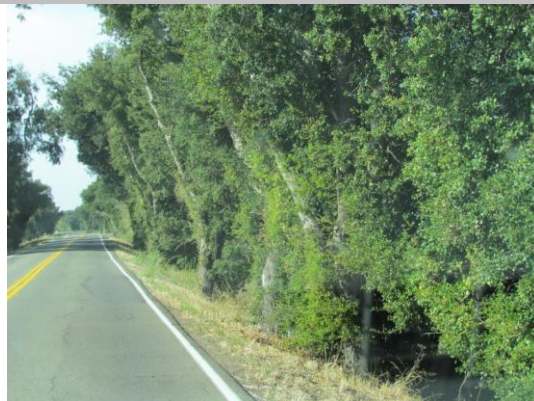
Photo 1 of 1 : FA_2014_RD0556_19_32_20141113_00026.jpg

Woody tree growth on the waterside levee section.

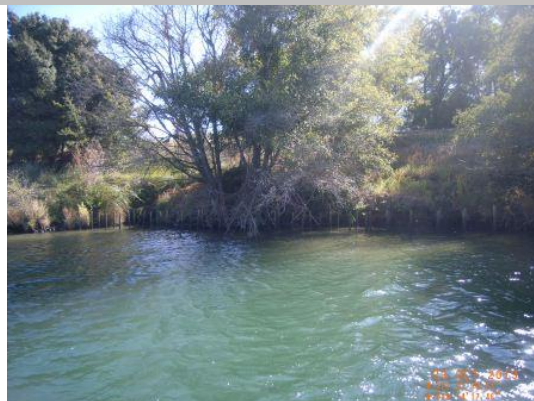
USACE 2013 Photo #1

LM Start	0.31	Rating **	M	Issue No.	28
LM End	0.60	Issue Type +	Ma	Location *	WS
Category	Supplemental			GPS Latitude/Longitude	
				Start	End
Item	USACE Erosion Survey			38.238784 °	38.237862 °
				-121.523932 °	-121.529188 °
DWR ID	DWR_RD0556_02_f_2014_28				
Action/Comments					
Inspector Comments: 2002 - Two rocked sections (150 ft long) at the downstream end. 2005 - Lots of old brush boxes, some with established vegetation in the area behind the boxes. 2006 - Some small spots fixed with stone. 2009 - Minimal new erosion, rock in the middle of the reach may be new. 2011 - Minor new erosion at the toe. 2013: Minor new erosion. [2013 Site ID: SAC_26-0_L]

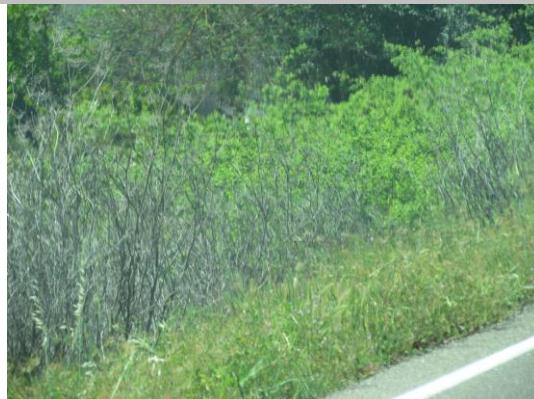
Photo 1 of 1 : FA_2014_RD0556_19_24_20141030_00006.jpg

Unsatisfactory growth on the landward slope and toe of the levee section.

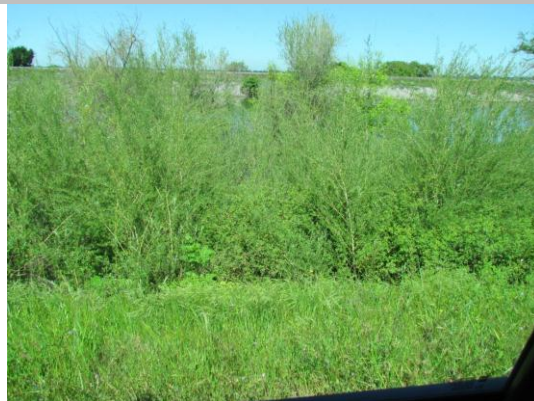
Photo 1 of 1 : FA_2014_RD0556_19_69_20141030_00013.jpg

Unwanted wild growth on the water side slope and toe. No new photo taken during Fall inspection 2014.

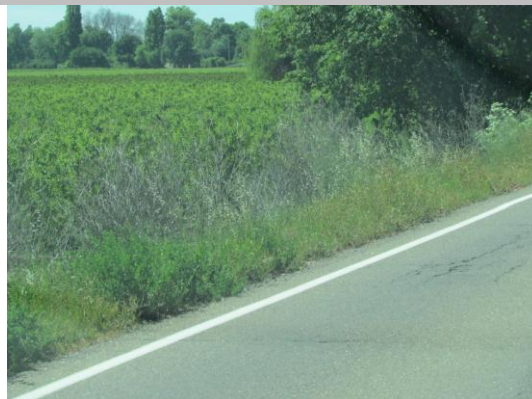
Photo 1 of 1 : FA_2014_RD0556_19_71_20141030_00014.jpg

Wild growth on landward levee section greater than 4-foot tall covering the levee slope and toe. No new photo Fall 2014.

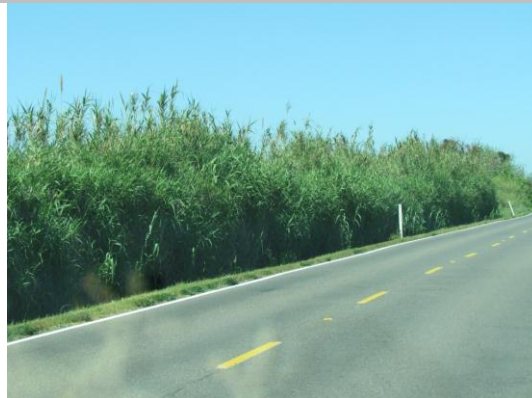
Photo 1 of 1 : FA_2014_RD0556_19_35_20141030_00011.jpg

Unsatisfactory wild growth of bambo blocking view of the levee section on the waterside shoulder and slope. No new photo.
