**Flood Control Project Maintenance
Levee Inspections**

Fall 2015 Levee Maintenance Deficiency Summary Report

Sacramento River Basin

Reclamation District No. 0556 Upper Andrus

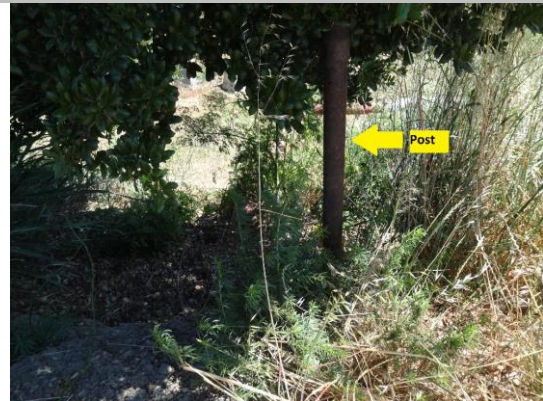
Photo 2 of 3 : UCIP_FA_2015_4405.jpg

Action/Comments					
Inspector Comments: FS_ID:46799 DS_ID:25106 EP_NO: N/A FS_HLM: 1.16 Repair Type: Non-Urgent Crossing Status: Found UCIP Comments: Possible erosion above pipe on LS needs attention. FIELD_STRUCT_DESC: 8-inch steel irrigation pipe unknown feet below crown visible on LS 6 ft away from 10-inch pipe. Post likely for protection of vent located off the crown on shoulder. Electric pole next to pipe on LS. FS Date: 05/27/2015

LS view: Post located above pipe on LS slope.

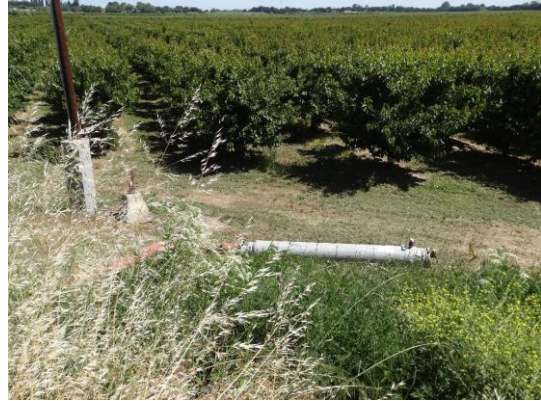
Photo 3 of 3 : UCIP_FA_2015_4406.jpg

Electric pole next to pipe on LS.

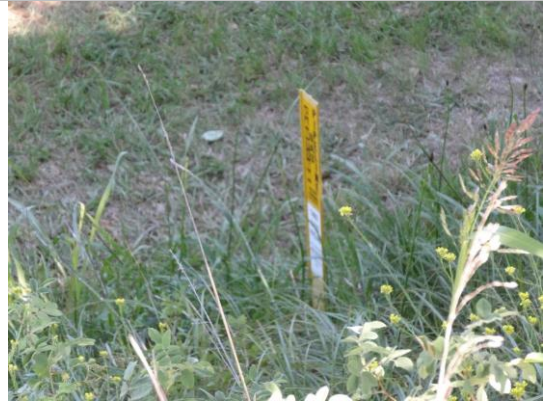
Photo 1 of 4 : UCIP_FA_2015_5798.jpg

LM Start	0.43	Rating **	M	Issue No.	391
LM End	0.43	Issue Type +	En	Location *	LS
Category	Supplemental			GPS Latitude/Longitude	
				Start	End
Item	DWR UCIP Field Study			38.233537 °	38.233537 °
				-121.520483 °	-121.520483 °
DWR ID					
Action/Comments					
Inspector Comments: FS_ID:45564 DS_ID:20820 EP_NO: 3448 FS_HLM: 0.43 Repair Type: Non-Urgent Crossing Status: Indicator Found UCIP Comments: Dense vegetation inhibited visibility of gasline marker on WS. Need to contact owner to determine status of crossing. FIELD_STRUCT_DESC: 4-1/2-inch steel pipe gas line through levee, 4.0 feet below the crown. Location marker on waterward shoulder. (App. 3448-PG&E pipe not located 2/91). Cut in pavement visible at crossing. Gasline marker on LS and opposite bank at RD 263. FS Date: 05/27/2015

Gasline marker present on LS.

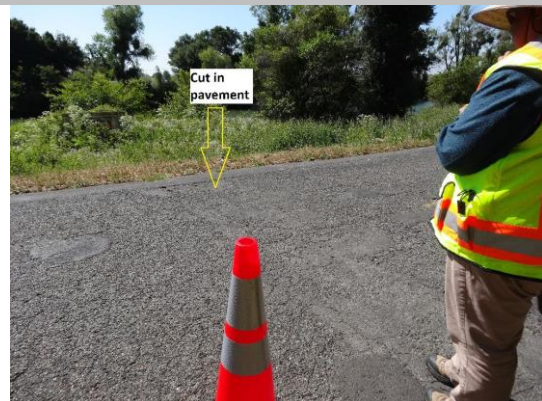
Photo 3 of 4 : UCIP_FA_2015_6321.jpg

Inspector Comments: FS_ID:45564
 DS_ID:20820
 EP_NO: 3448
 FS_HLM: 0.43
 Repair Type: Non-Urgent
 Crossing Status: Indicator Found
 UCIP Comments: Dense vegetation inhibited visibility of gasline marker on WS. Need to contact owner to determine status of crossing.
 FIELD_STRUCT_DESC: 4-1/2-inch steel pipe gas line through levee, 4.0 feet below the crown. Location marker on waterward shoulder.
 (App. 3448-PG&E pipe not located 2/91). Cut in pavement visible at crossing. Gasline marker on LS and opposite bank at RD 263.
 FS Date: 05/27/2015

View of WS; cut in pavement in alignment with arrow and Olivia indicating location of crossing trench.

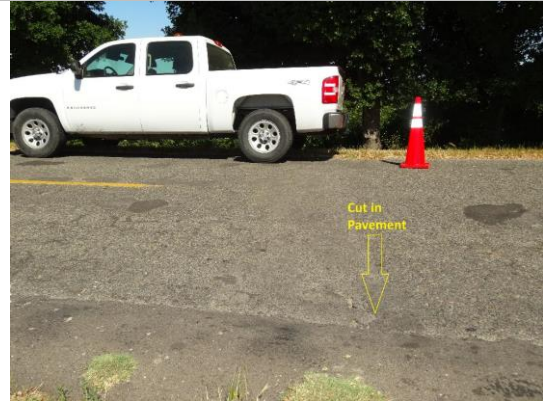
Photo 4 of 4 : UCIP_FA_2015_6322.jpg

View of LS. Cut in pavement in alignment with tree on LS and arrow.

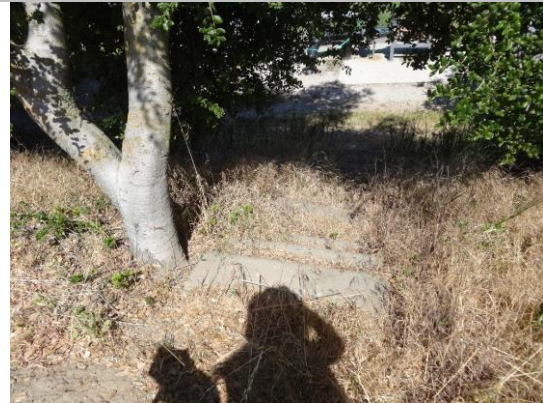
Photo 1 of 3 : UCIP_FA_2015_6323.jpg

LM Start	0.53	Rating **	M	Issue No.	392
LM End	0.53	Issue Type +	En	Location *	LS
Category	Supplemental			GPS Latitude/Longitude	
				Start	End
Item	DWR UCIP Field Study			38.232450 °	38.232450 °
				-121.521624 °	-121.521624 °
DWR ID					
Action/Comments					
Inspector Comments: FS_ID:45663 DS_ID:20821 EP_NO: 5548 FS_HLM: 0.53 Repair Type: Non-Urgent Crossing Status: Found UCIP Comments: Dense vegetation prevents inspection of WS slope. FIELD_STRUCT_DESC: 12-inch steel pipe through levee, 5.0 feet below crown. 1-1/4-inch electrical conduit through the levee. Concrete steps on landward slope. Pump off landward toe. Cuts visible on pavement. (App. 5548). FS Date: 05/13/2015

Concrete steps on LS slope.

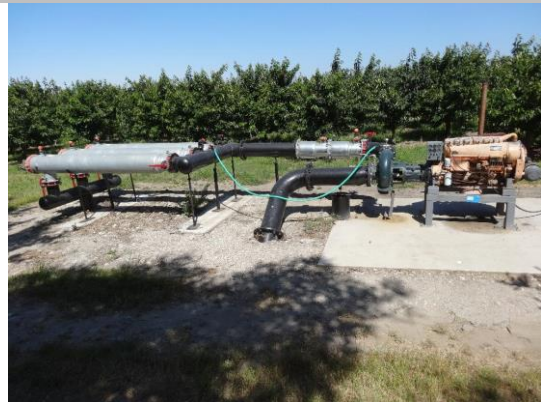
Photo 3 of 3 : UCIP_FA_2015_6326.jpg

Inspector Comments: FS_ID:45663
 DS_ID:20821
 EP_NO: 5548
 FS_HLM: 0.53
 Repair Type: Non-Urgent
 Crossing Status: Found
 UCIP Comments: Dense vegetation prevents inspection of WS slope.
 FIELD_STRUCT_DESC: 12-inch steel pipe through levee, 5.0 feet below crown. 1-1/4-inch electrical conduit through the levee. Concrete steps on landward slope. Pump off landward toe. Cuts visible on pavement. (App. 5548).
 FS Date: 05/13/2015

Pump and pipe into levee off LS toe.

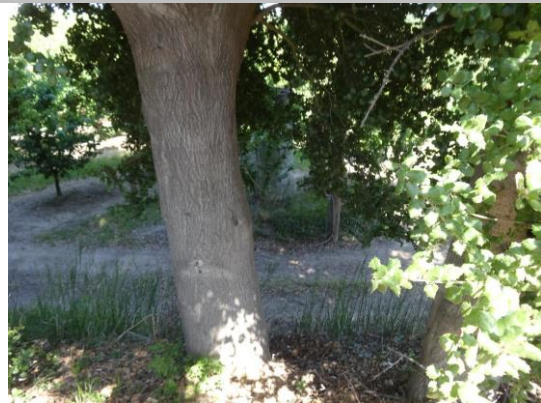
Photo 2 of 2 : UCIP_FA_2015_6376.jpg

LM Start	0.54	Rating **	M	Issue No.	393
LM End	0.54	Issue Type +	En	Location *	LS
Category	Supplemental			GPS Latitude/Longitude	
				Start	End
Item	DWR UCIP Field Study			38.232354 °	38.232354 °
				-121.521727 °	-121.521727 °
DWR ID					
Action/Comments					
Inspector Comments: FS_ID:45664					
DS_ID:20826					
EP_NO: 5548A					
FS_HLM: 0.54					
Repair Type: Non-Urgent					
Crossing Status: Found

View of LS with standpipe visible behind tree.

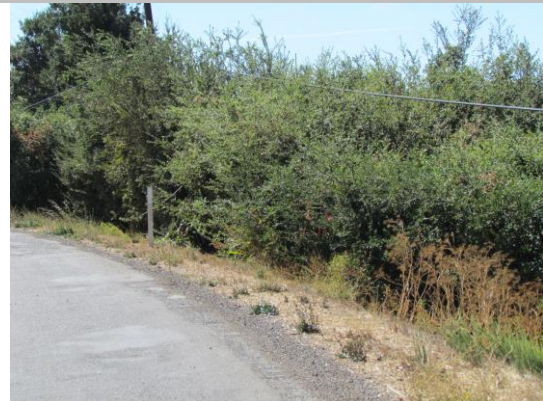
Photo 1 of 1 : FA_2015_RD0556_18_10_20151007_00029.jpg

Unsatisfactory woody tree growth on the landside shoulder and slope.

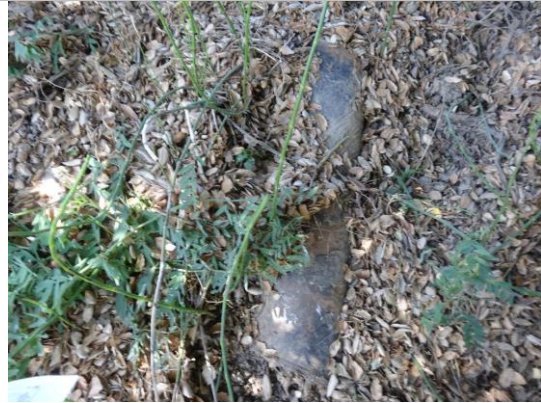
Photo 1 of 3 : UCIP_FA_2015_6377.jpg

Action/Comments					
Inspector Comments: FS_ID:45683 DS_ID:20823 EP_NO: 11169 FS_HLM: 1.17 Repair Type: Non-Urgent Crossing Status: Found UCIP Comments: Appears abandoned in place and if so should be done so properly. Dense vegetation on WS limits visibility. FIELD_STRUCT_DESC: 10-inch pipe through levee, 3.8 feet below crown. (Lower end of rock revetment)(ABO 11169 - Mealer and 4848). Abandoned in place. O&M Manual Sac 103, June 1954 FS Date: 05/27/2015

LS view of pipe appearing abandoned in place.

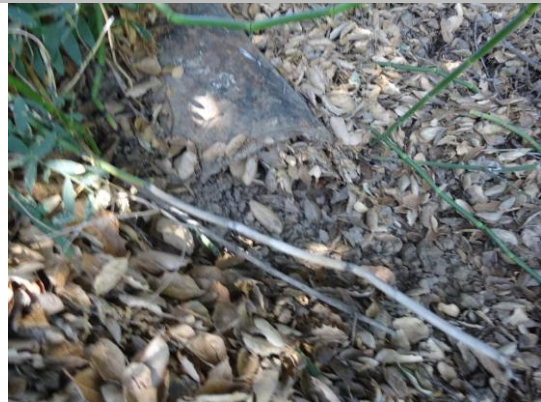
Photo 2 of 3 : UCIP_FA_2015_6378.jpg

Closeup of abandoned pipe.

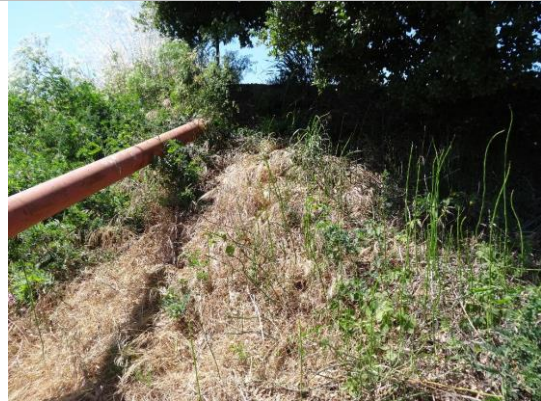
Photo 3 of 3 : UCIP_FA_2015_6379.jpg

View up LS slope. 10" pipe (not visible) rests next to (visible) 8" pipe.

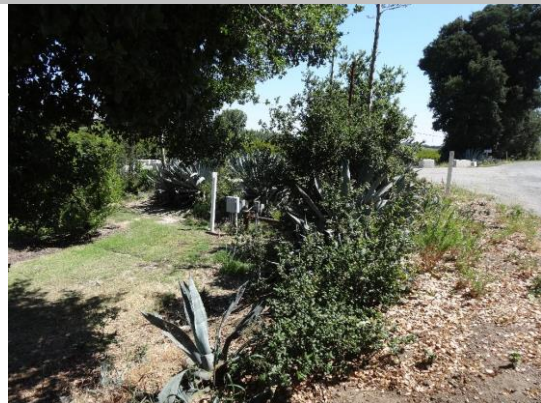
Photo 1 of 1 : UCIP_FA_2015_5797.jpg

LM Start	1.33	Rating **	M	Issue No.	395
LM End	1.33	Issue Type +	En	Location *	LS
Category	Supplemental			GPS Latitude/Longitude	
				Start	End
Item	DWR UCIP Field Study			38.227622 °	38.227622 °
				-121.532154 °	-121.532154 °
DWR ID					
Action/Comments					
Inspector Comments: FS_ID:45692 DS_ID:20825 EP_NO: 13302 FS_HLM: 1.32 Repair Type: Non-Urgent Crossing Status: Found UCIP Comments: Seal beneath siphon breaker off LS toe leaking. Rodent activity near crown off LS shoulder. Need to contact owner about leaky seal. Dense vegetation prevented inspection of WS slope. FIELD_STRUCT_DESC: 6-inch steel pipe and 2-inch GI electrical conduit through levee 2 feet below crown; roadway with siphon valve on landward shoulder. Concrete stand and pump on landward toe; circuit box also. Cuts visible on pavement. 6-inch PVC standpipe adjacent to pipe off LS toe. (Kay Dix Ranch App. 13302). O&M Manual Sac 103, June 1954 FS Date: 05/27/2015

Pipe, standpipe, electrical box at LS toe. Pumphouse in bush behind electrical box.

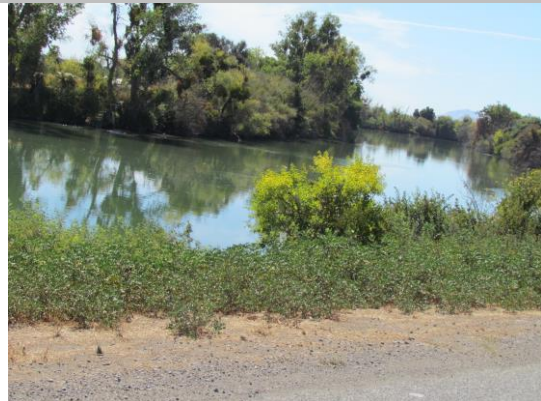
Photo 1 of 1 : FA_2015_RD0556_18_71_20151006_00022.jpg

Looking downstream from levee mile 1.27- 1.55 wild roses on waterside slope and berm.

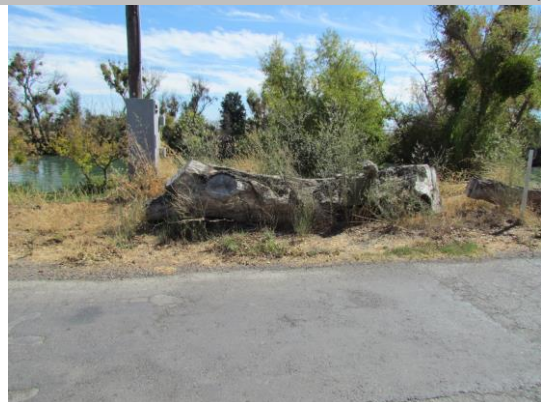
Photo 1 of 1 : FA_2015_RD0556_18_9_20151006_00025.jpg

Unsatisfactory dumping of cut up tree sections on the waterside levee shoulder.

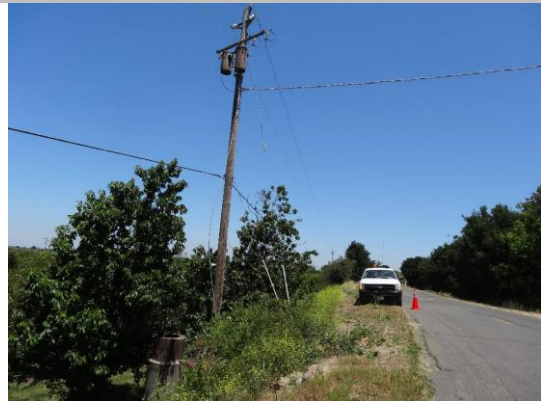
Photo 2 of 2 : UCIP_FA_2015_5801.jpg

Action/Comments					
Inspector Comments: FS_ID:45743 DS_ID:20827 EP_NO: 11169 FS_HLM: 1.56 Repair Type: Non-Urgent Crossing Status: Found UCIP Comments: Dense vegetation on LS and WS limited accessibility. FIELD_STRUCT_DESC: 8-inch steel pipe through levee, 3.5 feet below crown. Pump and gate valve on WS berm. 2-inch electrical conduit into WS slope. A 36-inch concrete standpipe and concrete block step on Landward Slope. (Listed as 10-inch in ABO 11169 - Mealer). O&M Manual Sac 103, June 1954 FS Date: 05/27/2015

Service pole next to standpipe off LS toe.

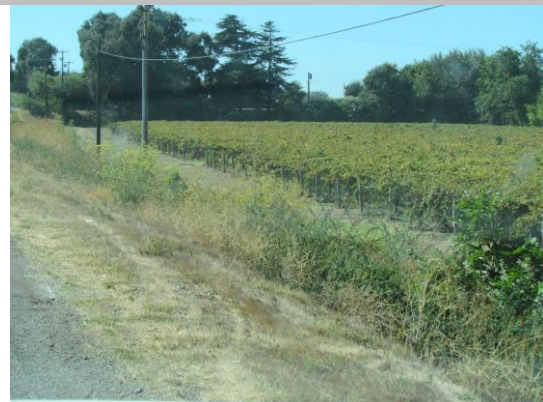
Photo 1 of 1 : FA_2015_RD0556_18_73_20151006_00026.jpg

Looking downstream from landside levee mile 1.72-1.95 unsatisfactory tall weed growth on the slope and toe.

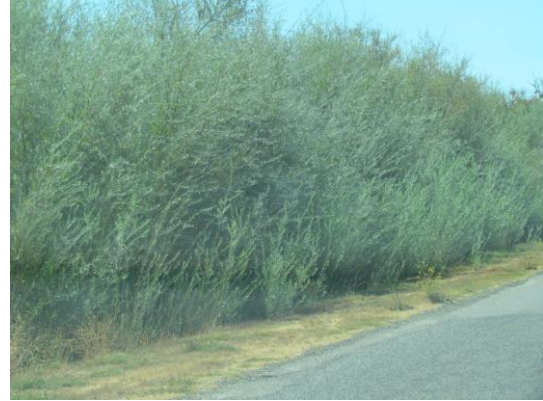
Photo 1 of 1 : FA_2015_RD0556_18_74_20151006_00027.jpg

Levee mile 1.74-2.00 waterside wild growth of arundo present on levee shoulder and slope, unable to see the ground.

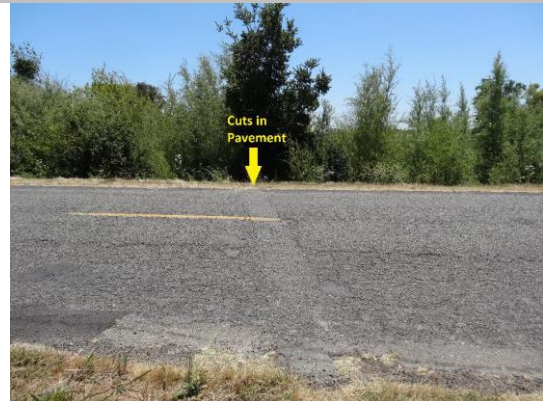
Photo 1 of 3 : UCIP_FA_2015_5802.jpg

LM Start	1.79	Rating **	M	Issue No.	397
LM End	1.79	Issue Type +	En	Location *	WS
Category	Supplemental			GPS Latitude/Longitude	
				Start	End
Item	DWR UCIP Field Study			38.223999 °	38.223999 °
				-121.538735 °	-121.538735 °
DWR ID					
Action/Comments					
Inspector Comments: FS_ID:45746 DS_ID:20828 EP_NO: 3735 FS_HLM: 1.78 Repair Type: Non-Urgent Crossing Status: Indicator Found UCIP Comments: Dense vegetation on LS and WS limited accessibility. FIELD_STRUCT_DESC: 4-inch electric conduit through levee, 4.0 feet below the crown. Pump on berm. Underground submarine cable crossing. (App. 3735-PG&E). Electric pole on LS in alignment with cuts in pavement. FS Date: 05/27/2015

View of WS and cuts in pavement.

Action/Comments					
Inspector Comments: FS_ID:45746 DS_ID:20828 EP_NO: 3735 FS_HLM: 1.78 Repair Type: Non-Urgent Crossing Status: Indicator Found UCIP Comments: Dense vegetation on LS and WS limited accessibility. FIELD_STRUCT_DESC: 4-inch electric conduit through levee, 4.0 feet below the crown. Pump on berm. Underground submarine cable crossing. (App. 3735-PG&E). Electric pole on LS in alignment with cuts in pavement. FS Date: 05/27/2015

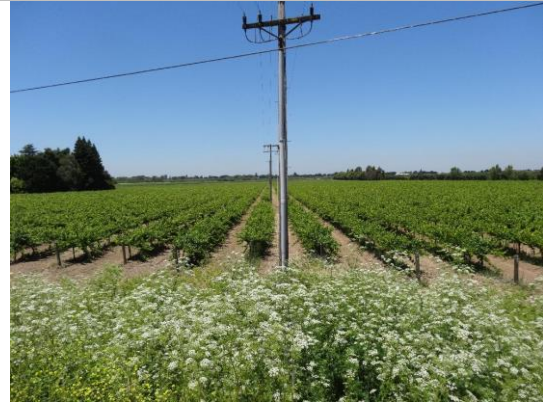
Photo 2 of 3 : UCIP_FA_2015_5847.jpg

Cuts in pavement in alignment with electric pole off LS toe.

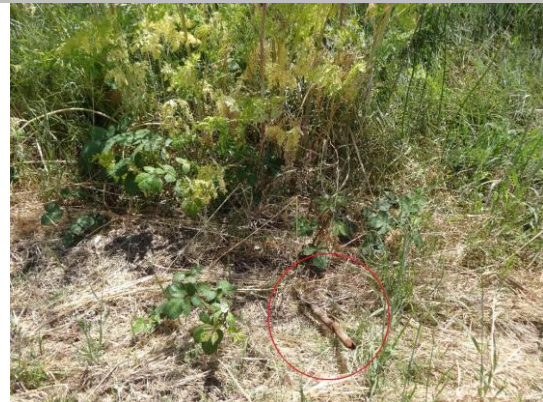
Photo 3 of 3 : UCIP_FA_2015_5848.jpg

Pipe debris present at LS toe.

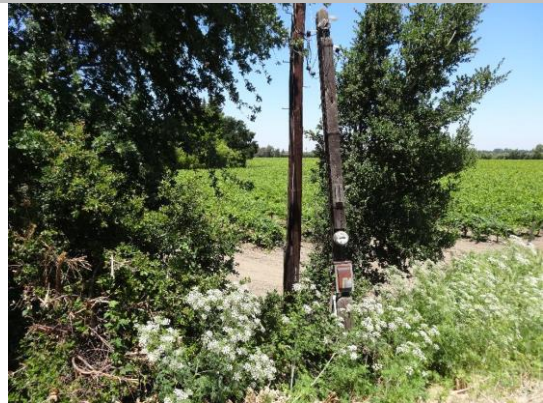
Photo 2 of 3 : UCIP_FA_2015_5850.jpg

LM Start	1.89	Rating **	M	Issue No.	398
LM End	1.89	Issue Type +	En	Location *	WS
Category	Supplemental			GPS Latitude/Longitude	
				Start	End
Item	DWR UCIP Field Study			38.223760 °	38.223760 °
				-121.540629 °	-121.540629 °
DWR ID					
Action/Comments					
Inspector Comments: FS_ID:45764					
DS_ID:20829					
EP_NO: 11178					
FS_HLM: 1.88					
Repair Type: Non-Urgent					
Crossing Status: Found

Pole on LS slope with electric box and 2-inch conduit.

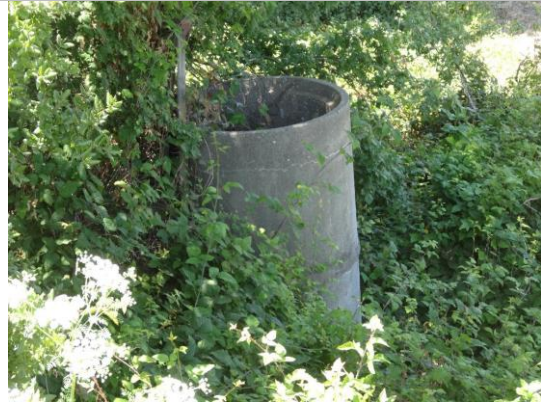
Photo 3 of 3 : UCIP_FA_2015_5851.jpg

Standpipe on LS next to service pole.

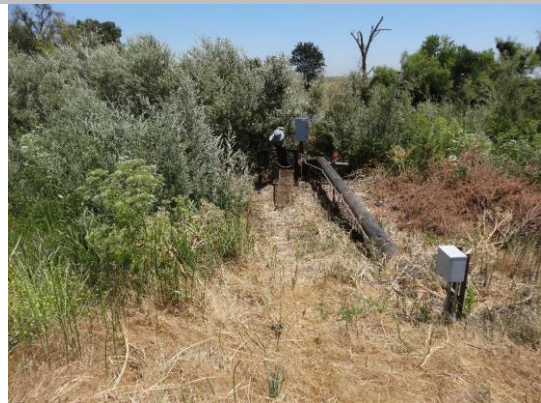
Photo 1 of 3 : UCIP_FA_2015_5858.jpg

LM Start	2.13	Rating **	M	Issue No.	399
LM End	2.13	Issue Type +	En	Location *	WS
Category	Supplemental			GPS Latitude/Longitude	
				Start	End
Item	DWR UCIP Field Study			38.222560 °	38.222560 °
				-121.544485 °	-121.544485 °
DWR ID					
Action/Comments					
Inspector Comments: FS_ID:45786 DS_ID:20830 EP_NO: 2392 FS_HLM: 2.13 Repair Type: Non-Urgent Crossing Status: Found UCIP Comments: Hole and exposed depression adjacent to pipe at LS. Dense vegetation on WS and LS limited visibility. FIELD_STRUCT_DESC: 12 inch steel irrigation pipe through levee, 3.0 feet below crown. Slant pump on bank. 1-inch electrical conduit through levee beside 12-inch pipe, visible on WS. Service pole and 2 standpipes at LW toe, one of which is a 6-inch standpipe. (App. 2392 - Swett) FS Date: 05/27/2015

WS view: Slant pump, 12-inch and 1-inch pipe through levee.

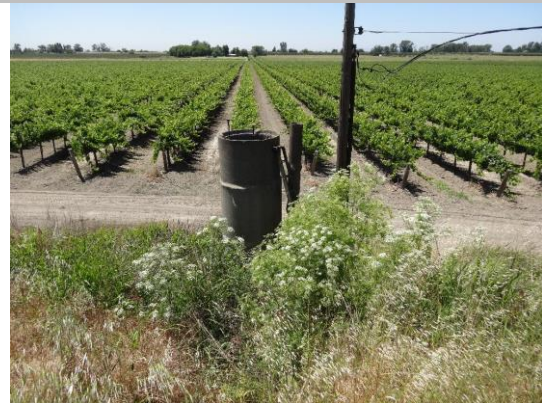
Photo 3 of 3 : UCIP_FA_2015_5860.jpg

Inspector Comments: FS_ID:45786
 DS_ID:20830
 EP_NO: 2392
 FS_HLM: 2.13
 Repair Type: Non-Urgent
 Crossing Status: Found
 UCIP Comments: Hole and exposed depression adjacent to pipe at LS.
 Dense vegetation on WS and LS limited visibility.
 FIELD_STRUCT_DESC: 12 inch steel irrigation pipe through levee, 3.0 feet below crown. Slant pump on bank. 1-inch electrical conduit through levee beside 12-inch pipe, visible on WS. Service pole and 2 standpipes at LW toe, one of which is a 6-inch standpipe. (App. 2392 - Swett)
 FS Date: 05/27/2015

LS: 2 standpipes and service pole.

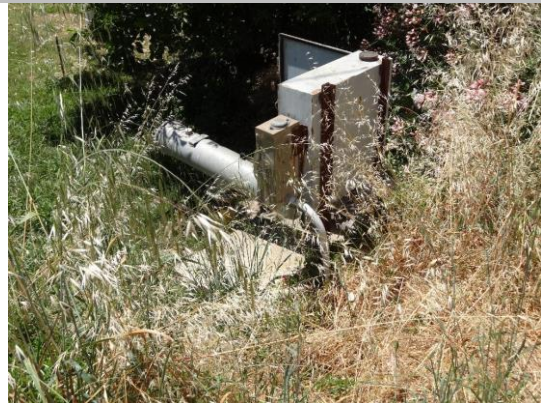
Photo 2 of 2 : UCIP_FA_2015_6381.jpg

Inspector Comments: FS_ID:45803
 DS_ID:20831
 EP_NO: 11169
 FS_HLM: 2.43
 Repair Type: Urgent
 Crossing Status: Found
 UCIP Comments: 2'x2' hole on levee off LS shoulder.
 FIELD_STRUCT_DESC: 8 inch steel irrigation pipe through levee, 3.7 feet below crown. Pump and switch panel on berm. Service pole on landward side. A 9 ft x 36-inch concrete standpipe on landside of the levee. 3 cables encased in 1.5-inch steel pipe at WS alongside 8-inch pipe, disconnected at WS. (ABO 11169-Mealer). O&M Manual Sac 103, June 1954.
 FS Date: 05/27/2015

Closeup of 8-inch pipe, electrical conduit and box at LS berm.

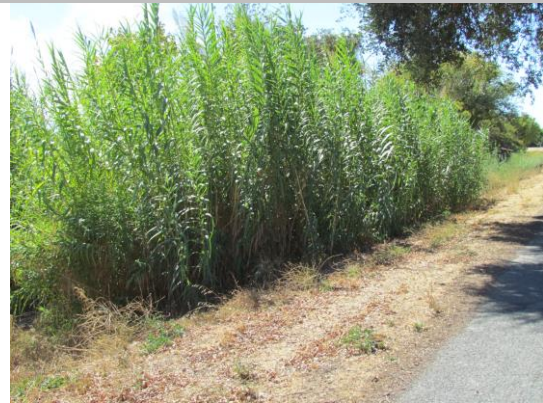
Photo 1 of 1 : FA_2015_RD0556_18_78_20151007_00039.jpg

Looking downstream from waterside shoulder, arundo blocking view of levee section.

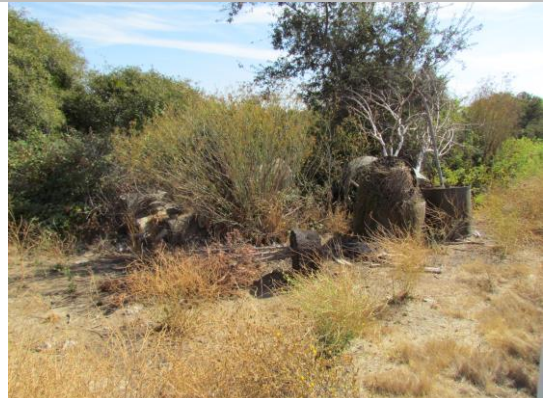
Photo 1 of 1 : FA_2015_RD0556_18_23_20151007_00033.jpg

At this location the landowner has discarded concrete pipe and plant containers on the waterside levee shoulder.

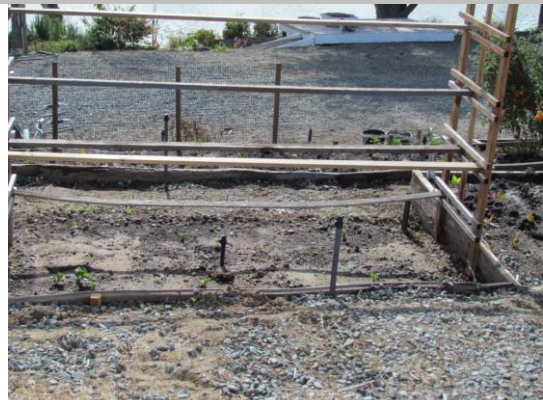
Photo 2 of 2 : FA_2015_RD0556_18_70_20150915_00017.jpg

Landowner has dug into waterward slope and placed planterboxes.

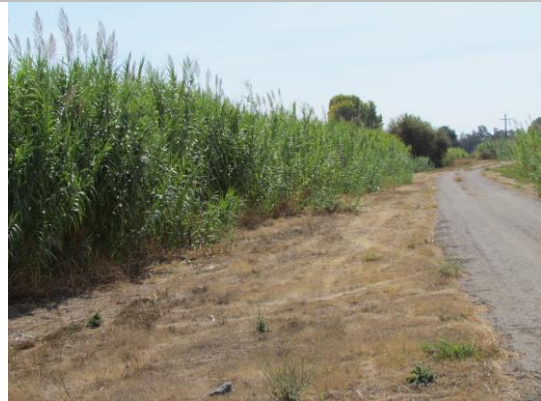
Photo 1 of 1 : FA_2015_RD0556_18_67_20151007_00032.jpg

Looking downstream on waterside the arundo completely covering the levee section.

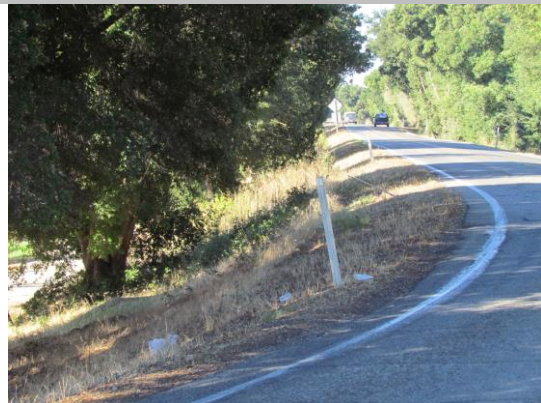
Photo 1 of 1 : FA_2015_RD0556_19_43_20151106_00029.jpg

RD 556 Unit 2 looking downstream from the landside shoulder wild weeds present on the levee slope and toe.

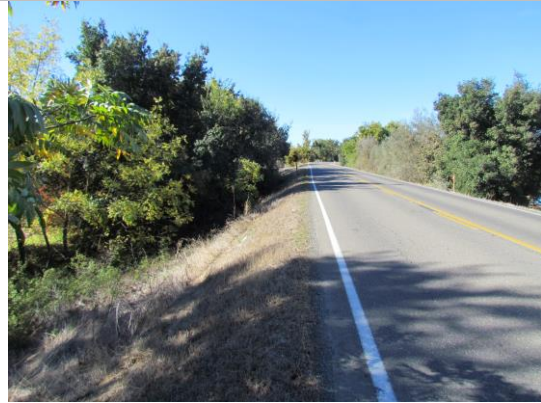
Photo 1 of 1 : FA_2015_RD0556_19_66_20151106_00030.jpg

Looking downstream from the landside levee slope levee mile ,0.57.

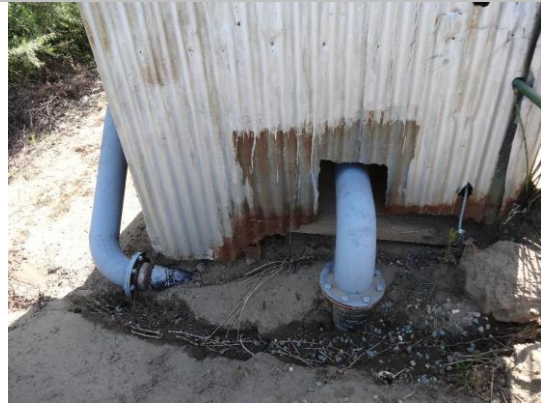
Photo 1 of 3 : UCIP_FA_2015_0903.jpg

WS- pipe daylight from the pump house.

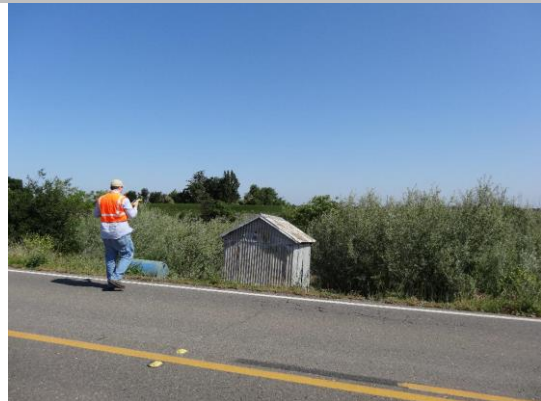
Photo 3 of 3 : UCIP_FA_2015_0905.jpg

WS- pump house on levee berm

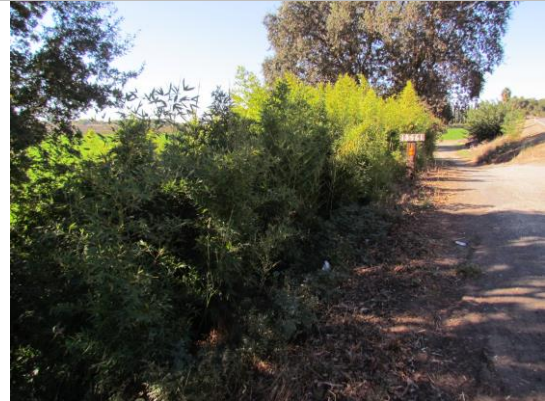
Photo 1 of 1 : FA_2015_RD0556_19_76_20151106_00031.jpg

Unsatisfactory growth of bambo on the landside shoulder.

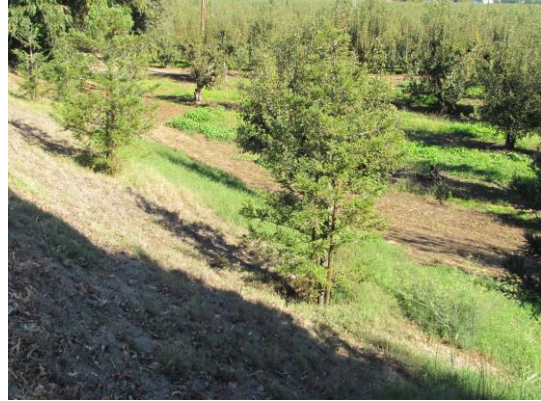
Photo 1 of 1 : FA_2015_RD0556_19_1_20151110_00037.jpg

RD 556 Unit 2 Levee mile 2.28 unauthorized planting of redwood trees planted on the slope.

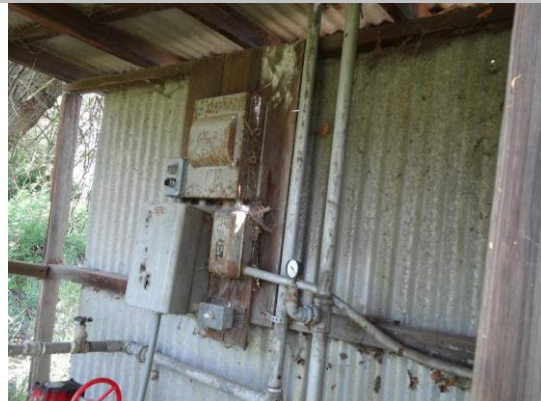
Photo 1 of 3 : UCIP_FA_2015_0646.jpg

WS- power control panel and electric conduit in pump house.

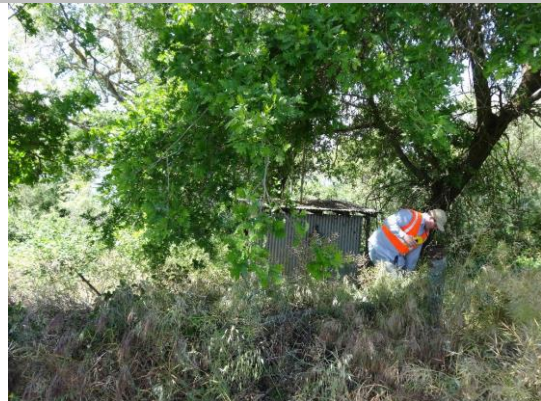
Photo 3 of 3 : UCIP_FA_2015_0648.jpg

WS- pump house on levee berm

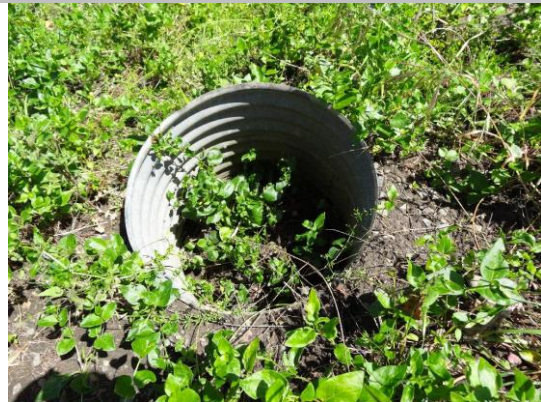
Photo 2 of 3 : UCIP_FA_2015_0638.jpg

LS- siphon breaker in CMP riser on levee slope.

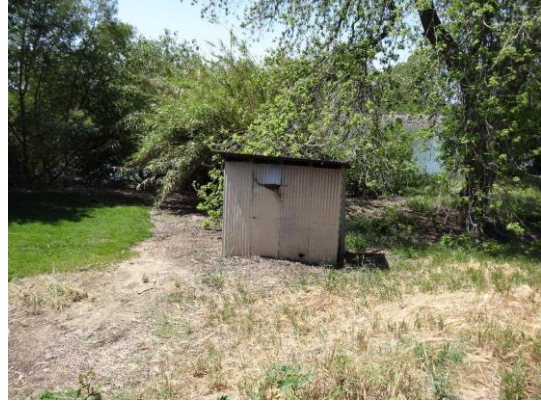
Photo 3 of 3 : UCIP_FA_2015_0639.jpg

WS- pump house on levee berm.

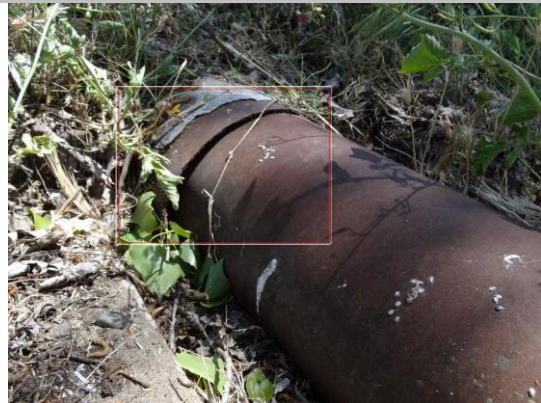
Photo 2 of 3 : UCIP_FA_2015_0641.jpg

WS- 9-inch pipe sleeved through 10 inch steel pipe.

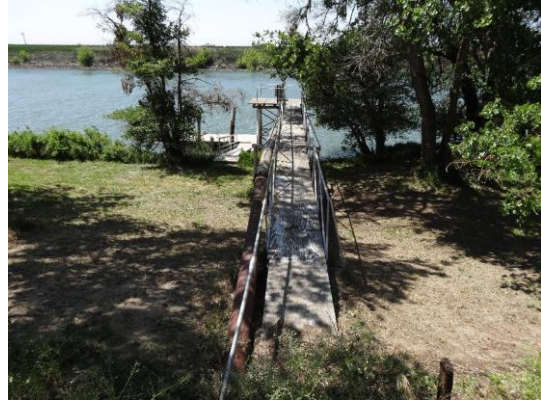
Photo 3 of 3 : UCIP_FA_2015_0642.jpg

WS- walkway, pump, and pipe on steel pile structure in the river.

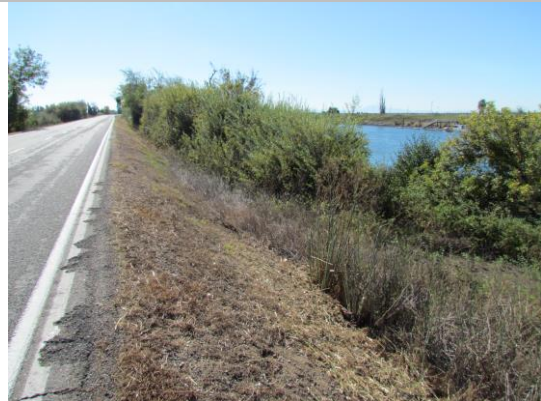
Photo 1 of 1 : FA_2015_RD0556_19_84_20151106_00032.jpg

Looking downstream from the waterside levee slope at the bambo and other unsatisfactory weeds covering the levee slope from 3.16 to 5.58.

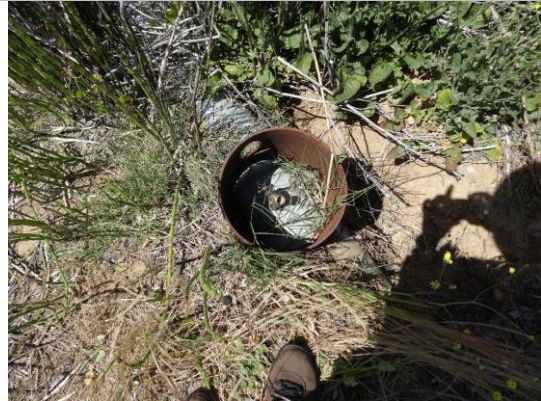
Photo 1 of 3 : UCIP_FA_2015_0754.jpg

WS- siphon breaker on levee slope.

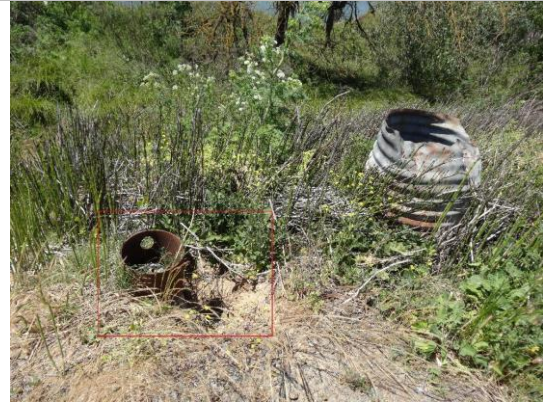
Photo 2 of 3 : UCIP_FA_2015_0755.jpg

WS- siphon breaker and abandoned CMP riser laying adjacent to it.

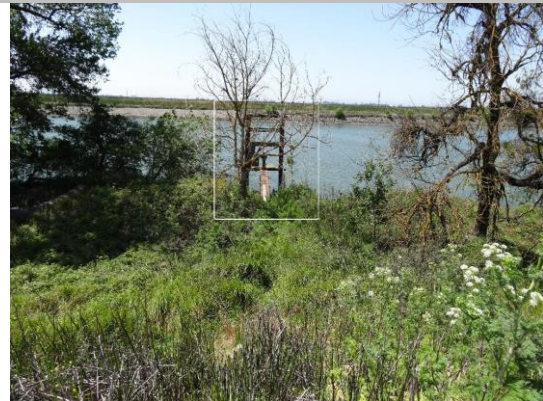
Photo 3 of 3 : UCIP_FA_2015_0756.jpg

WS- pump, pipe, and walkway on steel structure in the stream.

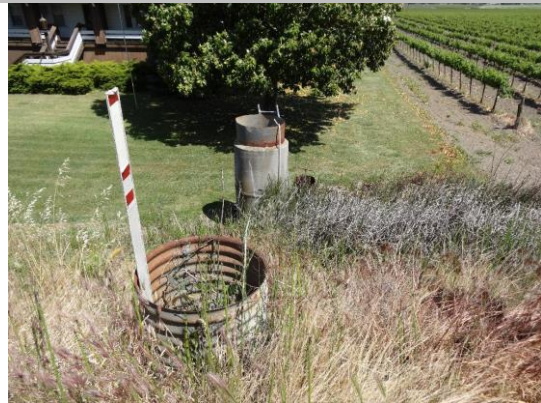
Photo 2 of 3 : UCIP_FA_2015_0758.jpg

LS- siphon breaker in CMP riser and concrete standpipe behind CMP riser.

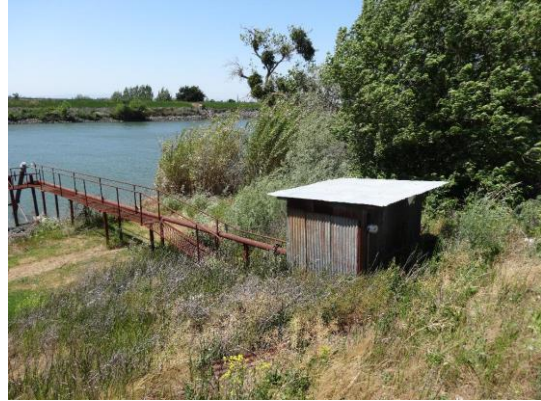
Photo 3 of 3 : UCIP_FA_2015_0759.jpg

WS- pipe and pump on steel pile structure. Steel walkway from pump house to the pump on steel structure.

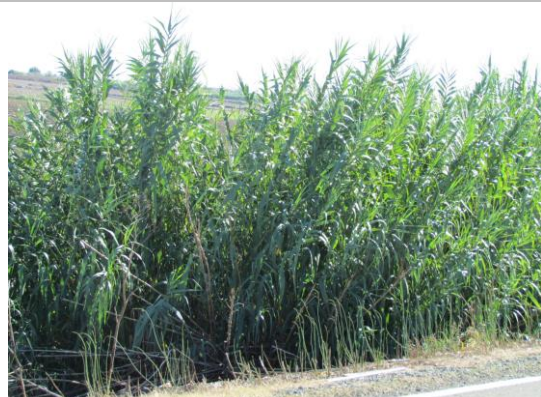
Photo 1 of 1 : FA_2015_RD0556_19_87_20151110_00035.jpg

RD 556 Unit 2 looking downstream from the landside shoulder levee miles 4.21-4.22.

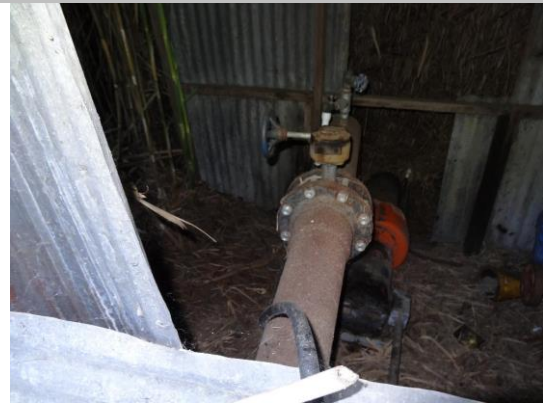
Photo 1 of 3 : UCIP_FA_2015_0799.jpg

WS- pump, gate valve and pipe in pump house.

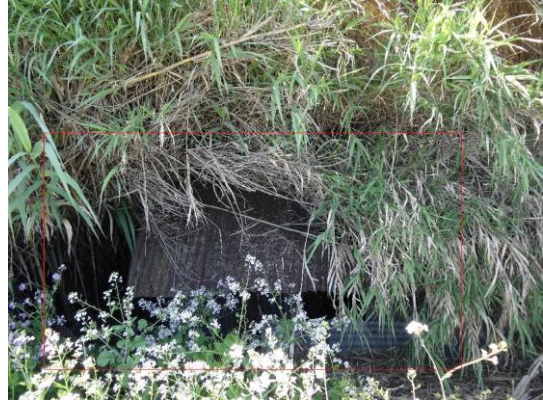
Photo 2 of 3 : UCIP_FA_2015_0800.jpg

WS- pump house inside the dense vegetation.

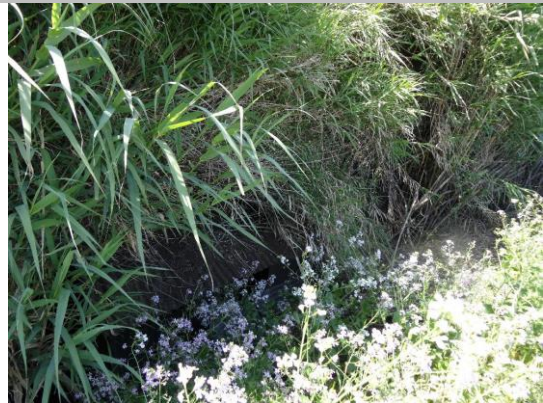
Photo 3 of 3 : UCIP_FA_2015_0801.jpg

WS- pump house not visible due to the dense vegetation.

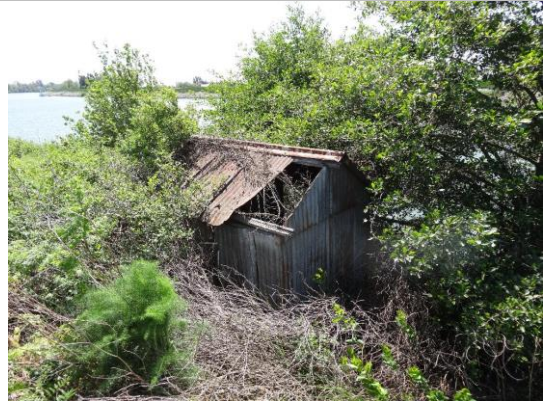
Photo 2 of 3 : UCIP_FA_2015_0803.jpg

WS- abandoned pump house on levee slope. Dense vegetation on levee slope.

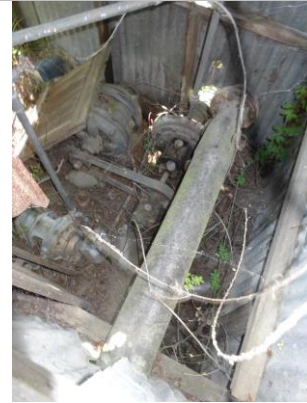
Photo 3 of 3 : UCIP_FA_2015_0804.jpg

WS- abandoned gate valve, pump, and pipe in pump house

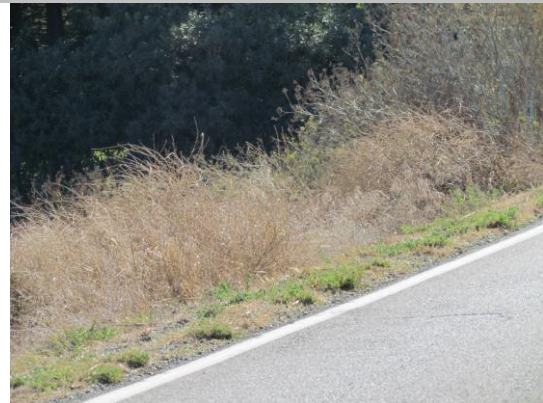
Photo 1 of 1 : FA_2015_RD0556_19_88_20151110_00036.jpg

RD 556 Unit 2 looking downstream from levee miles 4.31 - 5.31 unsatisfactory tall weed growth on the landside levee slope.

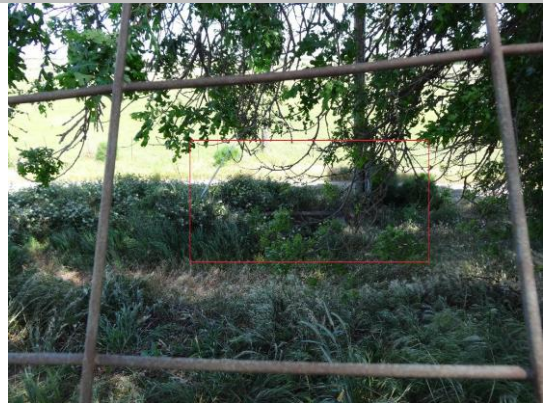
Photo 2 of 3 : UCIP_FA_2015_0806.jpg

LS- concrete distribution box near levee toe.

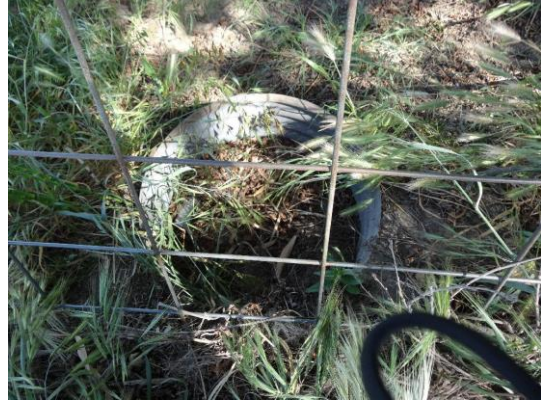
Photo 3 of 3 : UCIP_FA_2015_0807.jpg

LS- obstructed siphon breaker in CMP riser on levee slope.

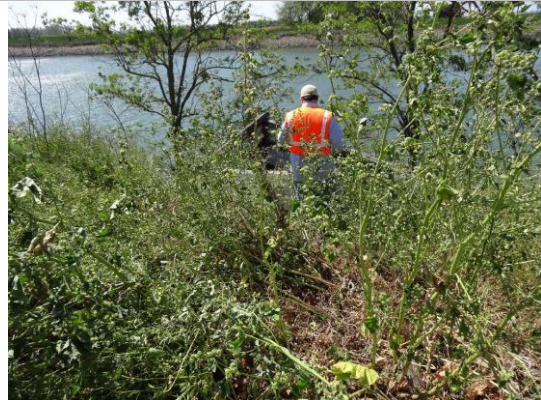
Photo 2 of 2 : UCIP_FA_2015_0809.jpg

WS- pump house on levee slope.

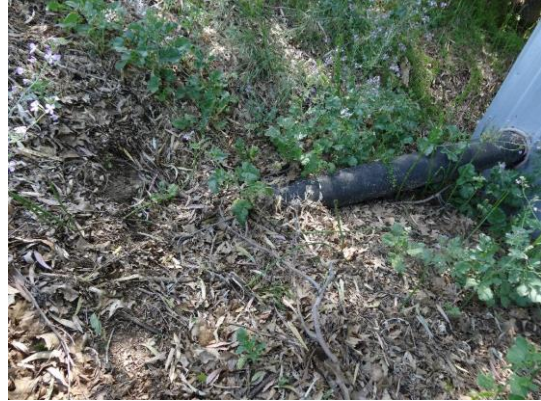
Photo 1 of 2 : UCIP_FA_2015_0810.jpg

WS- pipe daylight from the levee.

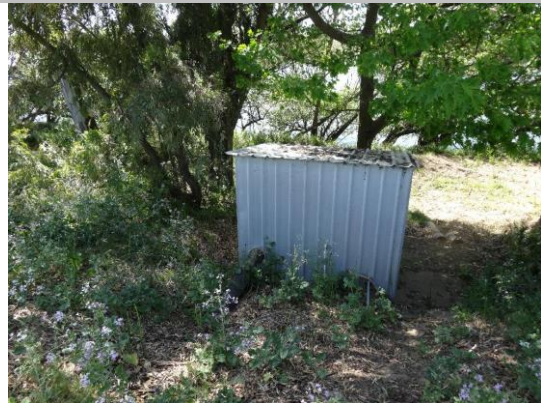
Photo 2 of 2 : UCIP_FA_2015_0811.jpg

LM Start	5.21	Rating **	U	Issue No.	101 (cont)
LM End	5.21	Issue Type +	En	Location *	WS

WS- pump house on levee slope
