**Flood Control Project Maintenance
Levee Inspections**

Fall 2016 Levee Maintenance Deficiency Summary Report

**Flood Control Project Maintenance
Levee Inspections**
LMA District Cover Sheet
Fall 2016 Levee Inspection Results

Reclamation District No. 0556 Upper Andrus

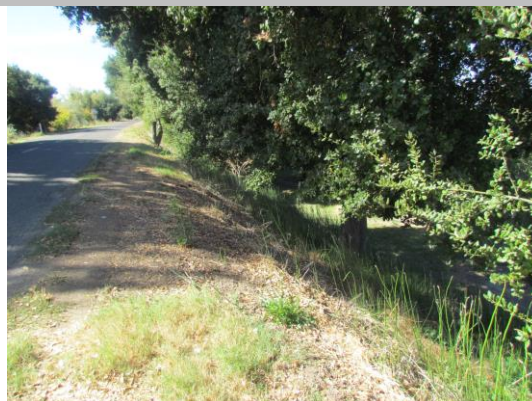
Photo 1 of 1 : FA_2016_RD0556_18_26_20161025_00050.jpg

RD 556 Unit 1 landside levee miles 0.24-0.73 looking downstream.

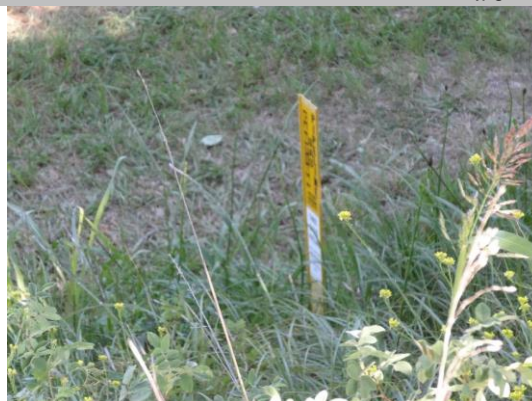
Photo 1 of 2 : UCIP_FA_2016_45564_74151.jpg

LM Start	0.44	Rating **	M	Issue No.	388
LM End	0.44	Issue Type +	En	Location *	WS
Category	Supplemental			GPS Latitude/Longitude	
				Start	End
Item	DWR UCIP Field Study			38.233537 °	38.233537 °
				-121.520483 °	-121.520483 °
DWR ID					
Comment Code					
Inspector Comment					
FS_ID:45564					
DS_ID:20820					
EP_NO: 3448					
Repair Type: Non-Urgent					
Crossing Status: Indicator Found					
UCIP Comments: Dense vegetation inhibited visibility of gasline marker on WS. Need to contact owner to determine status of crossing.					
FIELD_STRUCT_DESC: 4-1/2-inch steel pipe gas line through levee, 4.0 feet below the crown. Location marker on waterward shoulder. (App. 3448-PG&E pipe not located 2/91). Cut in pavement visible at crossing. Gasline marker on LS and opposite bank at RD 263.					
FS Date: 5/27/2015

Gasline marker present on LS.

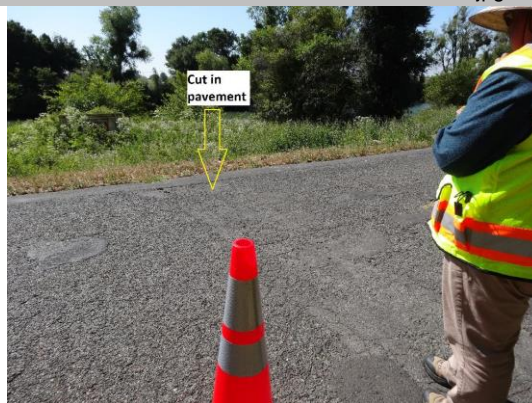
Photo 2 of 2 : UCIP_FA_2016_45564_74146.jpg

View of WS; cut in pavement in alignment with arrow and Olivia indicating location of crossing trench.

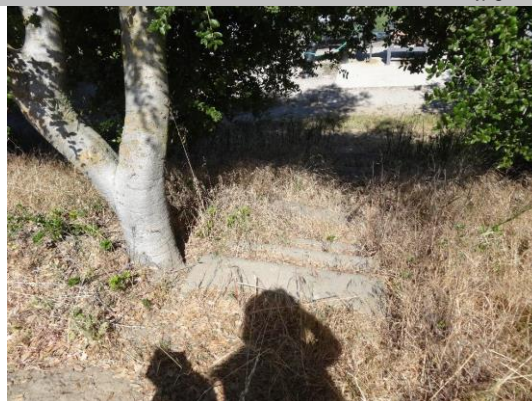
Photo 1 of 2 : UCIP_FA_2016_45663_74180.jpg

FS_ID:45663
DS_ID:20821
EP_NO: 5548
Repair Type: Non-Urgent
Crossing Status: Found
UCIP Comments: Dense vegetation prevents inspection of WS slope.
FIELD_STRUCT_DESC: 12-inch steel pipe through levee, 5.0 feet below crown. 1-1/4-inch electrical conduit through the levee. Concrete steps on landward slope. Pump off landward toe. Cuts visible on pavement. (App. 5548).
FS Date: 5/13/2015

Concrete steps on LS slope.

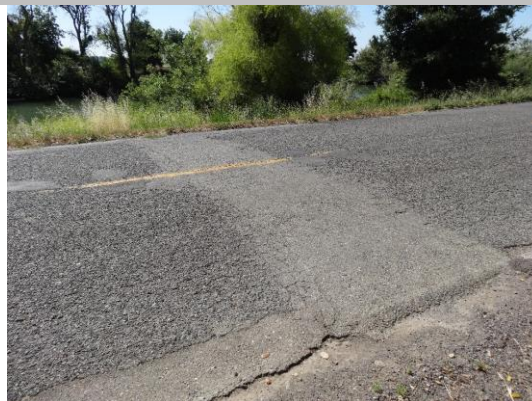
Photo 2 of 2 : UCIP_FA_2016_45663_74181.jpg

View of WS with cuts visible on pavement.

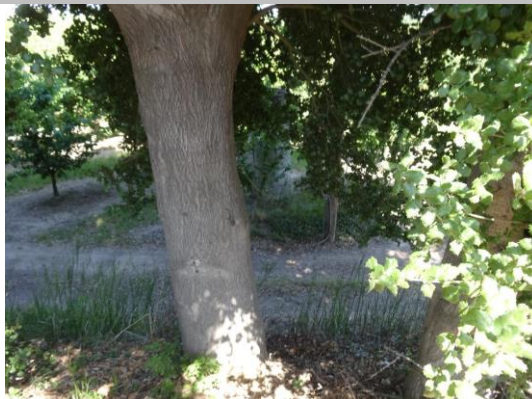
Photo 1 of 2 : UCIP_FA_2016_45664_74190.jpg

FS_ID:45664
DS_ID:20826
EP_NO: 5548A
Repair Type: Non-Urgent
Crossing Status: Found
UCIP Comments: Dense vegetation prevented inspection of WS slope.
FIELD_STRUCT_DESC: 14-inch pipe through levee 5.0 feet below the crown. Pole with panel and standpipe on landward toe (5548A- Kay Dix Ranch 1986).
FS Date: 5/27/2015

View of LS with standpipe visible behind tree.

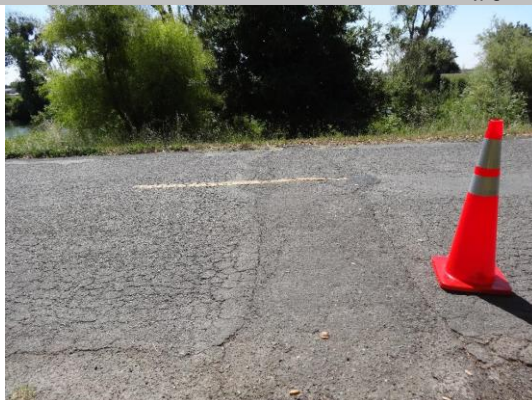
Photo 2 of 2 : UCIP_FA_2016_45664_74191.jpg

View of WS with cuts visible on pavement.

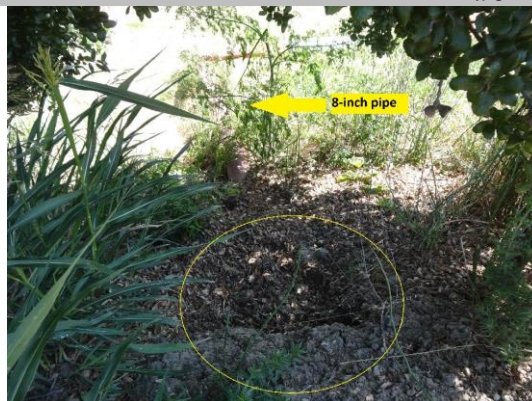
Photo 1 of 2 : UCIP_FA_2016_46799_74739.jpg

FS_ID:46799
DS_ID:25106
EP_NO: N/A
Repair Type: Non-Urgent
Crossing Status: Found
UCIP Comments: Possible erosion above pipe on LS needs attention.
FIELD_STRUCT_DESC: 8-inch steel irrigation pipe unknown feet below crown visible on LS 6 ft away from 10-inch pipe. Post likely for protection of vent located off the crown on shoulder. Electric pole next to pipe on LS.
FS Date: 5/27/2015

LS view: 8-inch pipe off LS slope with possible erosion above pipe (circled).

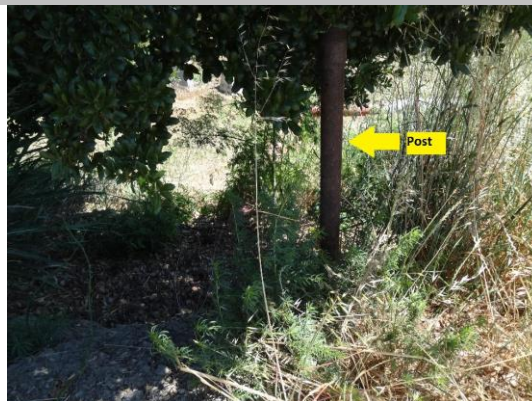
Photo 2 of 2 : UCIP_FA_2016_46799_74740.jpg

LS view: Post located above pipe on LS slope.

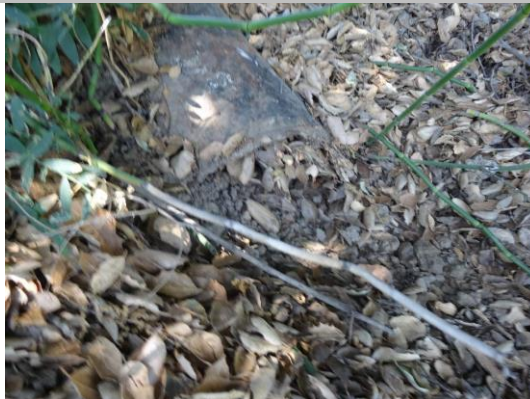
Photo 2 of 2 : UCIP_FA_2016_45683_74201.jpg

FS_ID:45683
DS_ID:20823
EP_NO: 11169
Repair Type: Non-Urgent
Crossing Status: Found
UCIP Comments: Appears abandoned in place and if so should be done so properly. Dense vegetation on WS limits visibility.
FIELD_STRUCT_DESC: 10-inch pipe through levee, 3.8 feet below crown. (Lower end of rock revetment)(ABO 11169 - Mealer and 4848).
Abandoned in place. O&M Manual Sac 103, June 1954
FS Date: 5/27/2015

Closeup of abandoned pipe.

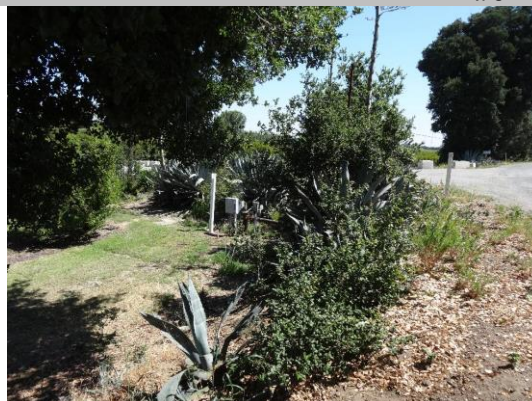
Photo 1 of 2 : UCIP_FA_2016_45692_74204.jpg

Comment Code					
Inspector Comment					
FS_ID:45692 DS_ID:20825 EP_NO: 13302 Repair Type: Non-Urgent Crossing Status: Found UCIP Comments: Seal beneath siphon breaker off LS toe leaking. Rodent activity near crown off LS shoulder. Need to contact owner about leaky seal. Dense vegetation prevented inspection of WS slope. FIELD_STRUCT_DESC: 6-inch steel pipe and 2-inch GI electrical conduit through levee 2 feet below crown; roadway with siphon valve on landward shoulder. Concrete stand and pump on landward toe; circuit box also. Cuts visible on pavement. 6-inch PVC standpipe adjacent to pipe off LS toe. (Kay Dix Ranch App. 13302). O&M Manual Sac 103, June 1954 FS Date: 5/27/2015

Pipe, standpipe, electrical box at LS toe. Pump house in bush behind electrical box.

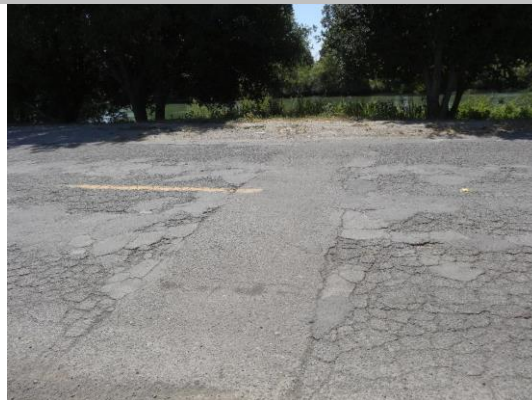
Photo 2 of 2 : UCIP_FA_2016_45692_74205.jpg

WS view and cuts visible on pavement.

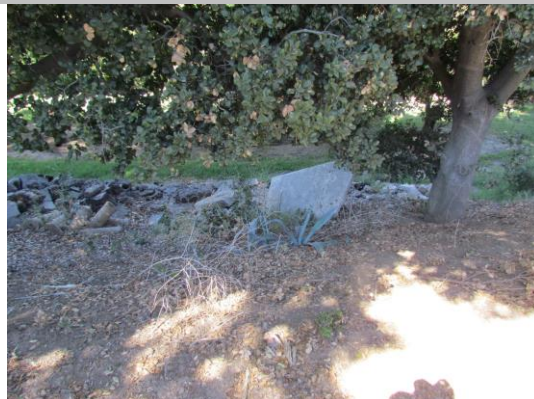
Photo 1 of 3 : FA_2016_RD0556_18_27_20161025_00052.jpg

ARD 556 unit 1 levee miles 1.34-1.37 unauthorized piles of asphalt and concrete dumped on the landside levee toe.

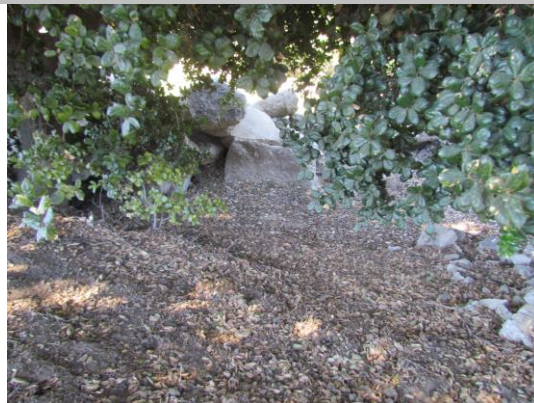
Photo 2 of 3 : FA_2016_RD0556_18_27_20161025_00053.jpg

RD 556 Unit 1 levee miles 1.34-1.37.

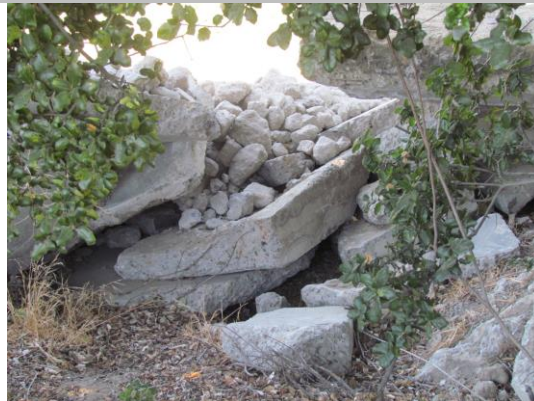
Photo 3 of 3 : FA_2016_RD0556_18_27_20161025_00054.jpg

RD 556 unit 1 levee miles 1.34-1.37 landside.

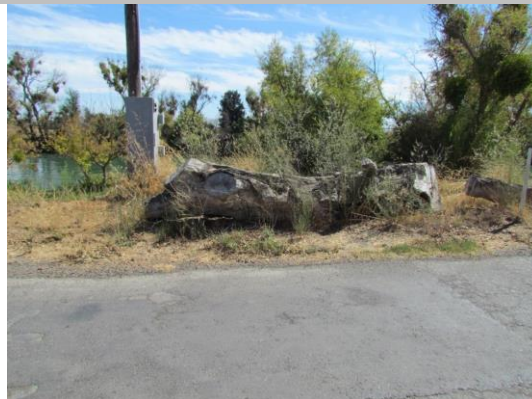
Photo 1 of 1 : FA_2016_RD0556_18_9_20160919_00002.jpg

Unsatisfactory dumping of cut up tree sections on the waterside levee shoulder.

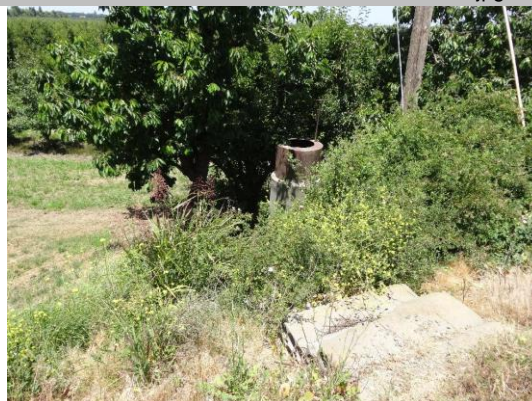
Photo 1 of 2 : UCIP_FA_2016_45743_74240.jpg

LM Start	1.57	Rating **	M	Issue No.	393
LM End	1.57	Issue Type +	En	Location *	WS
Category	Supplemental			GPS Latitude/Longitude	
				Start	End
Item	DWR UCIP Field Study			38.225001 °	38.225001 °
				-121.535007 °	-121.535007 °
DWR ID					
Comment Code					
Inspector Comment					
FS_ID:45743					
DS_ID:20827					
EP_NO: 11169					
Repair Type: Non-Urgent					
Crossing Status: Found					
UCIP Comments: Dense vegetation on LS and WS limited accessibility.					
FIELD_STRUCT_DESC: 8-inch steel pipe through levee, 3.5 feet below crown. Pump and gate valve on WS berm. 2-inch electrical conduit into WS slope. A 36-inch concrete standpipe and concrete block step on Landward Slope. (Listed as 10-inch in ABO 11169 - Mealer). O&M Manual Sac 103, June 1954					
FS Date: 5/27/2015

Concrete standpipe and steps off LS toe.

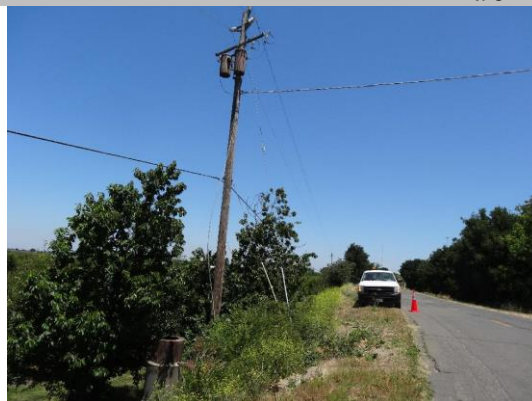
Photo 2 of 2 : UCIP_FA_2016_45743_74241.jpg

Service pole next to standpipe off LS toe.

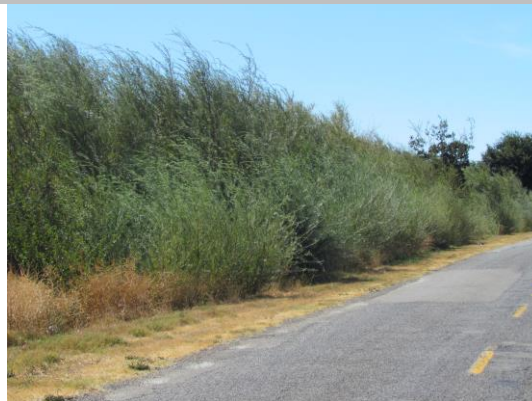
Photo 1 of 1 : FA_2016_RD0556_18_74_20161101_00057.jpg

RD 556 Unit 1 waterside levee mile 1.74-2.29.

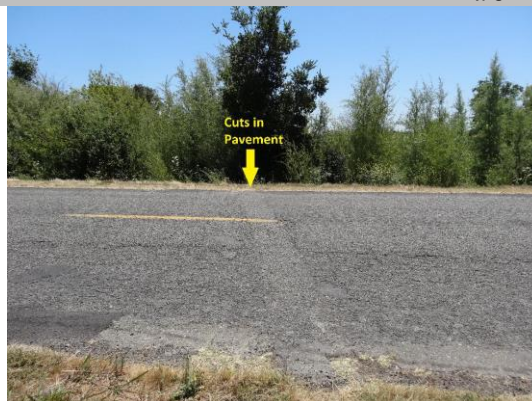
Photo 1 of 2 : UCIP_FA_2016_45746_74250.jpg

FS_ID:45746
DS_ID:20828
EP_NO: 3735
Repair Type: Non-Urgent
Crossing Status: Indicator Found
UCIP Comments: Dense vegetation on LS and WS limited accessibility.
FIELD_STRUCT_DESC: 4-inch electric conduit through levee, 4.0 feet below the crown. Pump on berm. Underground submarine cable crossing. (App. 3735-PG&E). Electric pole on LS in alignment with cuts in pavement.
FS Date: 5/27/2015

View of WS and cuts in pavement.

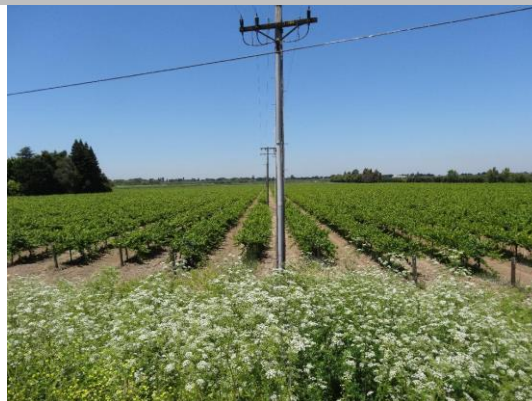
Photo 2 of 2 : UCIP_FA_2016_45746_74251.jpg

Cuts in pavement in alignment with electric pole off LS toe.

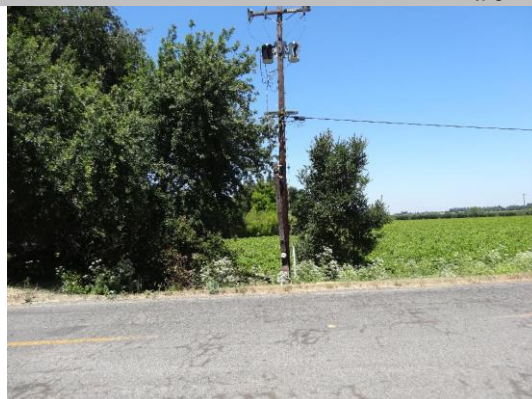
Photo 1 of 2 : UCIP_FA_2016_45764_74260.jpg

LM Start	1.89	Rating **	M	Issue No.	395
LM End	1.89	Issue Type +	En	Location *	WS
Category	Supplemental			GPS Latitude/Longitude	
				Start	End
Item	DWR UCIP Field Study			38.223760 °	38.223760 °
				-121.540629 °	-121.540629 °
DWR ID					
Comment Code					
Inspector Comment					
FS_ID:45764 DS_ID:20829 EP_NO: 11178 Repair Type: Non-Urgent Crossing Status: Found UCIP Comments: Dense vegetation on WS and LS. Some oil leakage inside pumphouse. FIELD_STRUCT_DESC: 8-inch steel irrigation pipe through levee, 3.7 feet below crown. 2-inch electric conduit through levee next to 8-inch. A 1-inch air valve and pump on berm. Service pole on landward slope. Tin and wood pump house on berm. A 12-ft x 36-inch concrete standpipe on landside. (ABO- 11178 - Swett). O&M Manual Sac 103, June 1954 FS Date: 5/27/2015

LS view: service pole on LW slope. Standpipe not visible in photo.

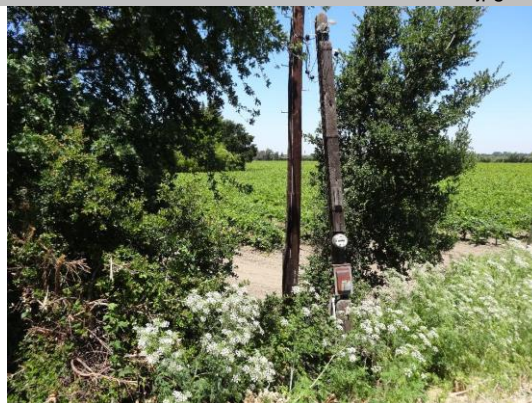
Photo 2 of 2 : UCIP_FA_2016_45764_74261.jpg

Pole on LS slope with electric box and 2-inch conduit.

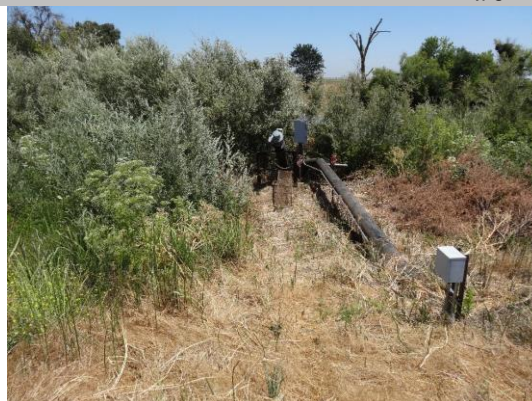
Photo 1 of 2 : UCIP_FA_2016_45786_74280.jpg

LM Start	2.13	Rating **	M	Issue No.	396
LM End	2.13	Issue Type +	En	Location *	WS
Category	Supplemental			GPS Latitude/Longitude	
				Start	End
Item	DWR UCIP Field Study			38.222560 °	38.222560 °
				-121.544485 °	-121.544485 °
DWR ID					
Comment Code					
Inspector Comment					
FS_ID:45786 DS_ID:20830 EP_NO: 2392 Repair Type: Non-Urgent Crossing Status: Found UCIP Comments: Hole and exposed depression adjacent to pipe at LS. Dense vegetation on WS and LS limited visibility. FIELD_STRUCT_DESC: 12 inch steel irrigation pipe through levee, 3.0 feet below crown. Slant pump on bank. 1-inch electrical conduit through levee beside 12-inch pipe, visible on WS. Service pole and 2 standpipes at LW toe, one of which is a 6-inch standpipe. (App. 2392 - Swett) FS Date: 5/27/2015

WS view: Slant pump, 12-inch and 1-inch pipe through levee.

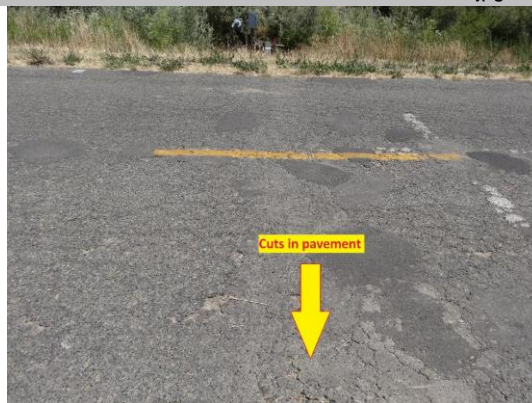
Photo 2 of 2 : UCIP_FA_2016_45786_74281.jpg

View toward WS with cuts in pavement in alignment with pipe on WS

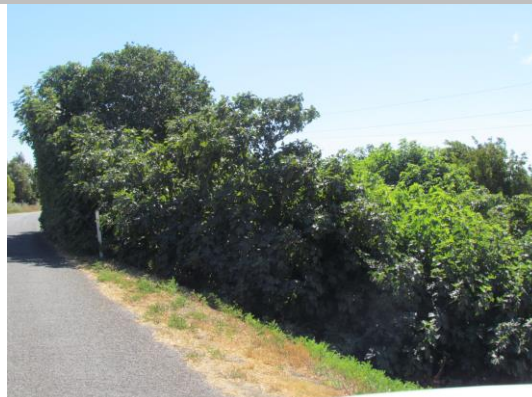
Photo 1 of 1 : FA_2016_RD0556_18_47_20161025_00055.jpg

RD 556 Unit 1 levee miles 2.38-2.42 landside slope.

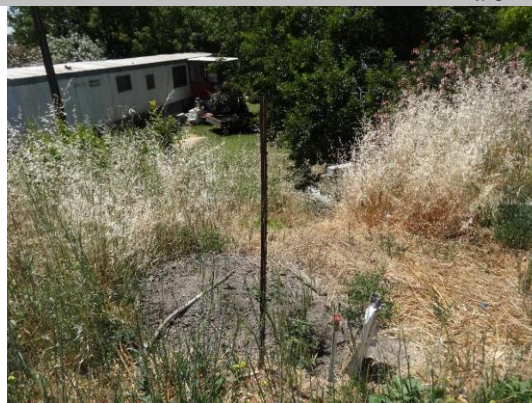
Photo 1 of 2 : UCIP_FA_2016_45803_74285.jpg

LM Start	2.44	Rating **	U	Issue No.	397
LM End	2.44	Issue Type +	En	Location *	LS
Category	Supplemental			GPS Latitude/Longitude	
				Start	End
Item	DWR UCIP Field Study			38.218242 °	38.218242 °
				-121.543807 °	-121.543807 °
DWR ID					
Comment Code					
Inspector Comment					
FS_ID:45803 DS_ID:20831 EP_NO: 11169 Repair Type: Urgent Crossing Status: Found UCIP Comments: 2'x2' hole on levee off LS shoulder. FIELD_STRUCT_DESC: 8 inch steel irrigation pipe through levee, 3.7 feet below crown. Pump and switch panel on berm. Service pole on landward side. A 9 ft x 36-inch concrete standpipe on landside of the levee. 3 cables encased in 1.5-inch steel pipe at WS alongside 8-inch pipe, disconnected at WS. (ABO 11169-Mealer). O&M Manual Sac 103, June 1954. FS Date: 5/27/2015

Pipe, pump @LS toe. 2'x2' hole off shoulder. Spigot in hole possibly for irrigation. House and service pole in background.

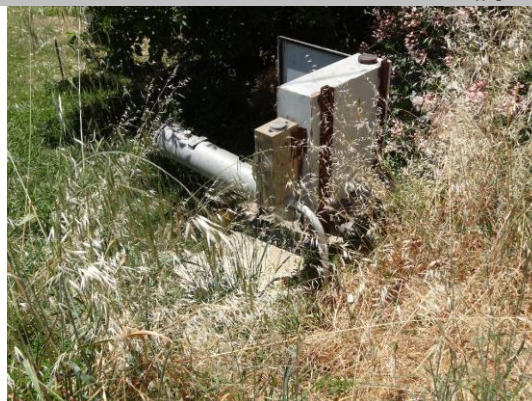
Photo 2 of 2 : UCIP_FA_2016_45803_74286.jpg

Closeup of 8-inch pipe, electrical conduit and box at LS berm.

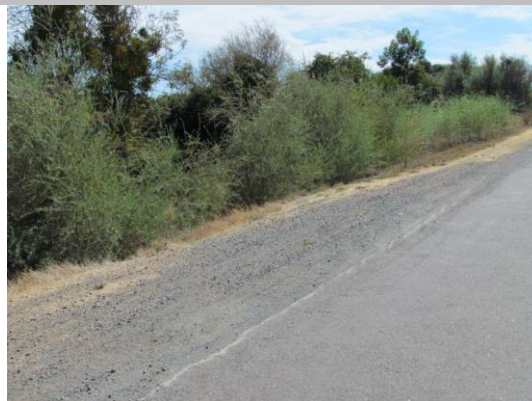
Photo 1 of 1 : FA_2016_RD0556_18_80_20160919_00014.jpg

Looking downstream from levee mile 3.32-3.92 waterside unsatisfactory growth of willows blocks the view of the slope.

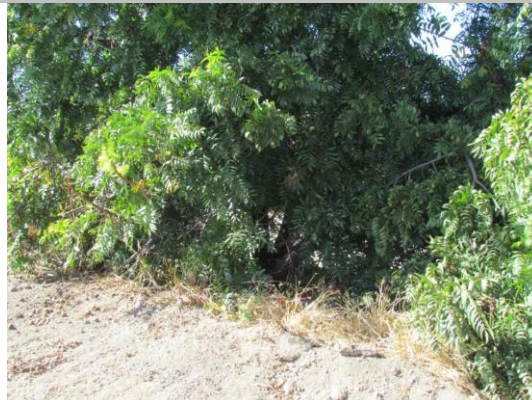
Photo 1 of 1 : FA_2016_RD0556_18_83_20160919_00015.jpg

Looking downstream from the landside slope unsatisfactory woody tree growth blocking view of levee section.

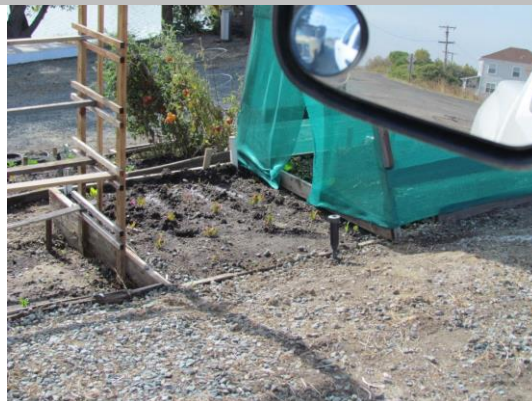
Photo 2 of 2 : FA_2016_RD0556_18_70_20160919_00011.jpg

Continue placement of unauthorized planter boxes into levee slope waterside.

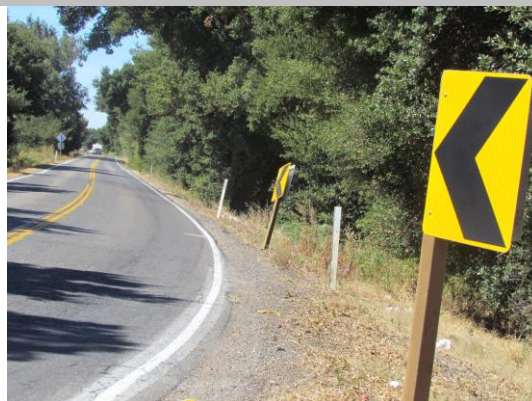
Photo 1 of 1 : FA_2016_RD0556_19_82_20161031_00051.jpg

RD 556 Unit 2 looking downstream of waterside slope.

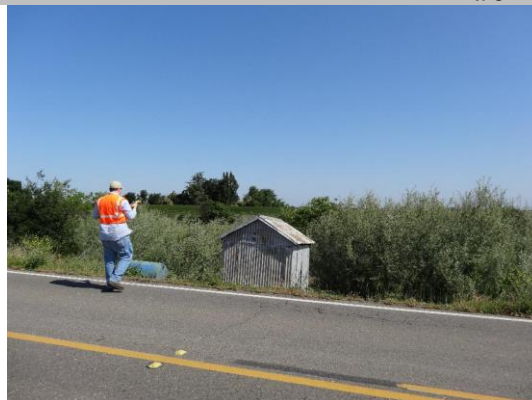
Photo 1 of 2 : UCIP_FA_2016_12512_20245.jpg

WS- pump house on levee berm

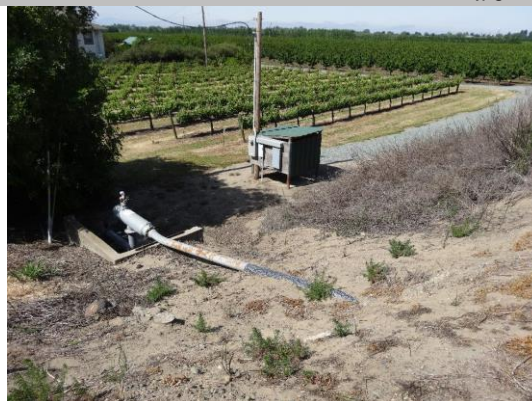
Photo 2 of 2 : UCIP_FA_2016_12512_20244.jpg

LS- steel pipe on a concrete box

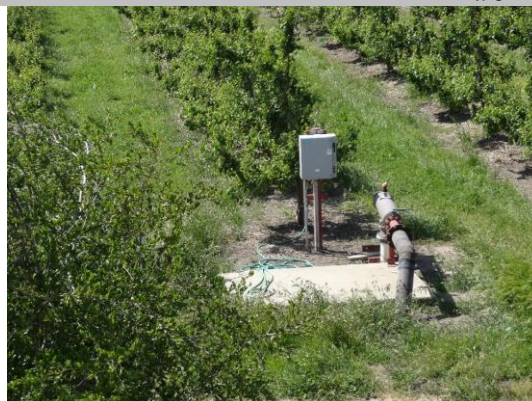
Photo 1 of 2 : UCIP_FA_2016_12573_20381.jpg

LS- 6-inch steel pipe on orchard.

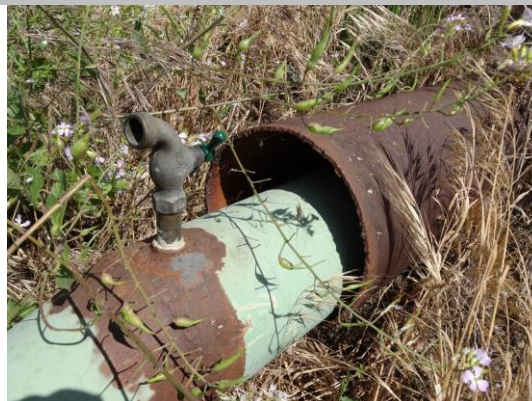
Photo 2 of 2 : UCIP_FA_2016_12573_20380.jpg

LS- 6-inch steel pipe sleeved through 10-inch steel pipe. 6" pipe is attached with air release valve.

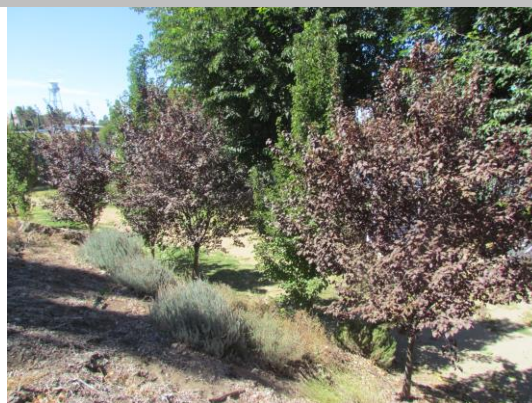
Photo 1 of 2 : FA_2016_RD0556_19_27_20161031_00053.jpg

RD 556 Unit 2 levee mile 2.16-2.19 waterside toe of slope.

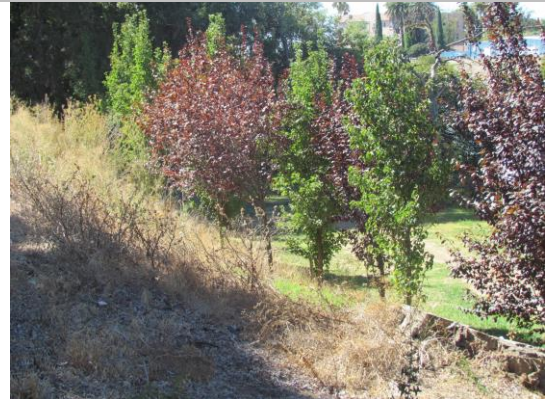
Photo 2 of 2 : FA_2016_RD0556_19_27_20161031_00054.jpg

RD 556 Unit 2 levee mile 2.16-2.19 waterside toe looking downstream.

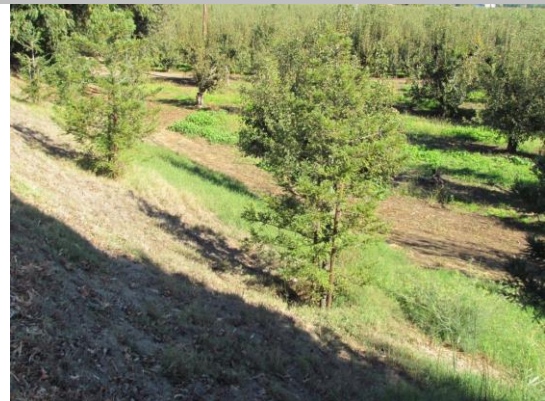
Photo 1 of 1 : FA_2016_RD0556_19_1_20160919_00001.jpg

RD 556 Unit 2 Levee mile 2.28 unauthorized planting of redwood trees planted on the slope.

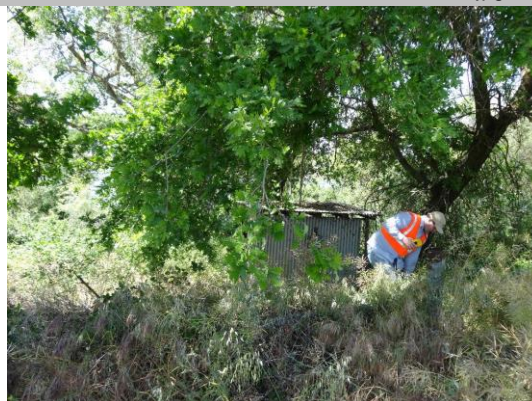
Photo 1 of 2 : UCIP_FA_2016_12574_20388.jpg

WS- pump house on levee berm

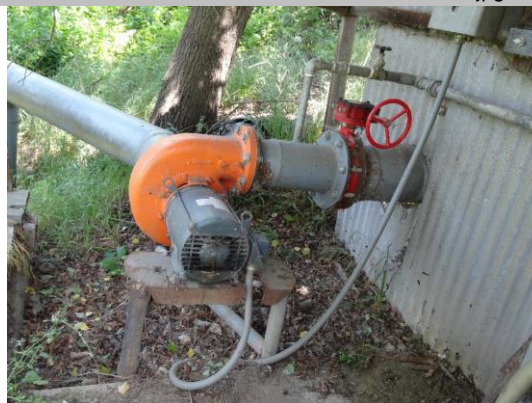
Photo 2 of 2 : UCIP_FA_2016_12574_20387.jpg

WS- pump, and gate valve in pump house.

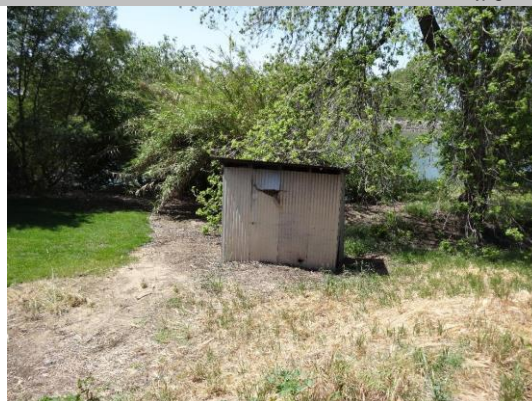
Photo 1 of 2 : UCIP_FA_2016_41713_20284.jpg

WS- pump house on levee berm.

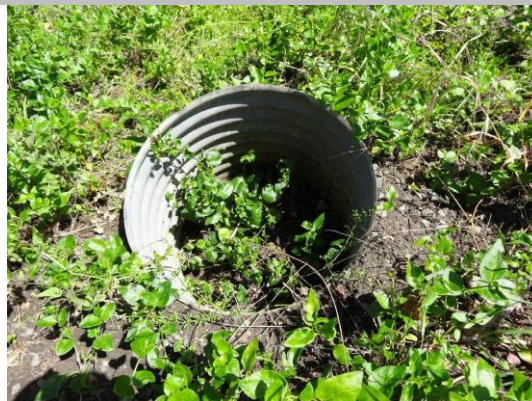
Photo 2 of 2 : UCIP_FA_2016_41713_20283.jpg

LS- siphon breaker in CMP riser on levee slope.

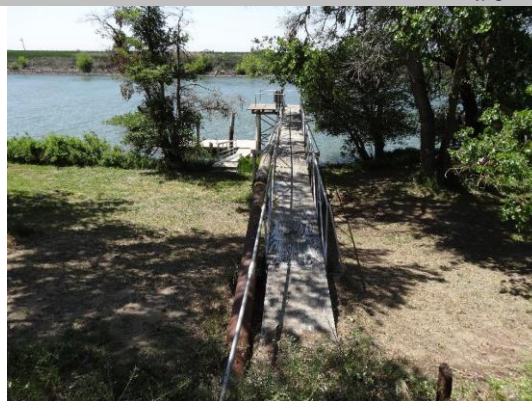
Photo 1 of 2 : UCIP_FA_2016_12525_20290.jpg

WS- walkway, pump, and pipe on steel pile structure in the river.

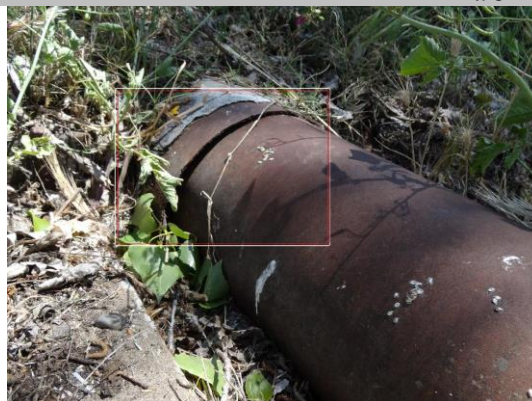
Photo 2 of 2 : UCIP_FA_2016_12525_20289.jpg

WS- 9-inch pipe sleeved through 10 inch steel pipe.

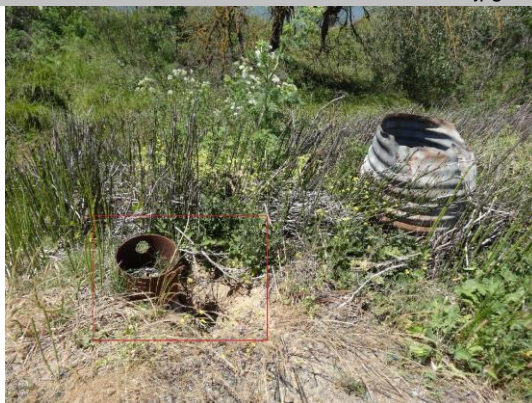
Photo 2 of 2 : UCIP_FA_2016_12527_20296.jpg

WS- siphon breaker and abandoned CMP riser laying adjacent to it.

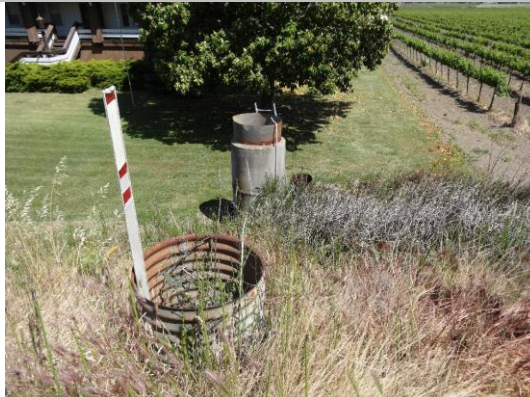
Photo 2 of 2 : UCIP_FA_2016_12543_20301.jpg

LS- siphon breaker in CMP riser and concrete standpipe behind CMP riser.

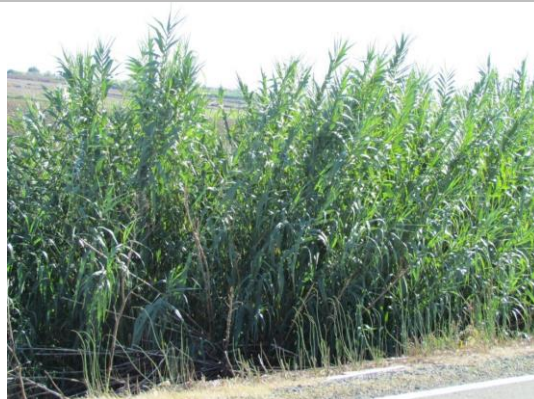
Photo 1 of 1 : FA_2016_RD0556_19_87_20160919_00014.jpg

RD 556 Unit 2 looking downstream from the landside shoulder levee miles 4.21-4.22.

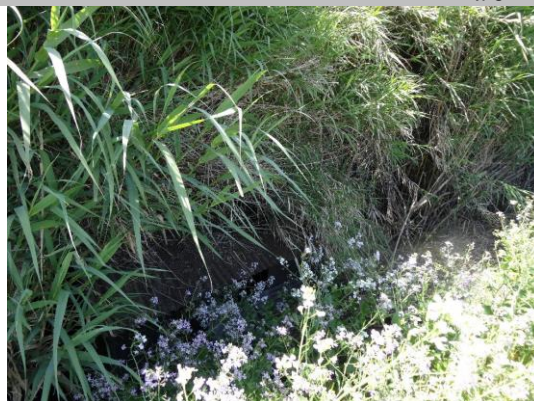
Photo 1 of 2 : UCIP_FA_2016_12545_20310.jpg

WS- pump house not visible due to the dense vegetation.

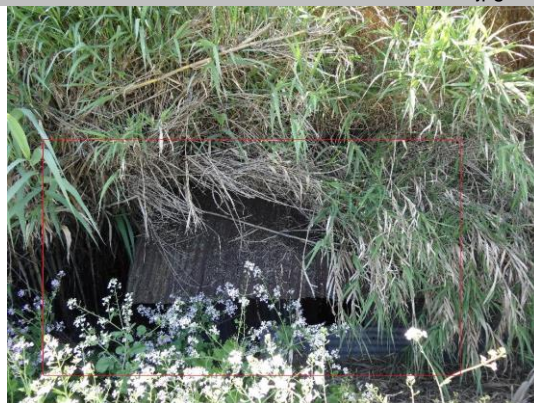
Photo 2 of 2 : UCIP_FA_2016_12545_20309.jpg

WS- pump house inside the dense vegetation.

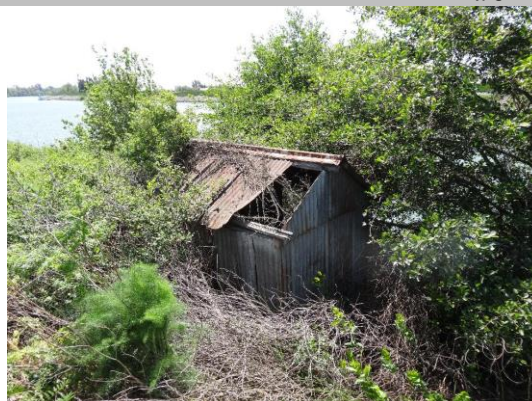
Photo 1 of 2 : UCIP_FA_2016_12546_20314.jpg

WS- abandoned pump house on levee slope. Dense vegetation on levee slope.

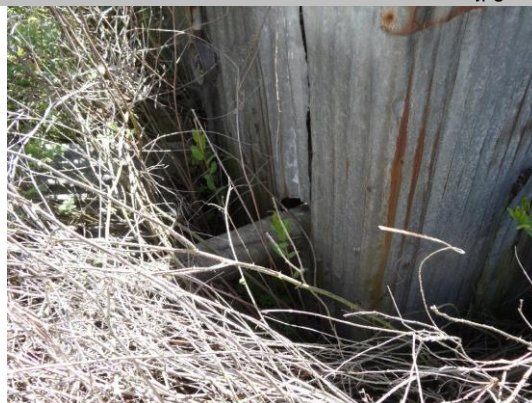
Photo 2 of 2 : UCIP_FA_2016_12546_20313.jpg

WS- pipe daylight from levee slope to pump house.

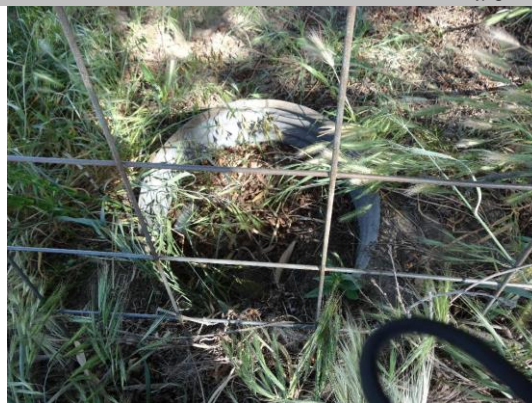
Photo 1 of 2 : UCIP_FA_2016_12547_20320.jpg

LS- obstructed siphon breaker in CMP riser on levee slope.

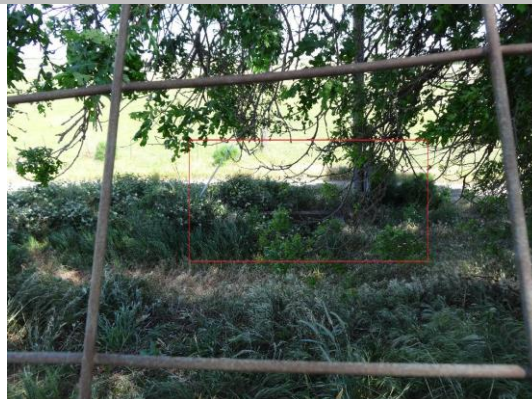
Photo 2 of 2 : UCIP_FA_2016_12547_20319.jpg

LS- concrete distribution box near levee toe.

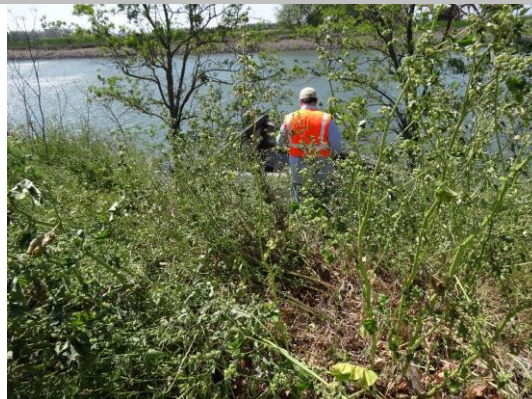
Photo 1 of 2 : UCIP_FA_2016_12564_20347.jpg

WS- pump house on levee slope.

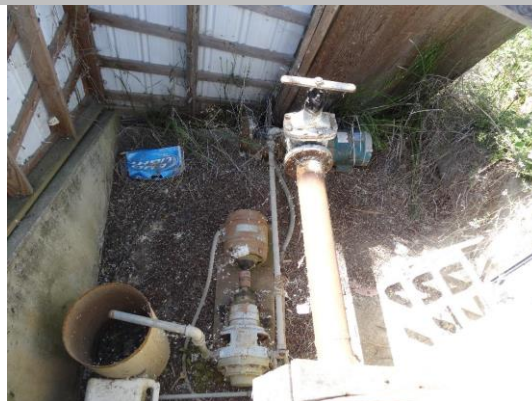
Photo 2 of 2 : UCIP_FA_2016_12564_20346.jpg

WS- pump, pipe and gate valve in pump house.

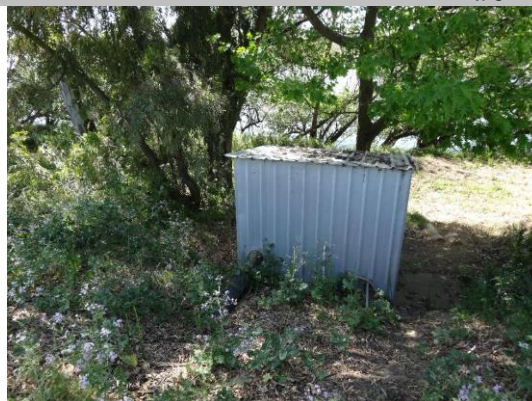
Photo 1 of 2 : UCIP_FA_2016_12570_20364.jpg

WS- pump house on levee slope

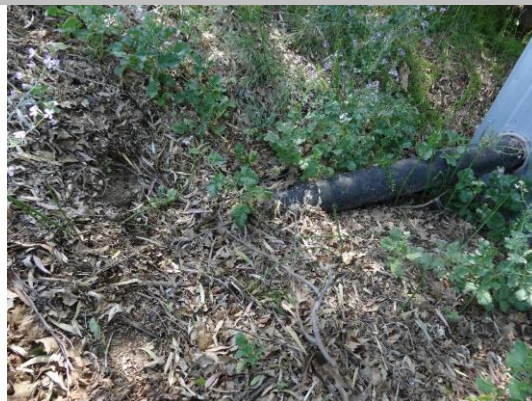
Photo 2 of 2 : UCIP_FA_2016_12570_20363.jpg

WS- pipe daylight from the levee.

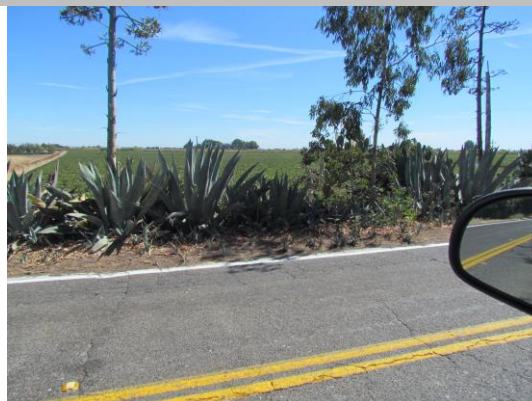
Photo 1 of 1 : FA_2016_RD0556_19_31_20161101_00055.jpg

RD 556 Unit 2 levee mile 5.40-5.44 landside levee shoulder and slope looking downstream.
