**Flood Control Project Maintenance  
Levee Inspections**

**Fall 2017 Levee Maintenance Deficiency Summary Report**

**Sacramento River Basin**

**Reclamation District No. 0556 Upper Andrus**

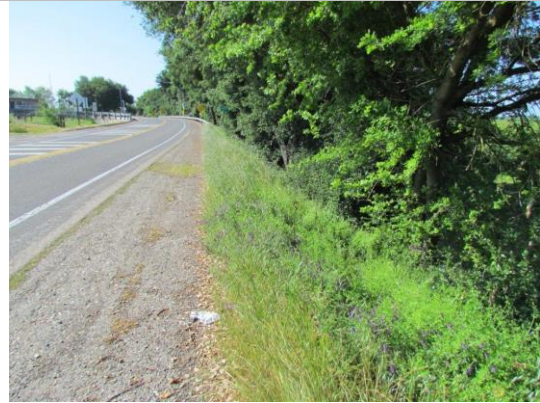
Photo 1 of 1 : FA\_2017\_RD0556\_18\_21\_20171002\_00004.jpg

Looking downstream from levee mile 0.09 woody tree growth and wild weeds covering the levee slope and shoulder landside levee section.

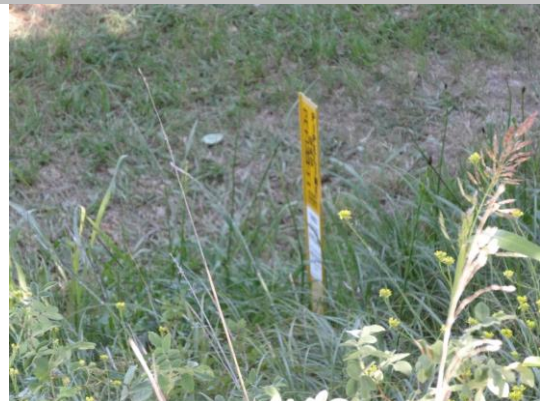
Photo 1 of 3 : UCIP\_FA\_2017\_45564\_74151.jpg

Gasline marker present on LS.

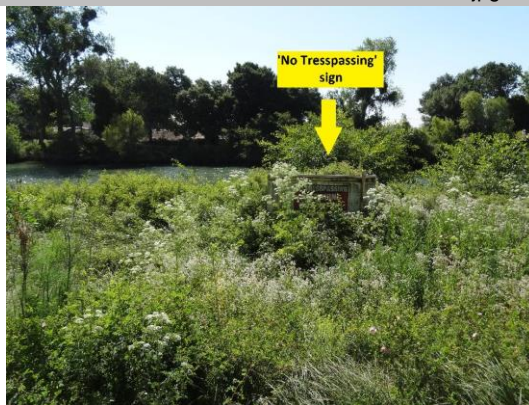
Photo 3 of 3 : UCIP\_FA\_2017\_45564\_74152.jpg

View of WS. Dense vegetation limited visibility of 'No Trespassing' sign.

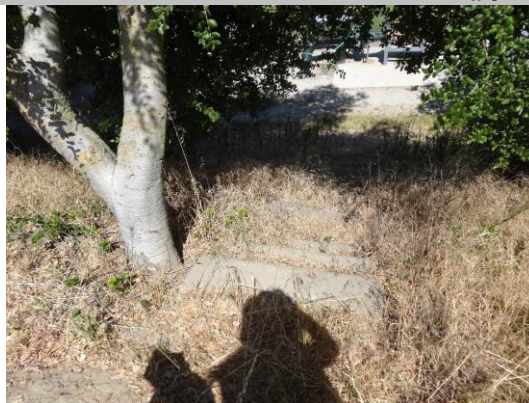
Photo 1 of 3 : UCIP\_FA\_2017\_45663\_74180.jpg

LM Start	0.53	Rating **	M	Issue No.	388	
LM End	0.53	Issue Type +	En	Location *		
Category	Supplemental			GPS Latitude/Longitude		
				Start	End	
Item	DWR UCIP Field Study			38.232450 °	38.232450 °	
				-121.521624 °	-121.521624 °	
DWR ID						
Comment Code						
Inspector Comment						
FS_ID:45663						
DS_ID:20821						
EP_NO: 5548						
Repair Type: Non-Urgent						
Crossing Status: Found						
UCIP Comments: Dense vegetation prevents inspection of WS slope.						
FIELD_STRUCT_DESC: 12-inch steel pipe through levee, 5.0 feet						
below crown. 1-1/4-inch electrical conduit through the levee. Concrete						
steps on landward slope. Pump off landward toe. Cuts visible on						
pavement. (App. 5548).						
FS Date: 5/13/2015

Concrete steps on LS slope.

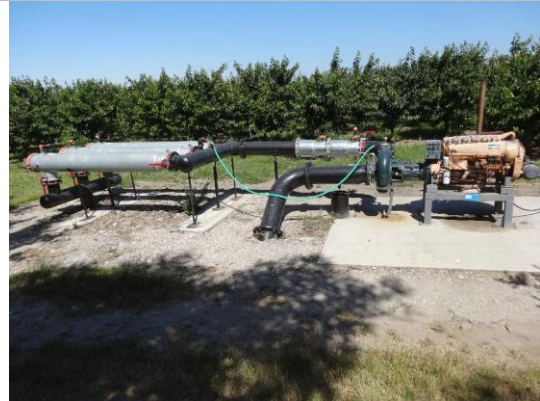
Photo 3 of 3 : UCIP\_FA\_2017\_45663\_74182.jpg

Pump and pipe into levee off LS toe.

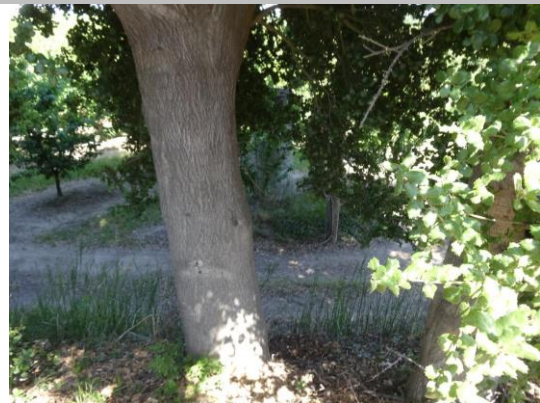
Photo 1 of 3 : UCIP\_FA\_2017\_45664\_74190.jpg

LM Start	0.54	Rating **	M	Issue No.	389
LM End	0.54	Issue Type +	En	Location *	
Category	Supplemental			GPS Latitude/Longitude	
				Start	End
Item	DWR UCIP Field Study			38.232354 °	38.232354 °
				-121.521727 °	-121.521727 °
DWR ID					
Comment Code					
Inspector Comment					
FS_ID:45664 DS_ID:20826 EP_NO: 5548A Repair Type: Non-Urgent Crossing Status: Found UCIP Comments: Dense vegetation prevented inspection of WS slope. FIELD_STRUCT_DESC: 14-inch pipe through levee 5.0 feet below the crown. Pole with panel and standpipe on landward toe (5548A- Kay Dix Ranch 1986). FS Date: 5/27/2015

View of LS with standpipe visible behind tree.

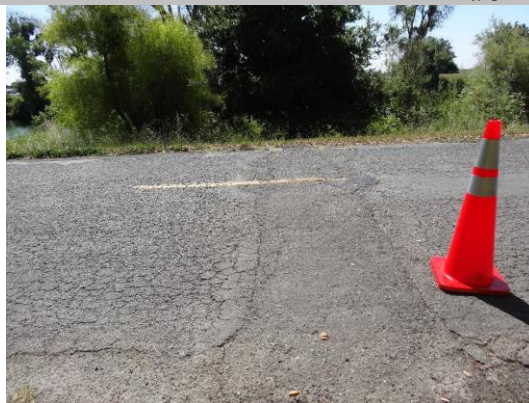
Photo 2 of 3 : UCIP\_FA\_2017\_45664\_74191.jpg

View of WS with cuts visible on pavement.

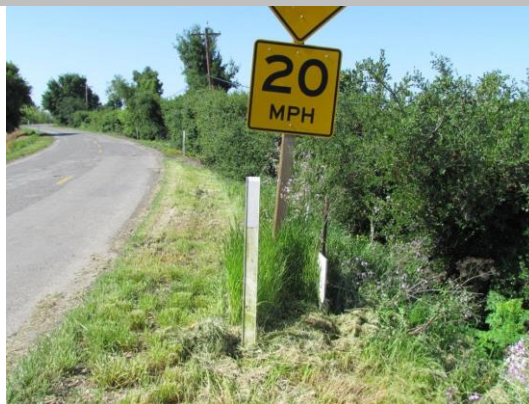
Photo 1 of 1 : FA\_2017\_RD0556\_18\_10\_20171002\_00003.jpg

RD 556 Unit 1 levee miles 0.93-1.54 looking downstream landside slope.

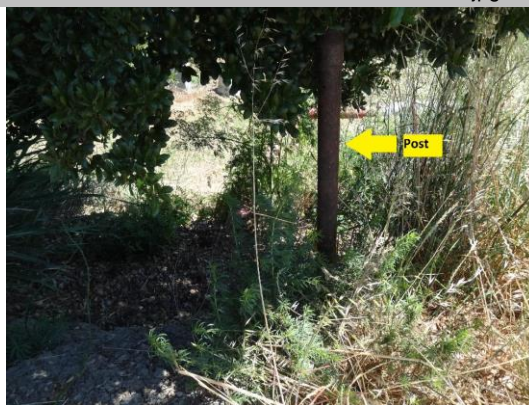
Photo 2 of 3 : UCIP\_FA\_2017\_46799\_74740.jpg

LS view: Post located above pipe on LS slope.

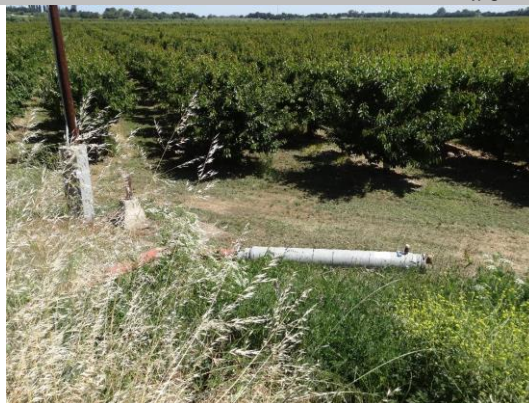
Photo 3 of 3 : UCIP\_FA\_2017\_46799\_74741.jpg

Electric pole next to pipe on LS.

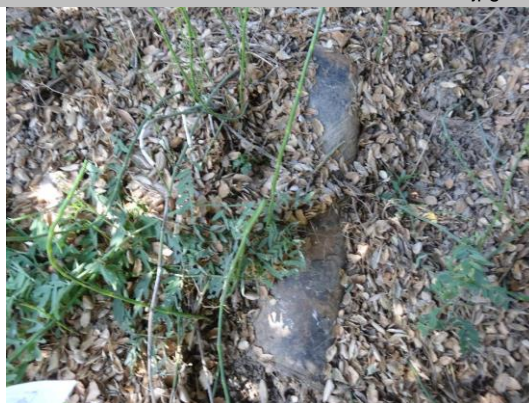
Photo 1 of 3 : UCIP\_FA\_2017\_45683\_74200.jpg

LM Start	1.17	Rating **	M	Issue No.	391
LM End	1.17	Issue Type +	En	Location *	
Category	Supplemental			GPS Latitude/Longitude	
				Start	End
Item	DWR UCIP Field Study			38.227568 °	38.227568 °
				-121.529489 °	-121.529489 °
DWR ID					
Comment Code					
Inspector Comment					
FS_ID:45683 DS_ID:20823 EP_NO: 11169 Repair Type: Non-Urgent Crossing Status: Found UCIP Comments: Appears abandoned in place and if so should be done so properly. Dense vegetation on WS limits visibility. FIELD_STRUCT_DESC: 10-inch pipe through levee, 3.8 feet below crown. (Lower end of rock revetment)(ABO 11169 - Mealer and 4848). Abandoned in place. O&M Manual Sac 103, June 1954 FS Date: 5/27/2015

LS view of pipe appearing abandoned in place.

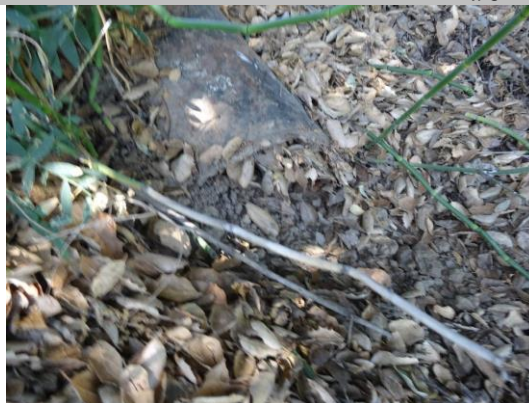
Photo 2 of 3 : UCIP\_FA\_2017\_45683\_74201.jpg

Closeup of abandoned pipe.

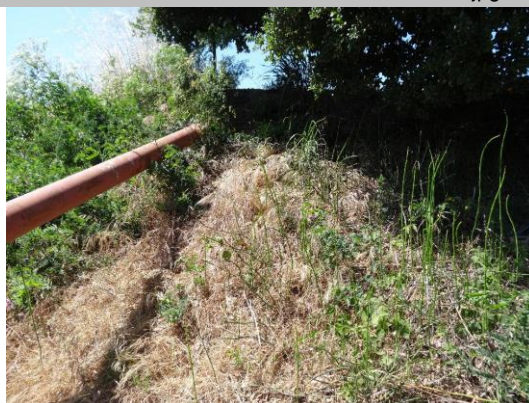
Photo 3 of 3 : UCIP\_FA\_2017\_45683\_74202.jpg

View up LS slope. 10" pipe (not visible) rests next to (visible) 8" pipe.

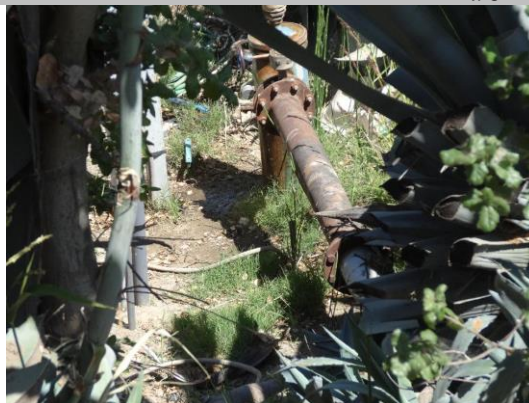
Photo 3 of 3 : UCIP\_FA\_2017\_45692\_74206.jpg

Comment Code						
Inspector Comment						
FS_ID:45692						
DS_ID:20825						
EP_NO: 13302						
Repair Type: Non-Urgent						
Crossing Status: Found						
UCIP Comments: Seal beneath siphon breaker off LS toe leaking.						
Rodent activity near crown off LS shoulder. Need to contact owner						
about leaky seal. Dense vegetation prevented inspection of WS slope.						
FIELD_STRUCT_DESC: 6-inch steel pipe and 2-inch GI electrical						
conduit through levee 2 feet below crown; roadway with siphon valve on						
landward shoulder. Concrete stand and pump on landward toe; circuit						
box also. Cuts visible on pavement. 6-inch PVC standpipe adjacent to						
pipe off LS toe. (Kay Dix Ranch App. 13302). O&M Manual Sac 103,						
June 1954						
FS Date: 5/27/2015

Closeup of pipe at LS toe. Seal beneath siphon breaker leaking.

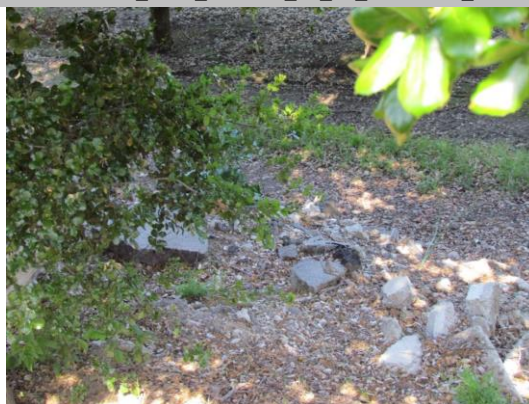
Photo 1 of 3 : FA\_2017\_RD0556\_18\_27\_20171002\_00005.jpg

RD 556 Unit 1 levee mile 1.34-1.37 landside toe.

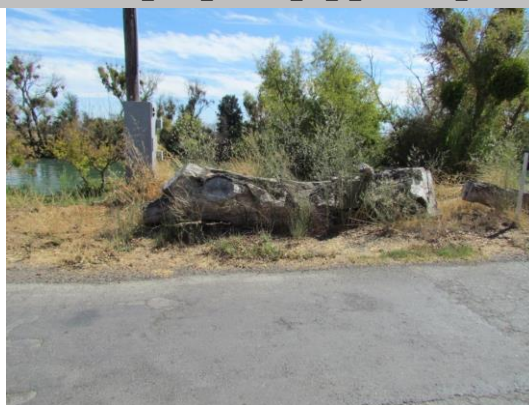
Photo 1 of 1 : FA\_2017\_RD0556\_18\_9\_20171002\_00002.jpg

Cut tree sections on the waterside levee shoulder remain to prevent parking.

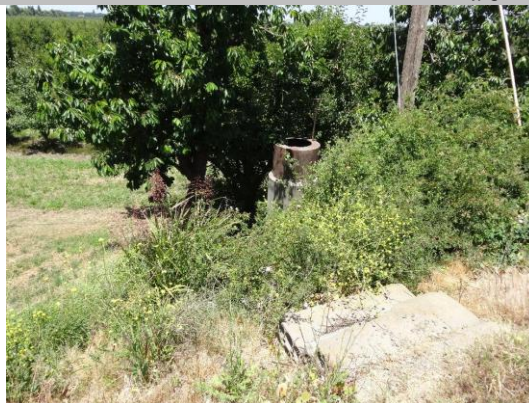
Photo 1 of 3 : UCIP\_FA\_2017\_45743\_74240.jpg

LM Start	1.57	Rating **	M	Issue No.	393	
LM End	1.57	Issue Type +	En	Location *		
Category	Supplemental			GPS Latitude/Longitude		
				Start	End	
Item	DWR UCIP Field Study			38.225001 °	38.225001 °	
				-121.535007 °	-121.535007 °	
DWR ID						
Comment Code						
Inspector Comment						
FS_ID:45743						
DS_ID:20827						
EP_NO: 11169						
Repair Type: Non-Urgent						
Crossing Status: Found						
UCIP Comments: Dense vegetation on LS and WS limited accessibility.						
FIELD_STRUCT_DESC: 8-inch steel pipe through levee, 3.5 feet below crown. Pump and gate valve on WS berm. 2-inch electrical conduit into WS slope. A 36-inch concrete standpipe and concrete block step on Landward Slope. (Listed as 10-inch in ABO 11169 - Mealer). O&M Manual Sac 103, June 1954						
FS Date: 5/27/2015

Concrete standpipe and steps off LS toe.

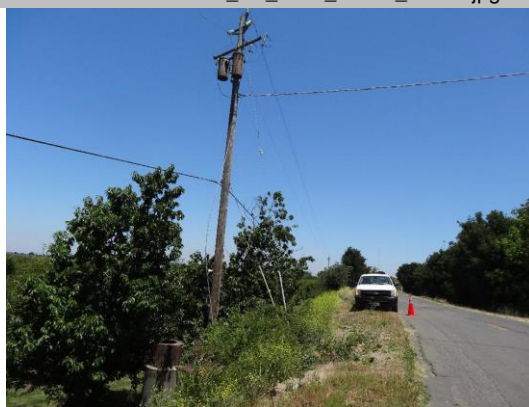
Photo 2 of 3 : UCIP\_FA\_2017\_45743\_74241.jpg

Service pole next to standpipe off LS toe.

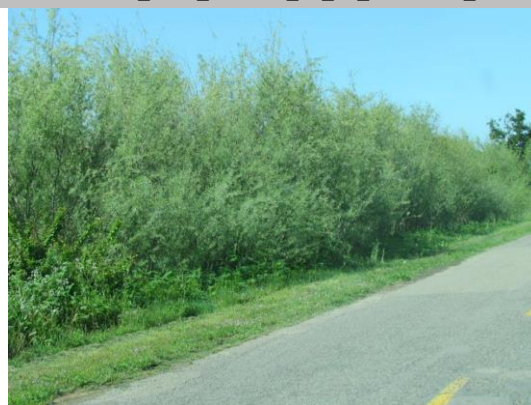
Photo 1 of 1 : FA\_2017\_RD0556\_18\_74\_20171002\_00024.jpg

RD 556 Unit 1 waterside levee mile 1.74-2.29.

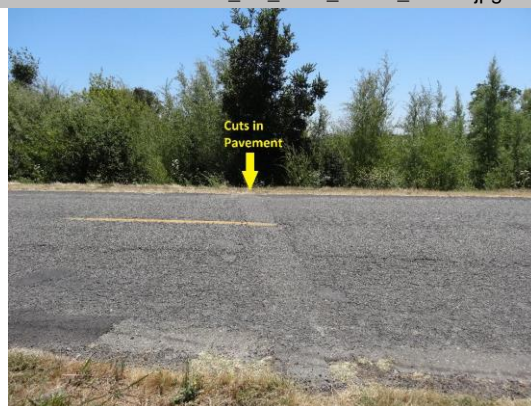
Photo 1 of 3 : UCIP\_FA\_2017\_45746\_74250.jpg

LM Start	1.79	Rating **	M	Issue No.	394
LM End	1.79	Issue Type +	En	Location *	
Category	Supplemental			GPS Latitude/Longitude	
				Start	End
Item	DWR UCIP Field Study			38.223999°	38.223999°
				-121.538735°	-121.538735°
DWR ID					
Comment Code					
Inspector Comment					
FS_ID:45746					
DS_ID:20828					
EP_NO: 3735					
Repair Type: Non-Urgent					
Crossing Status: Indicator Found					
UCIP Comments: Dense vegetation on LS and WS limited accessibility.					
FIELD_STRUCT_DESC: 4-inch electric conduit through levee, 4.0 feet below the crown. Pump on berm. Underground submarine cable crossing. (App. 3735-PG&E). Electric pole on LS in alignment with cuts in pavement.					
FS Date: 5/27/2015

View of WS and cuts in pavement.

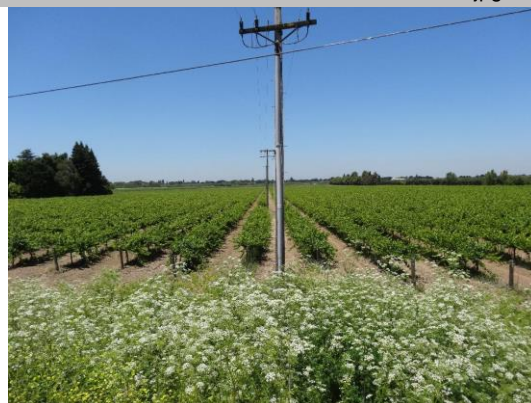
Photo 2 of 3 : UCIP\_FA\_2017\_45746\_74251.jpg

Cuts in pavement in alignment with electric pole off LS toe.

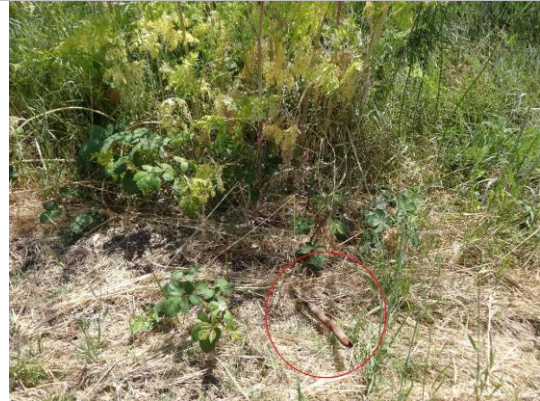
Photo 3 of 3 : UCIP\_FA\_2017\_45746\_74252.jpg

Pipe debris present at LS toe.

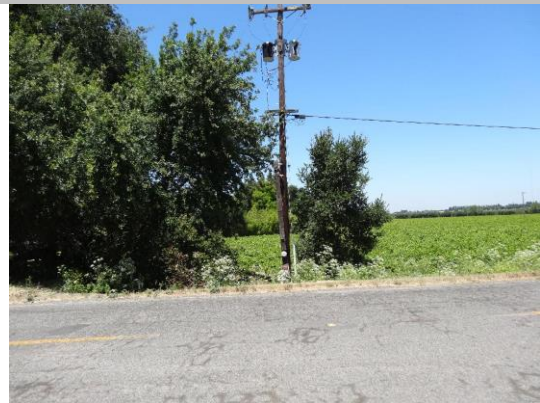
Photo 1 of 3 : UCIP\_FA\_2017\_45764\_74260.jpg

LM Start	1.89	Rating **	M	Issue No.	395
LM End	1.89	Issue Type +	En	Location *	
Category	Supplemental			GPS Latitude/Longitude	
				Start	End
Item	DWR UCIP Field Study			38.223760 °	38.223760 °
				-121.540629 °	-121.540629 °
DWR ID					
Comment Code					
Inspector Comment					
FS_ID:45764 DS_ID:20829 EP_NO: 11178 Repair Type: Non-Urgent Crossing Status: Found UCIP Comments: Dense vegetation on WS and LS. Some oil leakage inside pumphouse. FIELD_STRUCT_DESC: 8-inch steel irrigation pipe through levee, 3.7 feet below crown. 2-inch electric conduit through levee next to 8-inch. A 1-inch air valve and pump on berm. Service pole on landward slope. Tin and wood pump house on berm. A 12-ft x 36-inch concrete standpipe on landside. (ABO- 11178 - Swett). O&M Manual Sac 103, June 1954 FS Date: 5/27/2015

LS view: service pole on LW slope. Standpipe not visible in photo.

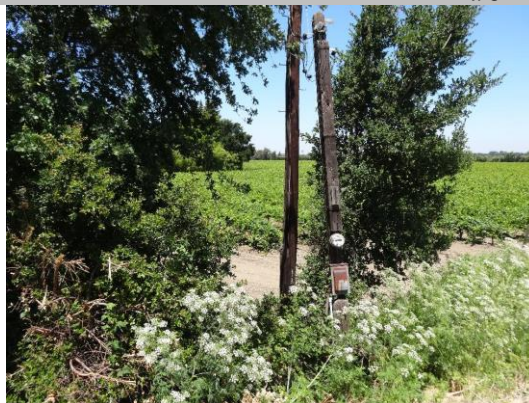
Photo 2 of 3 : UCIP\_FA\_2017\_45764\_74261.jpg

Pole on LS slope with electric box and 2-inch conduit.

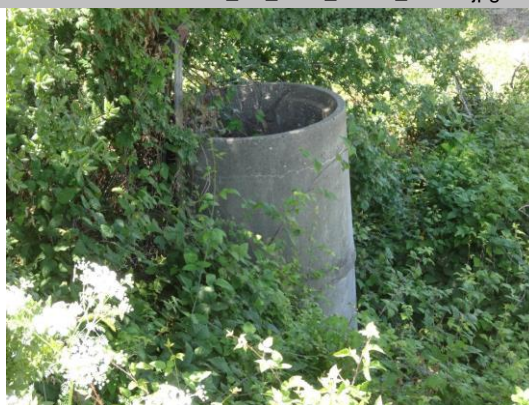
Photo 3 of 3 : UCIP\_FA\_2017\_45764\_74262.jpg

Standpipe on LS next to service pole.

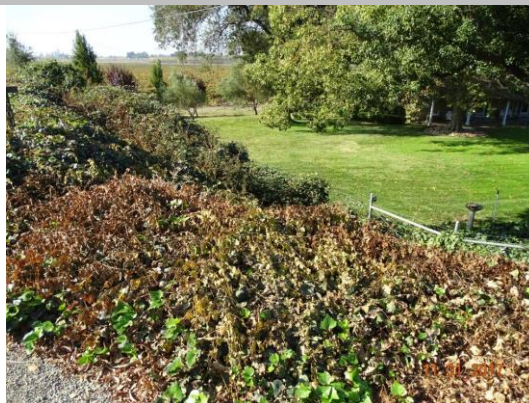
Photo 1 of 1 : FA\_2017\_RD0556\_18\_25\_20171117\_00062.jpg

Unpermitted fence covered in berry vines along landside levee toe should be moved back 10 feet to allow access.

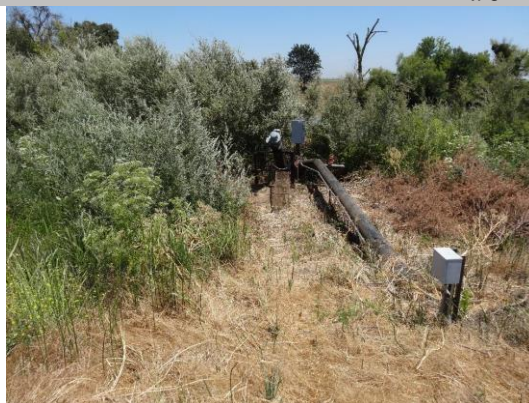
Photo 1 of 3 : UCIP\_FA\_2017\_45786\_74280.jpg

LM Start	2.13	Rating **	M	Issue No.	396	
LM End	2.13	Issue Type +	En	Location *		
Category	Supplemental			GPS Latitude/Longitude		
				Start		End
Item	DWR UCIP Field Study			38.222560 °		38.222560 °
				-121.544485 °		-121.544485 °
DWR ID						
Comment Code						
Inspector Comment						
FS_ID:45786 DS_ID:20830 EP_NO: 2392 Repair Type: Non-Urgent Crossing Status: Found UCIP Comments: Hole and exposed depression adjacent to pipe at LS. Dense vegetation on WS and LS limited visibility. FIELD_STRUCT_DESC: 12 inch steel irrigation pipe through levee, 3.0 feet below crown. Slant pump on bank. 1-inch electrical conduit through levee beside 12-inch pipe, visible on WS. Service pole and 2 standpipes at LW toe, one of which is a 6-inch standpipe. (App. 2392 - Swett) FS Date: 5/27/2015

WS view: Slant pump, 12-inch and 1-inch pipe through levee.

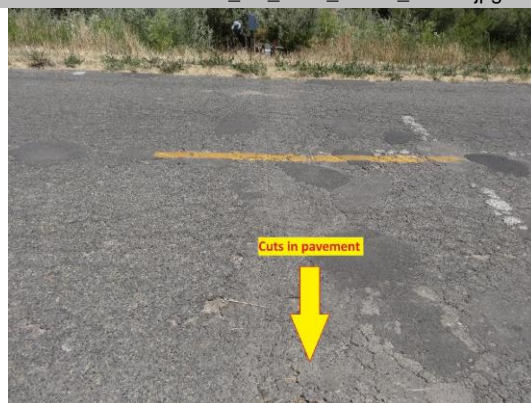
Photo 2 of 3 : UCIP\_FA\_2017\_45786\_74281.jpg

View toward WS with cuts in pavement in alignment with pipe on WS

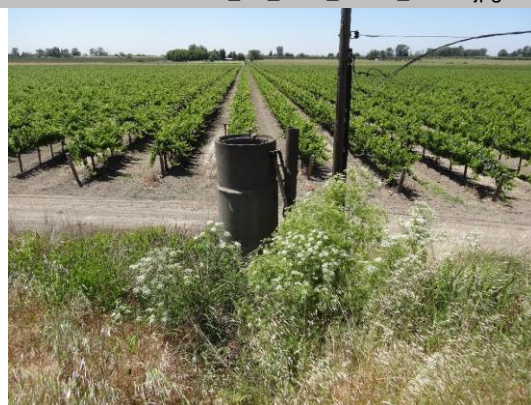
Photo 3 of 3 : UCIP\_FA\_2017\_45786\_74282.jpg

LS: 2 standpipes and service pole.

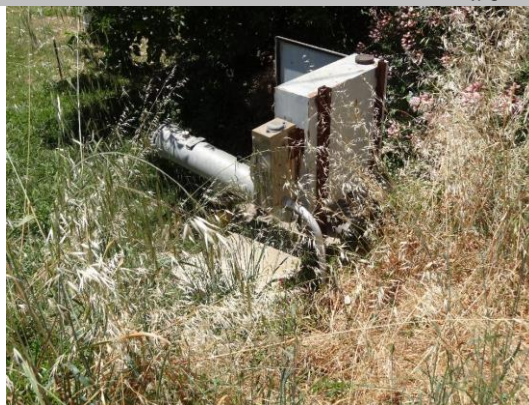
Photo 2 of 3 : UCIP\_FA\_2017\_45803\_74286.jpg

Closeup of 8-inch pipe, electrical conduit and box at LS berm.

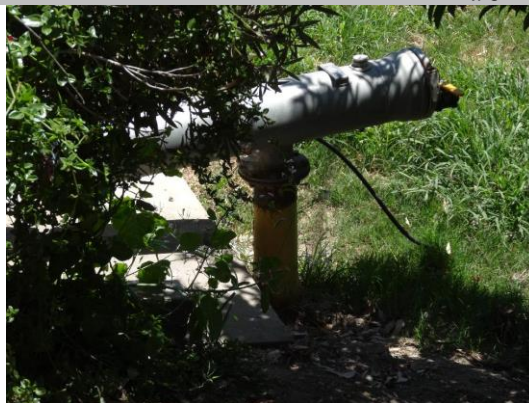
Photo 3 of 3 : UCIP\_FA\_2017\_45803\_74287.jpg

Closeup of 8-inch and 1.5-inch pipes and platform off LS toe.

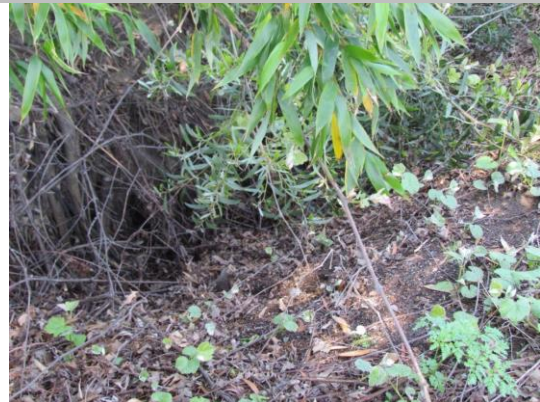
Photo 1 of 2 : FA\_2017\_RD0556\_18\_33\_20171002\_00010.jpg

RD 556 Unit 1 levee mile 2.72 fallen tree damage to shoulder and slope.

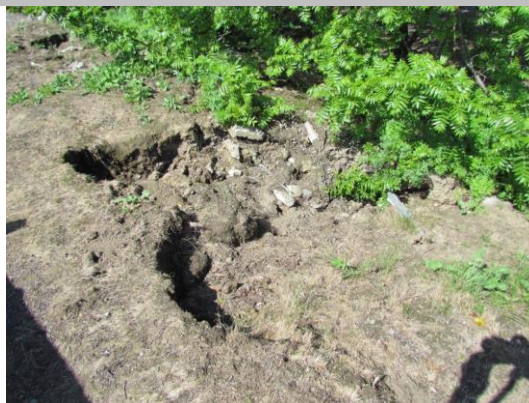
Photo 1 of 2 : FA\_2017\_RD0556\_18\_36\_20171002\_00013.jpg

556 Unit 1 levee mile 3.22 landside slope erosion.

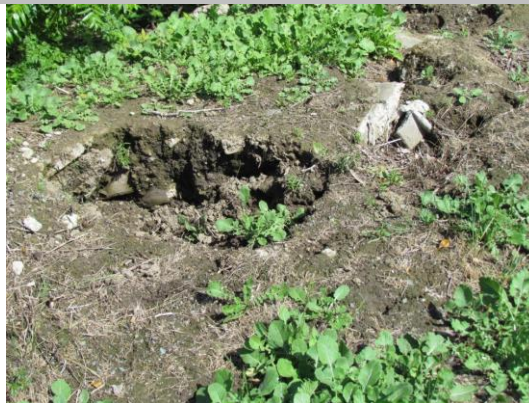
Photo 2 of 2 : FA\_2017\_RD0556\_18\_36\_20171002\_00014.jpg

556 Unit 1 slope erosion levee mile 3.22.

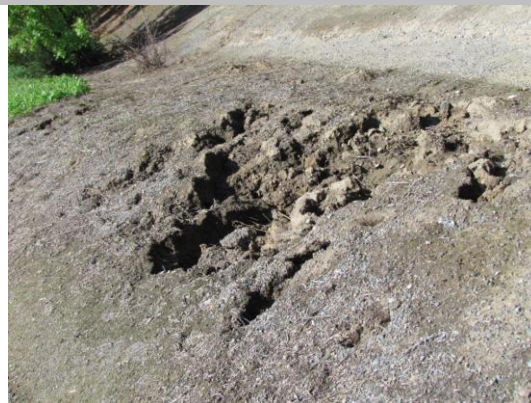
Photo 1 of 1 : FA\_2017\_RD0556\_18\_37\_20171002\_00015.jpg

556 Unit 1 levee mile 3.24 landside slope.

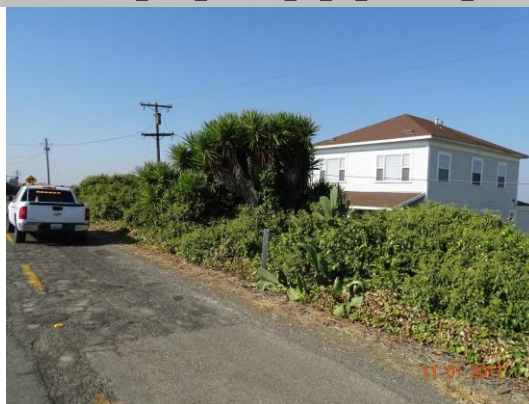
Photo 1 of 1 : FA\_2017\_RD0556\_18\_30\_20171117\_00067.jpg

LM Start	3.91	Rating **	U	Issue No.	30
LM End	3.91	Issue Type +	En	Location *	LS
Category	Earthen Levee			GPS Latitude/Longitude	
				Start	End
Item	Vegetation			38.201672 °	38.201672 °
				-121.542133 °	-121.542133 °
DWR ID	DWR_RD0556_01_f_2017_30				
Comment Code					
V6 : Landscaping					
Inspector Comment

Trim/thin landscaping to allow inspection and access to levee slope and toe.

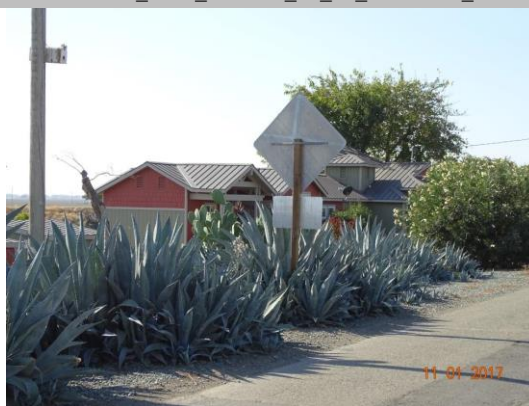
Photo 1 of 1 : FA\_2017\_RD0556\_18\_34\_20171117\_00068.jpg

Remove large cactus from waterside shoulder to allow inspection and access.

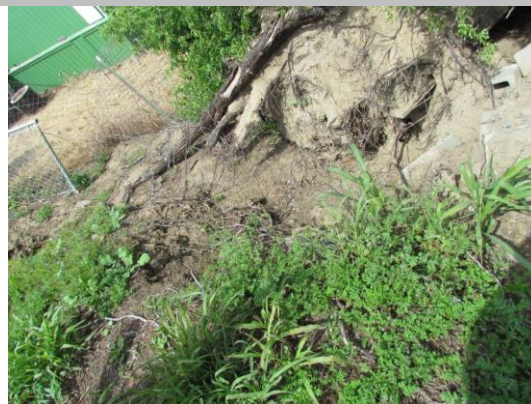
Photo 1 of 2 : FA\_2017\_RD0556\_18\_44\_20171002\_00018.jpg

RD 556 Unit 1 levee mile 5.46 fallen tree on landside slope and damage to the slope.

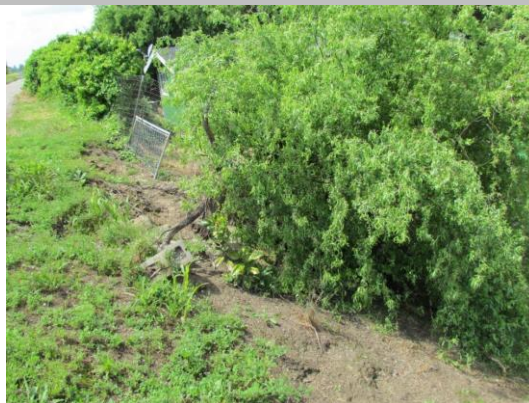
Photo 2 of 2 : FA\_2017\_RD0556\_18\_44\_20171002\_00019.jpg

view from upstream.

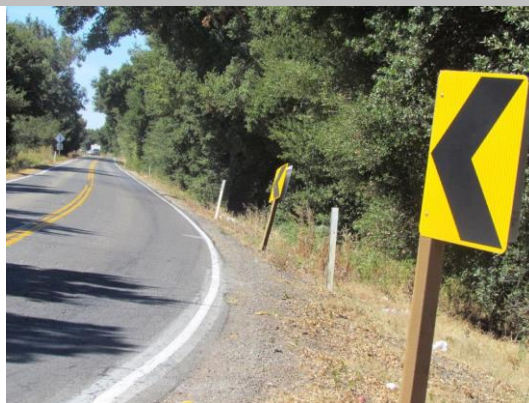
Photo 2 of 2 : FA\_2017\_RD0556\_19\_82\_20171002\_00014.jpg

RD 556 Unit 2 looking downstream of waterside slope.

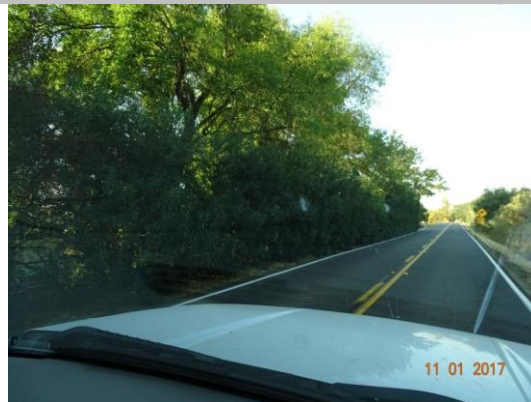
Photo 1 of 1 : FA\_2017\_RD0556\_19\_25\_20171117\_00053.jpg

Trim/thin oleanders.

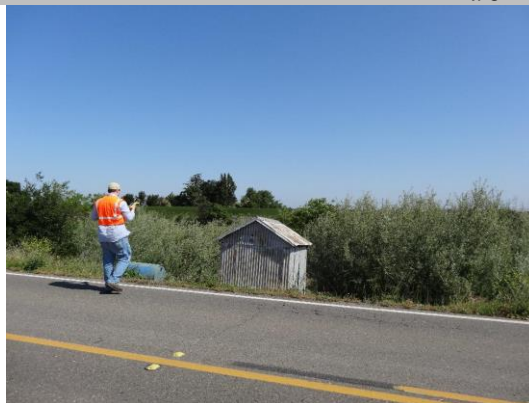
Photo 1 of 3 : UCIP\_FA\_2017\_12512\_20245.jpg

WS- pump house on levee berm

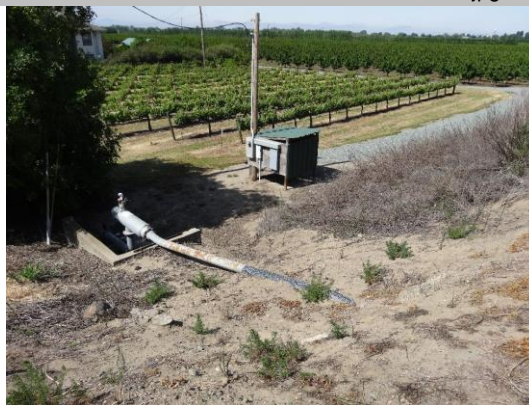
Photo 2 of 3 : UCIP\_FA\_2017\_12512\_20244.jpg

LS- steel pipe on a concrete box

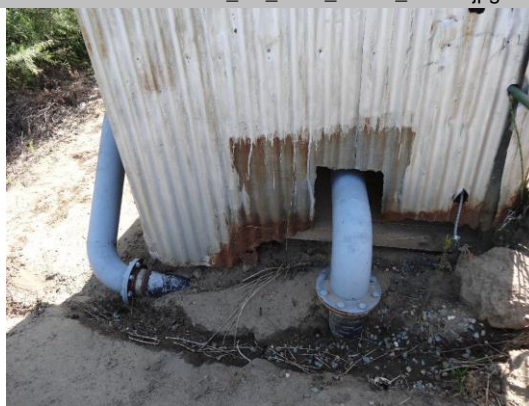
Photo 3 of 3 : UCIP\_FA\_2017\_12512\_20243.jpg

WS- pipe daylight from the pump house.

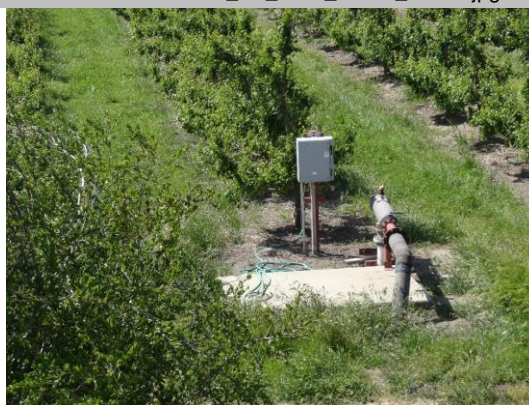
Photo 1 of 3 : UCIP\_FA\_2017\_12573\_20381.jpg

LS- 6-inch steel pipe on orchard.

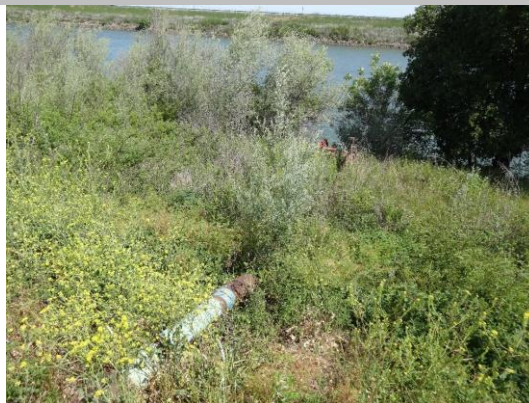
Photo 3 of 3 : UCIP\_FA\_2017\_12573\_20383.jpg

WS- 6-inch steel pipe on levee slope

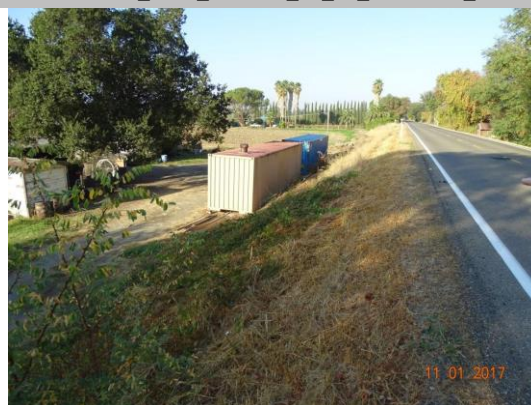
Photo 1 of 1 : FA\_2017\_RD0556\_19\_29\_20171117\_00055.jpg

Remove/relocate two large sea-train shipping containers to 10 feet from landside toe to allow inspection and access.

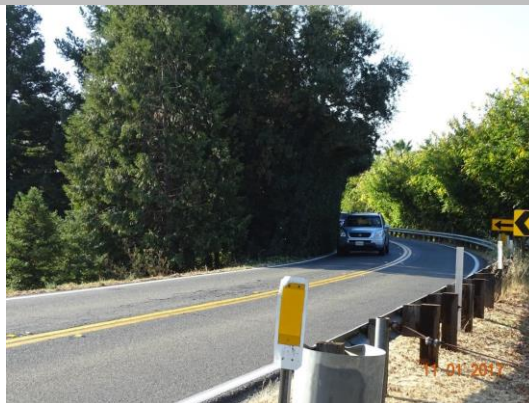
Photo 1 of 1 : FA\_2017\_RD0556\_19\_35\_20171117\_00060.jpg

Trim/thin oleanders to allow inspection and access to landside slope and toe.

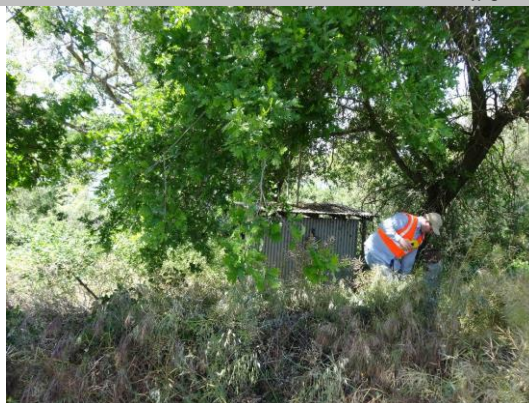
Photo 1 of 3 : UCIP\_FA\_2017\_12574\_20388.jpg

WS- pump house on levee berm

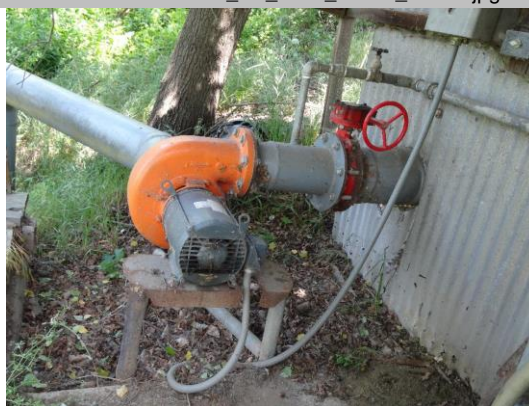
Photo 2 of 3 : UCIP\_FA\_2017\_12574\_20387.jpg

WS- pump, and gate valve in pump house.

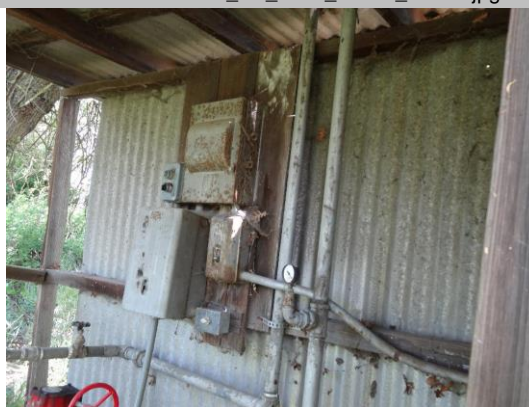
Photo 3 of 3 : UCIP\_FA\_2017\_12574\_20386.jpg

WS- power control panel and electric conduit in pump house.

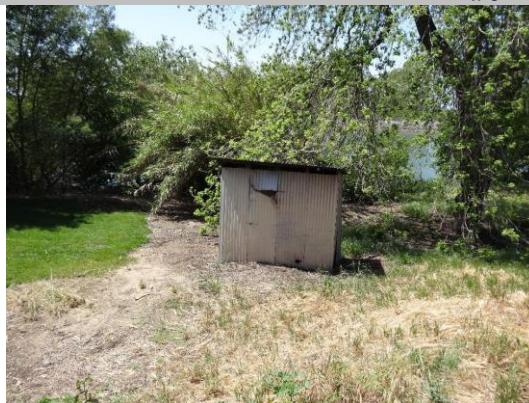
Photo 1 of 3 : UCIP\_FA\_2017\_41713\_20284.jpg

WS- pump house on levee berm.

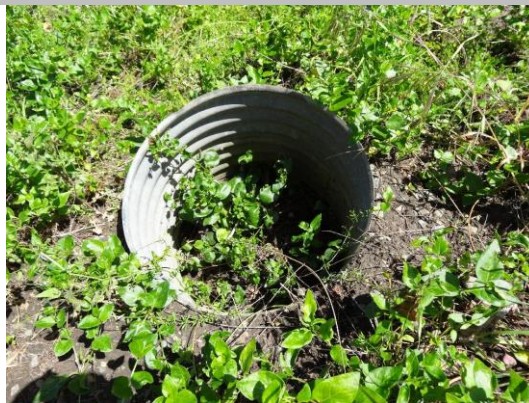
Photo 2 of 3 : UCIP\_FA\_2017\_41713\_20283.jpg

LS- siphon breaker in CMP riser on levee slope.

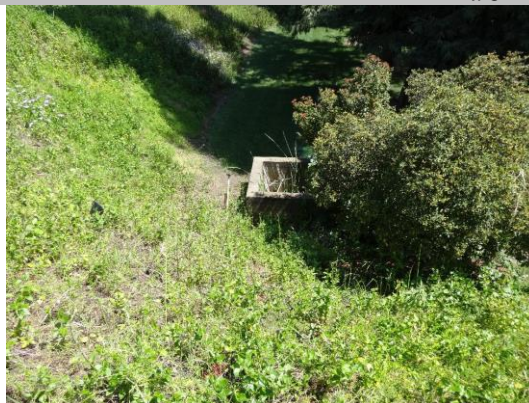
Photo 3 of 3 : UCIP\_FA\_2017\_41713\_20282.jpg

LS- concrete distribution box near toe of the levee

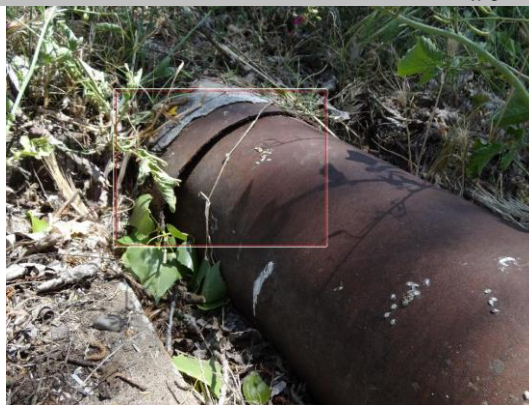
Photo 2 of 3 : UCIP\_FA\_2017\_12525\_20289.jpg

WS- 9-inch pipe sleeved through 10 inch steel pipe.

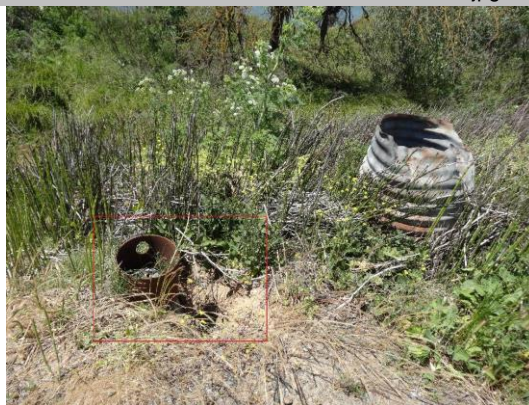
Photo 2 of 3 : UCIP\_FA\_2017\_12527\_20296.jpg

WS- siphon breaker and abandoned CMP riser laying adjacent to it.

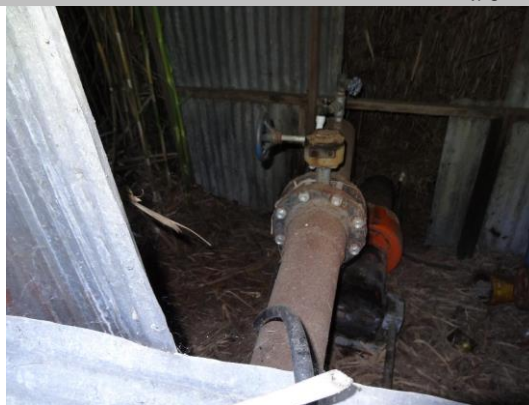
Photo 3 of 3 : UCIP\_FA\_2017\_12545\_20308.jpg

WS- pump, gate valve and pipe in pump house.

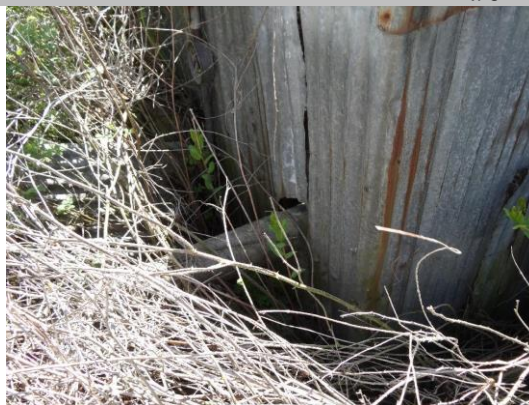
Photo 2 of 3 : UCIP\_FA\_2017\_12546\_20313.jpg

WS- pipe daylight from levee slope to pump house.

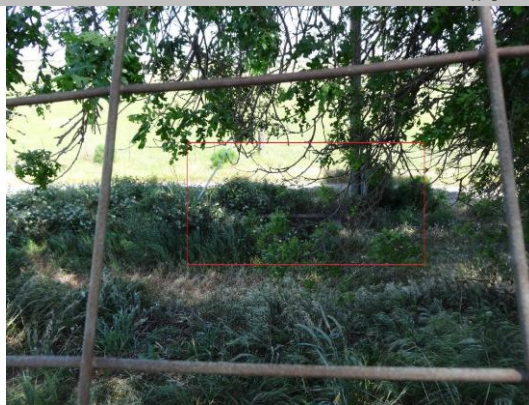
Photo 2 of 3 : UCIP\_FA\_2017\_12547\_20319.jpg

LS- concrete distribution box near levee toe.

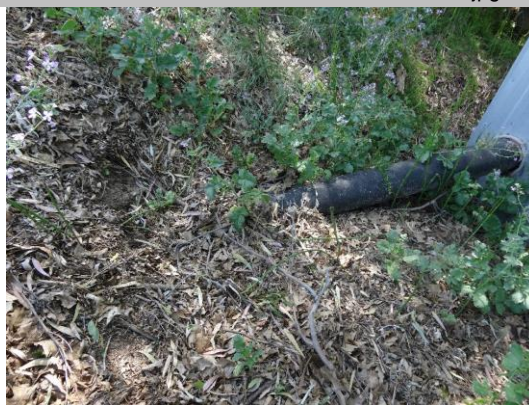
Photo 2 of 3 : UCIP\_FA\_2017\_12570\_20363.jpg

WS- pipe daylight from the levee.
