**Flood Control Project Maintenance
Levee Inspections**

Fall 2018 Levee Maintenance Deficiency Summary Report

Sacramento River Basin

Reclamation District No. 0556 Upper Andrus

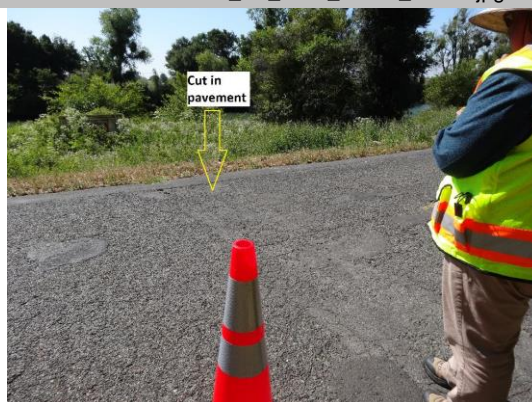
Photo 2 of 3 : UCIP_FA_2018_45564_74146.jpg

Comment Code					
Inspector Comment					
FS_ID:45564 DS_ID:20820 EP_NO: 3448 Repair Type: Non-Urgent Crossing Status: Indicator Found UCIP Comments: Dense vegetation inhibited visibility of gasline marker on WS. Need to contact owner to determine status of crossing. FIELD_STRUCT_DESC: 4.5-inch steel natural gas pipeline through the levee, 4 feet below the crown. Location marker on the waterside (WS) shoulder. Cut in pavement visible at the crossing. Gas line marker on the landside (LS) and on the opposite bank at Reclamation District No. 263 (RD0263). Pipe not located in February 1991. (Plans for construction of a 4.5-inch gas line across Georgiana Slough from Andrus Island to Tyler Island authorized under Permit No. 3448, 1960 - Pacific Gas and Electric Company [PG&E]). [Additional Reference(s): DWR Levee Log]. FS Date: 5/27/2015

View of WS; cut in pavement in alignment with arrow and Olivia indicating location of crossing trench.

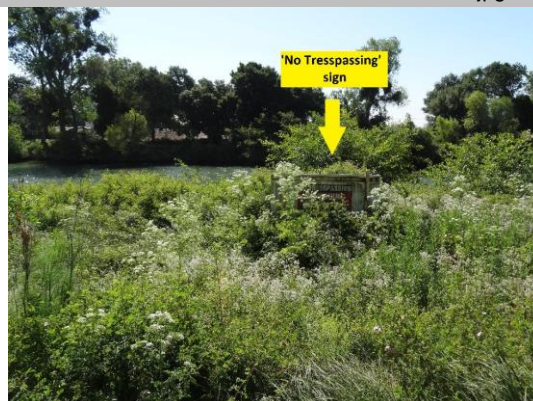
Photo 3 of 3 : UCIP_FA_2018_45564_74152.jpg

Comment Code						
Inspector Comment						
FS_ID:45564 DS_ID:20820 EP_NO: 3448 Repair Type: Non-Urgent Crossing Status: Indicator Found UCIP Comments: Dense vegetation inhibited visibility of gasline marker on WS. Need to contact owner to determine status of crossing. FIELD_STRUCT_DESC: 4.5-inch steel natural gas pipeline through the levee, 4 feet below the crown. Location marker on the waterside (WS) shoulder. Cut in pavement visible at the crossing. Gas line marker on the landside (LS) and on the opposite bank at Reclamation District No. 263 (RD0263). Pipe not located in February 1991. (Plans for construction of a 4.5-inch gas line across Georgiana Slough from Andrus Island to Tyler Island authorized under Permit No. 3448, 1960 - Pacific Gas and Electric Company [PG&E]). [Additional Reference(s): DWR Levee Log]. FS Date: 5/27/2015

View of WS. Dense vegetation limited visibility of 'No Trespassing' sign.

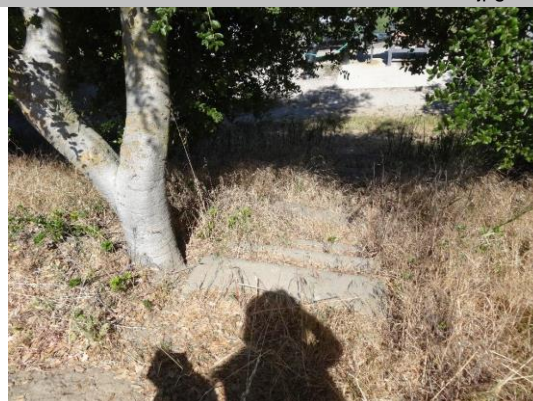
Photo 1 of 3 : UCIP_FA_2018_45663_74180.jpg

Comment Code						
Inspector Comment						
FS_ID:45663						
DS_ID:20821						
EP_NO: 5548						
Repair Type: Non-Urgent						
Crossing Status: Found						
UCIP Comments: Dense vegetation prevents inspection of WS slope.						
FIELD_STRUCT_DESC: 12-inch steel irrigation discharge pipe through the levee, 5 feet below the crown. 1.25-inch electrical conduit through the levee at the same location. Pump on the waterside (WS). Concrete steps on the landside (LS) slope. Cuts in pavement visible at the crossing. (Plans to install a pump with a 12-inch discharge pipe and one electrical conduit through the levee authorized under Permit No. 5548, 1966 - George K. Adams). [Additional Reference(s): DWR Levee Log].						
FS Date: 5/13/2015

Concrete steps on LS slope.

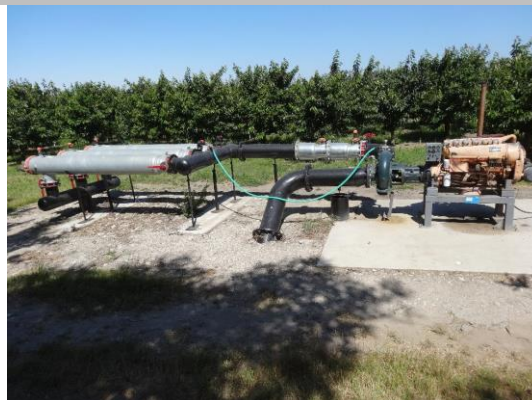
Photo 3 of 3 : UCIP_FA_2018_45663_74182.jpg

Comment Code						
Inspector Comment						
FS_ID:45663 DS_ID:20821 EP_NO: 5548 Repair Type: Non-Urgent Crossing Status: Found UCIP Comments: Dense vegetation prevents inspection of WS slope. FIELD_STRUCT_DESC: 12-inch steel irrigation discharge pipe through the levee, 5 feet below the crown. 1.25-inch electrical conduit through the levee at the same location. Pump on the waterside (WS). Concrete steps on the landside (LS) slope. Cuts in pavement visible at the crossing. (Plans to install a pump with a 12-inch discharge pipe and one electrical conduit through the levee authorized under Permit No. 5548, 1966 - George K. Adams). [Additional Reference(s): DWR Levee Log]. FS Date: 5/13/2015

Pump and pipe into levee off LS toe.

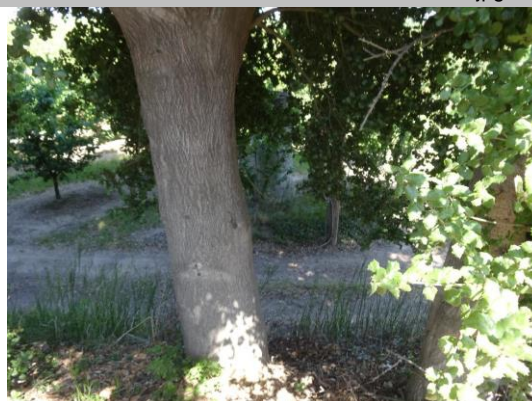
Photo 1 of 3 : UCIP_FA_2018_45664_74190.jpg

LM Start	0.54	Rating **	M	Issue No.	389	
LM End	0.54	Issue Type +	En	Location *		
Category	Supplemental			GPS Latitude/Longitude		
				Start		End
Item	DWR UCIP Field Study			38.232354 °		38.232354 °
				-121.521727 °		-121.521727 °
DWR ID	20826					
Comment Code						
Inspector Comment						
FS_ID:45664 DS_ID:20826 EP_NO: 5548A Repair Type: Non-Urgent Crossing Status: Found UCIP Comments: Dense vegetation prevented inspection of WS slope. FIELD_STRUCT_DESC: 14-inch steel irrigation discharge pipe through the levee, 5 feet below the crown. Pump on the waterside (WS). Electrical conduit through the levee at the same location. Pole with electrical panel at the landside (LS) toe. Standpipe at the LS toe. (Plans to install a 7-gauge, 14-inch pipe through the levee authorized under Permit No. 5548-A, 1981 - Kaydix Company). [Additional Reference(s): DWR Levee Log]. FS Date: 5/27/2015

View of LS with standpipe visible behind tree.

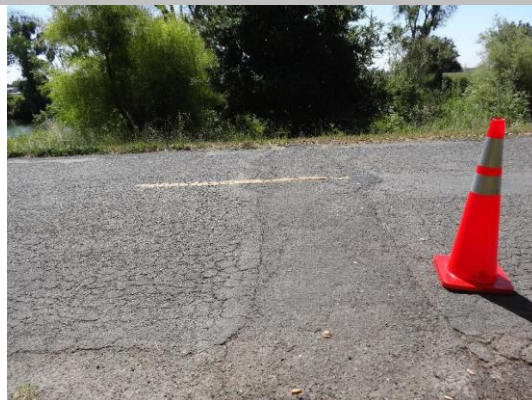
Photo 2 of 3 : UCIP_FA_2018_45664_74191.jpg

View of WS with cuts visible on pavement.

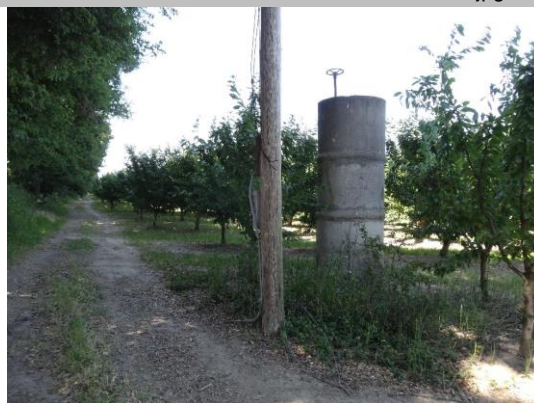
Photo 3 of 3 : UCIP_FA_2018_45664_74192.jpg

Comment Code						
Inspector Comment						
FS_ID:45664 DS_ID:20826 EP_NO: 5548A Repair Type: Non-Urgent Crossing Status: Found UCIP Comments: Dense vegetation prevented inspection of WS slope. FIELD_STRUCT_DESC: 14-inch steel irrigation discharge pipe through the levee, 5 feet below the crown. Pump on the waterside (WS). Electrical conduit through the levee at the same location. Pole with electrical panel at the landside (LS) toe. Standpipe at the LS toe. (Plans to install a 7-gauge, 14-inch pipe through the levee authorized under Permit No. 5548-A, 1981 - Kaydix Company). [Additional Reference(s): DWR Levee Log]. FS Date: 5/27/2015

Standpipe and service pole visible off LS toe.

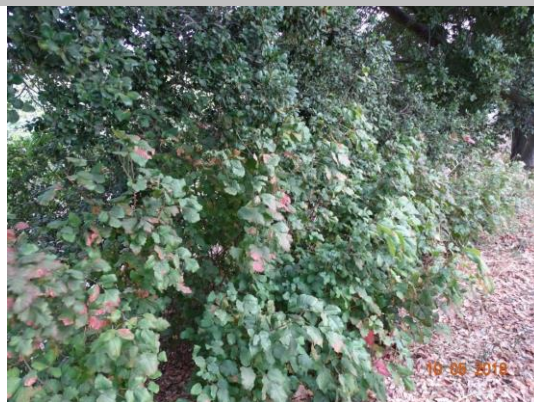
Photo 1 of 1 : FA_2018_RD0556_18_52_20181009_00066.jpg

LM Start	0.56	Rating **	M	Issue No.	52
LM End	0.56	Issue Type +	Ma	Location *	LS
Category	Earthen Levee			GPS Latitude/Longitude	
				Start	End
Item	Vegetation			38.232132 °	38.232132 °
				-121.521955 °	-121.521955 °
DWR ID	DWR_RD0556_01_f _ 2018_52				
Comment Code					
V2 : Remove the wild growth other than native grasses from the levee slopes.					
Inspector Comment					
Poison oak.

View of poison oak at the top of the water land side slope (October 2018).

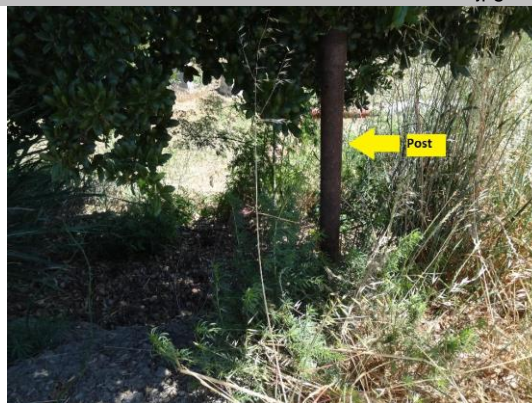
Photo 2 of 3 : UCIP_FA_2018_46799_74740.jpg

FS_ID:46799
DS_ID:25106
EP_NO: N/A
Repair Type: Non-Urgent
Crossing Status: Found
UCIP Comments: Possible erosion above pipe on LS needs attention.
FIELD_STRUCT_DESC: 8-inch steel irrigation pipe through the levee, at an unknown depth. Visible on the landside (LS), 6 feet away from the 10-inch pipe at HLM 1.17. Post likely for protection of vent located on the shoulder. Power pole next to pipe on the LS. This crossing was field discovered.
FS Date: 5/27/2015

LS view: Post located above pipe on LS slope.

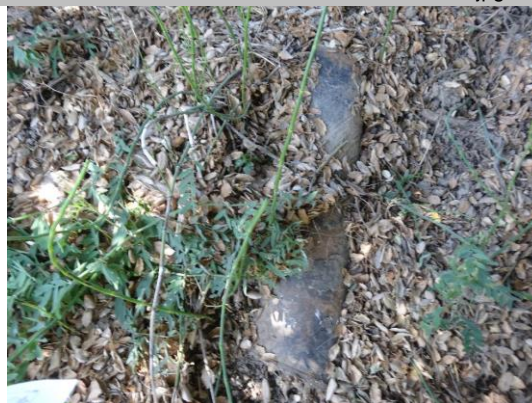
Photo 1 of 3 : UCIP_FA_2018_45683_74200.jpg

Comment Code						
Inspector Comment						
FS_ID:45683 DS_ID:20823 EP_NO: 11169 Repair Type: Non-Urgent Crossing Status: Found UCIP Comments: Appears abandoned in place and if so should be done so properly. Desnse vegetation on WS limits visibility. FIELD_STRUCT_DESC: *ABANDONED* 10-inch steel irrigation discharge pipe through the levee, 3.8 feet below the crown. Located at the lower end of the rock revetment. (Plans to replace an existing 10-inch suction pipe with a 10-inch slant propeller pump on the levee authorized under Permit No. 4848, 1965 - Kay Dix Ranch Company. Retention of a 10-inch pipe through the levee, 3.8 feet below the crown, authorized under Automatic Board Order (ABO) issued as Permit No. 11169, 1975 - Darrell T. and B. M. Mealer). Abandoned in place. [Additional Reference(s): DWR Levee Log. USACE Sacramento O&M Manual 103, June 1954, (Station ""R"" 548+59.8), invert elevation 16.8 feet]. FS Date: 5/27/2015

LS view of pipe appearing abandoned in place.

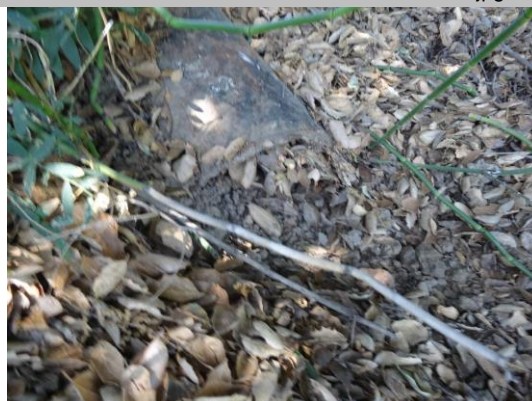
Photo 2 of 3 : UCIP_FA_2018_45683_74201.jpg

Comment Code						
Inspector Comment						
FS_ID:45683 DS_ID:20823 EP_NO: 11169 Repair Type: Non-Urgent Crossing Status: Found UCIP Comments: Appears abandoned in place and if so should be done so properly. Desnse vegetation on WS limits visibility. FIELD_STRUCT_DESC: *ABANDONED* 10-inch steel irrigation discharge pipe through the levee, 3.8 feet below the crown. Located at the lower end of the rock revetment. (Plans to replace an existing 10-inch suction pipe with a 10-inch slant propeller pump on the levee authorized under Permit No. 4848, 1965 - Kay Dix Ranch Company. Retention of a 10-inch pipe through the levee, 3.8 feet below the crown, authorized under Automatic Board Order (ABO) issued as Permit No. 11169, 1975 - Darrell T. and B. M. Mealer). Abandoned in place. [Additional Reference(s): DWR Levee Log. USACE Sacramento O&M Manual 103, June 1954, (Station ""R"" 548+59.8), invert elevation 16.8 feet]. FS Date: 5/27/2015

Closeup of abandoned pipe.

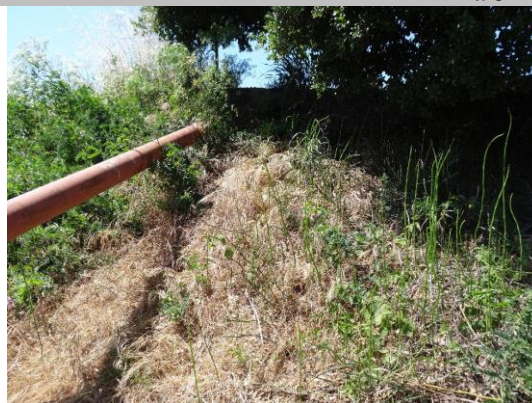
Photo 3 of 3 : UCIP_FA_2018_45683_74202.jpg

View up LS slope. 10" pipe (not visible) rests next to (visible) 8" pipe.

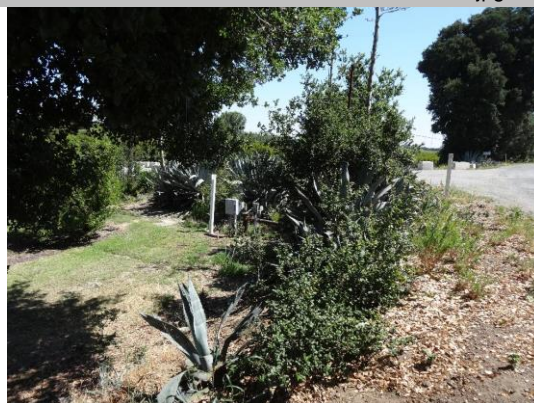
Photo 1 of 3 : UCIP_FA_2018_45692_74204.jpg

Comment Code						
Inspector Comment						
FS_ID:45692 DS_ID:20825 EP_NO: 13302 Repair Type: Non-Urgent Crossing Status: Found UCIP Comments: Seal beneath siphon breaker off LS toe leaking. Rodent activity near crown off LS shoulder. Need to contact owner about leaky seal. Dense vegetation prevented inspection of WS slope. FIELD_STRUCT_DESC: 6-inch steel irrigation discharge pipe and 2-inch galvanized iron electrical conduit through the levee, 2 feet below the crown. Siphon valve on the landside (LS) shoulder. Concrete stand and pump at the LS toe. Circuit box also at the LS toe. Cuts visible in pavement. 6-inch polyvinyl chloride (PVC) standpipe adjacent to the pipe off the LS toe. (Plans to install a 6-inch irrigation pipe and electrical conduit through the levee authorized under Permit No. 13302, 1981 - Kaydix Ranch). [Additional Reference(s): DWR Levee Log. USACE Sacramento O&M Manual 103, June 1954, (Station ""R"" 540+85), invert elevation 16.3 feet]. FS Date: 5/27/2015

Pipe, standpipe, electrical box at LS toe. Pump house in bush behind electrical box.

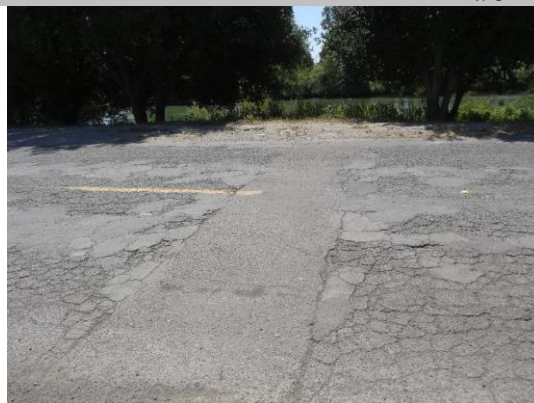
Photo 2 of 3 : UCIP_FA_2018_45692_74205.jpg

WS view and cuts visible on pavement.

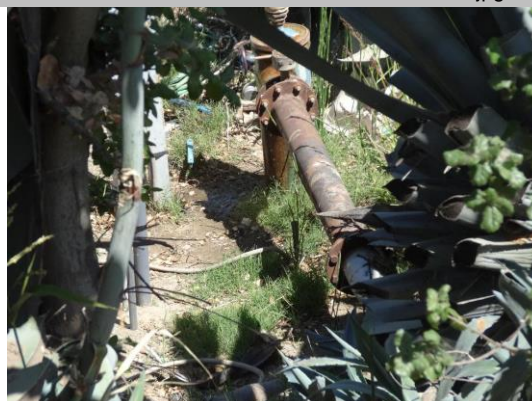
Photo 3 of 3 : UCIP_FA_2018_45692_74206.jpg

Comment Code						
Inspector Comment						
FS_ID:45692 DS_ID:20825 EP_NO: 13302 Repair Type: Non-Urgent Crossing Status: Found UCIP Comments: Seal beneath siphon breaker off LS toe leaking. Rodent activity near crown off LS shoulder. Need to contact owner about leaky seal. Dense vegetation prevented inspection of WS slope. FIELD_STRUCT_DESC: 6-inch steel irrigation discharge pipe and 2-inch galvanized iron electrical conduit through the levee, 2 feet below the crown. Siphon valve on the landside (LS) shoulder. Concrete stand and pump at the LS toe. Circuit box also at the LS toe. Cuts visible in pavement. 6-inch polyvinyl chloride (PVC) standpipe adjacent to the pipe off the LS toe. (Plans to install a 6-inch irrigation pipe and electrical conduit through the levee authorized under Permit No. 13302, 1981 - Kaydix Ranch). [Additional Reference(s): DWR Levee Log. USACE Sacramento O&M Manual 103, June 1954, (Station ""R"" 540+85), invert elevation 16.3 feet]. FS Date: 5/27/2015

Closeup of pipe at LS toe. Seal beneath siphon breaker leaking.

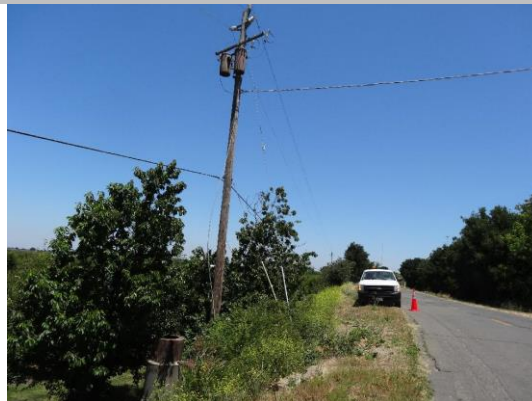
Photo 2 of 3 : UCIP_FA_2018_45743_74241.jpg

Comment Code					
Inspector Comment					
FS_ID:45743 DS_ID:20827 EP_NO: 11169 Repair Type: Non-Urgent Crossing Status: Found UCIP Comments: Dense vegetation on LS and WS limited accessibility. FIELD_STRUCT_DESC: 8-inch steel irrigation discharge pipe through the levee, 3.5 feet below the crown. 1-inch air valve. Pump and gate valve on the waterside (WS) berm. 2-inch electrical conduit through the levee. 36-inch concrete standpipe and concrete block step on the landside (LS) slope. (Retention of a 10-inch pipe through the levee, 3.5 feet below the crown, and a pump and a gate valve on the WS berm authorized under Automatic Board Order (ABO) issued as Permit No. 11169, 1975 - Darrell T. and B. M. Mealer). [Additional Reference(s): DWR Levee Log, 10-inch pipe referenced. USACE Sacramento O&M Manual 103, June 1954, (Station ""R"" 528+02.1), 10-inch pipe referenced, invert elevation 16.6 feet]. FS Date: 5/27/2015

Service pole next to standpipe off LS toe.

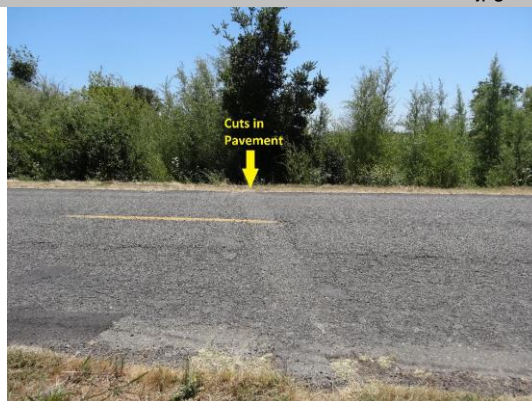
Photo 1 of 3 : UCIP_FA_2018_45746_74250.jpg

Comment Code					
Inspector Comment					
FS_ID:45746 DS_ID:20828 EP_NO: 3735 Repair Type: Non-Urgent Crossing Status: Indicator Found UCIP Comments: Dense vegetation on LS and WS limited accessibility. FIELD_STRUCT_DESC: 4-inch electrical conduit of an unknown material under Georgiana Slough and through its levees, 4 feet below the crown. Pump on the waterside (WS) berm. Power pole on the landside (LS) in alignment with the cuts in the pavement. (Plans for installation of a 12-kilovolt submarine cable under Georgiana Slough and through its levees authorized under Permit No. 3735, 1961 - Pacific Gas and Electric Company [PG&E]). [Additional Reference(s): DWR Levee Log]. FS Date: 5/27/2015

View of WS and cuts in pavement.

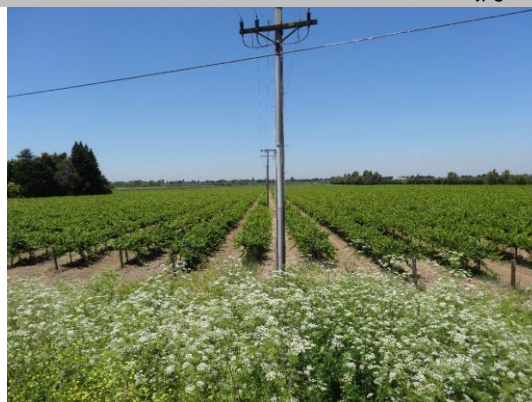
Photo 2 of 3 : UCIP_FA_2018_45746_74251.jpg

Cuts in pavement in alignment with electric pole off LS toe.

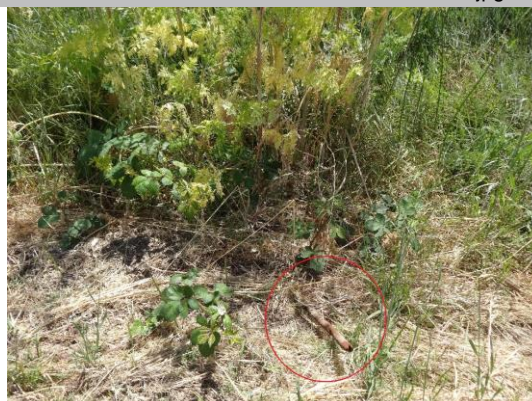
Photo 3 of 3 : UCIP_FA_2018_45746_74252.jpg

Comment Code						
Inspector Comment						
FS_ID:45746 DS_ID:20828 EP_NO: 3735 Repair Type: Non-Urgent Crossing Status: Indicator Found UCIP Comments: Dense vegetation on LS and WS limited accessibility. FIELD_STRUCT_DESC: 4-inch electrical conduit of an unknown material under Georgiana Slough and through its levees, 4 feet below the crown. Pump on the waterside (WS) berm. Power pole on the landside (LS) in alignment with the cuts in the pavement. (Plans for installation of a 12-kilovolt submarine cable under Georgiana Slough and through its levees authorized under Permit No. 3735, 1961 - Pacific Gas and Electric Company [PG&E]). [Additional Reference(s): DWR Levee Log]. FS Date: 5/27/2015

Pipe debris present at LS toe.

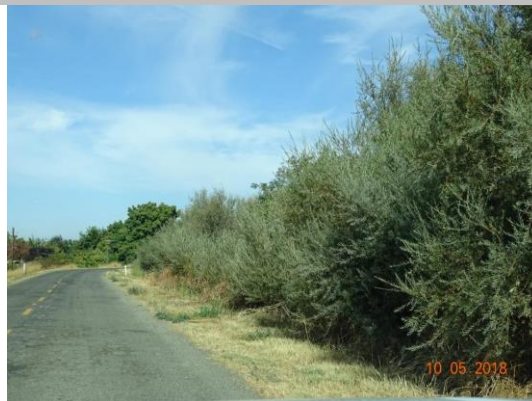
Photo 1 of 1 : FA_2018_RD0556_18_64_20181009_00073.jpg

View of vegetation on the water side slope (October 2018).

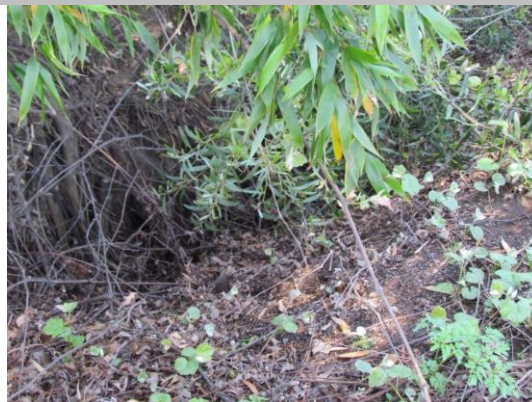
Photo 1 of 2 : FA_2018_RD0556_18_33_20180925_00017.jpg

RD 556 Unit 1 levee mile 2.72 fallen tree damage to shoulder and slope.

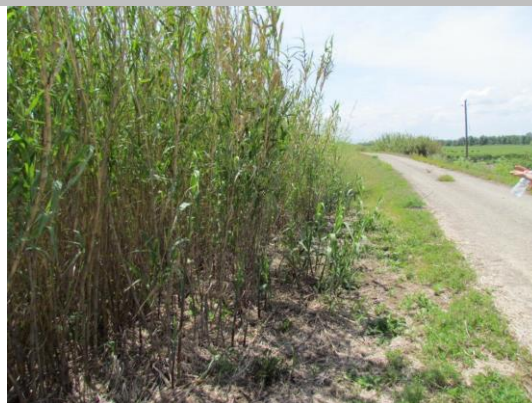
Photo 1 of 1 : FA_2018_RD0556_18_67_20180925_00030.jpg

Looking downstream on the waterside arundo completely blocking view of the slope and shoulder.

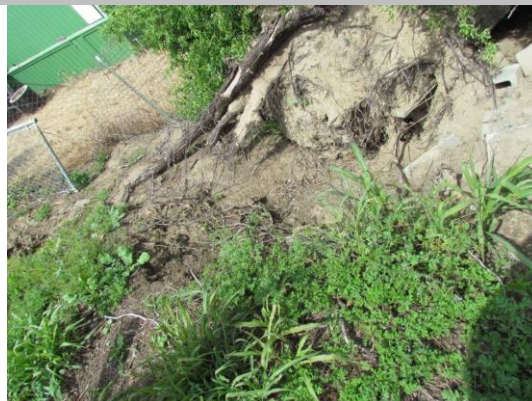
Photo 1 of 2 : FA_2018_RD0556_18_44_20180925_00024.jpg

RD 556 Unit 1 levee mile 5.46 fallen tree on landside slope and damage to the slope.

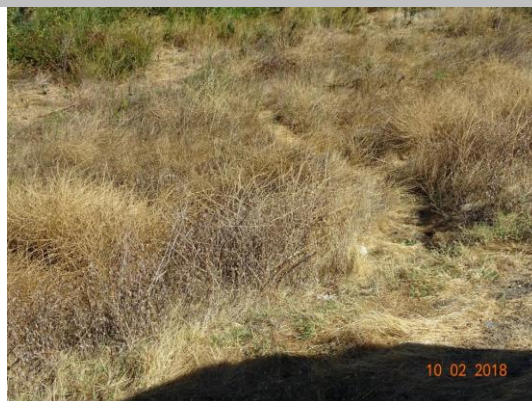
Photo 1 of 1 : FA_2018_RD0556_19_22_20181003_00061.jpg

View of footpath down the water side slope that is beginning to dig into levee (October 2018).

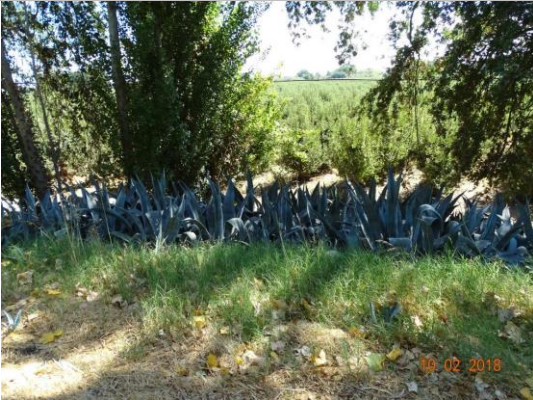
Photo 1 of 1 : FA_2018_RD0556_19_87_20181003_00075.jpg

View of cactus on the land side slope (October 2018).

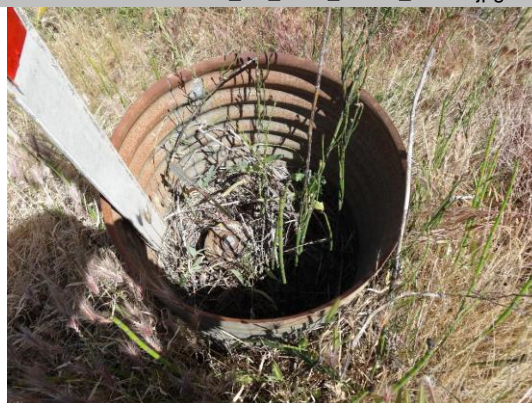
Photo 3 of 3 : UCIP_FA_2018_12543_20300.jpg

LS- siphon breaker in CMP riser. It needs cleaning.

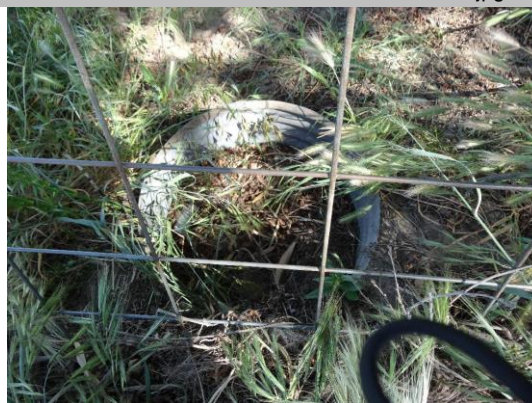
Photo 1 of 3 : UCIP_FA_2018_12547_20320.jpg

LS- obstructed siphon breaker in CMP riser on levee slope.
