**Flood Control Project Maintenance
Levee Inspections**

Fall 2019 Levee Maintenance Deficiency Summary Report

Sacramento River Basin

Reclamation District No. 0556 Upper Andrus

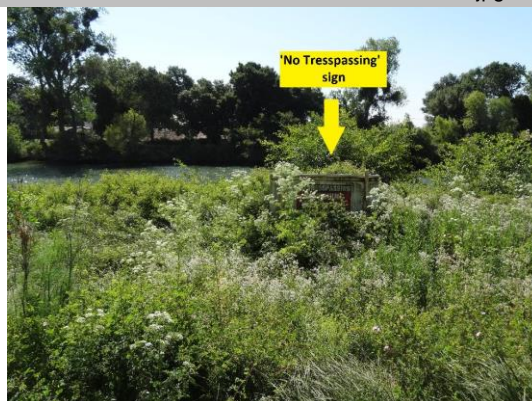
Photo 3 of 3 : UCIP_FA_2019_45564_74152.jpg

Comment Code						
Inspector Comment						
DS_ID:20820 FS_ID:45564 EP_NO: 3448 Repair Type: Non-Urgent Crossing Status: Indicator Found UCIP Comments: Dense vegetation inhibited visibility of gasline marker on WS. Need to contact owner to determine status of crossing. FIELD_STRUCT_DESC: 4.5-inch steel natural gas pipeline through the levee, 4 feet below the crown. Location marker on the waterside (WS) shoulder. Cut in pavement visible at the crossing. Gas line marker on the landside (LS) and on the opposite bank at Reclamation District No. 263 (RD0263). Pipe not located in February 1991. (Plans for construction of a 4.5-inch gas line across Georgiana Slough from Andrus Island to Tyler Island authorized under Permit No. 3448, 1960 - Pacific Gas and Electric Company [PG&E]). [Additional Reference(s): DWR Levee Log]. FS Date: 5/27/2015

View of WS. Dense vegetation limited visibility of 'No Trespassing' sign.

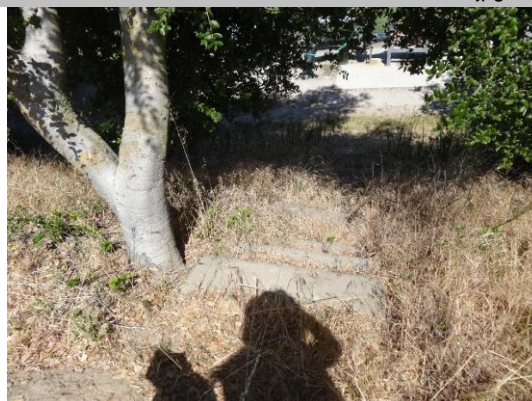
Photo 1 of 3 : UCIP_FA_2019_45663_74180.jpg

Comment Code						
Inspector Comment						
DS_ID:20821 FS_ID:45663 EP_NO: 5548 Repair Type: Non-Urgent Crossing Status: Found UCIP Comments: Dense vegetation prevents inspection of WS slope. FIELD_STRUCT_DESC: 12-inch steel irrigation discharge pipe through the levee, 5 feet below the crown. 1.25-inch electrical conduit through the levee at the same location. Pump on the waterside (WS). Concrete steps on the landside (LS) slope. Cuts in pavement visible at the crossing. (Plans to install a pump with a 12-inch discharge pipe and one electrical conduit through the levee authorized under Permit No. 5548, 1966 - George K. Adams). [Additional Reference(s): DWR Levee Log]. FS Date: 5/13/2015

Concrete steps on LS slope.

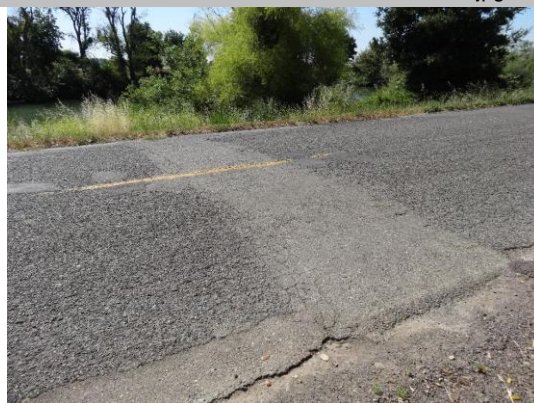
Photo 2 of 3 : UCIP_FA_2019_45663_74181.jpg

View of WS with cuts visible on pavement.

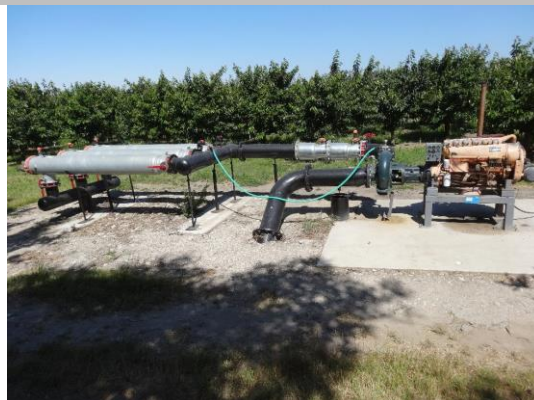
Photo 3 of 3 : UCIP_FA_2019_45663_74182.jpg

Pump and pipe into levee off LS toe.

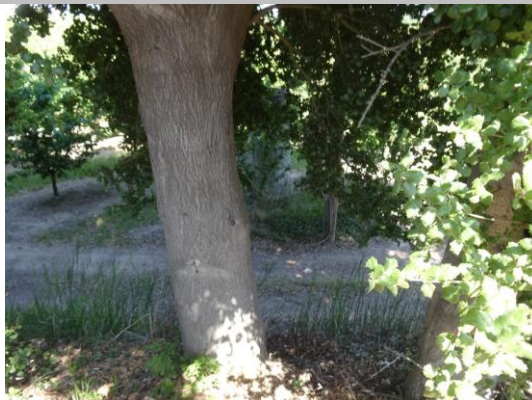
Photo 1 of 3 : UCIP_FA_2019_45664_74190.jpg

Comment Code						
Inspector Comment						
DS_ID:20826 FS_ID:45664 EP_NO: 5548A Repair Type: Non-Urgent Crossing Status: Found UCIP Comments: Dense vegetation prevented inspection of WS slope. FIELD_STRUCT_DESC: 14-inch steel irrigation discharge pipe through the levee, 5 feet below the crown. Pump on the waterside (WS). Electrical conduit through the levee at the same location. Pole with electrical panel at the landside (LS) toe. Standpipe at the LS toe. (Plans to install a 7-gauge, 14-inch pipe through the levee authorized under Permit No. 5548-A, 1981 - Kaydix Company). [Additional Reference(s): DWR Levee Log]. FS Date: 5/27/2015

View of LS with standpipe visible behind tree.

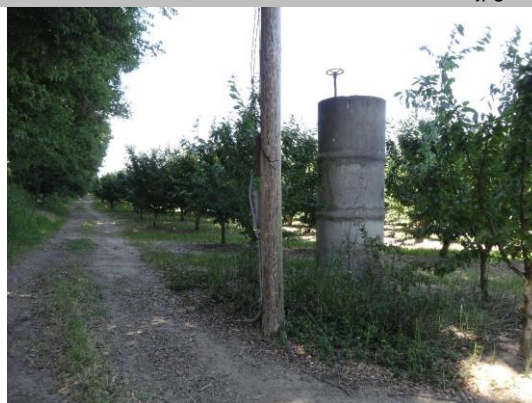
Photo 3 of 3 : UCIP_FA_2019_45664_74192.jpg

Standpipe and service pole visible off LS toe.

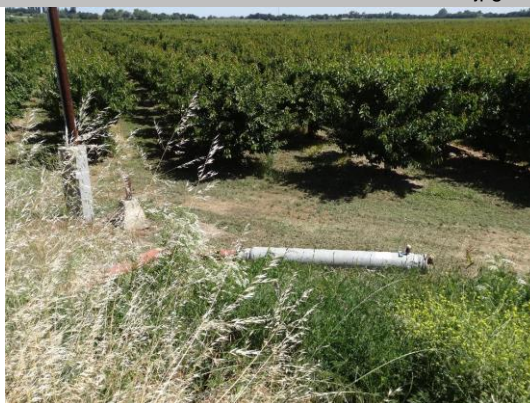
Photo 3 of 3 : UCIP_FA_2019_46799_74741.jpg

Electric pole next to pipe on LS.

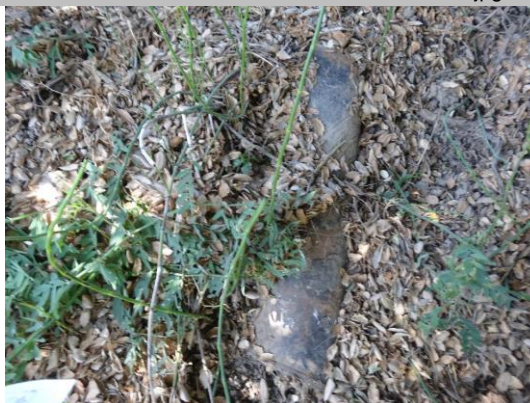
Photo 1 of 3 : UCIP_FA_2019_45683_74200.jpg

Comment Code						
Inspector Comment						
DS_ID:20823 FS_ID:45683 EP_NO: 11169 Repair Type: Non-Urgent Crossing Status: Found UCIP Comments: Appears abandoned in place and if so should be done so properly. Desnse vegetation on WS limits visibility. FIELD_STRUCT_DESC: *ABANDONED* 10-inch steel irrigation discharge pipe through the levee, 3.8 feet below the crown. Located at the lower end of the rock revetment. (Plans to replace an existing 10-inch suction pipe with a 10-inch slant propeller pump on the levee authorized under Permit No. 4848, 1965 - Kay Dix Ranch Company. Retention of a 10-inch pipe through the levee, 3.8 feet below the crown, authorized under Automatic Board Order (ABO) issued as Permit No. 11169, 1975 - Darrell T. and B. M. Mealer). Abandoned in place. [Additional Reference(s): DWR Levee Log. USACE Sacramento O&M Manual 103, June 1954, (Station ""R"" 548+59.8), invert elevation 16.8 feet]. FS Date: 5/27/2015

LS view of pipe appearing abandoned in place.

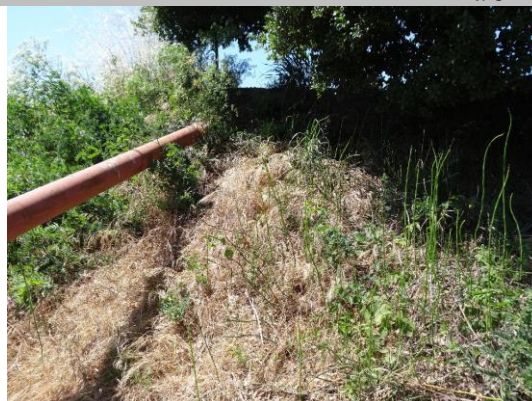
Photo 3 of 3 : UCIP_FA_2019_45683_74202.jpg

View up LS slope. 10" pipe (not visible) rests next to (visible) 8" pipe.

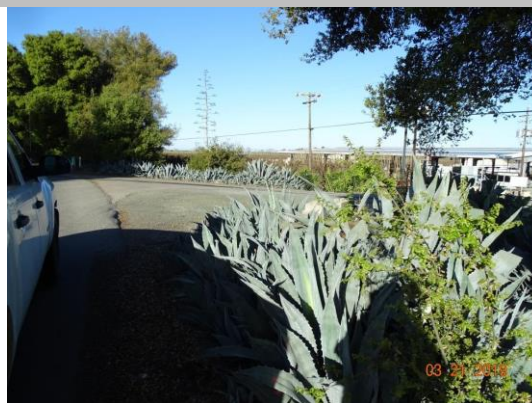
Photo 1 of 1 : FA_2019_RD0556_18_45_20190826_00027.jpg

View of cactus on the landside shoulder (Spring 2019).

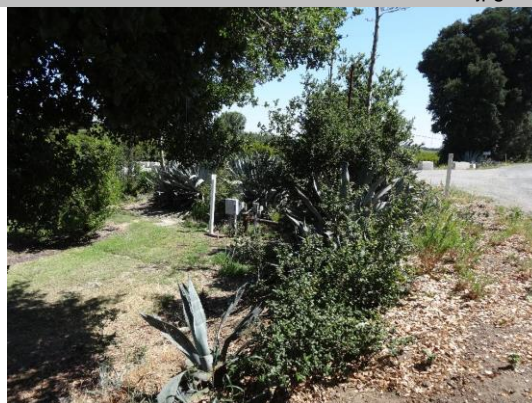
Photo 1 of 3 : UCIP_FA_2019_45692_74204.jpg

Comment Code						
Inspector Comment						
DS_ID:20825 FS_ID:45692 EP_NO: 13302 Repair Type: Non-Urgent Crossing Status: Found UCIP Comments: Seal beneath siphon breaker off LS toe leaking. Rodent activity near crown off LS shoulder. Need to contact owner about leaky seal. Dense vegetation prevented inspection of WS slope. FIELD_STRUCT_DESC: 6-inch steel irrigation discharge pipe and 2-inch galvanized iron electrical conduit through the levee, 2 feet below the crown. Siphon valve on the landside (LS) shoulder. Concrete stand and pump at the LS toe. Circuit box also at the LS toe. Cuts visible in pavement. 6-inch polyvinyl chloride (PVC) standpipe adjacent to the pipe off the LS toe. (Plans to install a 6-inch irrigation pipe and electrical conduit through the levee authorized under Permit No. 13302, 1981 - Kaydix Ranch). [Additional Reference(s): DWR Levee Log. USACE Sacramento O&M Manual 103, June 1954, (Station ""R"" 540+85), invert elevation 16.3 feet]. FS Date: 5/27/2015

Pipe, standpipe, electrical box at LS toe. Pumphouse in bush behind electrical box.

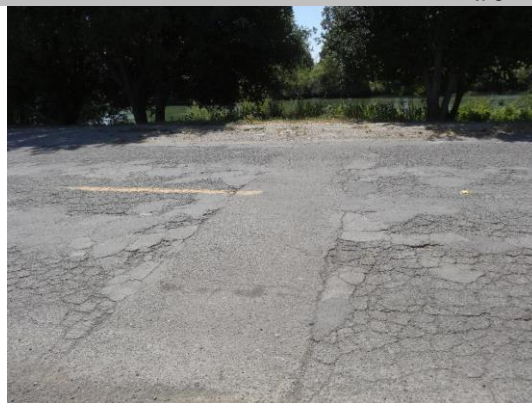
Photo 2 of 3 : UCIP_FA_2019_45692_74205.jpg

WS view and cuts visible on pavement.

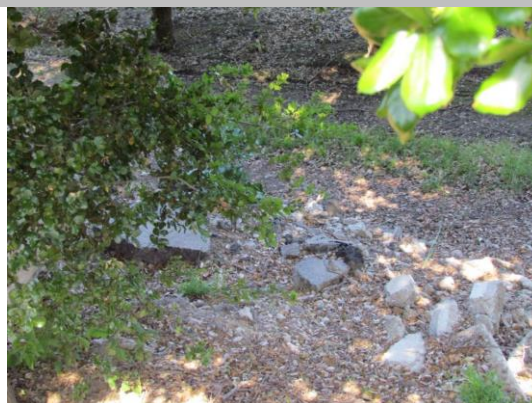
Photo 1 of 3 : FA_2019_RD0556_18_27_20190826_00009.jpg

View of concrete rubble at landside toe.

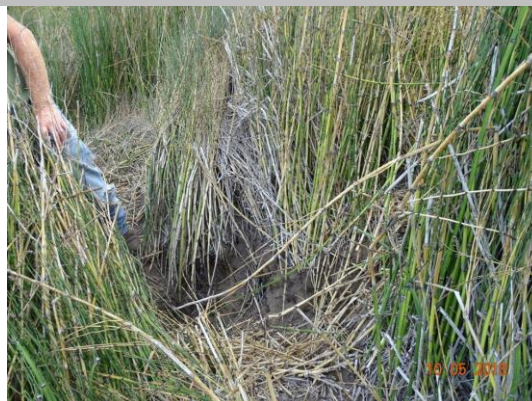
Photo 1 of 1 : FA_2019_RD0556_18_40_20190826_00024.jpg

View of erosion that is covered by vegetation on the landside slope (October 2018).

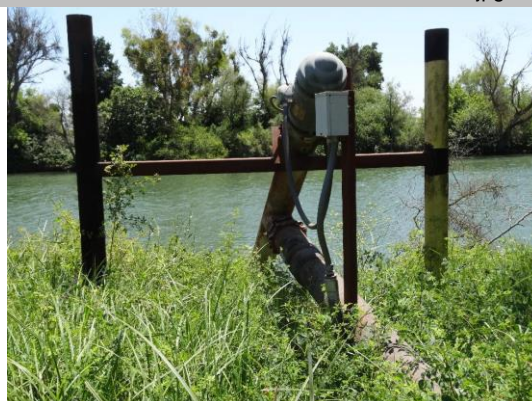
Photo 3 of 3 : UCIP_FA_2019_45743_74242.jpg

Slant pump and pipe with 2" electrical conduit into WS slope.

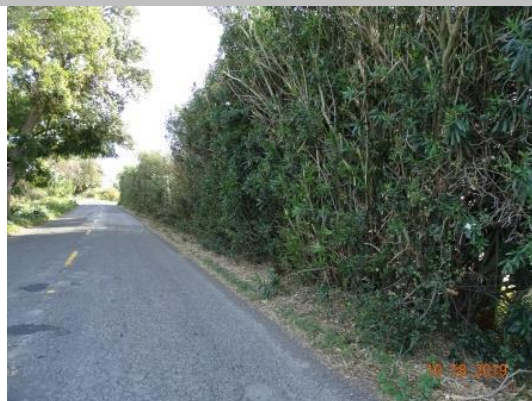
Photo 1 of 1 : FA_2019_RD0556_18_17_20191021_00078.jpg

View looking upstream at thick oleanders on the waterside slope (Fall 2019).

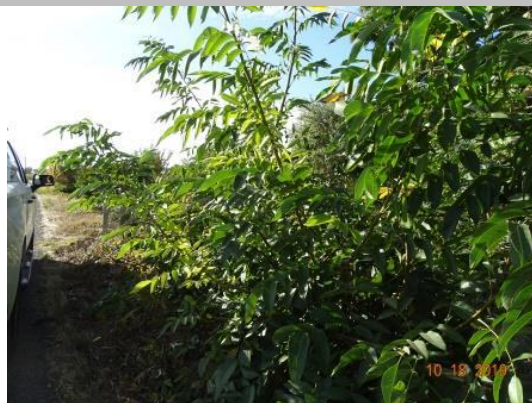
Photo 1 of 1 : FA_2019_RD0556_18_54_20191021_00068.jpg

View looking downstream at landscaping on the landside slope (Fall 2019).

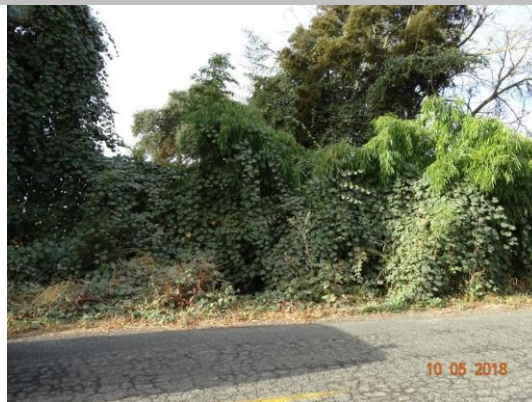
Photo 1 of 1 : FA_2019_RD0556_18_48_20190826_00029.jpg

View of wild grapes and bamboo on the landside slope (Fall 2018).

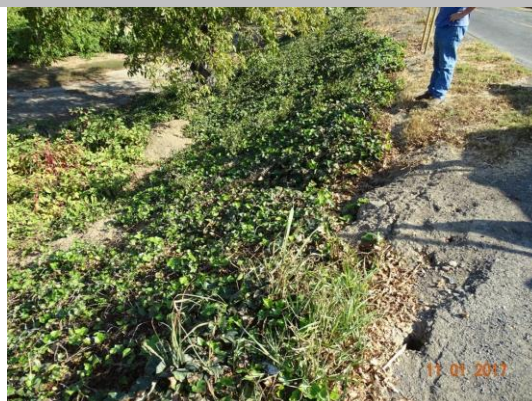
Photo 1 of 1 : FA_2019_RD0556_18_28_20190826_00012.jpg

Significant rodent activity in this area must be stopped. Holes should be backfilled.

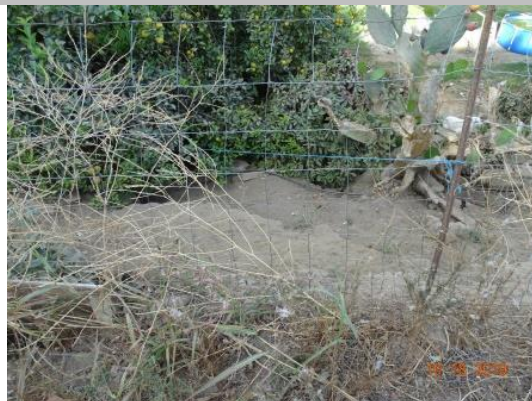
Photo 1 of 2 : FA_2019_RD0556_18_56_20191021_00072.jpg

View looking downslope at levee terracing on the landside slope due to goats (Fall 2019).

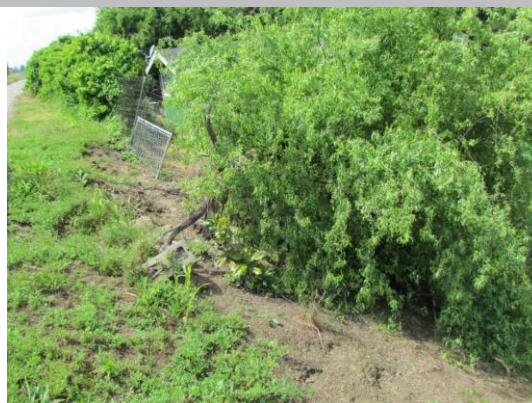
Photo 2 of 2 : FA_2019_RD0556_18_44_20190826_00026.jpg

View looking upstream at fallen tree landside slope and damage to the slope.

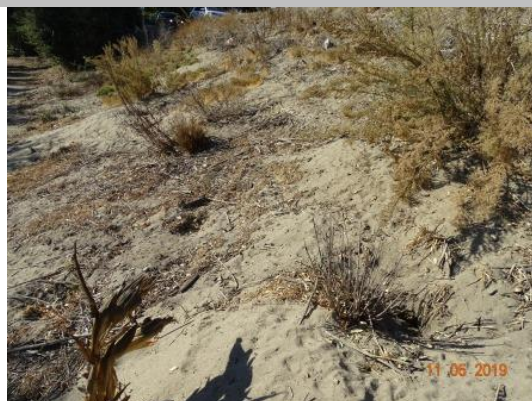
Photo 1 of 1 : FA_2019_RD0556_19_92_20191107_00103.jpg

View of multiple fresh squirrel holes in the landside slope (Fall 2019).

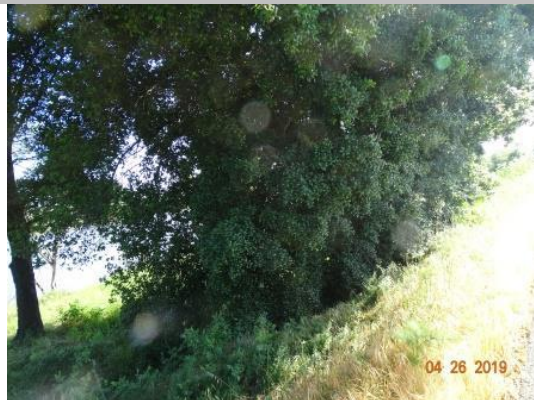
Photo 1 of 1 : FA_2019_RD0556_19_40_20190826_00023.jpg

View looking upstream at thick trees on the waterside slope (Spring 2019).

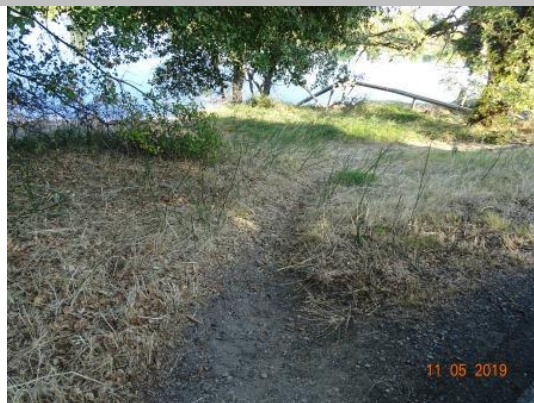
Photo 1 of 1 : FA_2019_RD0556_19_43_20191107_00081.jpg

View of fishermen trail digging into levee on the waterside slope (Fall 2019).

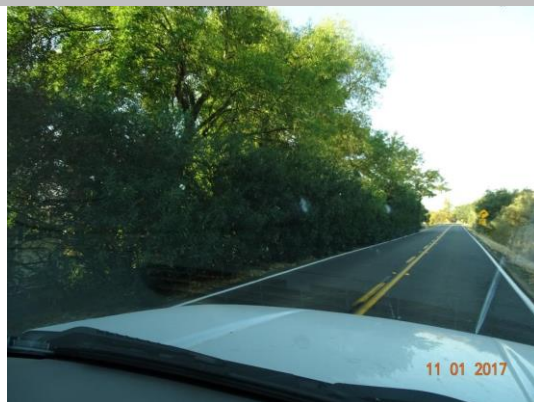
Photo 1 of 1 : FA_2019_RD0556_19_25_20190826_00010.jpg

View of oleanders on the landside of the levee.

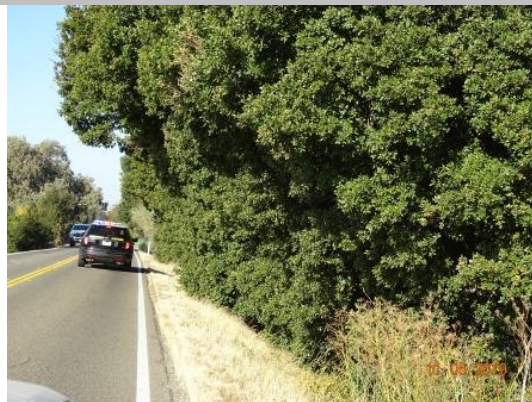
Photo 1 of 1 : FA_2019_RD0556_19_65_20191107_00082.jpg

View looking downstream at thick trees on the waterside slope (Fall 2019).

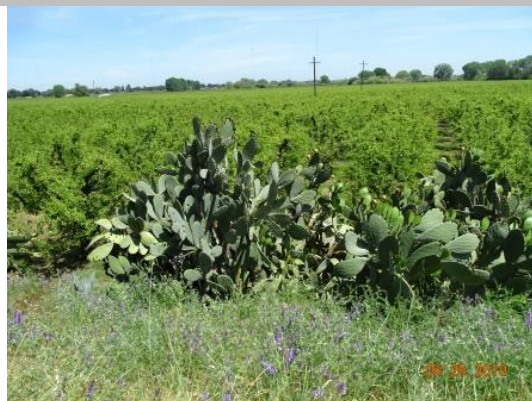
Photo 1 of 1 : FA_2019_RD0556_19_45_20190826_00026.jpg

View of cactus on the landside slope (Spring 2019).

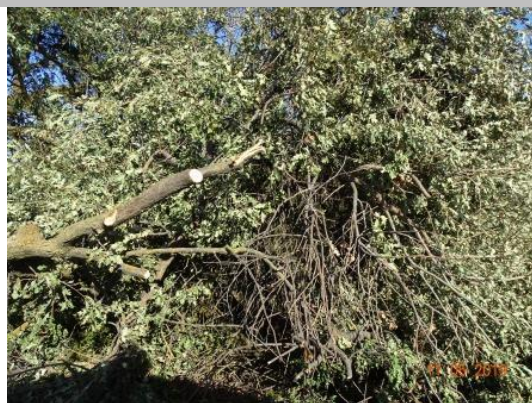
Photo 1 of 1 : FA_2019_RD0556_19_88_20191107_00099.jpg

View of broken tree limb blocking the view of the landside slope (Fall 2019).

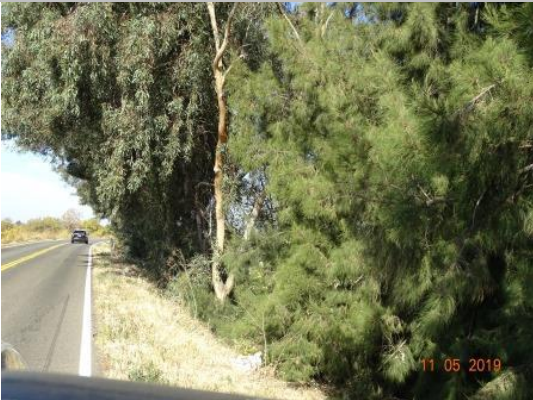
Photo 1 of 1 : FA_2019_RD0556_19_84_20191107_00097.jpg

View looking upstream at thick trees on the landside slope (Fall 2019).

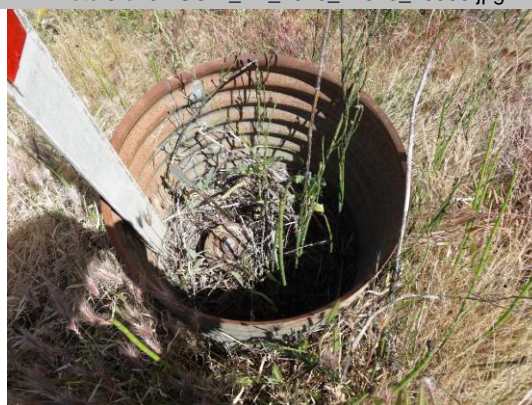
Photo 3 of 3 : UCIP_FA_2019_12543_20300.jpg

LS- siphon breaker in CMP riser. It needs cleaning.

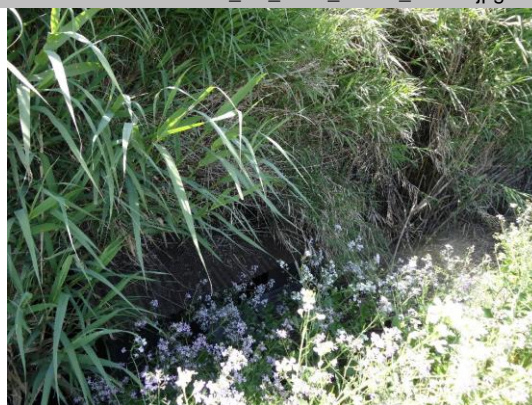
Photo 1 of 3 : UCIP_FA_2019_12545_20310.jpg

WS- pump house not visible due to the dense vegetation.

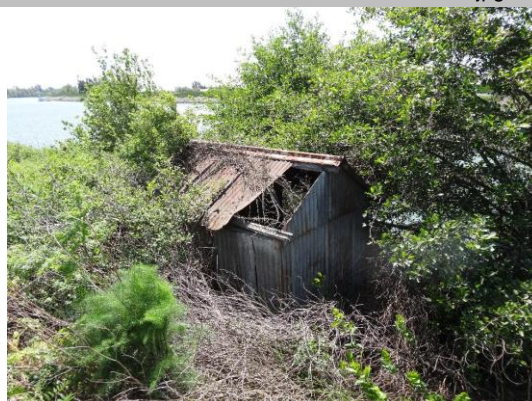
Photo 1 of 3 : UCIP_FA_2019_12546_20314.jpg

WS- abandoned pump house on levee slope. Dense vegetation on levee slope.

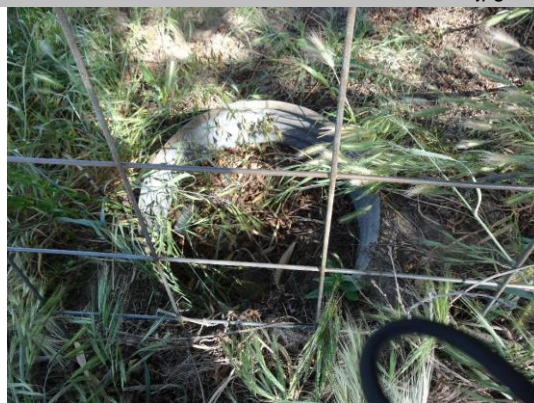
Photo 1 of 3 : UCIP_FA_2019_12547_20320.jpg

LS- obstructed siphon breaker in CMP riser on levee slope.
