Flood Control Project Maintenance Levee Inspections

Fall 2020 Levee Maintenance Deficiency Summary Report

Sacramento River Basin

Reclamation District No. 0556 Upper Andrus

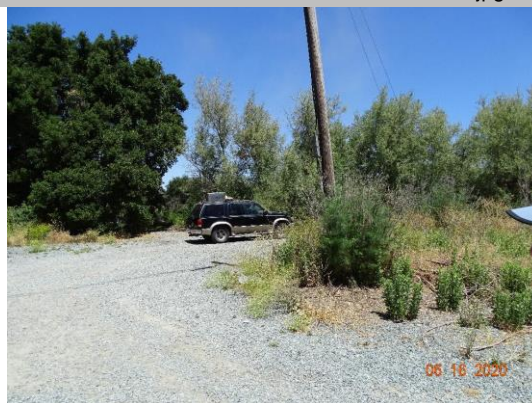
Photo 3 of 3 : UCIP_FA_2020_61316_88592.jpg

Water-Side: Telephone line pole on waterside berm. Overhead telephone line crossing the levee

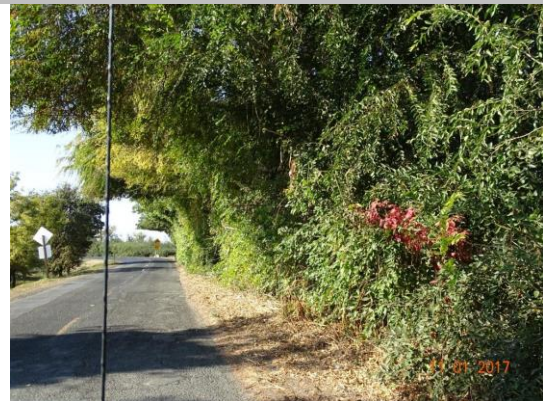
Photo 1 of 1 : FA_2020_RD0556_18_24_20200910_00009.jpg

Trim/thin landscaping to allow inspection and access to levee slope and toe.

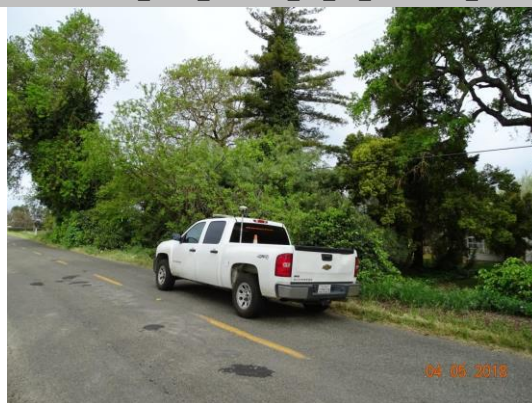
Photo 1 of 1 : FA_2020_RD0556_18_47_20200910_00029.jpg

Landscaping should be thinned.

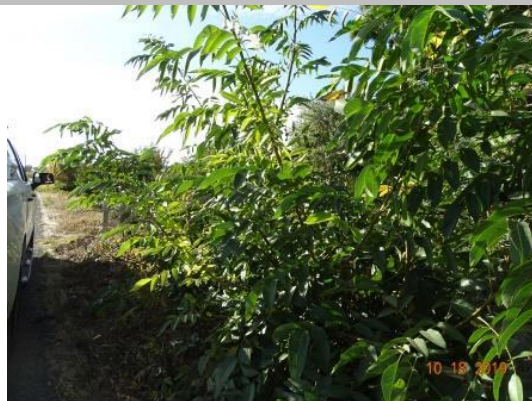
Photo 1 of 1 : FA_2020_RD0556_18_54_20200910_00035.jpg

View looking downstream at landscaping on the landside slope (Fall 2019).

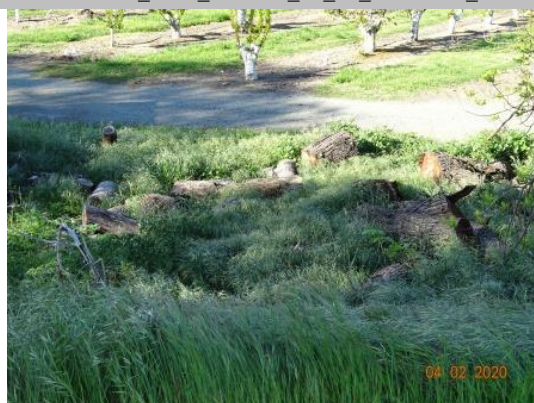
Photo 1 of 1 : FA_2020_RD0556_18_32_20200910_00017.jpg

View of large tree trunk sections on the landside hinge (Spring 2020).

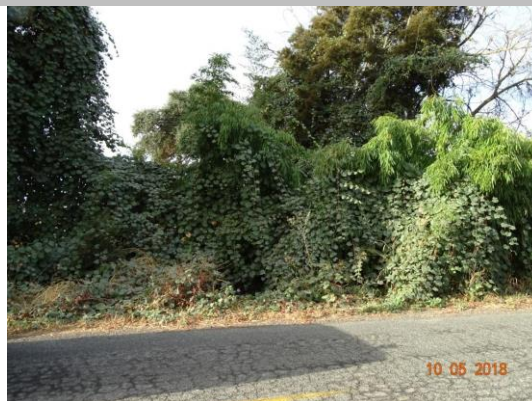
Photo 1 of 1 : FA_2020_RD0556_18_48_20200910_00030.jpg

View of wild grapes and bamboo on the landside slope (Fall 2018).

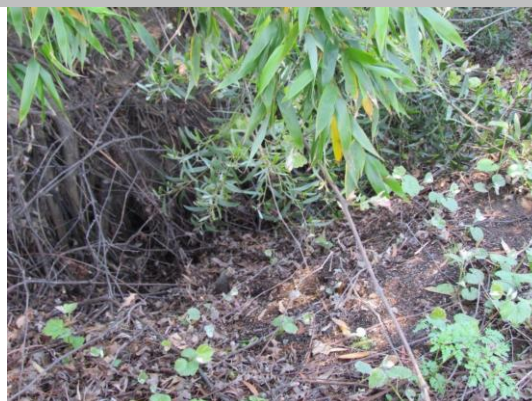
Photo 1 of 1 : FA_2020_RD0556_18_33_20200910_00018.jpg

View of fallen tree damage to shoulder and slope.

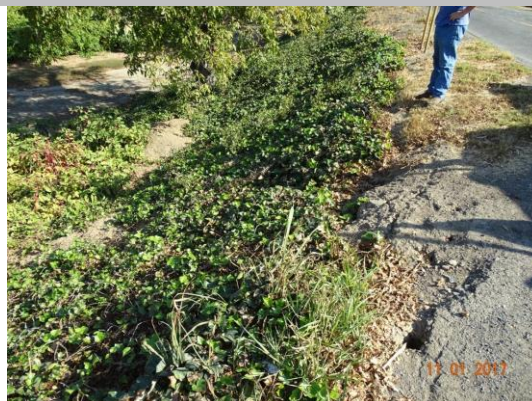
Photo 1 of 1 : FA_2020_RD0556_18_28_20200910_00013.jpg

Significant rodent activity in this area must be stopped. Holes should be backfilled.

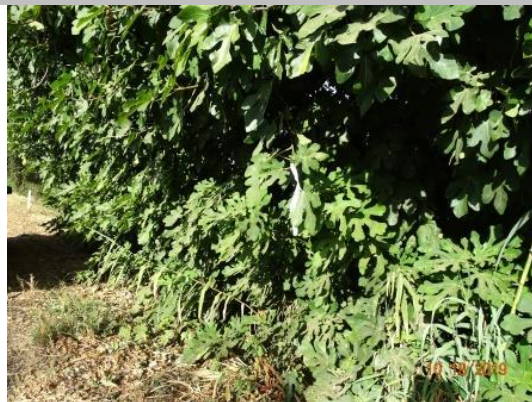
Photo 1 of 1 : FA_2020_RD0556_18_55_20200910_00036.jpg

View of fig tree on the landside slope (Fall 2019).

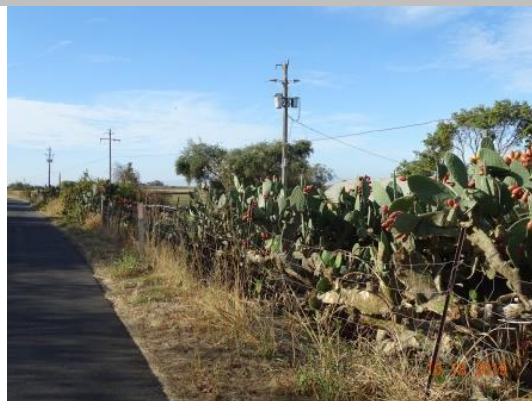
Photo 1 of 1 : FA_2020_RD0556_18_29_20200910_00014.jpg

View looking downstream at cactus on the landside slope (Fall 2019).

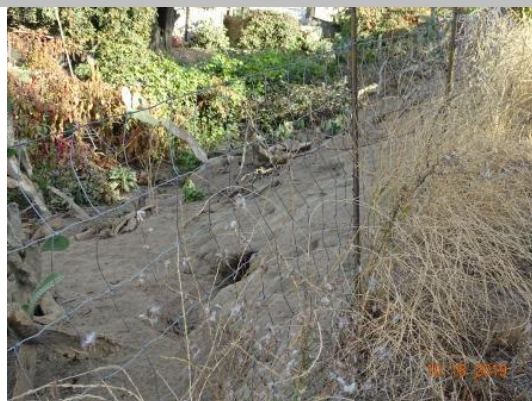
Photo 1 of 1 : FA_2020_RD0556_18_56_20200910_00038.jpg

View looking upstream at levee terracing on the landside slope due to goats (Fall 2019).

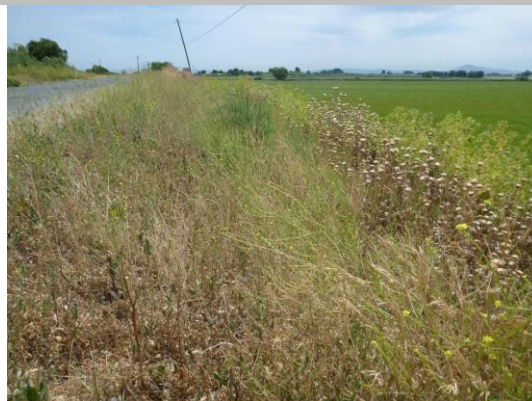
Photo 1 of 1 : FA_2020_RD0556_18_23_20200910_00008.jpg

LM Start	3.43	Rating **	U	Issue No.	12
LM End	3.43	Issue Type +	En	Location *	LS
Category	Earthen Levee			GPS Latitude/Longitude	
				Start	End
Item	Encroachments			38.208033 °	38.208033 °
				-121.541627 °	-121.541627 °
DWR ID	DWR_RD0556_01_s_2020_12				
Comment Code					
MA : Material					
Inspector Comment					
Pile of dirt on landside hinge.

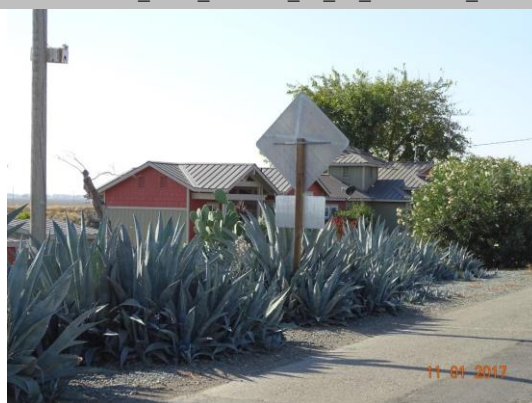
Photo 1 of 1 : FA_2020_RD0556_18_34_20200910_00019.jpg

View of large cactus on waterside shoulder

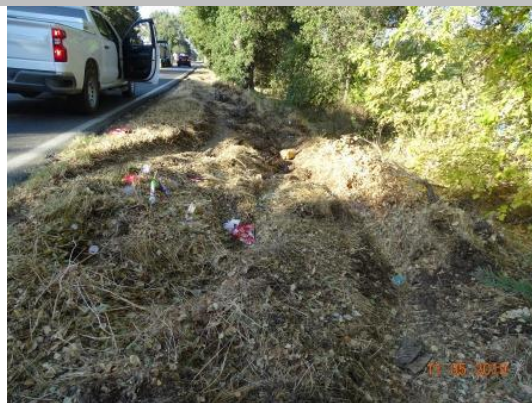
Photo 1 of 1 : FA_2020_RD0556_19_20_20200909_00008.jpg

View looking downstream at vehicle damage to the waterside slope (Fall 2019).

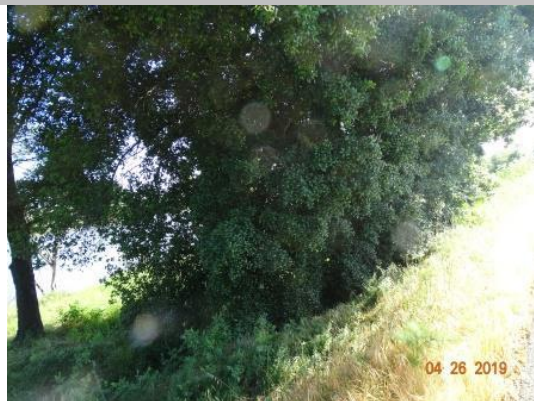
Photo 1 of 1 : FA_2020_RD0556_19_40_20200909_00023.jpg

View looking upstream at thick trees on the waterside slope (Spring 2019).

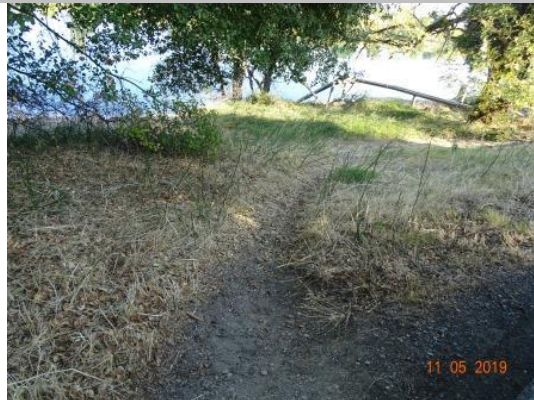
Photo 1 of 1 : FA_2020_RD0556_19_43_20200909_00025.jpg

View of fishermen trail digging into levee on the waterside slope (Fall 2019).

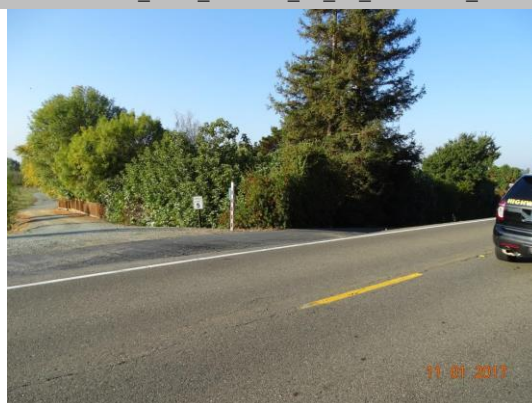
Photo 1 of 1 : FA_2020_RD0556_19_28_20200909_00013.jpg

View of oleanders on the landside of the levee.

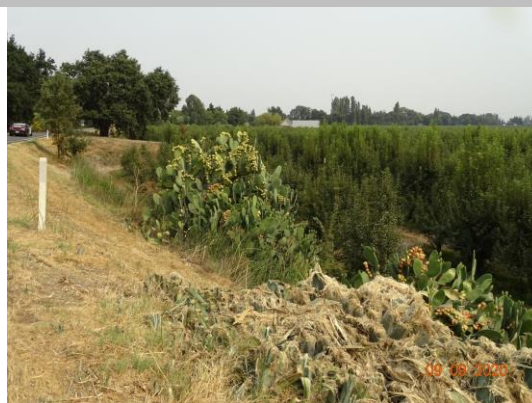
Photo 1 of 1 : FA_2020_RD0556_19_76_20200911_00071.jpg

View of large cactus on the landside slope (Fall 2020).

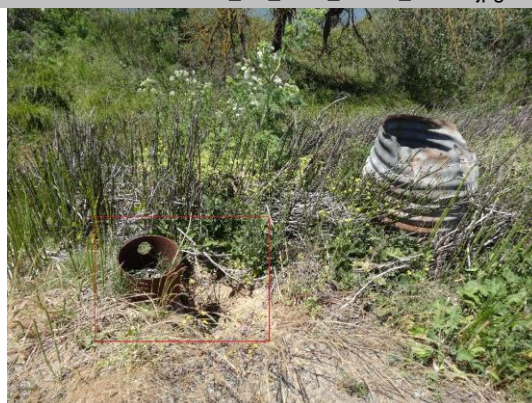
Photo 2 of 3 : UCIP_FA_2020_12527_20296.jpg

WS- siphon breaker and abandoned CMP riser laying adjacent to it.

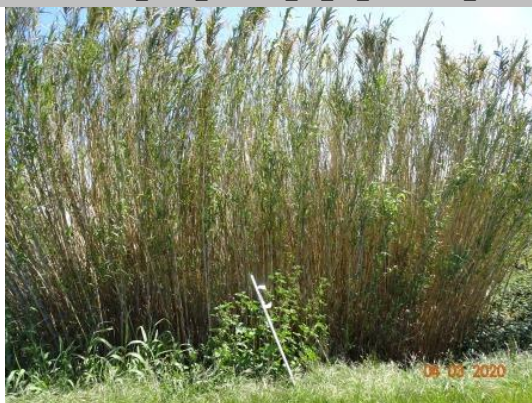
Photo 1 of 1 : FA_2020_RD0556_19_71_20200909_00049.jpg

View of thick arundo on the landside slope (Spring 2020).

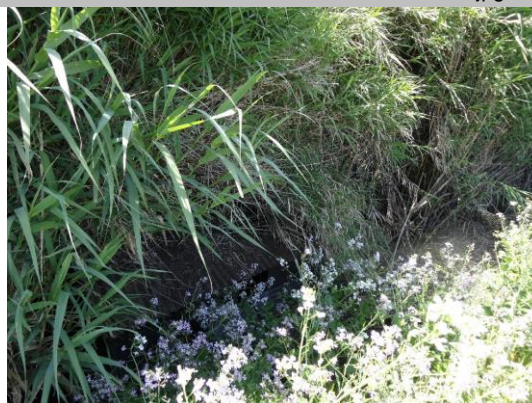
Photo 1 of 3 : UCIP_FA_2020_12545_20310.jpg

WS- pump house not visible due to the dense vegetation.

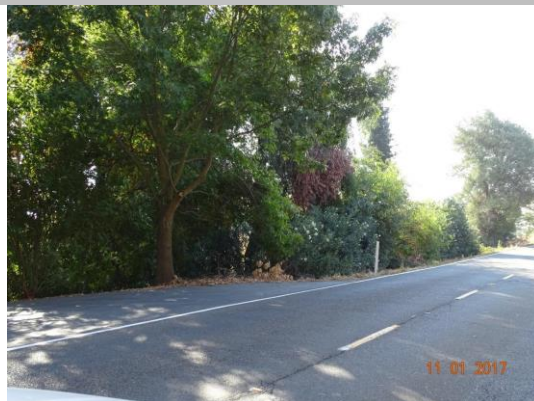
Photo 1 of 1 : FA_2020_RD0556_19_36_20200909_00020.jpg

View of landscaping on the landside.
