## Flood Control Project Maintenance Levee Inspections

### Fall 2021 Levee Maintenance Deficiency Summary Report

#### Sacramento River Basin

**Reclamation District No. 0556 Upper Andrus**

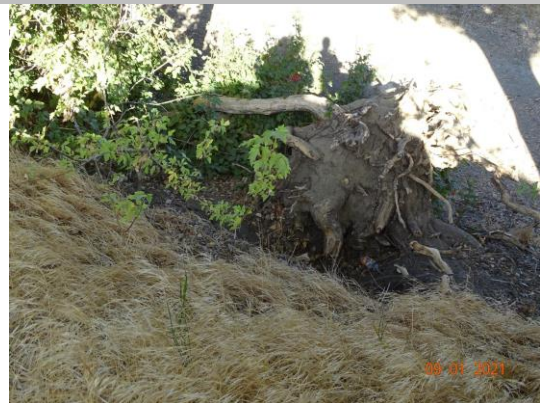
Photo 1 of 1 : FA\_2021\_RD0556\_18\_84\_20211004\_00158.jpg

View of fallen tree root ball and large hole in the landside slope (Fall 2021).

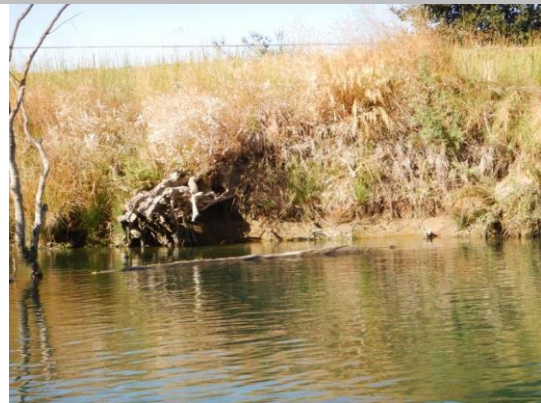
Photo 2 of 2 : FA\_2021\_RD0556\_18\_42\_20211218\_39.jpg

2018 Site ID: GEO 10.9 R  
 Status: Eroding  
 2018 Field Notes: New erosion throughout site.  
 Site History: 2017 - Significant toe erosion and whole bank failure in sections, large pockets from tree popouts.

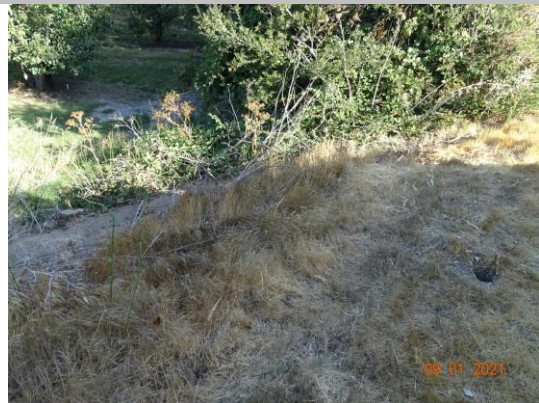
Photo 1 of 1 : FA\_2021\_RD0556\_18\_82\_20210901\_00157.jpg

View of animal holes in landside hinge and slope (Fall 2021).

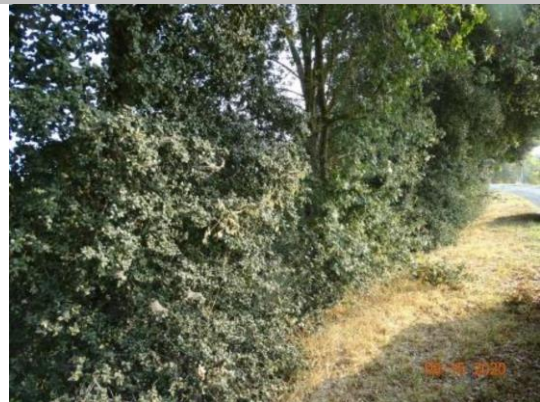
Photo 1 of 1 : FA\_2021\_RD0556\_18\_46\_20210830\_00026.jpg

View looking upstream at thick trees on the landside slope (Fall 2020).

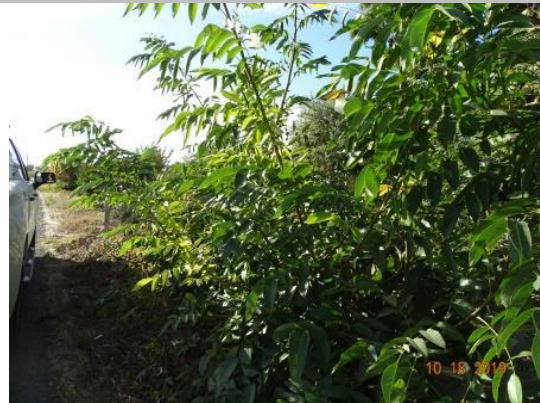
Photo 1 of 1 : FA\_2021\_RD0556\_18\_54\_20210830\_00031.jpg

View looking downstream at landscaping on the landside slope (Fall 2019).

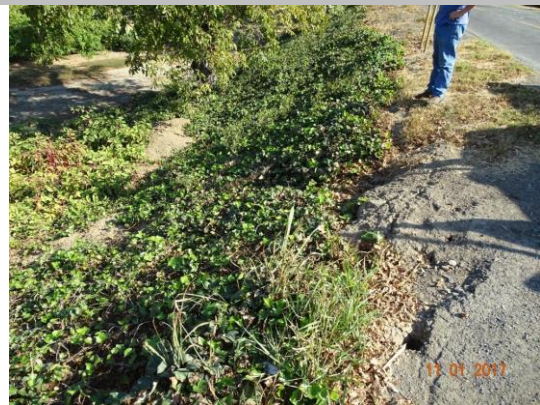
Photo 1 of 1 : FA\_2021\_RD0556\_18\_28\_20210830\_00010.jpg

Significant rodent activity in this area must be stopped. Holes should be backfilled.

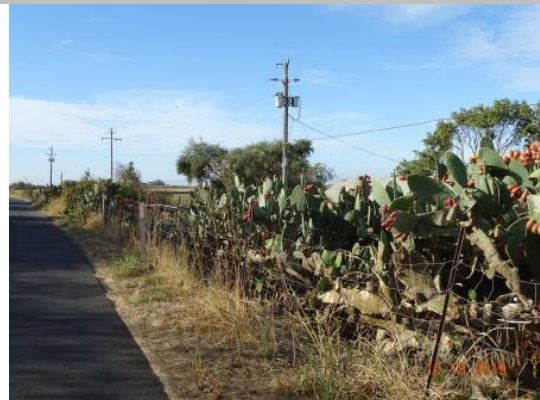
Photo 1 of 1 : FA\_2021\_RD0556\_18\_29\_20210830\_00011.jpg

View looking downstream at cactus on the landside slope (Fall 2019).

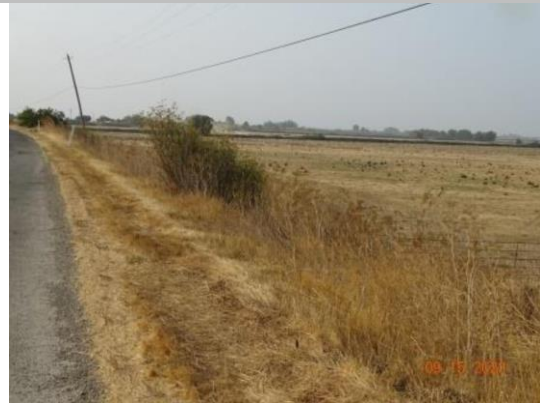
Photo 1 of 1 : FA\_2021\_RD0556\_18\_41\_20210830\_00021.jpg

View looking downstream at vegetation on the landside slope (Fall 2020).

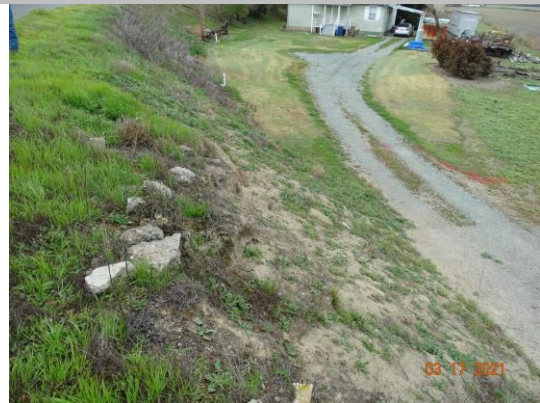
Photo 1 of 1 : FA\_2021\_RD0556\_18\_86\_20211004\_00160.jpg

View of erosion rivulets in the landside slope (Spring 2021).

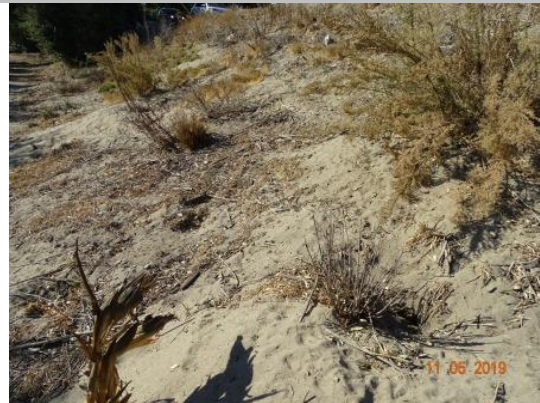
Photo 1 of 1 : FA\_2021\_RD0556\_19\_92\_20210830\_00057.jpg

View of multiple fresh squirrel holes in the landside slope (Fall 2019).

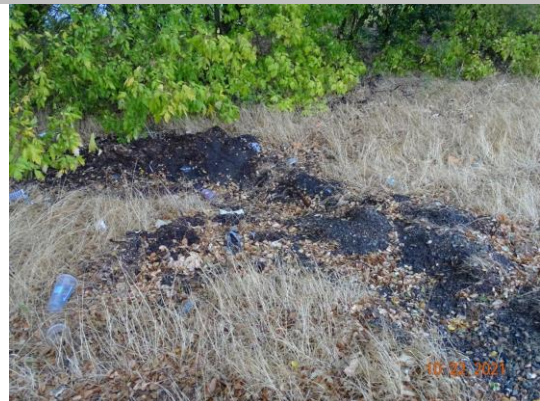
Photo 1 of 1 : FA\_2021\_RD0556\_19\_20\_20211022\_00094.jpg

View of depression caused by vehicle on the waterside slope (Fall 2021).

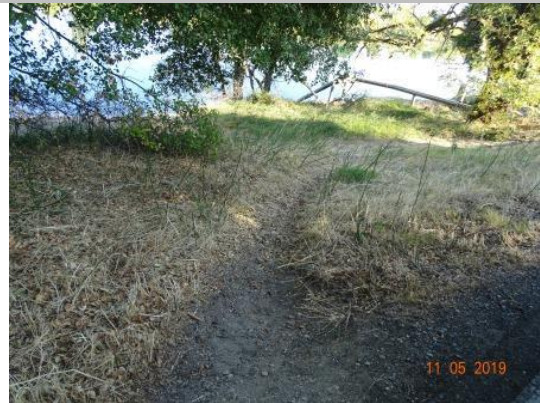
Photo 1 of 1 : FA\_2021\_RD0556\_19\_43\_20210830\_00024.jpg

View of fishermen trail digging into levee on the waterside slope (Fall 2019).

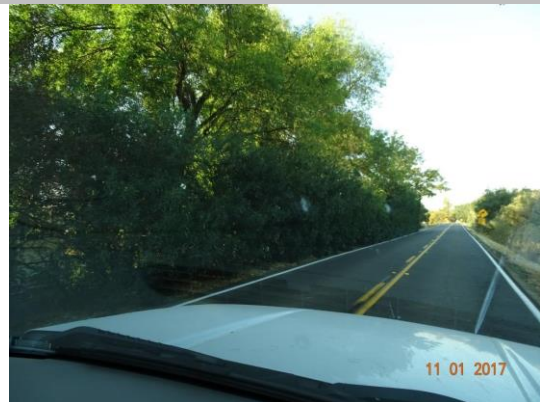
Photo 1 of 1 : FA\_2021\_RD0556\_19\_25\_20210830\_00011.jpg

View of oleanders on the landside of the levee.

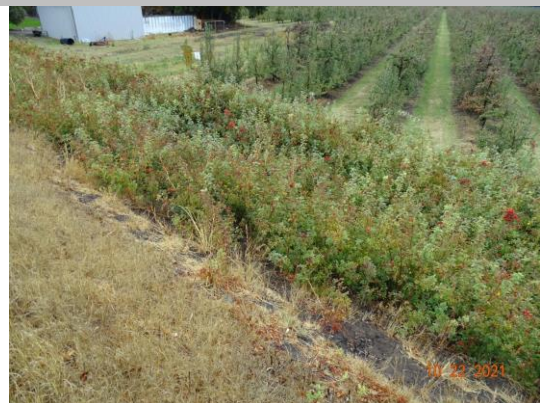
Photo 1 of 1 : FA\_2021\_RD0556\_19\_116\_20211022\_00107.jpg

View of thick vegetation on the landside slope (Fall 2021).

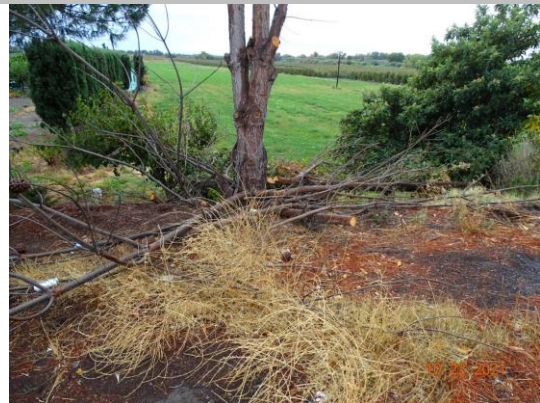
Photo 1 of 1 : FA\_2021\_RD0556\_19\_114\_20211022\_00106.jpg

View of down tree branches on the landside slope (Fall 2021).

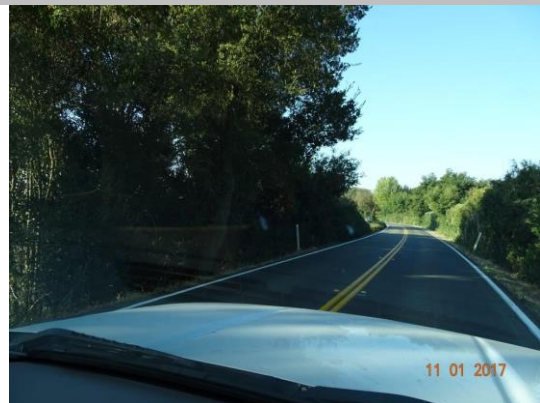
Photo 1 of 1 : FA\_2021\_RD0556\_19\_30\_20210830\_00015.jpg

Trim/thin oleanders on landside slope.

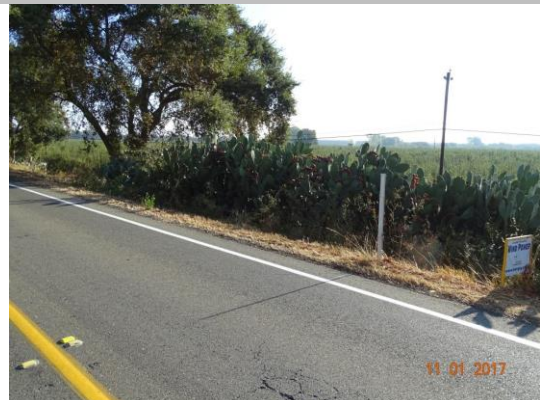
Photo 1 of 1 : FA\_2021\_RD0556\_19\_33\_20210830\_00018.jpg

View of large growth of prickly pear cactus.

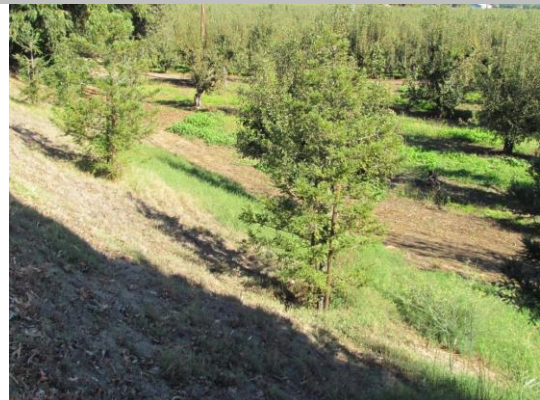
Photo 1 of 1 : FA\_2021\_RD0556\_19\_1\_20210830\_00001.jpg

RD 556 Unit 2 Levee mile 2.28 unauthorized planting of redwood trees planted on the slope.

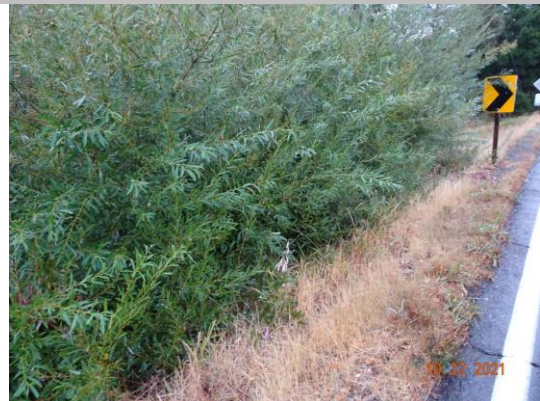
Photo 1 of 1 : FA\_2021\_RD0556\_19\_90\_20211022\_00099.jpg

View looking upstream at thick vegetation on the waterside slope (Fall 2021).

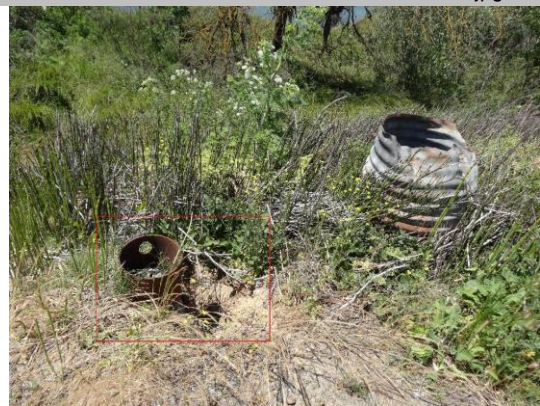
Photo 2 of 3 : UCIP\_FA\_2021\_12527\_20296.jpg

WS- siphon breaker and abandoned CMP riser laying adjacent to it.

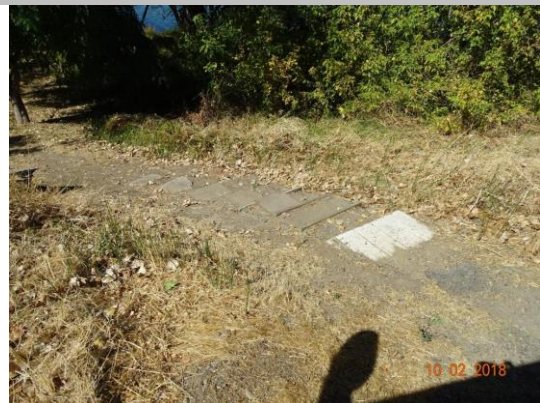
Photo 1 of 1 : FA\_2021\_RD0556\_19\_78\_20210830\_00050.jpg

View of stairs on waterside slope (October 2018).

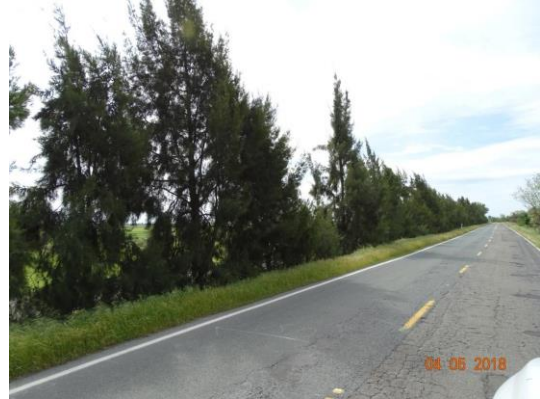
Photo 1 of 1 : FA\_2021\_RD0556\_19\_49\_20210830\_00030.jpg

View of landscaping trees on the landside.

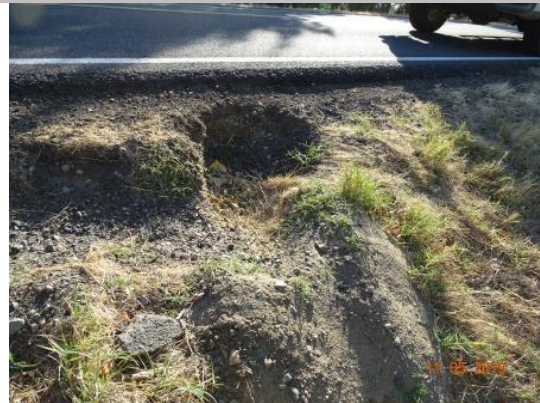
Photo 1 of 1 : FA\_2021\_RD0556\_19\_63\_20210830\_00042.jpg

View of erosion on the waterside shoulder (Fall 2019).

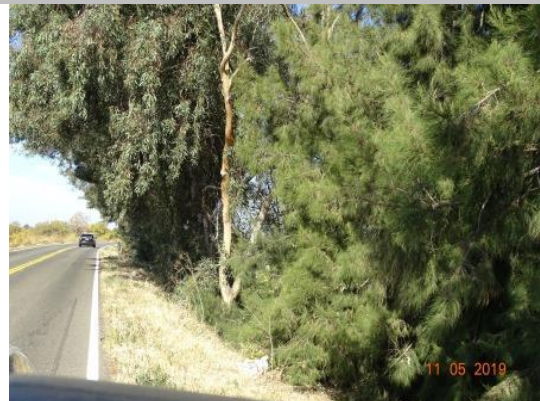
Photo 1 of 1 : FA\_2021\_RD0556\_19\_84\_20210830\_00053.jpg

View looking upstream at thick trees on the landside slope (Fall 2019).

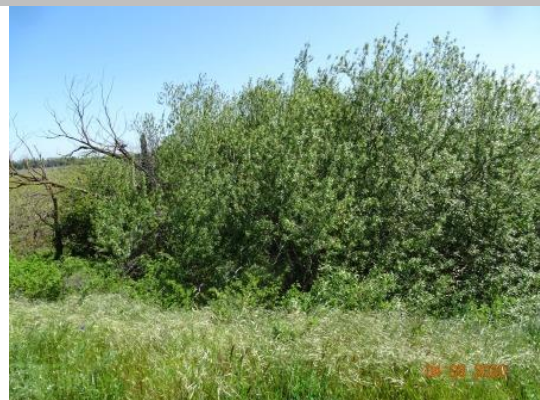
Photo 1 of 1 : FA\_2021\_RD0556\_19\_55\_20210830\_00035.jpg

View of thick tree on the landside slope (Spring 2020).

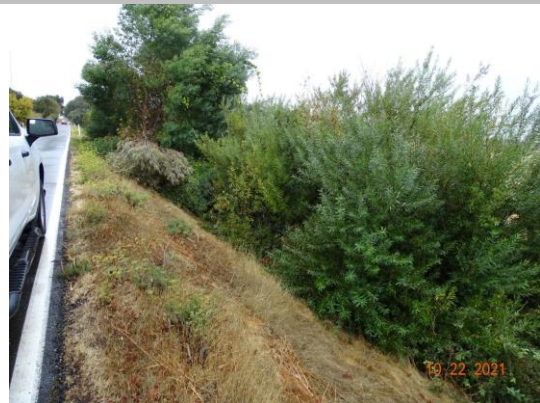
Photo 1 of 1 : FA\_2021\_RD0556\_19\_60\_20211022\_00103.jpg

View looking upstream at thick trees on the landside slope (Fall 2021).

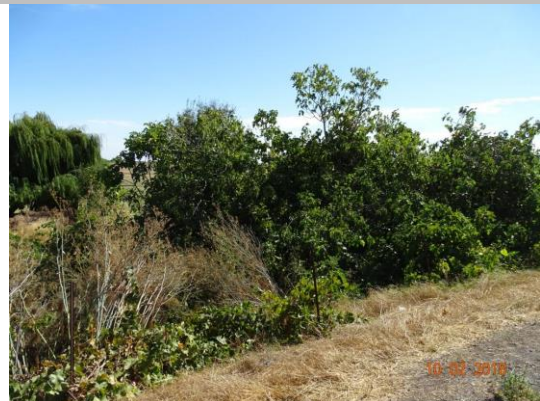
Photo 1 of 1 : FA\_2021\_RD0556\_19\_58\_20210830\_00038.jpg

View of fig tree on landside slope (October 2018).

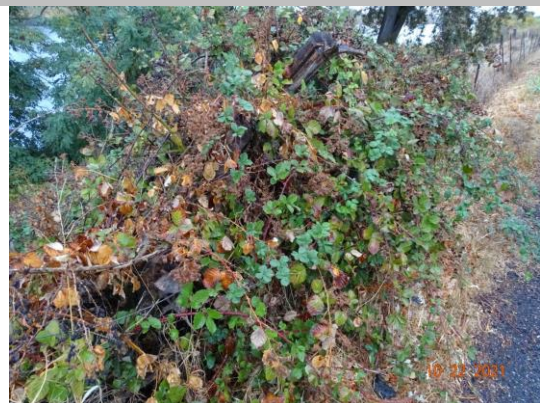
Photo 1 of 1 : FA\_2021\_RD0556\_19\_94\_20211022\_00100.jpg

View looking upstream at vegetation on the waterside slope (Fall 2021).

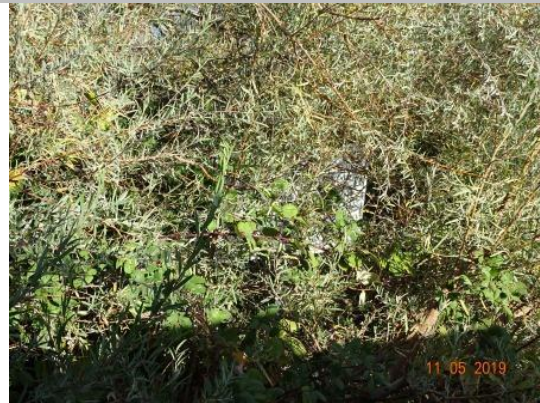
Photo 1 of 1 : FA\_2021\_RD0556\_19\_80\_20210830\_00052.jpg

View of environmental mitigation sign on the waterside slope. The sign is mostly obscured by vegetation (Fall 2019).
