**Flood Control Project Maintenance
Levee Inspections
Fall 2022 Levee Maintenance Deficiency Summary Report**

Sacramento River Basin

**Flood Control Project Maintenance
Levee Inspections
LMA District Cover Sheet**

Reclamation District No. 0556 Upper Andrus

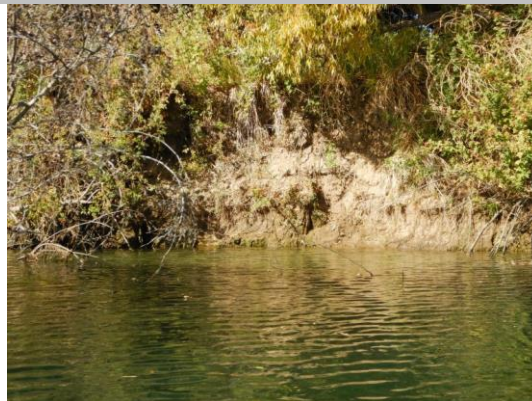
Photo 1 of 2 : FA_2022_RD0556_18_43_20220831_00027.jpg

LM Start	0.38	Rating **	M	Issue No.	43
LM End	0.58	Issue Type +	Ma	Location *	WS
Category	Supplemental			GPS Latitude/Longitude	
				Start	End
Item	2018 USACE Erosion Survey			38.234038 °	38.231879 °
				-121.519817 °	-121.522003 °
DWR ID	DWR_RD0556_01_s _ 2022_43				
Comment Code					
Inspector Comment					
2018 Site ID: GEO 11.8 R					
Status: Eroding					
2018 Field Notes: No observed change.					
Site History: 2017 - Tree popout popouts eminent , significant toe erosion and whole bank failure in sections

USACE 2018 Erosion Photo #1

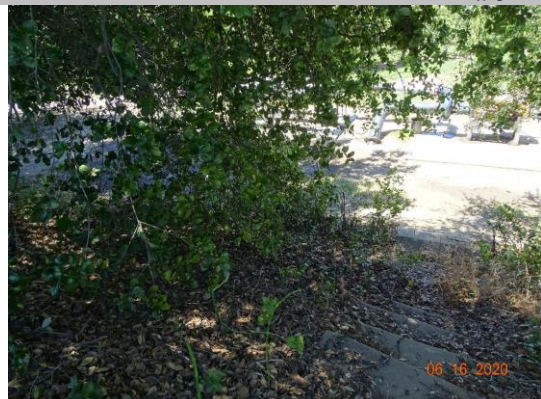
Photo 2 of 3 : UCIP_FA_2022_61336_88648.jpg

Comment Code						
Inspector Comment						
DS_ID:20821 FS_ID:61336 EP_NO: 5548 Repair Type: Non-Urgent EVAL Issue: 10, Unauthorized Modification or Non-Compliant Permit Crossing Status: Found UCIP Comments: 06/16/2020 Record remains Non-Urgent. Unable to inspect waterside slope due to overgrown vegetation. Unable to find pump on waterside, instead, a gas pump and screen filters installed on landside. Unable to find a permit for modification. (O.Yakimov - DWR UCIP) 05/13/2015 Dense vegetation prevents inspection of WS slope. (K.Fazel - DWR UCIP) FIELD_STRUCT_DESC: 12-inch steel irrigation discharge pipe through the levee, 5 feet below the crown. 1.25-inch electrical conduit through the levee at the same location. Pump and screen filters on the landside. Concrete steps on the landside (LS) slope. Cuts in pavement visible at the crossing. Siphon breaker on waterside shoulder. (12-inch pipe authorized under Permit No. 5548, 1966 - George K. Adams). [Additional Reference(s): DWR Levee Log, unk.yr. (HLM 0.54)]. FS Date: 6/16/2020 1:47:59 PM

Land-Side: View of levee slope looking from crown

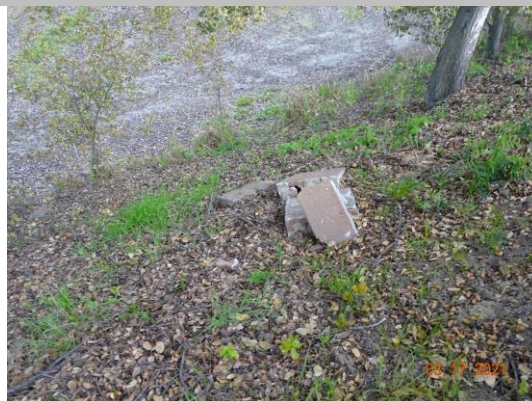
Photo 1 of 1 : FA_2022_RD0556_18_85_20220831_00047.jpg

View of bricks on the landside slope (Spring 2021).

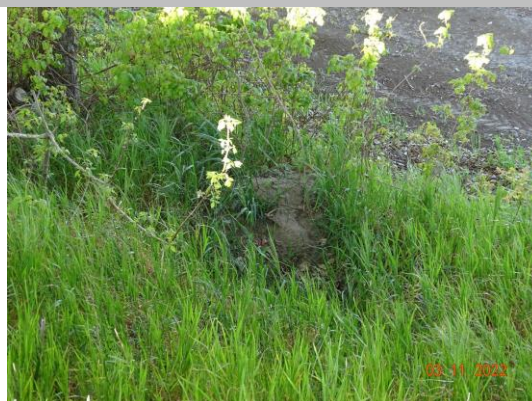
Photo 1 of 1 : FA_2022_RD0556_18_84_20220831_00046.jpg

LM Start	0.63	Rating **	U	Issue No.	84
LM End	0.63	Issue Type +	Ma	Location *	LS
Category	Earthen Levee			GPS Latitude/Longitude	
				Start	End
Item	Slope Stability			38.231428 °	38.231428 °
				-121.522772 °	-121.522772 °
DWR ID	DWR_RD0556_01_f_2021_84				
Comment Code					
S1 : Repair slope instability.					
Inspector Comment					
Tree fell over and created large hole in landside slope. Tree was removed but hole remains.

View of hole in the landside slope where root ball had been (Spring 2022).

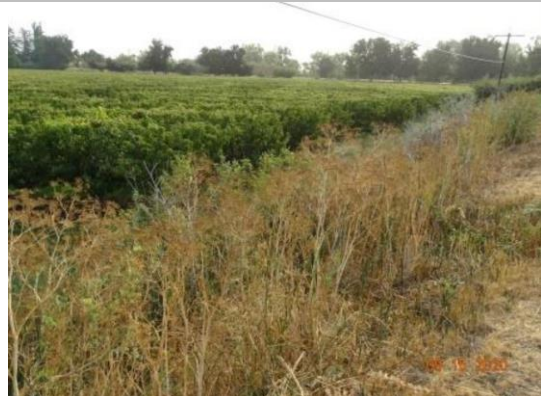
Photo 1 of 1 : FA_2022_RD0556_18_66_20220831_00042.jpg

View looking upstream at annual vegetation on the landside slope (Fall 2020).

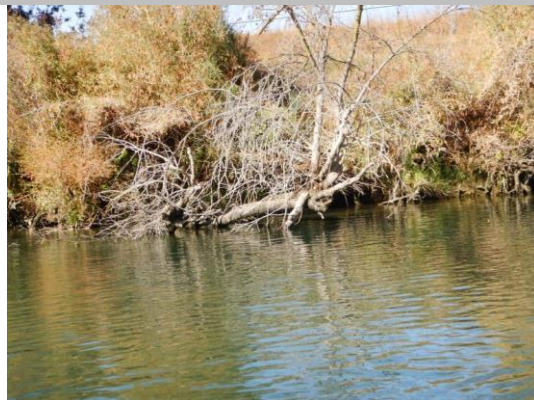
Photo 1 of 2 : FA_2022_RD0556_18_42_20220831_00025.jpg

LM Start	1.20	Rating **	M	Issue No.	42
LM End	1.53	Issue Type +	Ma	Location *	WS
Category	Supplemental			GPS Latitude/Longitude	
				Start	End
Item	2018 USACE Erosion Survey			38.227615 °	38.225374 °
				-121.529894 °	-121.534406 °
DWR ID	DWR_RD0556_01_s_2022_42				
Comment Code					
Inspector Comment					
2018 Site ID: GEO 10.9 R					
Status: Eroding					
2018 Field Notes: New erosion throughout site.					
Site History: 2017 - Significant toe erosion and whole bank failure in sections, large pockets from tree popouts.

USACE 2018 Erosion Photo #1

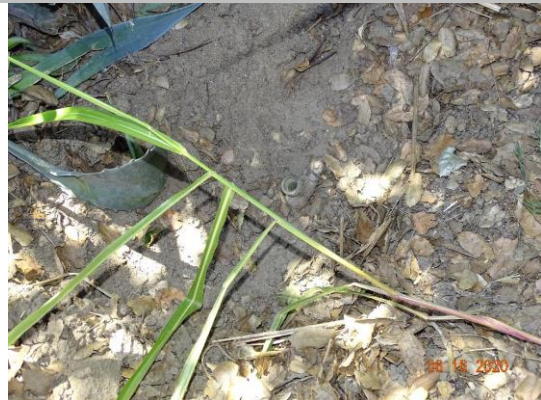
Photo 2 of 3 : UCIP_FA_2022_61398_88671.jpg

DS_ID:20825
FS_ID:61398
EP_NO: 13302
Repair Type: Non-Urgent
EVAL Issue: 6, Levee Damage or Threat for Levee Damage
Crossing Status: Found
UCIP Comments: 06/16/2020 Record remains Non-Urgent. Concrete standpipe on landside has been replaced with a pressure tank. Unable to find a permit for modification. Depression around air release vent on landside shoulder about 2 feet in diameter and 1/2-foot deep. (O.Yakimov - DWR UCIP)
05/27/2015 Seal beneath siphon breaker off LS toe leaking. Rodent activity near crown off LS shoulder. Need to contact owner about leaky seal. Dense vegetation prevented inspection of WS slope. (K.Fazel - DWR UCIP)
FIELD_STRUCT_DESC: 6-inch steel irrigation discharge pipe and 2-inch galvanized iron electrical conduit through the levee, 2 feet below the crown. Siphon valve on the landside (LS) shoulder. Pump, gate valve, and pressure tank at the LS toe. Service pole and electrical box at the LS toe. 6-inch polyvinyl chloride (PVC) standpipe adjacent to the pipe off the LS toe. (6-inch pipe authorized under Permit No. 13302, 1981 - Kaydix Ranch). [Additional Reference(s): DWR Levee Log, unk.yr. (HLM 1.32). USACE Sacramento O&M Manual, Unit 103, June 1954, Revised 29 December 2016, (Station 'R' 540+85), listed as 2-inch pipe. USACE As-Built Drawing No. 50-04-2671, Sheet 5, Station 540+85, 25 January 1951, Revised 18 Dec. 1952, listed as 2-inch pipe]. FS Date: 6/16/2020 4:21:56 PM

Land-Side: Air release valve on levee shoulder. Soil depression around it

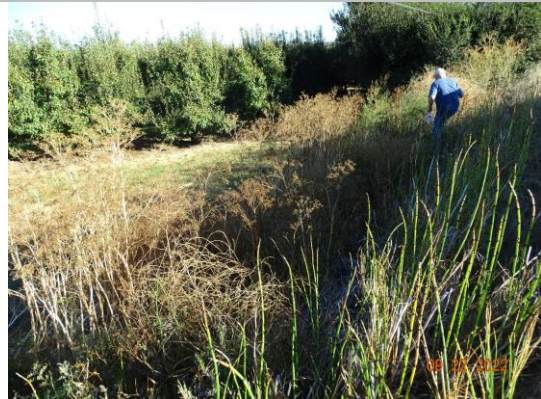
Photo 1 of 1 : FA_2022_RD0556_18_40_20221004_00175.jpg

View of the erosion on the LS slope (Fall 2022).

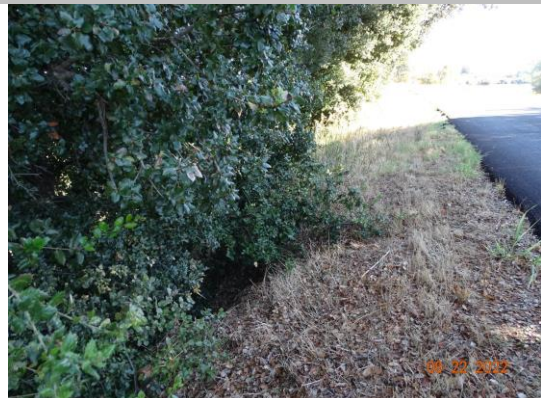
Photo 1 of 1 : FA_2022_RD0556_18_22_20221004_00176.jpg

LM Start	1.50	Rating **	M	Issue No.	22
LM End	1.50	Issue Type +	Ma	Location *	LS
Category	Earthen Levee			GPS Latitude/Longitude	
				Start	End
Item	Erosion / Rills			38.225840 °	38.225840 °
				-121.534157 °	-121.534157 °
DWR ID	DWR_RD0556_01_s_2012_22				
Comment Code					
E5 : Schedule repair of rills prior to the next inspection.					
Inspector Comment					
Dip at the top of the landside slope is greater than 3". Erosion seems to be caused by surface runoff.

View of the erosion on the upper LS slope (Fall 2022).

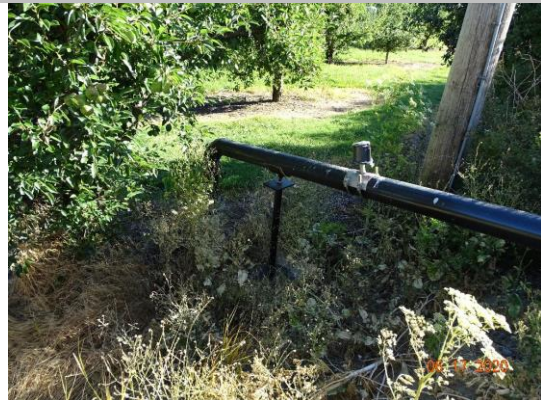
Photo 2 of 3 : UCIP_FA_2022_61399_88675.jpg

Comment Code						
Inspector Comment						
DS_ID:20827 FS_ID:61399 EP_NO: 11169 Repair Type: Non-Urgent EVAL Issue: 10, Unauthorized Modification or Non-Compliant Permit Crossing Status: Found UCIP Comments: 06/17/2020 Record remains Non-Urgent. Modifications to the crossing have been made after last UCIP inspection. Unable to find a permit for modifications. Enforcement case ENF 9545 open for this crossing. No permit has been identified authorizing original pipe. Need to have CVFPB review ABO and determine current owner. (O.Yakimov - DWR UCIP) 03/27/2015 Dense vegetation on LS and WS limited accessibility. (K.Fazel - DWR - UCIP) FIELD_STRUCT_DESC: 6-inch steel irrigation discharge pipe through the levee, 3.5 feet below the crown. Pump, butterfly valve, filler pump and pipe on the waterside (WS) berm. 2-inch electrical conduit through the levee. Service pole with electric meter and panel on waterside shoulder. (10-inch pipe [HLM 1.56] authorized under Automatic Board Order (ABO) issued as Permit No. 11169, 1975 - Darrell T. and B. M. Mealer). [Additional Reference(s): DWR Levee Log, unk.yr. (HLM 1.56), listed as 10-inch pipe. USACE Sacramento O&M Manual, Unit 103, June 1954, Revised 29 December 2016, (Station 'R' 528+02.1), listed as 10-inch pipe. USACE As-Built Drawing No. 50-04-2671, Sheet 4, near Station 528+00, 25 January 1951, Revised 18 Dec. 1952, listed as 10-inch pipe]. FS Date: 6/17/2020 9:36:26 AM

Land-Side: Pipe and junction pole at levee toe

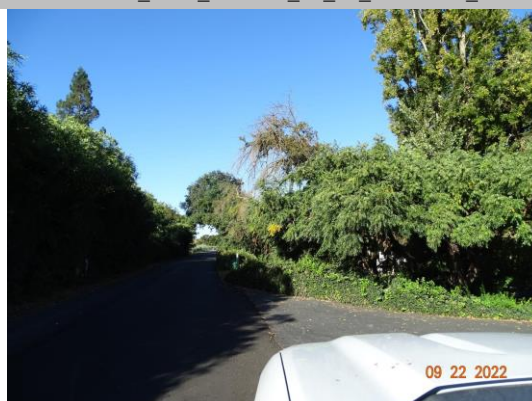
Photo 1 of 1 : FA_2022_RD0556_18_51_20221004_00178.jpg

View of the landscaping on the LS slope looking downstream (Fall 2022).

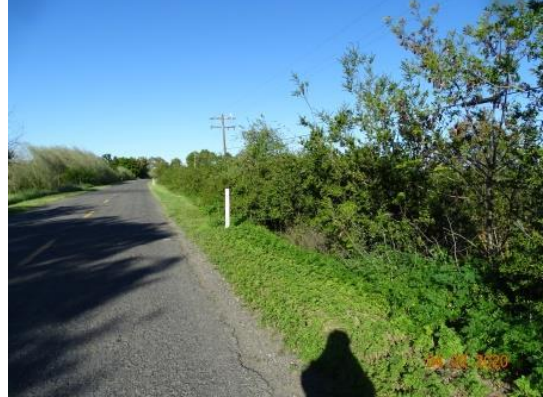
Photo 1 of 1 : FA_2022_RD0556_18_19_20220831_00003.jpg

View looking downstream at thick wild vegetation on the landside slope (Spring 2020).

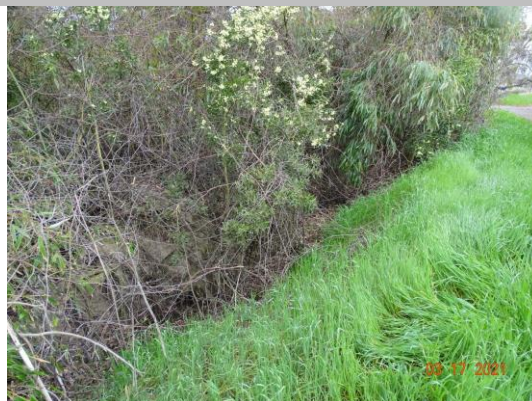
Photo 1 of 1 : FA_2022_RD0556_18_33_20220831_00015.jpg

LM Start	2.72	Rating **	U	Issue No.	33
LM End	2.72	Issue Type +	Ma	Location *	LS
Category	Earthen Levee			GPS Latitude/Longitude	
				Start	End
Item	Trim / Thin Trees			38.215107 °	38.215107 °
				-121.540677 °	-121.540677 °
DWR ID	DWR_RD0556_01_s_2017_33				
Comment Code					
T3 : Fallen tree with root ball.					
Inspector Comment					
Fallen tree on landside. Remove the fallen tree and repair the levee damage.

View of hole in landside slope caused by down tree (Spring 2021).

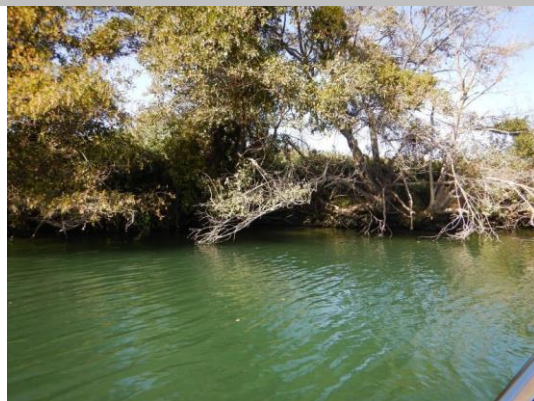
Photo 1 of 2 : FA_2022_RD0556_18_36_20220831_00017.jpg

LM Start	3.18	Rating **	M	Issue No.	36
LM End	3.50	Issue Type +	Ma	Location *	WS
Category	Supplemental			GPS Latitude/Longitude	
				Start	End
Item	2018 USACE Erosion Survey			38.210674 °	38.206919 °
				-121.538854 °	-121.541559 °
DWR ID	DWR_RD0556_01_s_2022_36				
Comment Code					
Inspector Comment					
2018 Site ID: GEO 9.0 R					
Status: Eroding					
2018 Field Notes: Site extended downstream.					
Site History: 2017 - Toe erosion and failed revetment.

USACE 2018 Erosion Photo #1

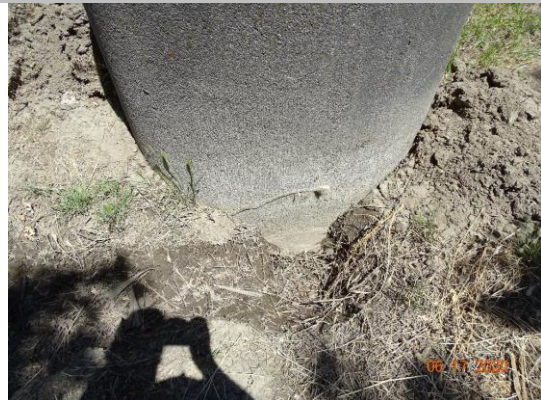
Photo 2 of 3 : UCIP_FA_2022_61291_89084.jpg

Comment Code						
Inspector Comment						
DS_ID:20836 FS_ID:61291 EP_NO: 11174 Repair Type: Urgent EVAL Issue: 2a, Levee Integrity Crossing Status: Found UCIP Comments: 06/17/2020 Record is Urgent. 30-feet long, 3-feet wide, and 1-foot deep trench was excavated along landside levee toe. Soil is wet at the bottom of trench. Soil depression on waterside shoulder in pipe alignment. Intake pipe and pipe from pumphouse towards levee slope have been replaced. Unable to find a permit for modifications. No permit has been identified authorizing original pipe through the levee. Need to have CVFPB review ABO and determine current owner. (O.Yakimov - DWR UCIP) FIELD_STRUCT_DESC: 6-inch steel irrigation pipe through levee, 3.4 feet below crown. Pump in pump house on berm. Service pole on landward slope. Gate valve located underground and 48-inch concrete standpipe at landside toe. 1-inch electrical conduit at this location. (6-inch pipe [HLM 3.18] authorized under Automatic Board Order (ABO) issued as Permit No. 11174, 1975 - Delores M. Pollard). [Additional Reference(s): DWR Levee Log, unk.yr. (HLM 3.18). USACE Sacramento O&M Manual, Unit 103, June 1954, Revised 29 December 2016, (Station 441+19.6), listed as 6-inch pipe. USACE As-Built Drawing No. 50-04-2671, Sheet 2, near Station 440+00, 25 January 1951, Revised 18 Dec. 1952. USACE As-Built Drawing No. 50-04-2631, Sheet 11, Station 441+19.6, March 1950, Revised 16 Dec.1952]. FS Date: 6/17/2020

Land-Side: Trench at the base of standpipe

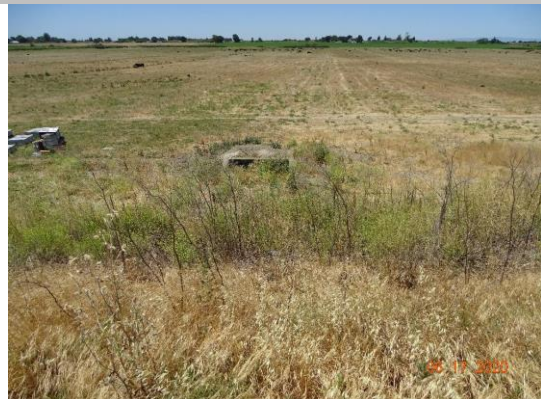
Photo 2 of 3 : UCIP_FA_2022_61301_89119.jpg

DS_ID:20840
FS_ID:61301
EP_NO: 11161
Repair Type: Urgent
EVAL Issue: 2b, Levee Integrity
Crossing Status: Found
UCIP Comments: 06/17/2020 Record is Urgent. Subsidence on landside shoulder measured 2' x 3' x 1.5'-deep around air vent. Crossing appears abandoned. Fence on landside slope and overgrown vegetation on both slopes prevent from detailed inspection of levee. No permit has been identified authorizing pipe. Need to have CVFPB review ABO and determine current owner. (O.Yakimov - DWR UCIP)
FIELD_STRUCT_DESC: 10-inch steel pipe through levee, 11.2 feet below crown. 2-inch air and vacuum valve and concrete spill box on landside of the levee. (10-inch pipe [HLM 3.57] authorized under Automatic Board Order (ABO) issued as Permit No. 11161, 1975 - L.J. Gamble & M. P. Darsie). [Additional Reference(s): DWR Levee Log, unk.yr. (HLM 3.57). USACE Sacramento O&M Manual, Unit 103, June 1954, Revised 29 December 2016, (Station 'R' 421+08.7), listed as 12-inch pipe. USACE As-Built Drawing No. 50-04-2671, Sheet 2, near Station 420+55, 25 January 1951, Revised 18 Dec. 1952, listed as 12-inch pipe. USACE As-Built Drawing No. 50-04-2631, Sheet 11, Station 421+08.7, March 1950, Revised 16 Dec.1952, listed as 12-inch pipe].

Land-Side: View of levee slope looking from crown

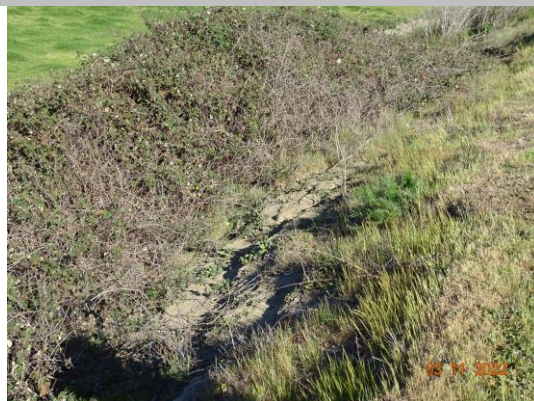
Photo 1 of 1 : FA_2022_RD0556_18_97_20220831_00053.jpg

LM Start	3.66	Rating **	M	Issue No.	97
LM End	3.71	Issue Type +	Ma	Location *	LS
Category	Earthen Levee			GPS Latitude/Longitude	
				Start	End
Item	Erosion / Livestock			38.204630 °	38.204020 °
				-121.541382 °	-121.541196 °
DWR ID	DWR_RD0556_01_s_2022_97				
Comment Code					
E4 : Repair the levee slope damaged by livestock and prevent large animal access.					
Inspector Comment					
Cow on levee creating path and holes in landside shoulder.

View of cow path digging into landside slope (Spring 2022).

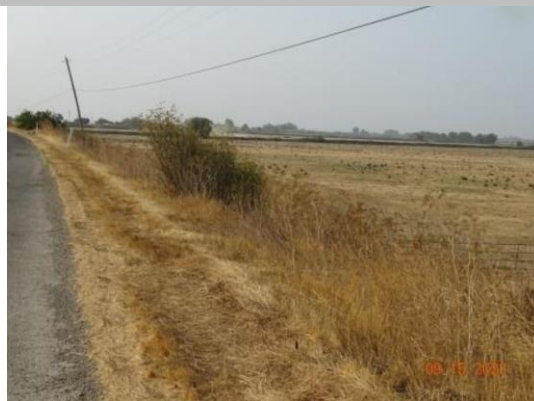
Photo 1 of 1 : FA_2022_RD0556_18_41_20220831_00024.jpg

View looking downstream at vegetation on the landside slope (Fall 2020).

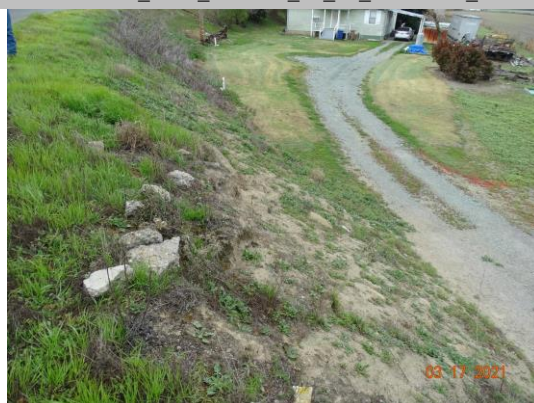
Photo 1 of 1 : FA_2022_RD0556_18_86_20220831_00048.jpg

LM Start	3.82	Rating **	M	Issue No.	86
LM End	3.82	Issue Type +	Ma	Location *	LS
Category	Earthen Levee			GPS Latitude/Longitude	
				Start	End
Item	Erosion / Rills			38.202481 °	38.202481 °
				-121.540839 °	-121.540839 °
DWR ID	DWR_RD0556_01_f_2021_86				
Comment Code					
E5 : Schedule repair of rills prior to the next inspection.					
Inspector Comment					
Exposed slope eroding, most likely due to runoff.

View of erosion rivulets in the landside slope (Spring 2021).

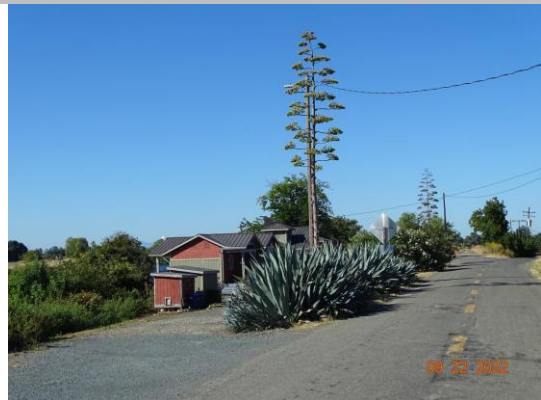
Photo 1 of 1 : FA_2022_RD0556_18_34_20221004_00190.jpg

View of the cactus on the WS shoulder (Fall 2022).

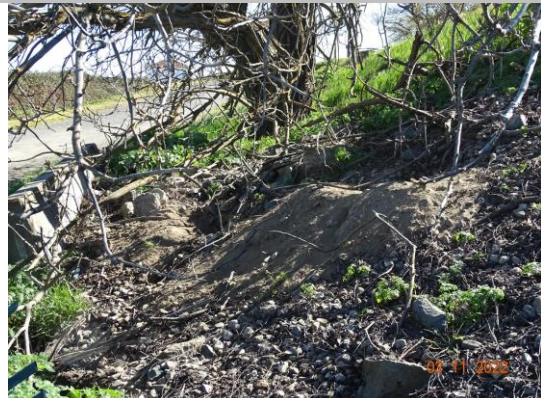
Photo 1 of 1 : FA_2022_RD0556_18_101_20220831_00057.jpg

View of multiple animal holes in the landside slope (Spring 2022).

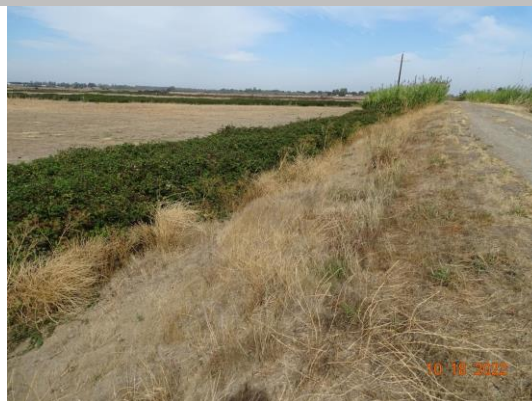
Photo 1 of 1 : FA_2022_RD0556_18_39_20221026_00195.jpg

View of the blackberries on the LS toe (Fall 2022).

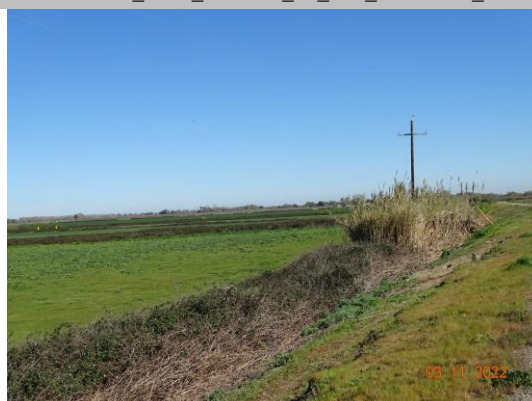
Photo 1 of 1 : FA_2022_RD0556_18_111_20220831_00059.jpg

View looking upstream of erosion due to cow path on the landside slope (Spring 2022).

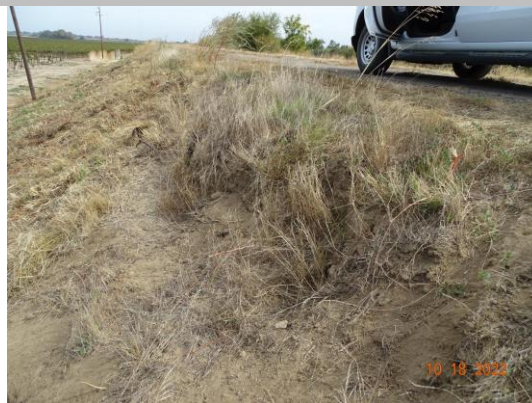
Photo 1 of 1 : FA_2022_RD0556_18_63_20221026_00192.jpg

View of the erosion due to livestock on the upper LS slope (Fall 2022).

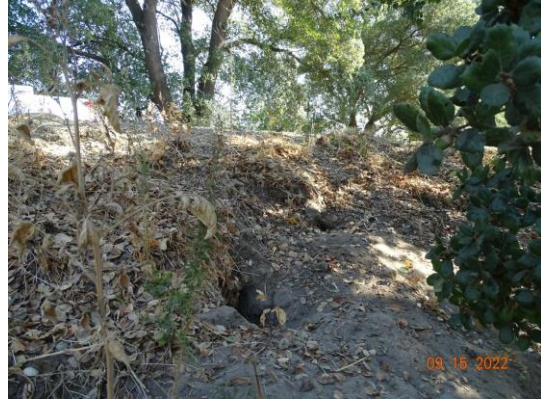
Photo 1 of 1 : FA_2022_RD0556_19_92_20221003_00068.jpg

View of the rodent holes looking up the LS slope (Fall 2022).

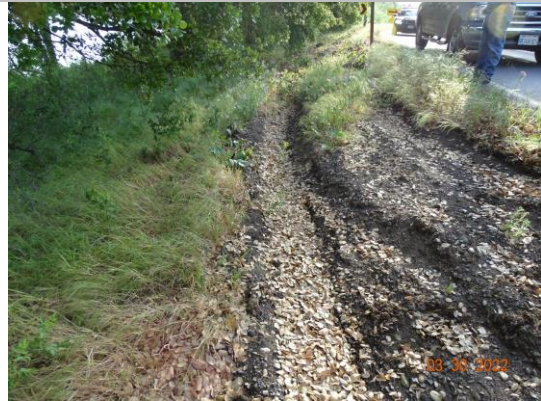
Photo 1 of 1 : FA_2022_RD0556_19_20_20220831_00017.jpg

View of damage to waterside slope due to a vehicle (Spring 2022).

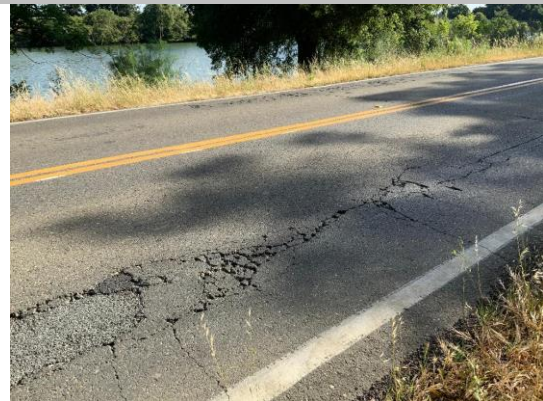
Photo 1 of 3 : UCIP_FA_2022_76292_113345.jpg

Levee crown with some visible cracking.

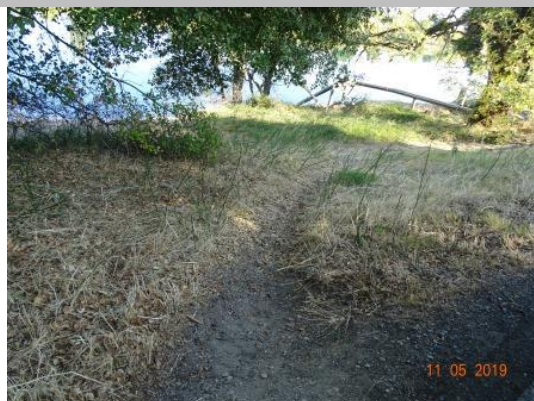
Photo 1 of 1 : FA_2022_RD0556_19_43_20220831_00031.jpg

View of fishermen trail digging into levee on the waterside slope (Fall 2019).

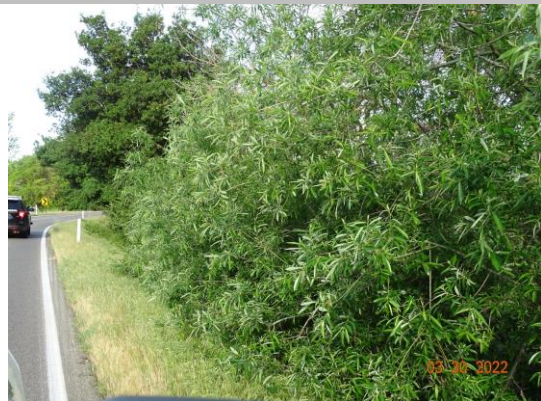
Photo 1 of 1 : FA_2022_RD0556_19_34_20220831_00025.jpg

View looking downstream at thick tree on the waterside slope (Spring 2022).

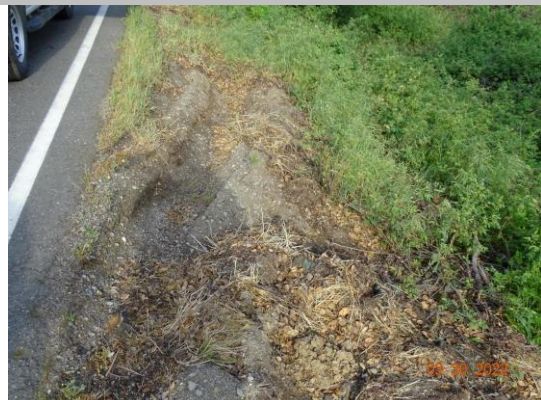
Photo 1 of 1 : FA_2022_RD0556_19_48_20220831_00035.jpg

View of damage to the waterside slope due to vehicle (Spring 2022).

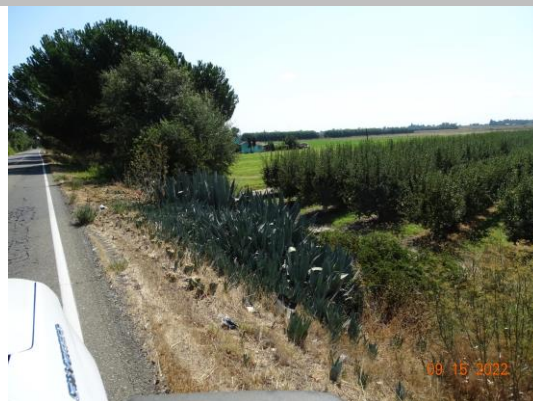
Photo 1 of 1 : FA_2022_RD0556_19_47_20221003_00085.jpg

View of the cactus on the LS slope (Fall 2022).

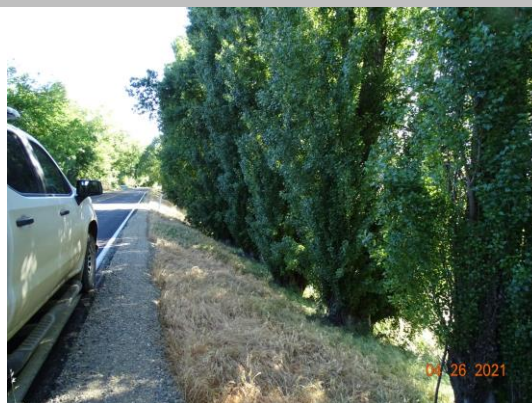
Photo 1 of 1 : FA_2022_RD0556_19_73_20220831_00052.jpg

View looking downstream at thick landscaping trees on the landside slope (Spring 2021).

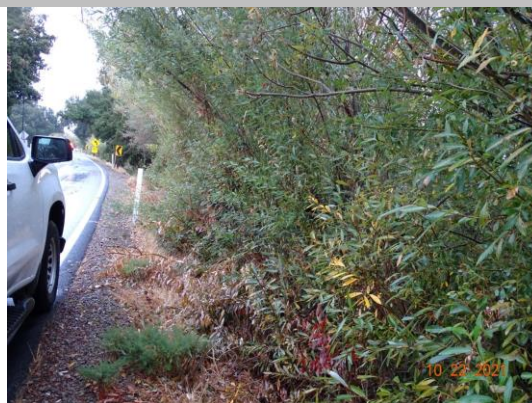
Photo 1 of 1 : FA_2022_RD0556_19_89_20220831_00062.jpg

View looking downstream at thick trees on the waterside slope (Fall 2021).

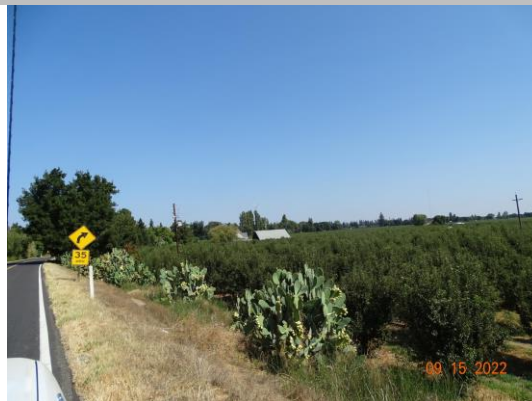
Photo 1 of 1 : FA_2022_RD0556_19_45_20221003_00081.jpg

View of the cactus on the LS slope (Fall 2022).

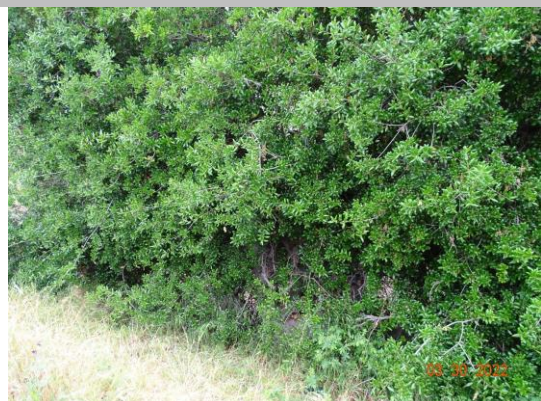
Photo 1 of 1 : FA_2022_RD0556_19_67_20220831_00048.jpg

View of thick trees needing trimming on the landside slope (Spring 2022).

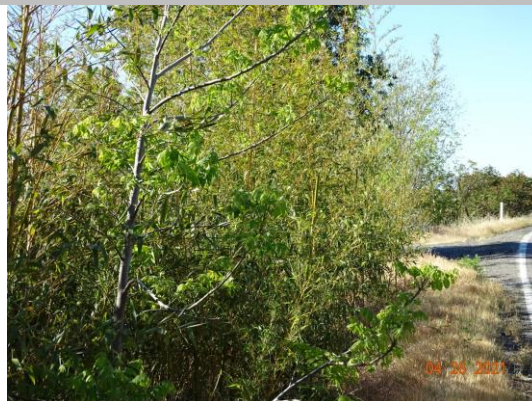
Photo 1 of 1 : FA_2022_RD0556_19_52_20220831_00038.jpg

View looking downstream at bamboo and trees of heaven on landside slope (Spring 2021).

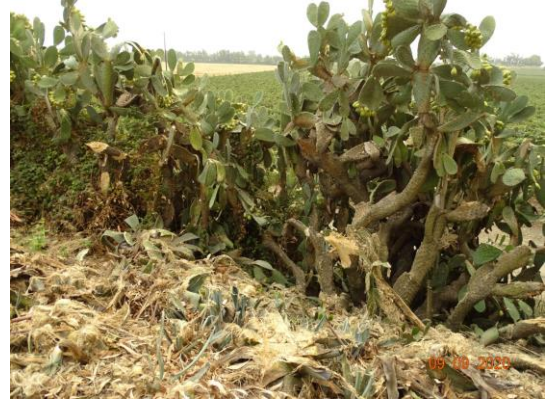
Photo 1 of 1 : FA_2022_RD0556_19_37_20220831_00028.jpg

View looking upstream at cactus partway down the landside slope (Fall 2020).

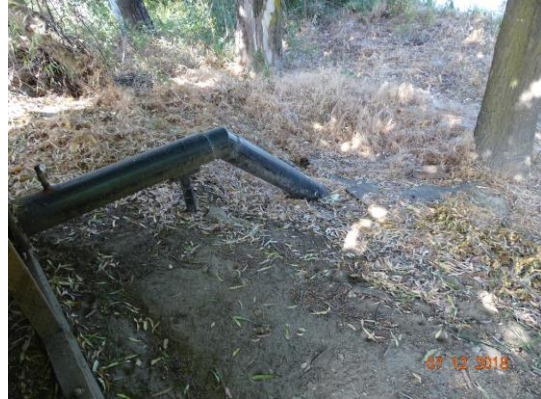
Photo 1 of 3 : UCIP_FA_2022_76310_77690.jpg

View of pipe on WS and a pit covered by plywood.
