Flood Control Project Maintenance Levee Inspections

Fall 2023 Levee Maintenance Deficiency Summary Report

Sacramento River Basin

Reclamation District No. 0556 Upper Andrus

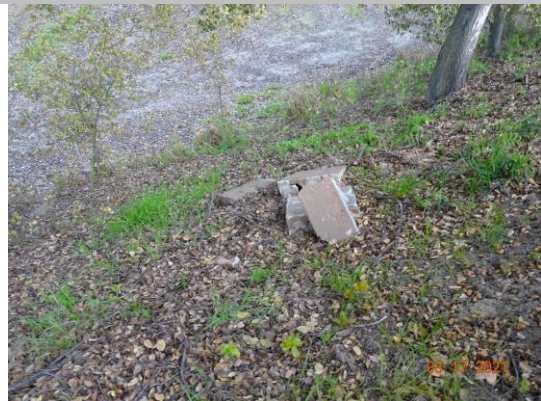
Photo 1 of 1 : FA_2023_RD0556_18_85_20231019_00044.jpg

View of bricks on the landside slope (Spring 2021).

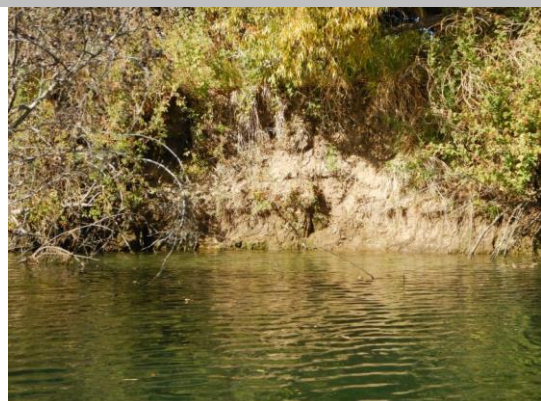
Photo 1 of 2 : FA_2023_RD0556_18_43_20231019_00026.jpg

LM Start	0.38	Rating **	M	Issue No.	43
LM End	0.58	Issue Type +	Ma	Location *	WS
Category	Supplemental			GPS Latitude/Longitude	
				Start	End
Item	2018 USACE Erosion Survey			38.234038°	38.231879°
				-121.519817°	-121.522003°
DWR ID	DWR_RD0556_01_s_2022_43				
Comment Code					
Inspector Comment					
2018 Site ID: GEO 11.8 R					
Status: Eroding					
2018 Field Notes: No observed change.					
Site History: 2017 - Tree popout popouts eminent , significant toe erosion and whole bank failure in sections

USACE 2018 Erosion Photo #1

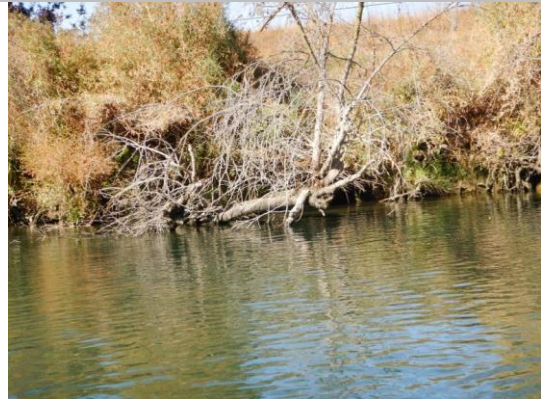
Photo 1 of 2 : FA_2023_RD0556_18_42_20231019_00024.jpg

LM Start	1.20	Rating **	M	Issue No.	42
LM End	1.53	Issue Type +	Ma	Location *	WS
Category	Supplemental			GPS Latitude/Longitude	
				Start	End
Item	2018 USACE Erosion Survey			38.227615°	38.225374°
				-121.529894°	-121.534406°
DWR ID	DWR_RD0556_01_s_2022_42				
Comment Code					
Inspector Comment					
2018 Site ID: GEO 10.9 R					
Status: Eroding					
2018 Field Notes: New erosion throughout site.					
Site History: 2017 - Significant toe erosion and whole bank failure in sections, large pockets from tree popouts.

USACE 2018 Erosion Photo #1

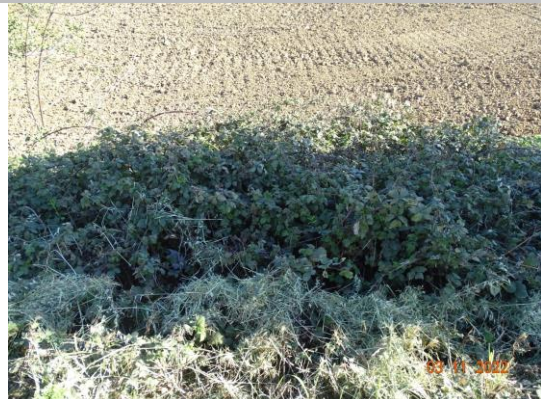
Photo 1 of 1 : FA_2023_RD0556_18_81_20231019_00041.jpg

View of blackberries on the landside slope (Spring 2022).

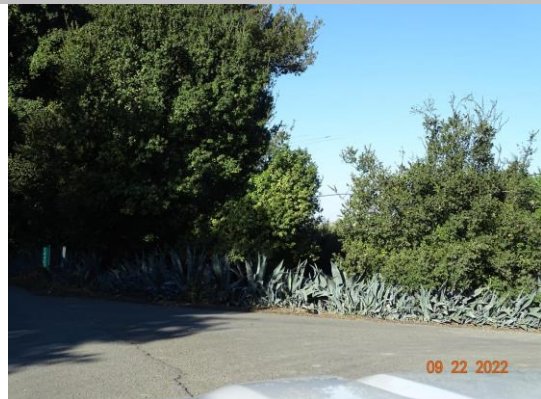
Photo 1 of 1 : FA_2023_RD0556_18_45_20231019_00029.jpg

View of the cactus on the LS shoulder (Fall 2022).

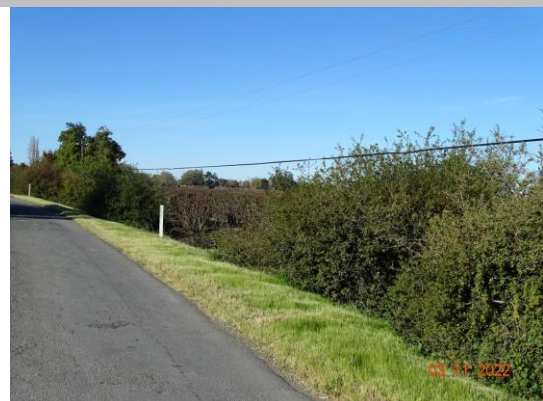
Photo 1 of 1 : FA_2023_RD0556_18_88_20231019_00046.jpg

View looking downstream at trees on the landside slope (Spring 2022).

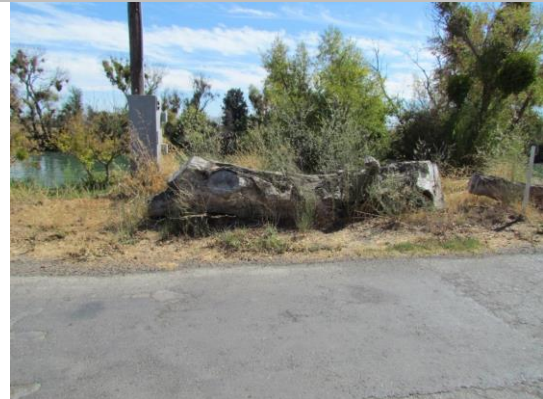
Photo 1 of 1 : FA_2023_RD0556_18_9_20231019_00001.jpg

Cut tree sections on the waterside levee shoulder remain to prevent parking.

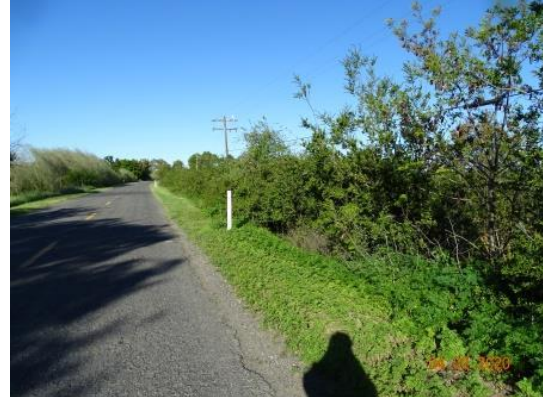
Photo 1 of 1 : FA_2023_RD0556_18_19_20231019_00003.jpg

View looking downstream at thick wild vegetation on the landside slope (Spring 2020).

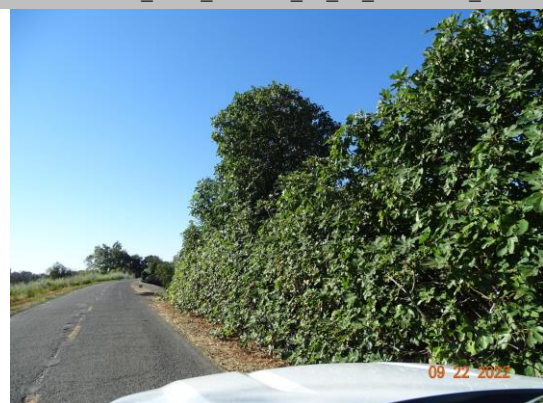
Photo 1 of 1 : FA_2023_RD0556_18_53_20231019_00034.jpg

View of the landscaping on the LS slope (Fall 2022).

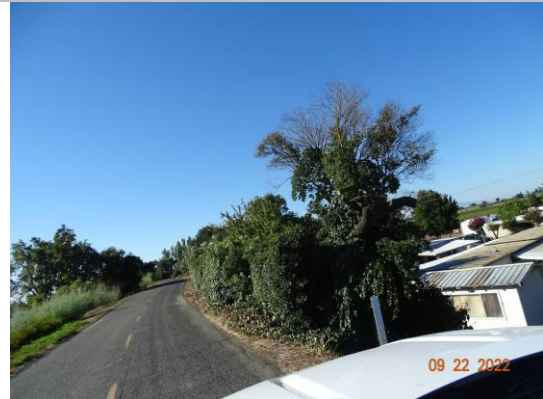
Photo 1 of 1 : FA_2023_RD0556_18_31_20231019_00012.jpg

View of the landscaping along the LS slope (Fall 2022).

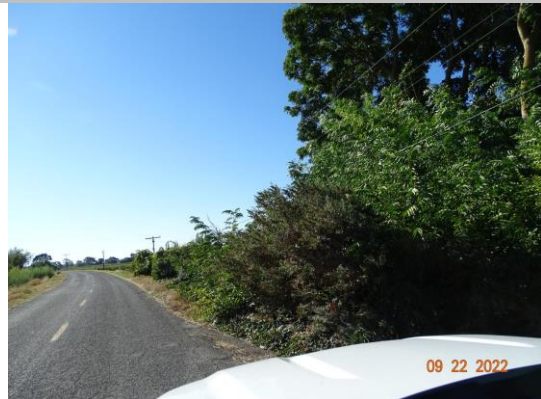
Photo 1 of 1 : FA_2023_RD0556_18_54_20231019_00035.jpg

View of the landscaping on the LS slope (Fall 2022).

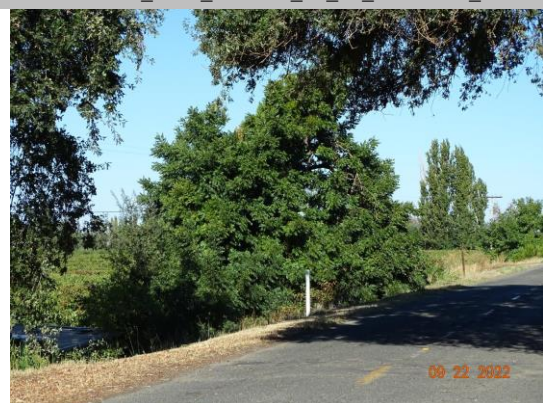
Photo 1 of 1 : FA_2023_RD0556_18_69_20231019_00040.jpg

View of the tree on the LS slope (Fall 2022).

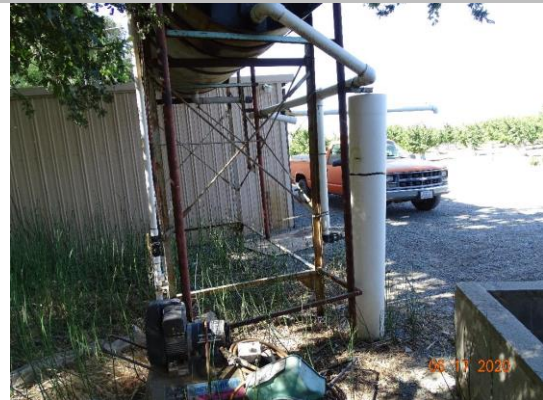
Photo 2 of 3 : UCIP_FA_2023_61501_89045.jpg

DS_ID:20848
FS_ID:61501
EP_NO: 11167
Repair Type: Non-Urgent
EVAL Issue: 10, Unauthorized Modification or Non-Compliant Permit
Crossing Status: Found
UCIP Comments: 06/17/2020 Record remains Non-Urgent. Unable to find a permit for sleeving 3-inch pipe through 8-inch pipe. No permit has been identified authorizing original pipe through the levee. Need to have CVFPB review ABO and determine current owner. (O.Yakimov - DWR UCIP)
06/05/2015 Pipe appears out of use; if so, coordinate with owner to abandon properly per Title 23. (K.Fazel - DWR UCIP)
FIELD_STRUCT_DESC: 3-inch steel irrigation discharge pipe sleeved through the 8-inch steel pipe, 3 feet below the crown. Annular space appears to be grouted. 3-inch pipe connected to the pump on the waterside (WS). 0.75-inch primer pipe. Gate valve on the WS berm. Polyvinyl chloride (PVC) standpipe off the landside (LS) toe, previously a 6-foot by 3-foot concrete standpipe. (8-inch pipe [HLM 2.70] authorized under Automatic Board Order (ABO) issued as Permit No. 11167, 1975 - Russel G. Graham). [Additional Reference(s): DWR Levee Log, unk.yr. (HLM 2.70). USACE Sacramento O&M Manual, Unit 103, June 1954, Revised 29 December 2016, (Station 'R' 468+52.7), listed as 8-inch pipe. USACE As-Built Drawing No. 50-04-2671, Sheet 3, Station 468+52.7, 25 January 1951, Revised 18 Dec. 1952, listed as 8-inch pipe].

Land-Side: View of piping on landside

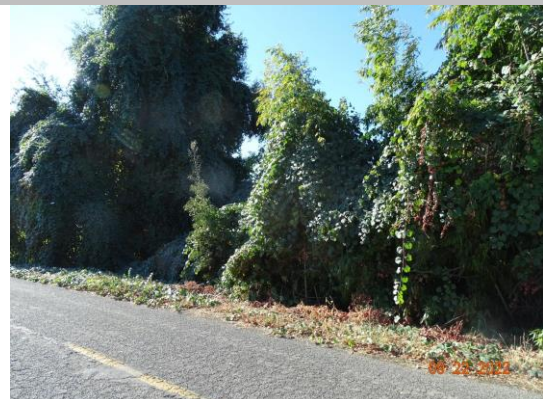
Photo 1 of 1 : FA_2023_RD0556_18_48_20231019_00032.jpg

View of the landscaping on the LS slope (Fall 2022).

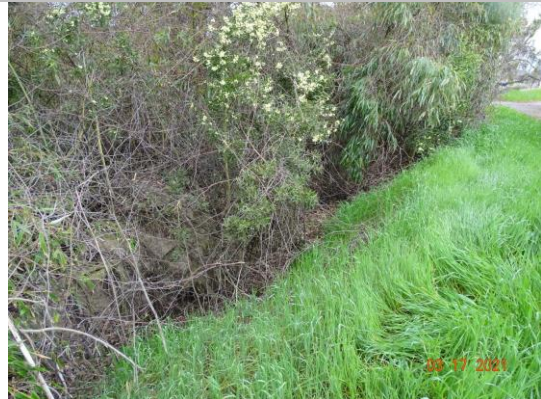
Photo 1 of 1 : FA_2023_RD0556_18_33_20231019_00014.jpg

LM Start	2.72	Rating **	U	Issue No.	33
LM End	2.72	Issue Type +	Ma	Location *	LS
Category	Earthen Levee			GPS Latitude/Longitude	
				Start	End
Item	Trim / Thin Trees			38.215107°	38.215107°
				-121.540677°	-121.540677°
DWR ID	DWR_RD0556_01_s_2017_33				
Comment Code					
T3 : Fallen tree with root ball.					
Inspector Comment					
Fallen trees on landside. Remove the fallen tree and repair the levee damage.

View of hole in landside slope caused by down tree (Spring 2021).

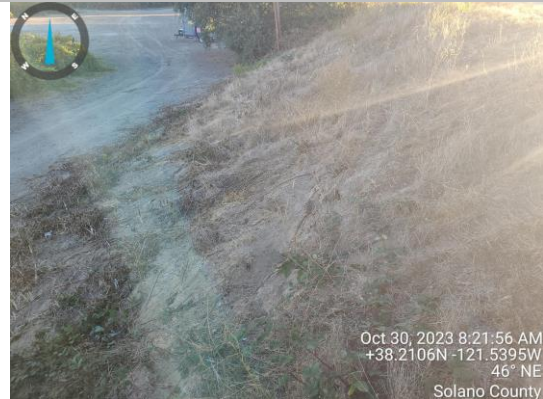
Photo 1 of 1 : FA_2023_RD0556_18_28_20231030_00092.jpg

View of rodent holes on the landside slope. Fall 2023.

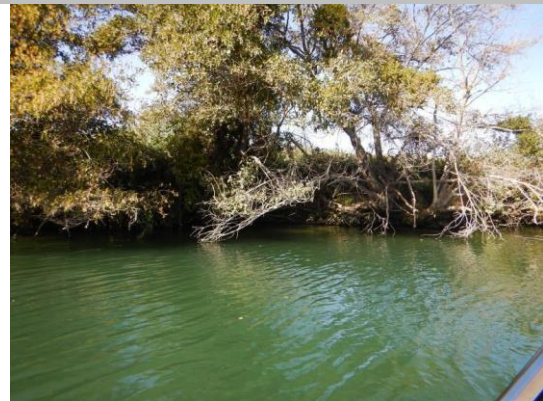
Photo 1 of 2 : FA_2023_RD0556_18_36_20231019_00016.jpg

LM Start	3.18	Rating **	M	Issue No.	36
LM End	3.50	Issue Type +	Ma	Location *	WS
Category	Supplemental			GPS Latitude/Longitude	
				Start	End
Item	2018 USACE Erosion Survey			38.210674°	38.206919°
				-121.538854°	-121.541559°
DWR ID	DWR_RD0556_01_s_2022_36				
Comment Code					
Inspector Comment					
2018 Site ID: GEO 9.0 R					
Status: Eroding					
2018 Field Notes: Site extended downstream.					
Site History: 2017 - Toe erosion and failed revetment.

USACE 2018 Erosion Photo #1

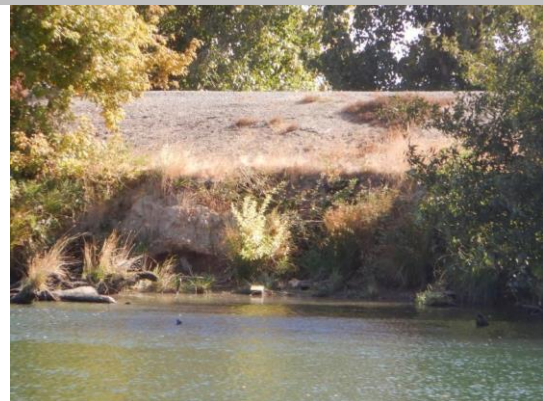
Photo 2 of 2 : FA_2023_RD0556_18_36_20231019_00017.jpg

USACE 2018 Erosion Photo #2

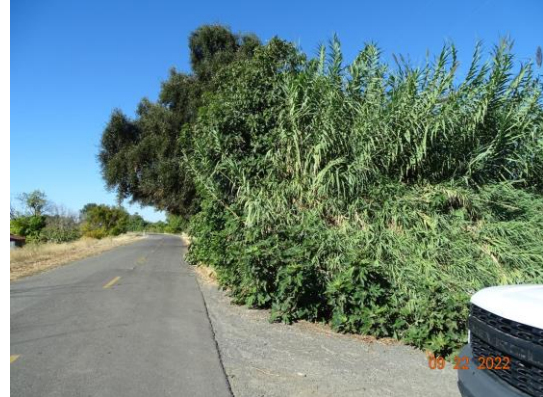
Photo 1 of 1 : FA_2023_RD0556_18_55_20231019_00036.jpg

View of the trees on the LS slope (Fall 2022).

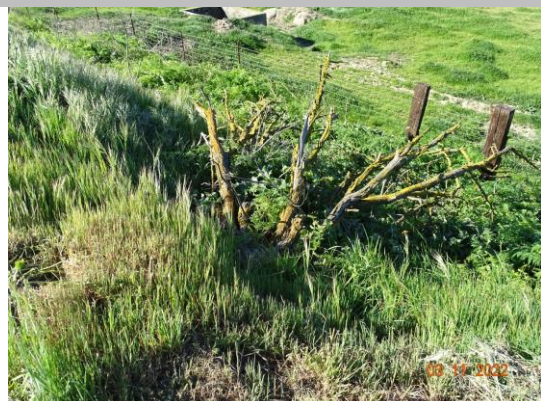
Photo 1 of 1 : FA_2023_RD0556_18_95_20231019_00048.jpg

View of down tree limbs on the landside slope (Spring 2022).

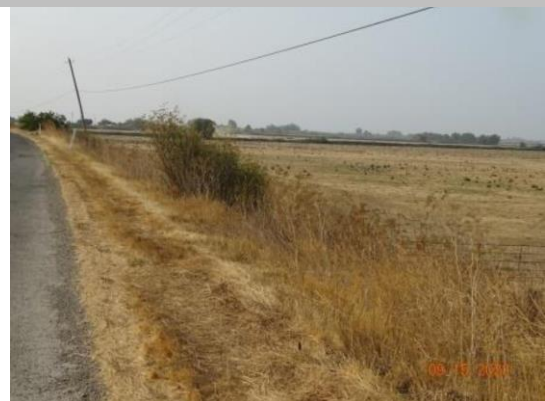
Photo 1 of 1 : FA_2023_RD0556_18_41_20231019_00023.jpg

View looking downstream at vegetation on the landside slope (Fall 2020).

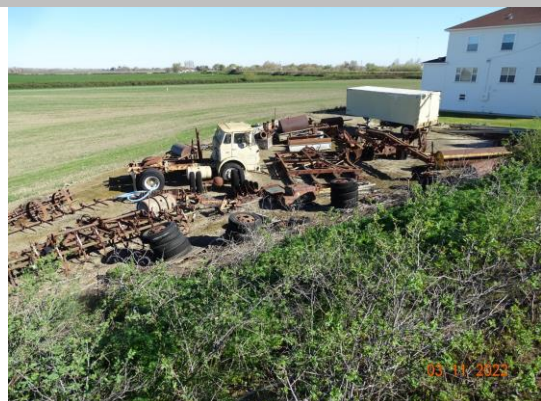
Photo 1 of 1 : FA_2023_RD0556_18_100_20231019_00050.jpg

View of equipment stored at landside toe (Spring 2022).

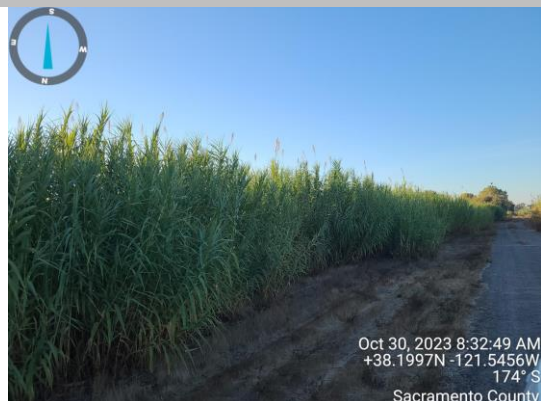
Photo 1 of 1 : FA_2023_RD0556_18_23_20231030_00094.jpg

View of arundo on the waterside shoulder. Fall 2023.

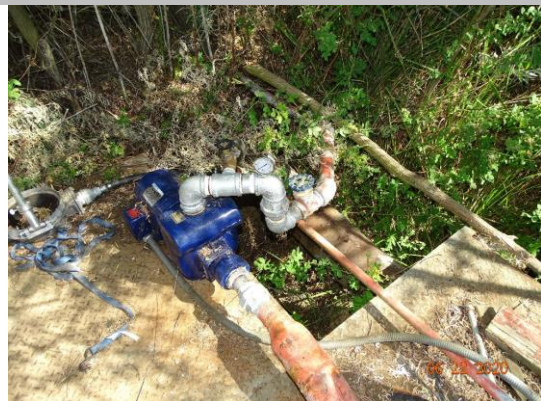
Photo 3 of 3 : UCIP_FA_2023_61308_89191.jpg

Water-Side: Pump on pile structure looks recently replaced

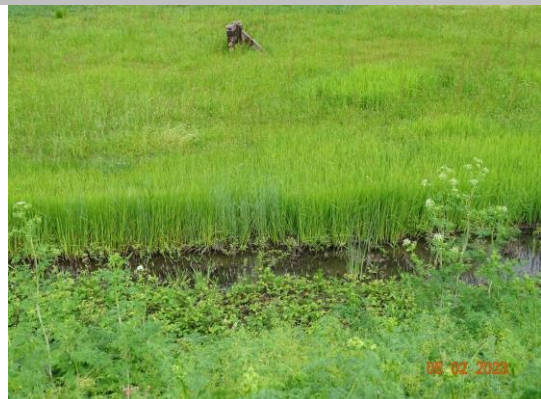
Photo 1 of 1 : FA_2023_RD0556_18_107_20231019_00052.jpg

View of the seepage area and ditch (Spring 2023).

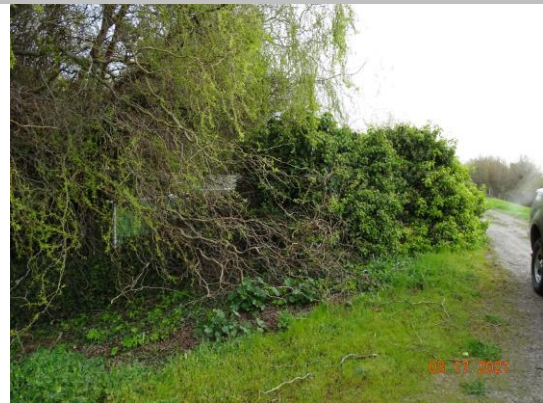
Photo 1 of 1 : FA_2023_RD0556_18_44_20231019_00028.jpg

View looking downstream landscaping shrubs on the landside slope (Spring 2021).

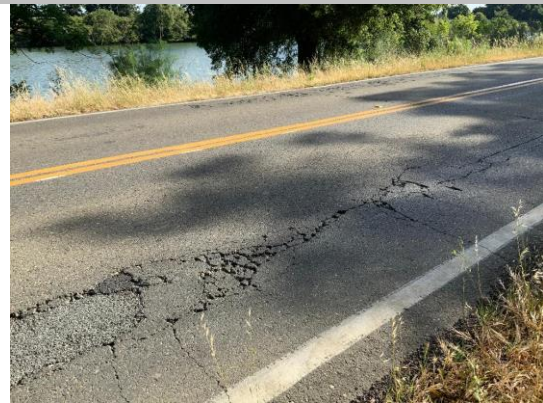
Photo 1 of 3 : UCIP_FA_2023_76292_113345.jpg

Levee crown with some visible cracking.

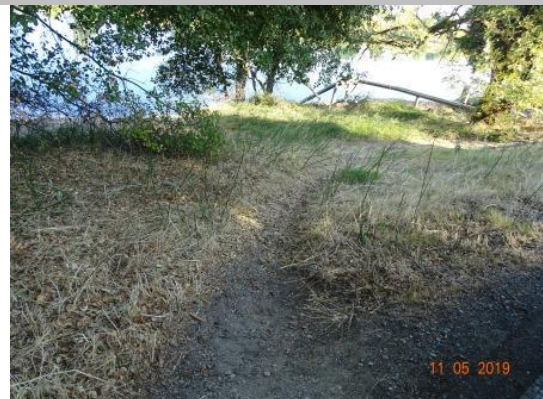
Photo 1 of 1 : FA_2023_RD0556_19_43_20231019_00031.jpg

View of fishermen trail digging into levee on the waterside slope (Fall 2019).

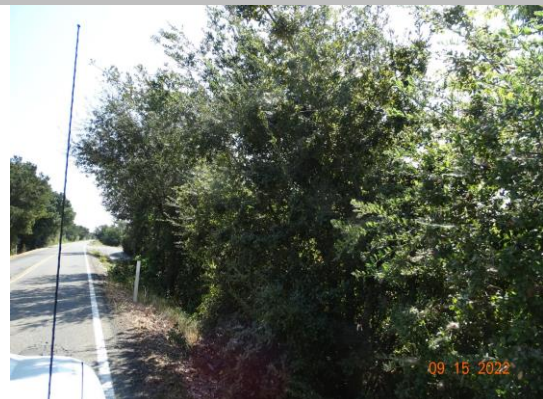
Photo 1 of 1 : FA_2023_RD0556_19_115_20231019_00067.jpg

View of the trees on the LS slope (Fall 2022).

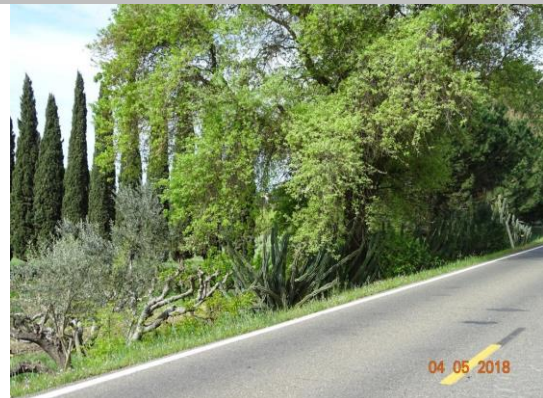
Photo 1 of 1 : FA_2023_RD0556_19_41_20231019_00030.jpg

View of cactus and other landscaping.

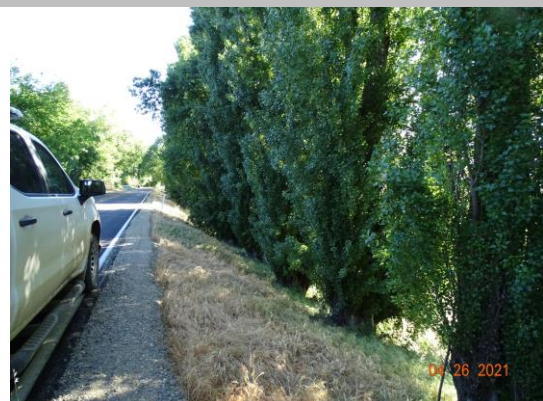
Photo 1 of 1 : FA_2023_RD0556_19_73_20231019_00051.jpg

View looking downstream at thick landscaping trees on the landside slope (Spring 2021).

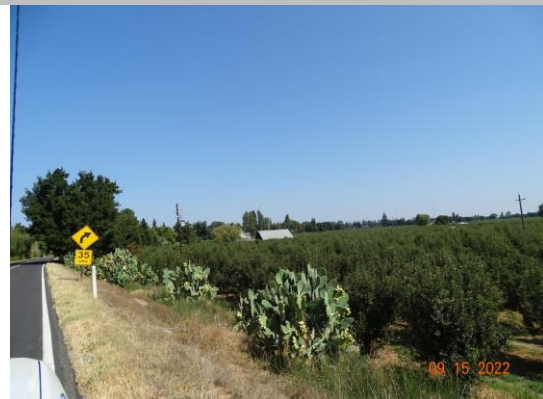
Photo 1 of 1 : FA_2023_RD0556_19_45_20231019_00032.jpg

View of the cactus on the LS slope (Fall 2022).

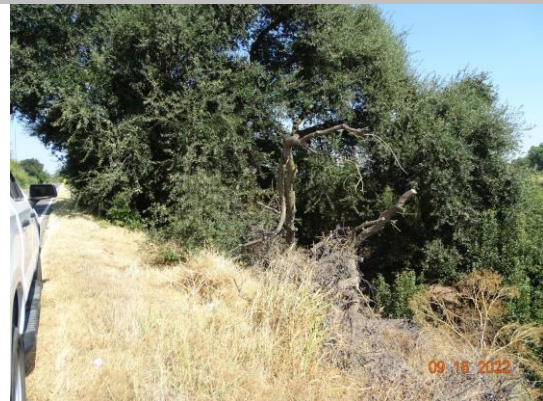
Photo 1 of 1 : FA_2023_RD0556_19_88_20231019_00060.jpg

View of the tree limb on the LS slope (Fall 2022).

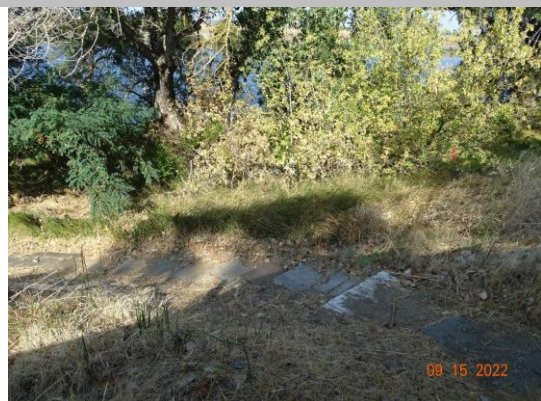
Photo 1 of 1 : FA_2023_RD0556_19_78_20231019_00054.jpg

View of the steps on the WS slope (Fall 2022).

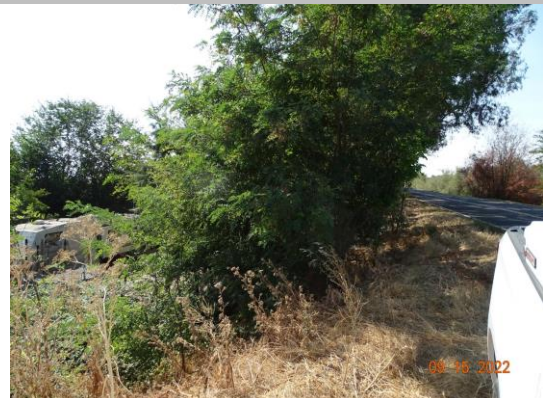
Photo 1 of 1 : FA_2023_RD0556_19_84_20231019_00058.jpg

View of the trees on the LS slope (Fall 2022).

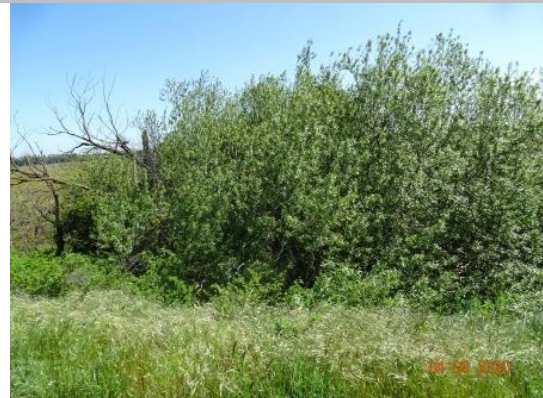
Photo 1 of 1 : FA_2023_RD0556_19_55_20231019_00039.jpg

View of thick tree on the landside slope (Spring 2020).

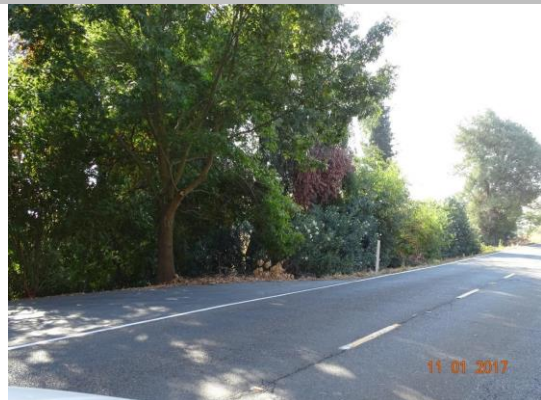
Photo 1 of 1 : FA_2023_RD0556_19_36_20231019_00027.jpg

View of landscaping on the landside.

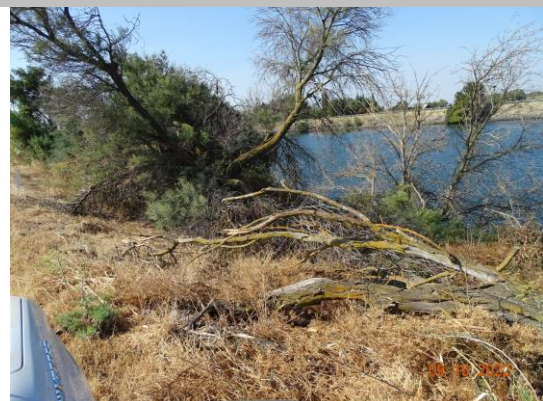
Photo 1 of 1 : FA_2023_RD0556_19_27_20231019_00020.jpg

View of the fallen tree on the WS slope (Fall 2022).

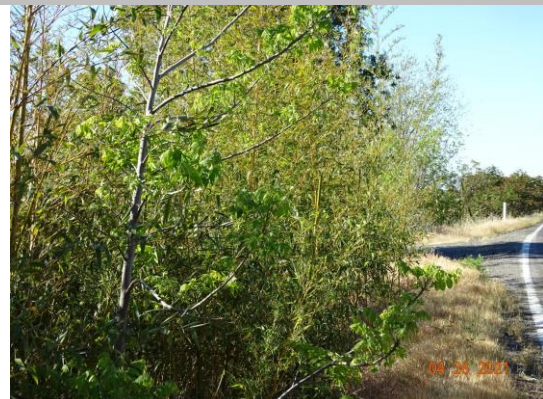
Photo 1 of 1 : FA_2023_RD0556_19_52_20231019_00038.jpg

View looking downstream at bamboo and trees of heaven on landside slope (Spring 2021).

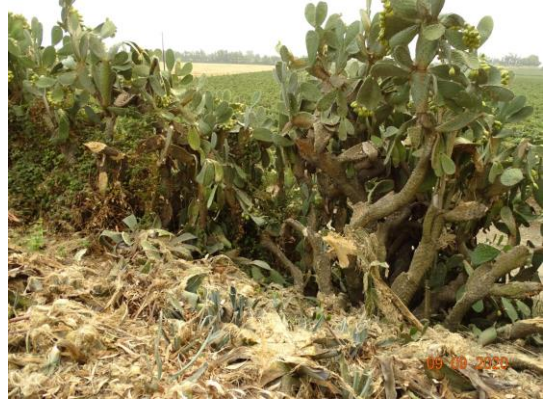
Photo 1 of 1 : FA_2023_RD0556_19_37_20231019_00028.jpg

View looking upstream at cactus partway down the landside slope (Fall 2020).

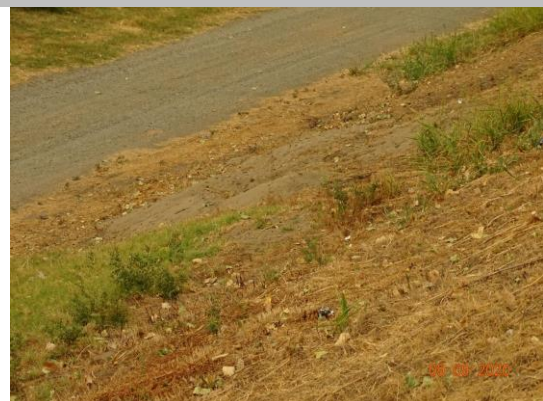
Photo 1 of 1 : FA_2023_RD0556_19_79_20231019_00055.jpg

View looking downstream at burrow holes on the landside slope (Fall 2020).
