**Flood Control Project Maintenance
Levee Inspections
Fall 2024 Levee Maintenance Deficiency Summary Report**

Sacramento River Basin

| RD0556 | Overall LMA Rating | Total LMA Miles | | | | | | |
|---|---|---|---|---|---|---|---|---|
| Reclamation District No. 0556 Upper Andrus | U | 11.20 | | | | | | |

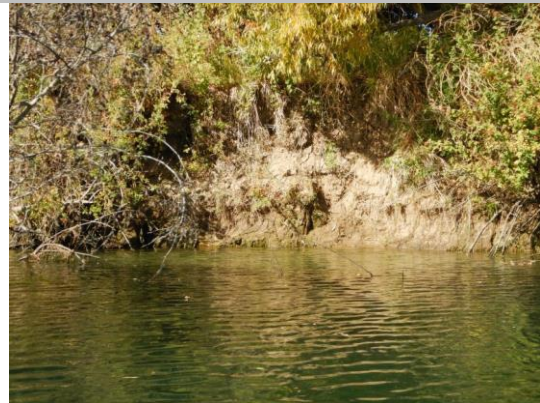
Photo 1 of 2 : FA_2024_RD0556_18_43_20241001_00024.jpg

| Site History: 2017 - Tree popout popouts eminent , significant toe erosion and whole bank failure in sections | | | | | |

USACE 2018 Erosion Photo #1

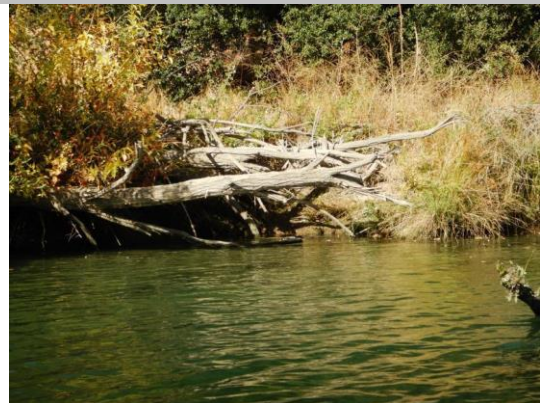
Photo 2 of 2 : FA_2024_RD0556_18_43_20241001_00025.jpg

USACE 2018 Erosion Photo #2

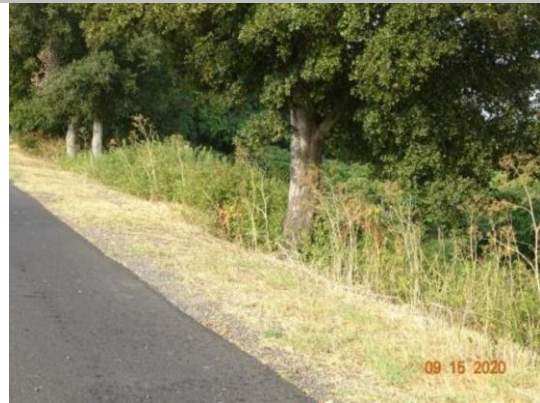
Photo 1 of 1 : FA_2024_RD0556_18_65_20241001_00038.jpg

View looking downstream at vegetation on the landside slope (Fall 2020).

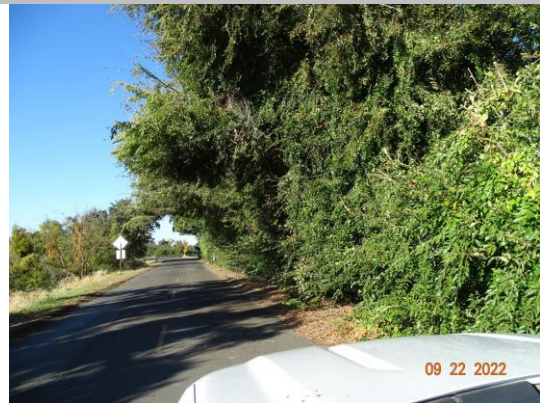
Photo 1 of 1 : FA_2024_RD0556_18_24_20241001_00006.jpg

View of the vegetation on the LS slope (Fall 2022).

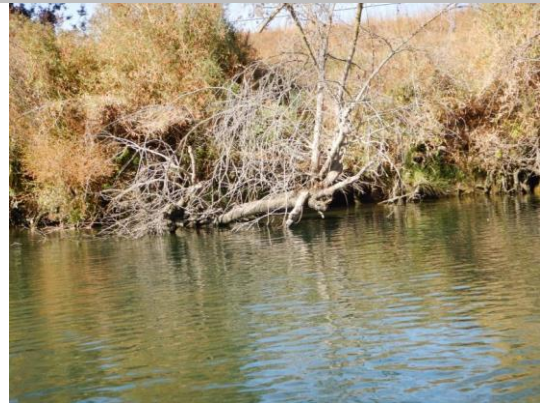
Photo 1 of 2 : FA_2024_RD0556_18_42_20241001_00022.jpg

| Site History: 2017 - Significant toe erosion and whole bank failure in sections, large pockets from tree popouts. | | | | | |

USACE 2018 Erosion Photo #1

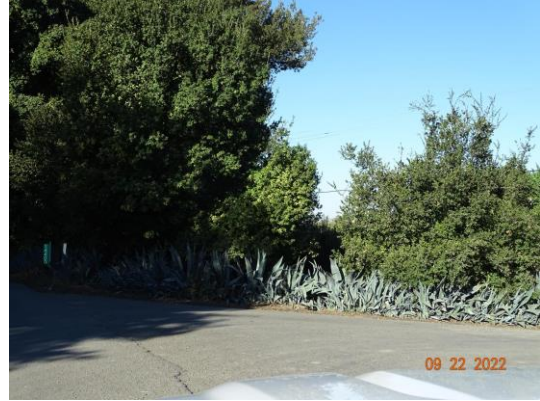
Photo 1 of 1 : FA_2024_RD0556_18_45_20241001_00027.jpg

View of the cactus on the LS shoulder (Fall 2022).

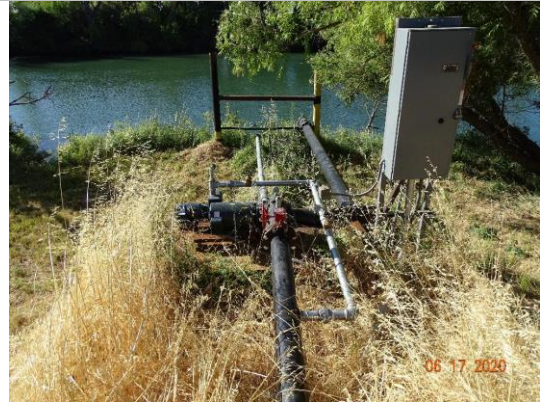
Photo 3 of 3 : UCIP_FA_2024_61399_88679.jpg

Water-Side: Pump, filler pump and line, butterfly valve on levee berm

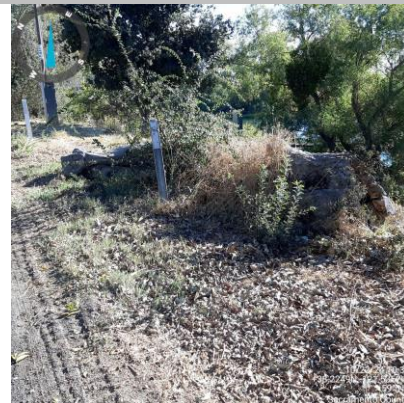
Photo 1 of 1 : FA_2024_RD0556_18_59_20241023_00092.jpg

View of log sitting on the waterside shoulder. (Fall 2024)

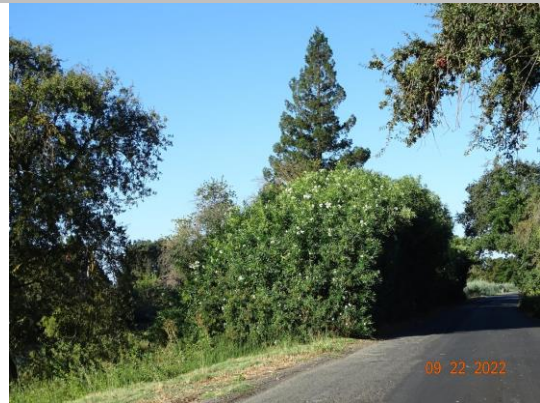
Photo 1 of 1 : FA_2024_RD0556_18_17_20241001_00001.jpg

View of the oleander on the WS shoulder and slope (Fall 2022).

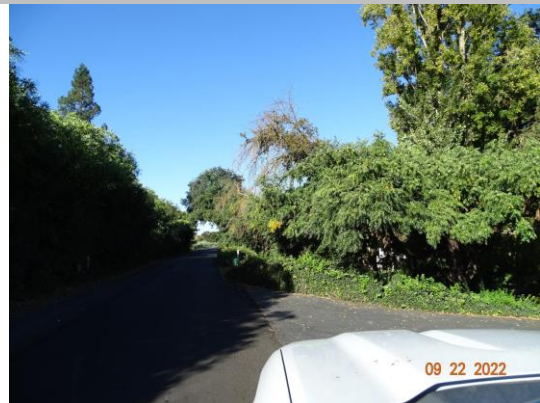
Photo 1 of 1 : FA_2024_RD0556_18_51_20241001_00031.jpg

View of the landscaping on the LS slope looking downstream (Fall 2022).

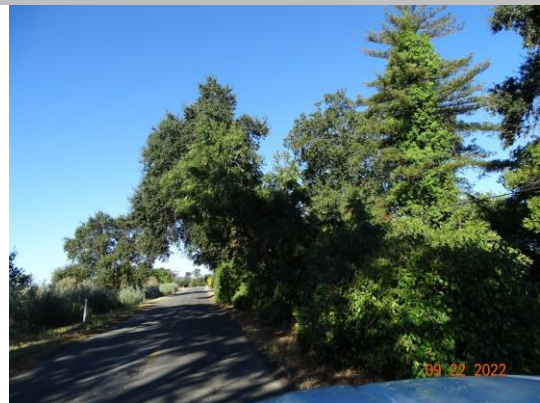
Photo 1 of 1 : FA_2024_RD0556_18_47_20241001_00029.jpg

View of the landscaping on the LS slope (Fall 2022).

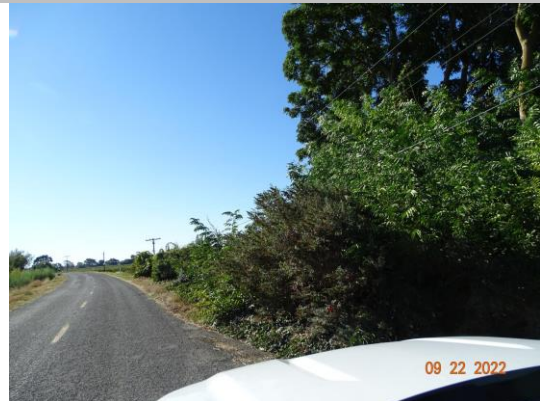
Photo 1 of 1 : FA_2024_RD0556_18_54_20241001_00033.jpg

View of the landscaping on the LS slope (Fall 2022).

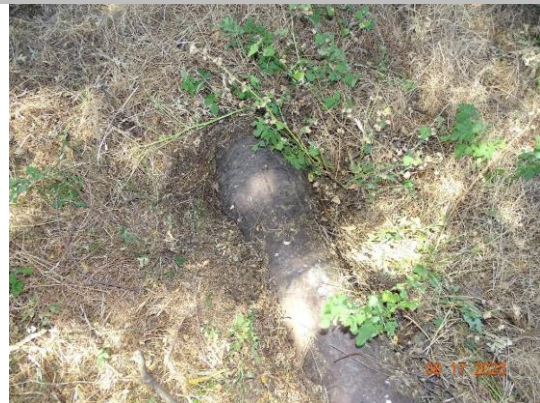
Photo 3 of 3 : UCIP_FA_2024_61500_89039.jpg

DS_ID:20833
FS_ID:61500
EP_NO: 11167
Repair Type: Non-Urgent
EVAL Issue: 10, Unauthorized Modification or Non-Compliant Permit
Crossing Status: Found
UCIP Comments: 06/17/2020 Record is Non-Urgent. Unable to find a permit for sleeving 10-inch pipe through 12-inch pipe. Unauthorized encroachment recorded in Levee Log prior to 2011. Need to have CVFPB review ABO and determine current owner. (O.Yakimov - DWR UCIP)
FIELD_STRUCT_DESC: 10-inch steel irrigation pipe sleeved through 12-inch steel pipe through levee, 4.0 feet below crown. Slant pump and gate valve on bank. 2-inch conduit through the levee 2 feet below crown. Service pole at landward toe. (12-inch pipe [HLM 2.7] authorized under Automatic Board Order (ABO) issued as Permit No. 11167, 1975 - Russel G. Graham). [Additional Reference(s): DWR Levee Log, unk.yr. (HLM 2.70)].
FS Date: 6/17/2020

Water-Side: 12-inch to 10-inch sleeved pipe connection on levee slope

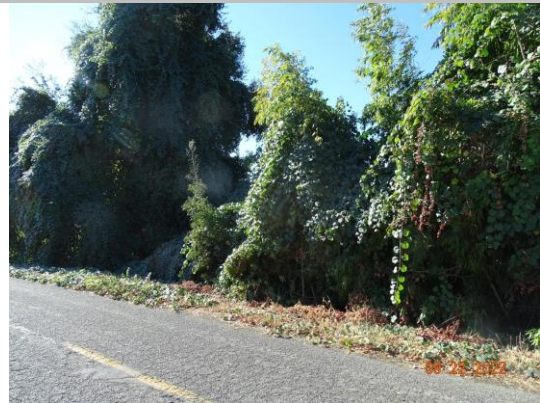
Photo 1 of 1 : FA_2024_RD0556_18_48_20241001_00030.jpg

View of the landscaping on the LS slope (Fall 2022).

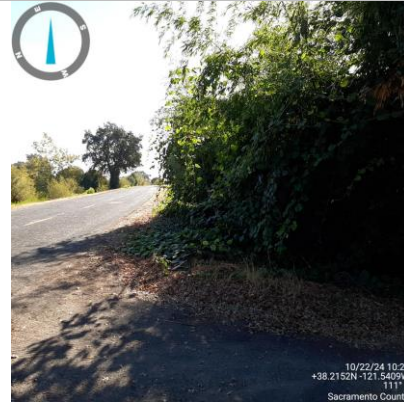
Photo 1 of 2 : FA_2024_RD0556_18_33_20241023_00094.jpg

| Fallen trees on landside. Remove the fallen tree and repair the levee damage. Ivy to be trimmed back to provide access to the fallen tree. | | | | | |

View of ivy and trees to be trimmed to expose fallen tree on the landside shoulder. (Fall 2024)

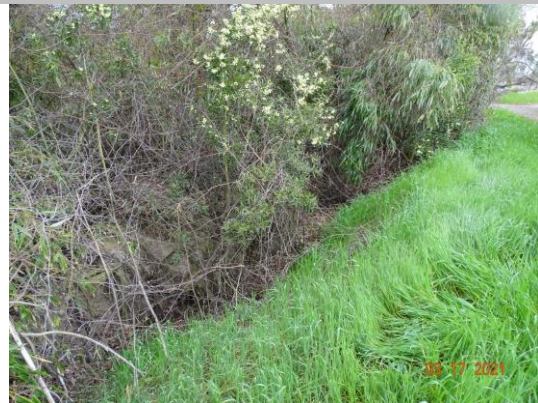
Photo 2 of 2 : FA_2024_RD0556_18_33_20241001_00012.jpg

View of hole in landside slope caused by down tree (Spring 2021).

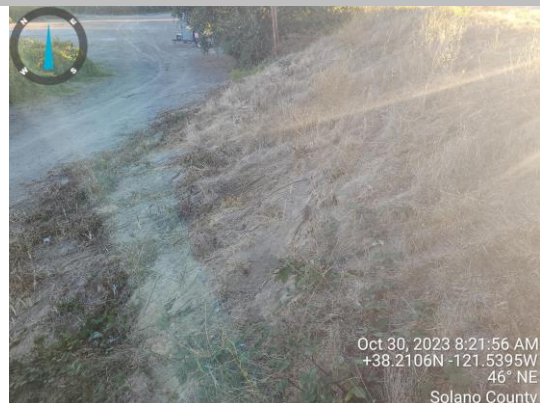
Photo 1 of 1 : FA_2024_RD0556_18_28_20241001_00008.jpg

View of rodent holes on the landside slope. Fall 2023.

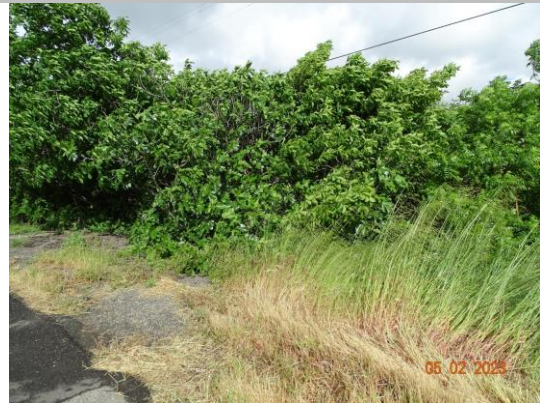
Photo 1 of 1 : FA_2024_RD0556_18_38_20241001_00019.jpg

View of the wild growth on the LS slope (Spring 2023).

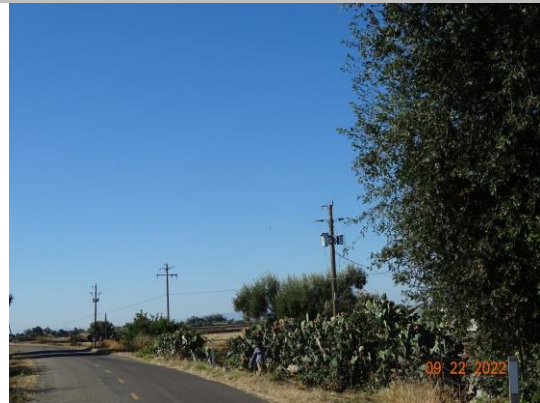
Photo 1 of 1 : FA_2024_RD0556_18_29_20241001_00009.jpg

View of the cactus on the LS slope (Fall 2022).

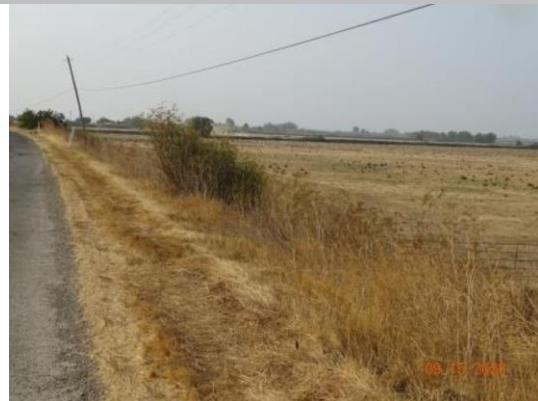
Photo 1 of 1 : FA_2024_RD0556_18_41_20241001_00021.jpg

View looking downstream at vegetation on the landside slope (Fall 2020).

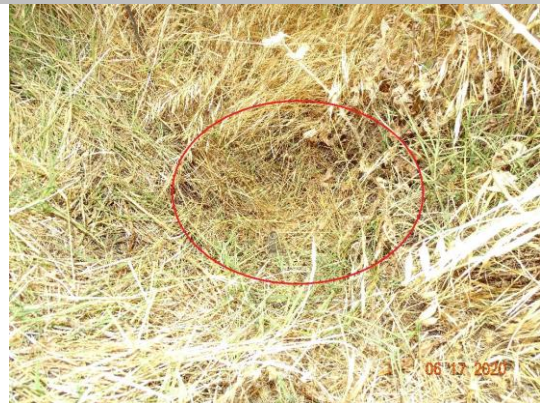
Photo 3 of 3 : UCIP_FA_2024_61301_89122.jpg

Land-Side: Sinkhole around air vent on levee shoulder

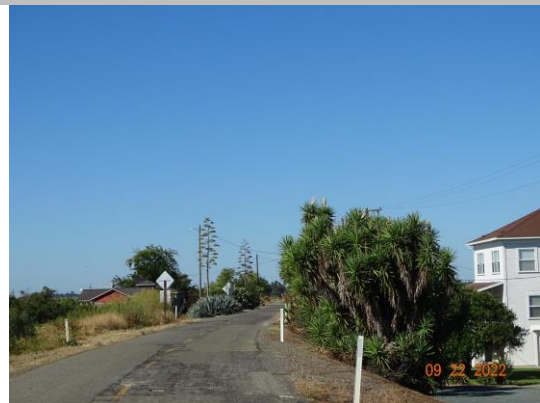
Photo 1 of 1 : FA_2024_RD0556_18_30_20241001_00010.jpg

View of the landscaping on the LS slope (Fall 2022).

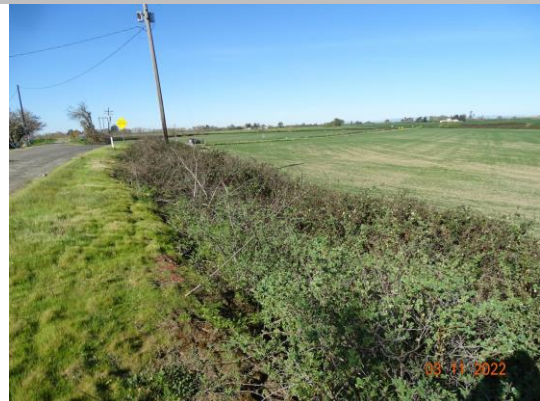
Photo 1 of 1 : FA_2024_RD0556_18_99_20241001_00046.jpg

View looking downstream at vegetation on the landside slope (Spring 2022).

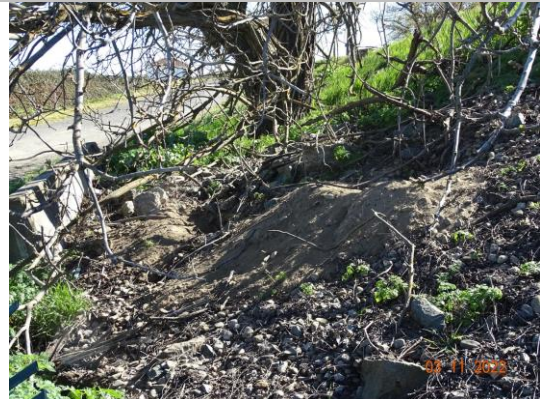
Photo 1 of 1 : FA_2024_RD0556_18_101_20241001_00048.jpg

View of multiple animal holes in the landside slope (Spring 2022).

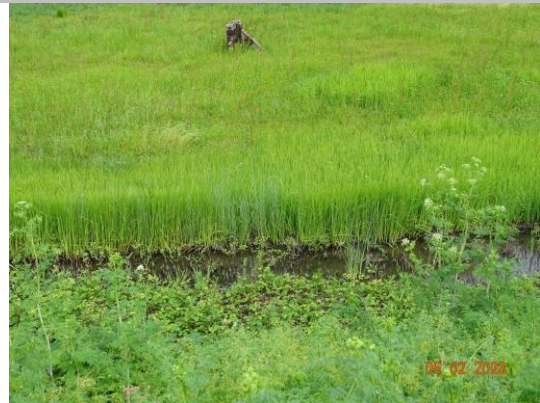
Photo 1 of 1 : FA_2024_RD0556_18_107_20241001_00049.jpg

View of the seepage area and ditch (Spring 2023).

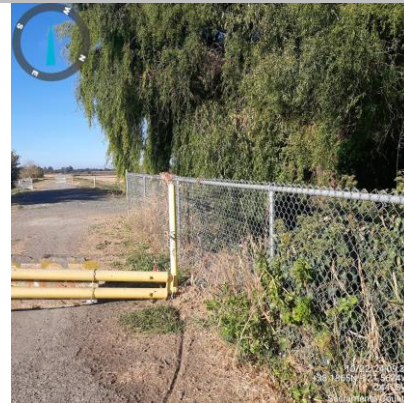
Photo 1 of 1 : FA_2024_RD0556_18_44_20241023_00100.jpg

View looking downstream landscaping shrubs on the landside slope (Fall 2024).

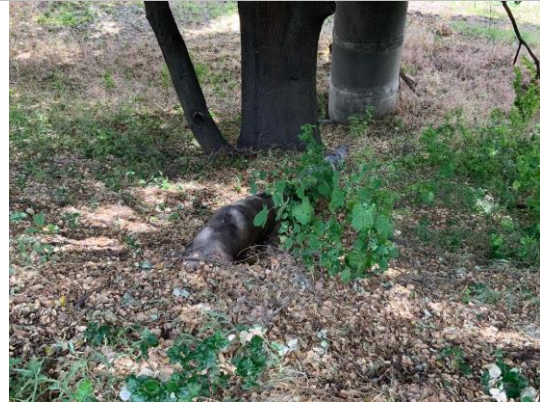
Photo 3 of 3 : UCIP_FA_2024_76291_113335.jpg

LS view: Closeup of exposed pipe on slope.

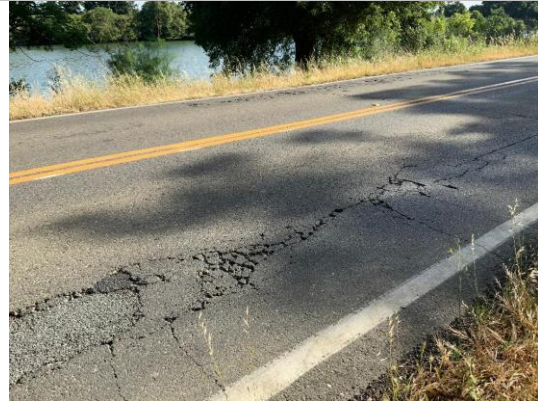
Photo 1 of 3 : UCIP_FA_2024_76292_113345.jpg

Levee crown with some visible cracking.

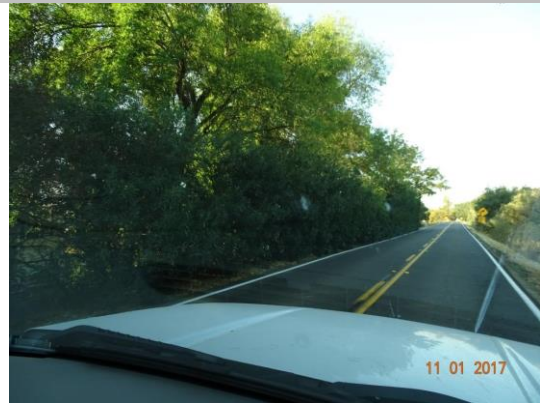
Photo 1 of 1 : FA_2024_RD0556_19_25_20241001_00017.jpg

View of oleanders on the landside of the levee.

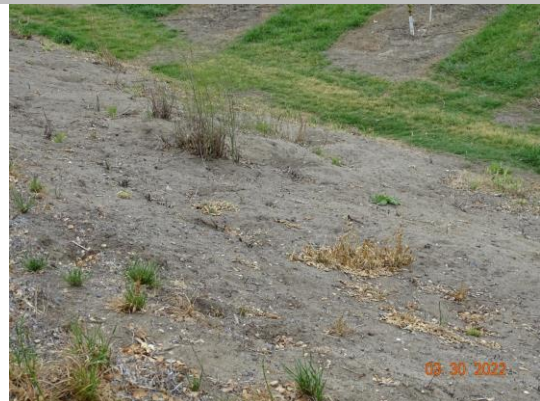
Photo 1 of 1 : FA_2024_RD0556_19_75_20241001_00046.jpg

View of animal holes in the landside slope (Spring 2022).

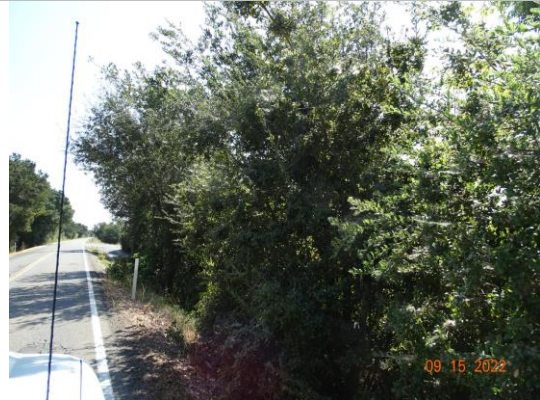
Photo 1 of 1 : FA_2024_RD0556_19_115_20241001_00060.jpg

View of the trees on the LS slope (Fall 2022).

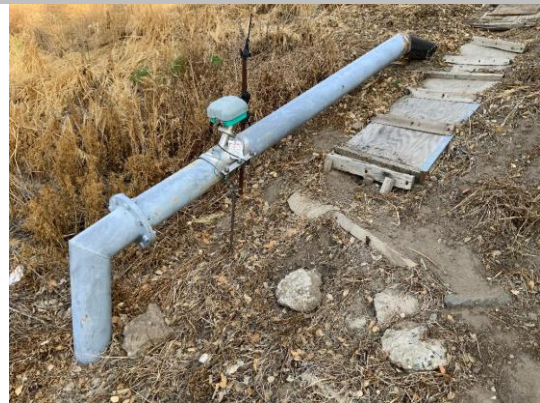
Photo 3 of 3 : UCIP_FA_2024_76296_113410.jpg

LS view: Closeup of pipe on slope from toe.

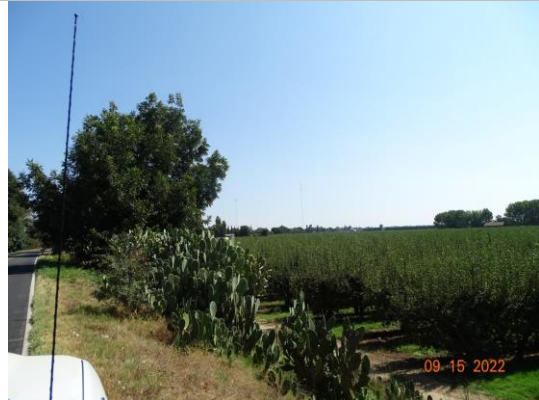
Photo 1 of 1 : FA_2024_RD0556_19_30_20241001_00021.jpg

View of the cactus on the LS slope (Fall 2022).

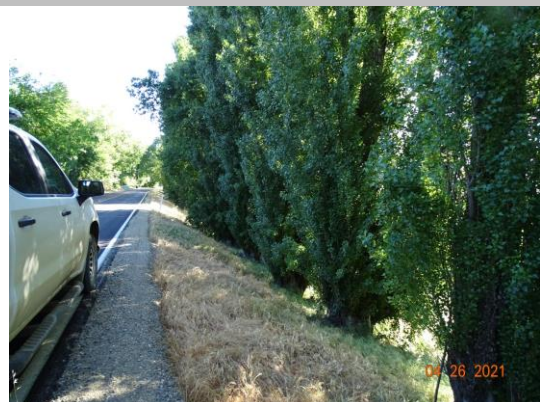
Photo 1 of 1 : FA_2024_RD0556_19_73_20241001_00045.jpg

View looking downstream at thick landscaping trees on the landside slope (Spring 2021).

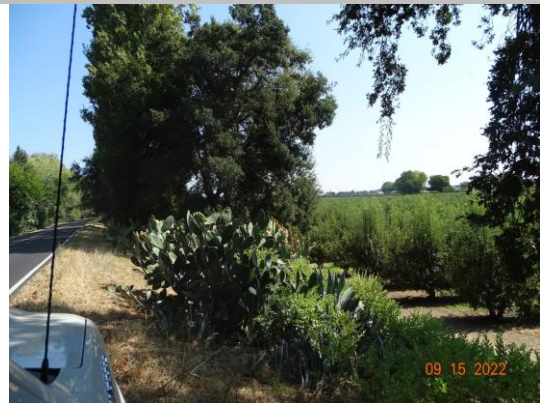
Photo 1 of 1 : FA_2024_RD0556_19_33_20241001_00024.jpg

View of the cactus on the LS slope (Fall 2022).

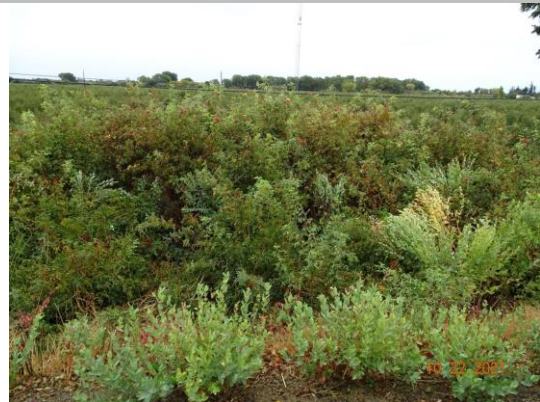
Photo 1 of 1 : FA_2024_RD0556_19_111_20241001_00059.jpg

View of thick vegetation on the landside slope (Fall 2021).

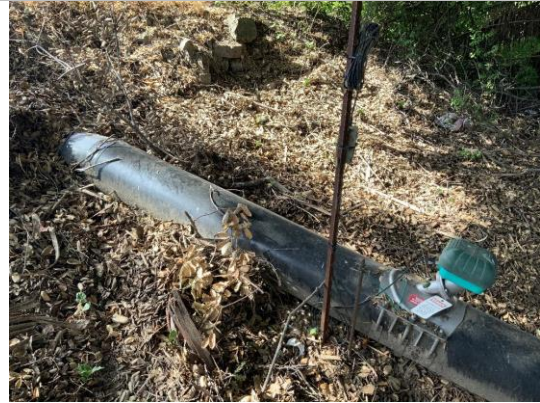
Photo 3 of 3 : UCIP_FA_2024_76299_113418.jpg

WS view: Closeup of pipe on slope.

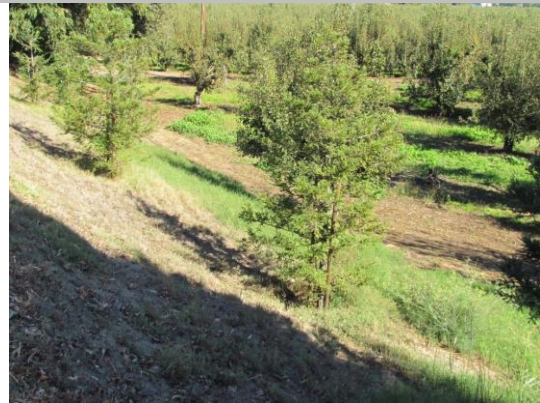
Photo 1 of 1 : FA_2024_RD0556_19_1_20241001_00001.jpg

View of unauthorized redwood trees planted on the slope.

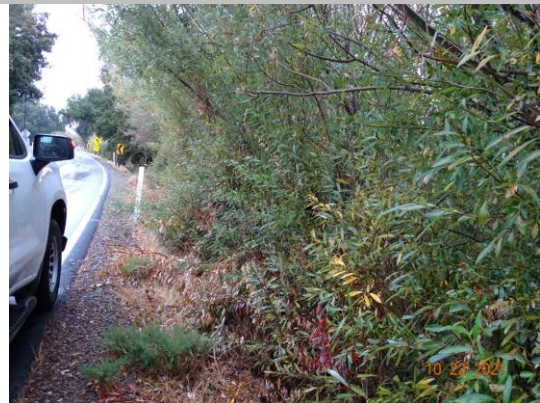
Photo 1 of 1 : FA_2024_RD0556_19_89_20241001_00054.jpg

View looking downstream at thick trees on the waterside slope (Fall 2021).

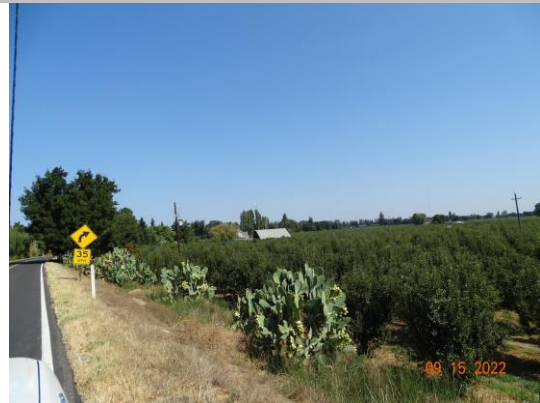
Photo 1 of 1 : FA_2024_RD0556_19_45_20241001_00030.jpg

View of the cactus on the LS slope (Fall 2022).

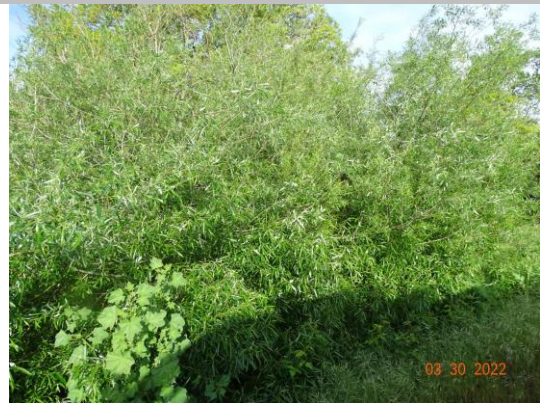
Photo 1 of 1 : FA_2024_RD0556_19_90_20241001_00055.jpg

View of thick willows on the waterside slope (Spring 2022).

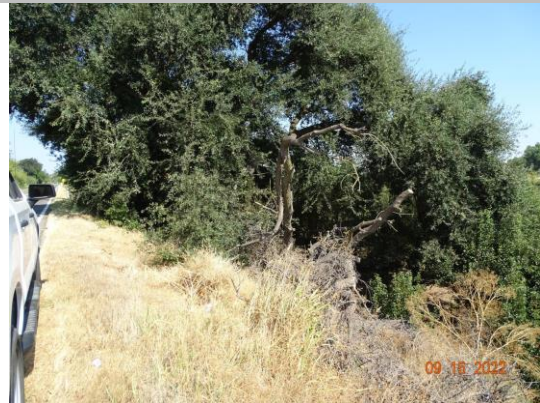
Photo 1 of 1 : FA_2024_RD0556_19_88_20241001_00053.jpg

View of the tree limb on the LS slope (Fall 2022).

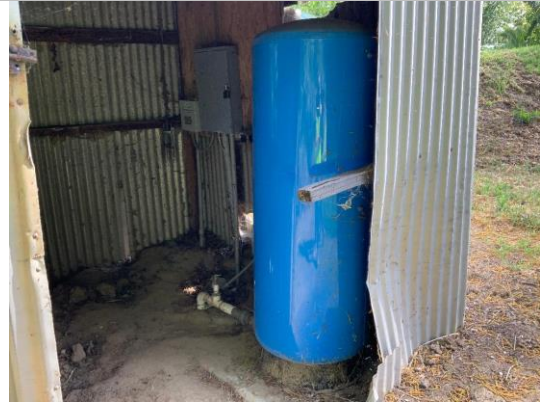
Photo 3 of 3 : UCIP_FA_2024_76302_113442.jpg

WS view: Tank inside pumphouse, no pump.

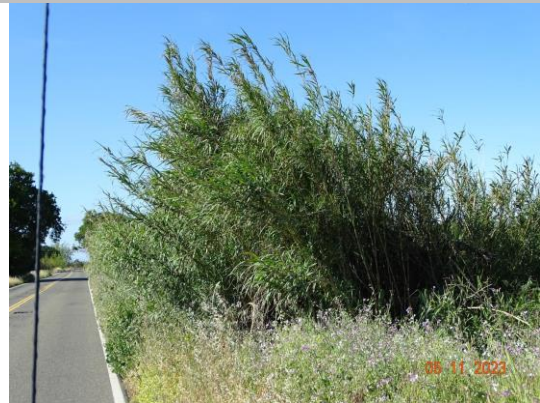
Photo 1 of 1 : FA_2024_RD0556_19_3_20241001_00003.jpg

View of the arundo on the WS slope (Spring 2023).

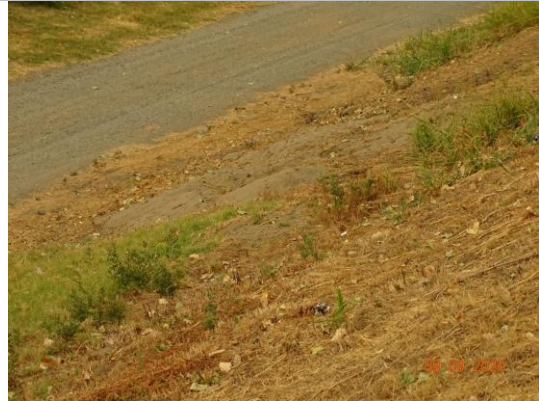
Photo 1 of 1 : FA_2024_RD0556_19_79_20241001_00049.jpg

View looking downstream at burrow holes on the landside slope (Fall 2020).
