**Flood Control Project Maintenance
Levee Inspections**
LMA District Cover Sheet
Spring 2015 Levee Inspection Results

Reclamation District No. 0556 Upper Andrus

Spring 2015 Levee Inspection Results

Waterway		Bank	Unit Miles
Unit No. 01 Georgiana Slough		Right	5.48

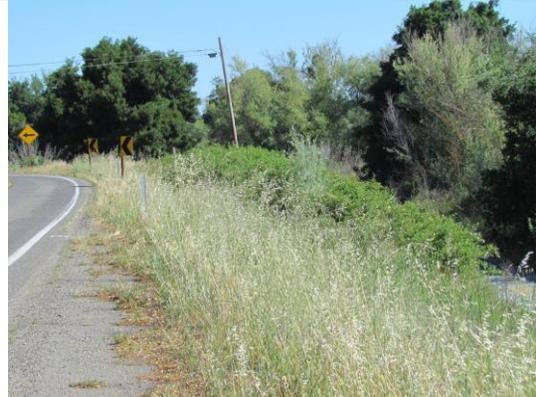
Photo 1 of 1 : SP_2015_RD0556_18_72_20150430_00023.jpg

LM Start	0.08	Rating **	U	Issue No.	72
LM End	0.22	Issue Type +	Ma	Location *	WS
Category	Earthen Levee		GPS Latitude/Longitude		
			Start	End	
Item	Vegetation		38.237925 °	38.236055 °	
			-121.518200 °	-121.518040 °	
DWR ID	DWR_RD0556_01_s_2015_72				
Action/Comments					
Remove the wild growth other than native grasses from the levee slopes. Inspector Comments: Remove the unacceptable wild growth.

RD 556 Unit 1 looking back upstream wild roses and other tall weeds on the levee slope.

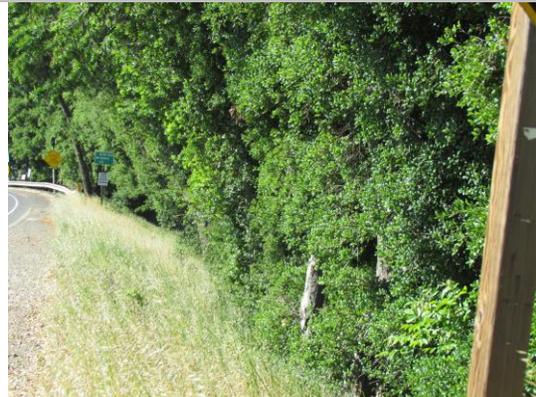
Photo 1 of 1 : SP_2015_RD0556_18_26_20150430_00025.jpg

LM Start	0.22	Rating **	U	Issue No.	26
LM End	1.70	Issue Type +	Ma	Location *	LS
Category	Earthen Levee		GPS Latitude/Longitude		
			Start	End	
Item	Vegetation		38.236055 °	38.224305 °	
			-121.518035 °	-121.537263 °	
DWR ID	DWR_RD0556_01_f_2014_26				
Action/Comments					
Trees / Woody Vegetation Inspector Comments: The woody tree growth blocks view of the levee slope.

Woody tree growth on the landward levee slope.

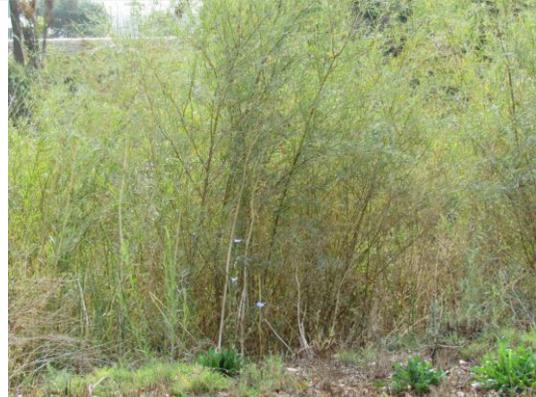
Photo 1 of 1 : SP_2015_RD0556_18_30_20150312_00009.jpg

LM Start	0.27	Rating **	U	Issue No.	30
LM End	0.61	Issue Type +	Ma	Location *	WS
Category	Earthen Levee		GPS Latitude/Longitude		
			Start	End	
Item	Vegetation		38.235427 °	38.231538 °	
			-121.518523 °	-121.522553 °	
DWR ID	DWR_RD0556_01_f_2014_30				
Action/Comments					
Trees / Woody Vegetation Inspector Comments: Remove the young willow trees from waterside slope.

Unacceptable wild tree growth on the waterside slope.

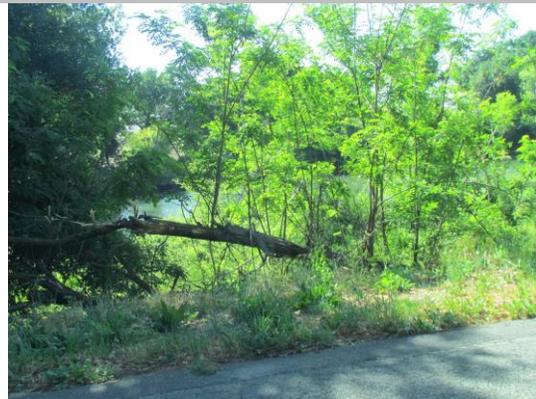
Photo 1 of 1 : SP_2015_RD0556_18_61_20150430_00027.jpg

LM Start	0.42	Rating **	U	Issue No.	61
LM End	0.42	Issue Type +	Ma	Location *	WS
Category	Earthen Levee		GPS Latitude/Longitude		
			Start	End	
Item	Encroachments		38.233775 °	38.233775 °	
			-121.520351 °	-121.520351 °	
DWR ID	DWR_RD0556_01_f_2012_61				
Action/Comments					
Tree or limb Inspector Comments: There is a dead tree at this location. Remove it from the levee section. The district is aware of this issue.

This fallen tree hasn't been removed from levee section waterward.

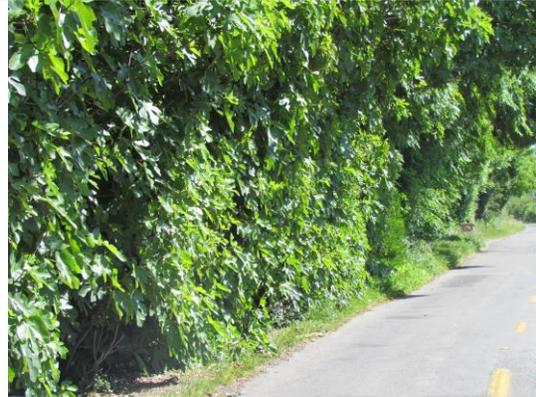
Photo 1 of 1 : SP_2015_RD0556_18_376_20150430_00028.jpg

LM Start	0.62	Rating **	U	Issue No.	376
LM End	0.90	Issue Type +	Ma	Location *	LS
Category	Earthen Levee			GPS Latitude/Longitude	
				Start	End
Item	Vegetation			38.231535 °	38.228602 °
				-121.522675 °	-121.526289 °
DWR ID	DWR_RD0556_01_s_2014_376				
Action/Comments					
Trees / Woody Vegetation Inspector Comments: District should remove these unacceptable fig trees from the landside levee section.

Remove the fig trees on the landside shoulder and toe.

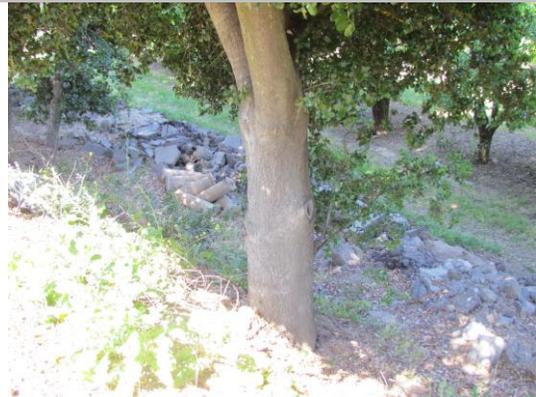
Photo 1 of 1 : SP_2015_RD0556_18_27_20150430_00031.jpg

LM Start	1.34	Rating **	U	Issue No.	27
LM End	1.37	Issue Type +	En	Location *	LS
Category	Earthen Levee		GPS Latitude/Longitude		
			Start	End	
Item	Encroachments		38.227521 °	38.227320 °	
			-121.532393 °	-121.532710 °	
DWR ID	DWR_RD0556_01_s_2013_27				
Action/Comments					
Debris Inspector Comments: Asphalt dumped along toe of levee. Issue not removed as of 10-30-2014 during the fall inspection.

Unauthorized asphalt dumped on the levee toe, District is aware of this encroachment.

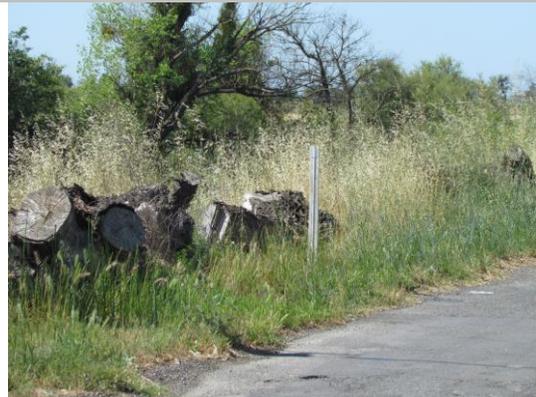
Photo 1 of 1 : SP_2015_RD0556_18_9_20150430_00032.jpg

LM Start	1.55	Rating **	U	Issue No.	9
LM End	1.57	Issue Type +	En	Location *	WS
Category	Earthen Levee			GPS Latitude/Longitude	
				Start	End
Item	Encroachments			38.225191 °	38.224976 °
				-121.534799 °	-121.535043 °
DWR ID	DWR_RD0556_01_s_2012_9				
Action/Comments					
Tree or limb Inspector Comments: These cut up tree sections remain on the waterward slope. The owner is on the Reclamation District's Board. Mr. Silva said he will ask him to remove the encroachment.

Unwanted large tree sections placed on the waterside levee shoulder. District is aware of this issue.

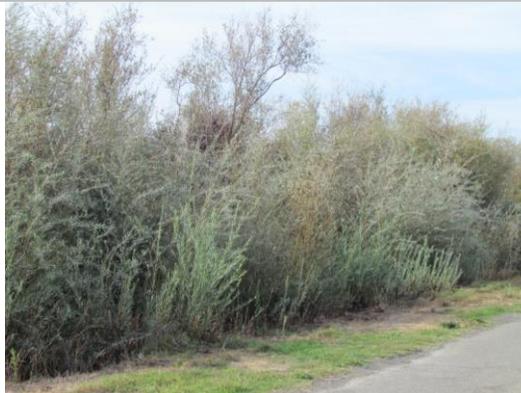
Photo 1 of 1 : SP_2015_RD0556_18_49_20150312_00011.jpg

LM Start	1.75	Rating **	U	Issue No.	49
LM End	1.99	Issue Type +	Ma	Location *	WS
Category	Earthen Levee			GPS Latitude/Longitude	
				Start	End
Item	Vegetation			38.224120 °	38.223590 °
				-121.538137 °	-121.542387 °
DWR ID	DWR_RD0556_01_f_2014_49				
Action/Comments					
Trees / Woody Vegetation Inspector Comments: Remove the unacceptable tree growth from the levee section on the waterward side.

Woody tree growth blocks view of the waterward slope.

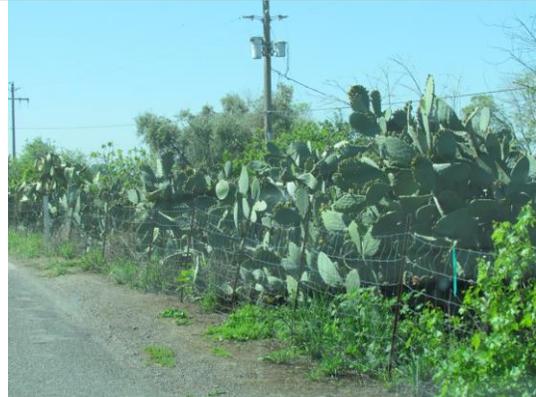
Photo 1 of 1 : SP_2015_RD0556_18_395_20150312_00022.jpg

LM Start	3.26	Rating **	M	Issue No.	395
LM End	3.37	Issue Type +	Ma	Location *	LS
Category	Earthen Levee			GPS Latitude/Longitude	
				Start	End
Item	Vegetation			38.210185 °	38.208899 °
				-121.540264 °	-121.541340 °
DWR ID	DWR_RD0556_01_f_2013_395				
Action/Comments					
Remove the wild growth other than native grasses from the levee slopes. Inspector Comments: This wild growth is unacceptable and blocking visibility and access.

Unacceptable wild growth of cactus completely blocking visibility of the entire levee section.

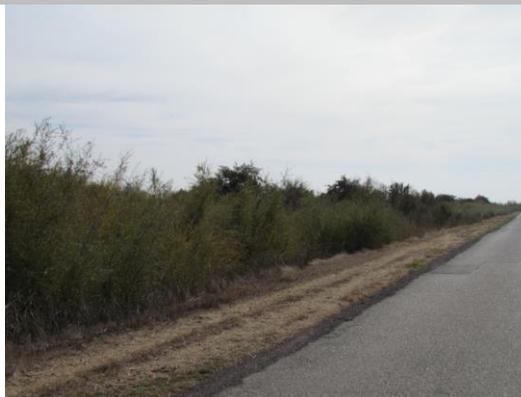
Photo 1 of 1 : SP_2015_RD0556_18_68_20150312_00016.jpg

Unacceptable woody tree growth on the waterside slope and toe.

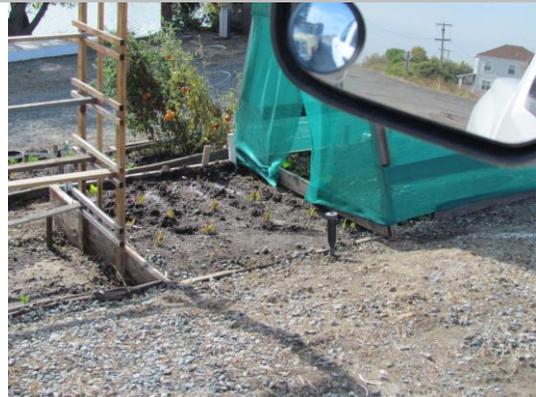
Photo 1 of 2 : SP_2015_RD0556_18_70_20150312_00018.jpg

Continued placement of unauthorized planter boxes into levee slope on the waterside.

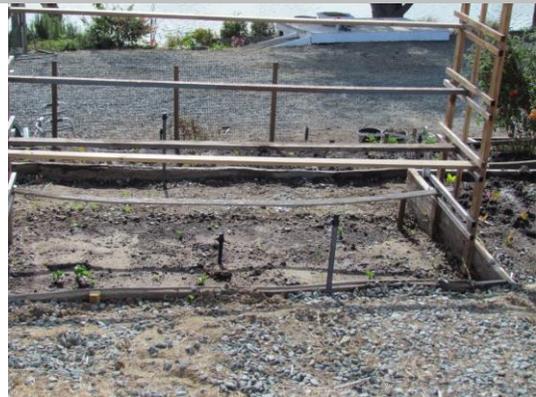
Photo 2 of 2 : SP_2015_RD0556_18_70_20150312_00019.jpg

Landowner has dug into waterward slope and built planter boxes.

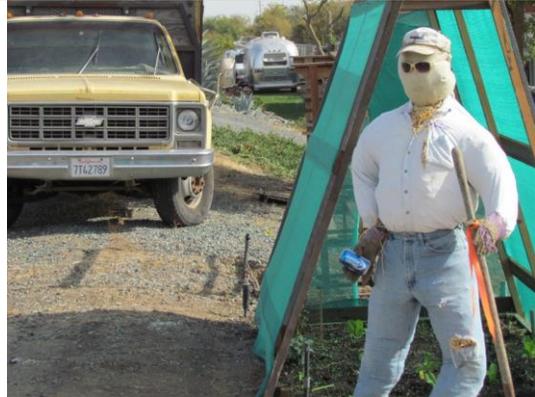
Photo 1 of 2 : SP_2015_RD0556_18_4_20150312_00001.jpg

LM Start	4.02	Rating **	U	Issue No.	4
LM End	4.05	Issue Type +	En	Location *	WS
Category	Earthen Levee		GPS Latitude/Longitude		
			Start	End	
Item	Encroachments		38.201028 °	38.200801 °	
			-121.543930 °	-121.544400 °	
DWR ID	DWR_RD0556_01_s_2014_4				
Action/Comments					
Abandoned vehicles Inspector Comments: The levee is used to store vehicles at this location. There are lots of issues going on at this location, storing vehicles just happens to be one of them. A notice of violation needs to be issued to landowner.

Unauthorized storage of vehicles and various other items stored at this location.

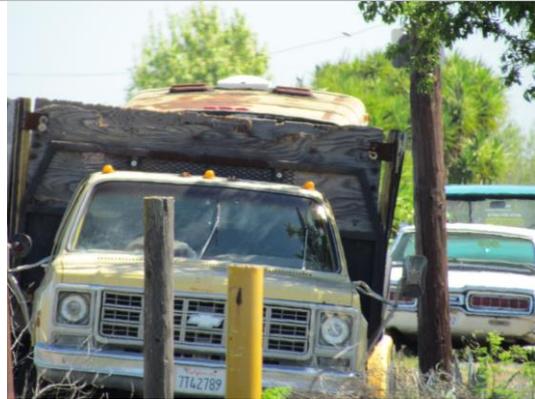
Photo 2 of 2 : SP_2015_RD0556_18_4_20150312_00002.jpg

Several vehicles using the water side shoulder as parking/storage.

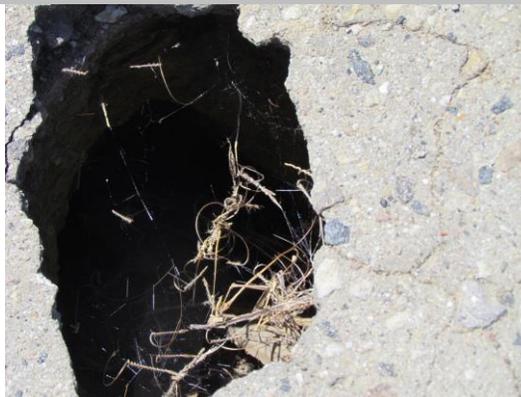
Photo 1 of 1 : SP_2015_RD0556_18_69_20150430_00035.jpg

This rodent hole is in the levee crown roadway and goes down some 3-4 foot deep. Repairs are needed.

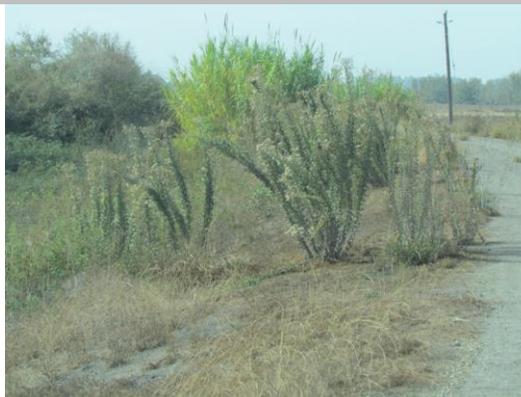
Photo 1 of 1 : SP_2015_RD0556_18_67_20150312_00015.jpg

Unacceptable tall weeds along with arundo present on the waterside slope.

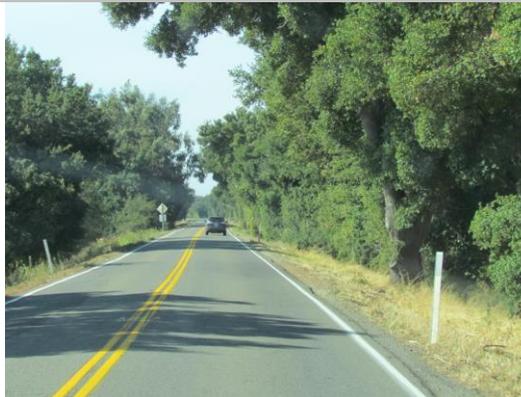
Photo 1 of 1 : SP_2015_RD0556_19_82_20150312_00016.jpg

Looking downstream waterside slope overgrown.

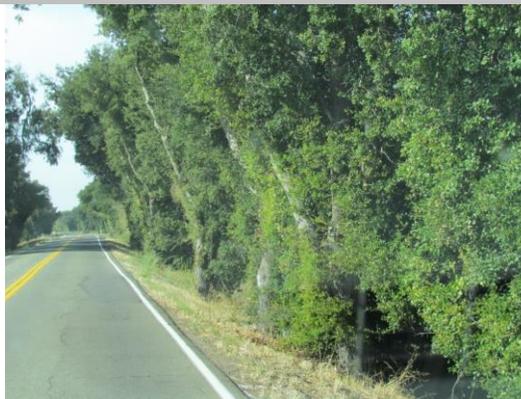
Photo 1 of 1 : SP_2015_RD0556_19_32_20150312_00011.jpg

Woody tree growth on the waterside levee section.

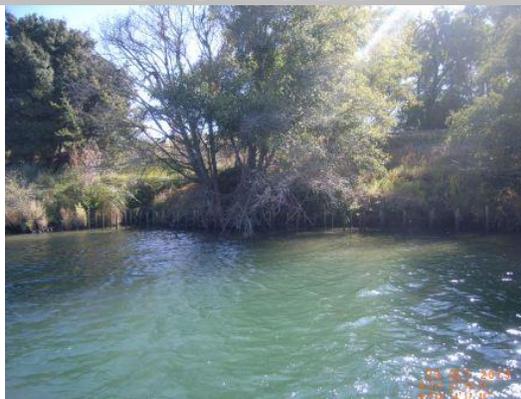
Photo 1 of 1 : SP_2015_RD0556_19_28_20150312_00010.jpg

LM Start	0.31	Rating **	M	Issue No.	28
LM End	0.60	Issue Type +	Ma	Location *	WS
Category	Supplemental			GPS Latitude/Longitude	
				Start	End
Item	USACE Erosion Survey			38.238784 °	38.237862 °
				-121.523932 °	-121.529188 °
DWR ID	DWR_RD0556_02_f_2014_28				
Action/Comments					
Inspector Comments: 2002 - Two rock sections (150 ft long) at the downstream end. 2005 - Lots of old brush boxes, some with established vegetation in the area behind the boxes. 2006 - Some small spots fixed with stone. 2009 - Minimal new erosion, rock in the middle of the reach may be new. 2011 - Minor new erosion at the toe. 2013: Minor new erosion. [2013 Site ID: SAC_26-0_L]

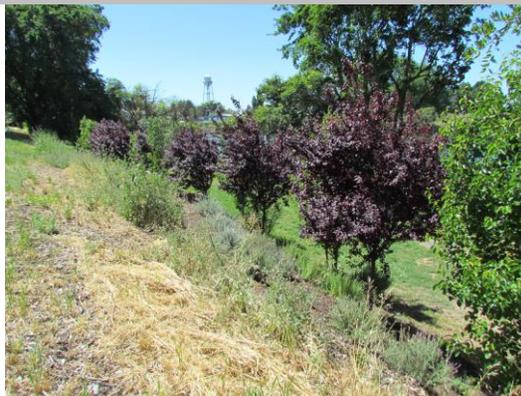
Photo 1 of 1 : SP_2015_RD0556_19_83_20150603_00028.jpg

Unauthorized planting of trees on the waterside toe of levee.
