**Flood Control Project Maintenance
Levee Inspections**

Maintenance Issue Types Only, Levee Inspection Report By Mile - Fall 2014

Reclamation District No. 0556 Upper Andrus

Waterway	Bank	Unit Miles	Inspection Start/End	Inspector
Unit No. 01 Georgiana Slough	Right	5.48	10/30/2014 10/30/2014	Herman Phillips

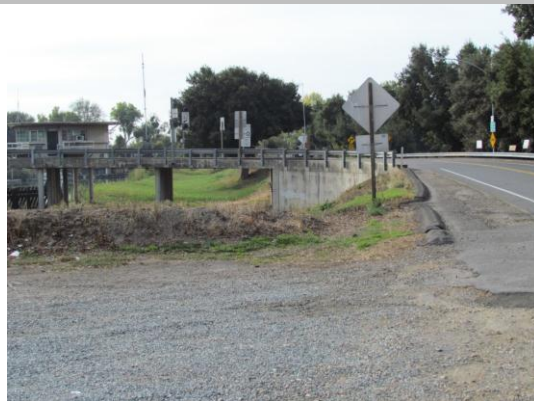
Photo 1 of 1 : FA_2014_RD0556_18_23_20141113_00013.jpg

LM Start	0.21	Rating **	M	Issue No.	23
LM End	1.37	Issue Type +	Ma	Location *	WS
Category	Earthen Levee			GPS Latitude/Longitude	
				Start	End
Item	Vegetation			38.236055 °	38.227238 °
				-121.518035 °	-121.532840 °
DWR ID	DWR_RD0556_01_f _ 2014_23				
Action/Comments					
Remove the wild growth other than native grasses from the levee slopes.

Looking downstream from levee mile 0.21 at the waterside slope. Tall weeds present beyond bridge.

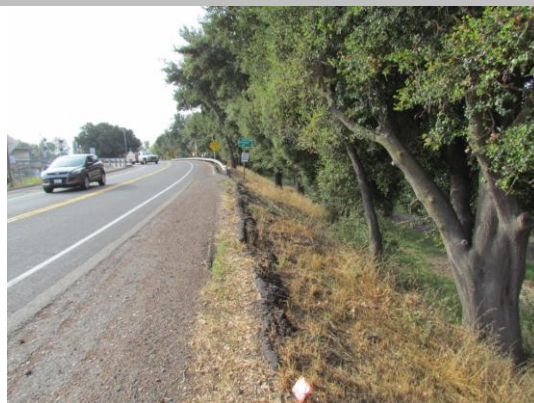
Photo 1 of 1 : FA_2014_RD0556_18_26_20141113_00014.jpg

LM Start	0.21	Rating **	M	Issue No.	26
LM End	1.70	Issue Type +	Ma	Location *	LS
Category	Earthen Levee			GPS Latitude/Longitude	
				Start	End
Item	Vegetation			38.236055 °	38.224305 °
				-121.518035 °	-121.537263 °
DWR ID	DWR_RD0556_01_f_2014_26				
Action/Comments					
Control annual grass and weeds on the levee slopes and easements.

Looking downstream from levee mile 0.21 at tall weeds on landside slope.

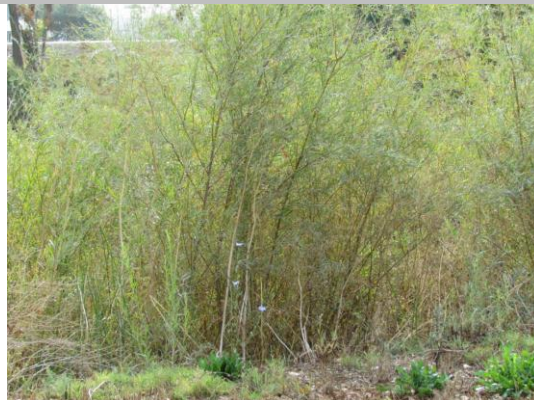
Photo 1 of 1 : FA_2014_RD0556_18_30_20141113_00015.jpg

LM Start	0.27	Rating **	U	Issue No.	30
LM End	0.61	Issue Type +	Ma	Location *	WS
Category	Earthen Levee			GPS Latitude/Longitude	
				Start	End
Item	Vegetation			38.235427 °	38.231538 °
				-121.518523 °	-121.522553 °
DWR ID	DWR_RD0556_01_f_2014_30				
Action/Comments					
Trees / Woody Vegetation					
Inspector Comments: Remove the young willow trees from waterside slope.

Woody tree growth on waterside, young willow trees.

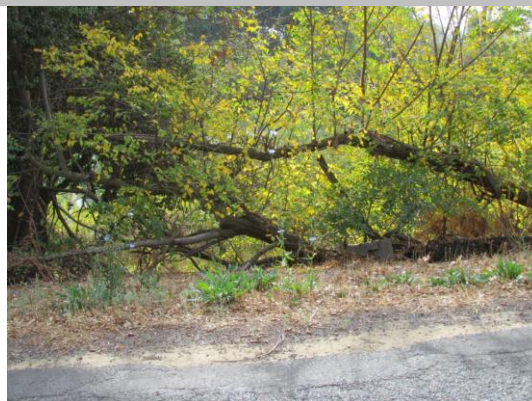
Photo 1 of 1 : FA_2014_RD0556_18_61_20141113_00016.jpg

LM Start	0.42	Rating **	U	Issue No.	61
LM End	0.42	Issue Type +	Ma	Location *	WS
Category	Earthen Levee			GPS Latitude/Longitude	
				Start	End
Item	Encroachments			38.233775 °	38.233775 °
				-121.520351 °	-121.520351 °
DWR ID	DWR_RD0556_01_f_2012_61				
Action/Comments					
Tree or limb Inspector Comments: At this location there is a dead tree. Remove it from the levee section.

This fallen down tree remains to be an issue, District need to remove from levee section.

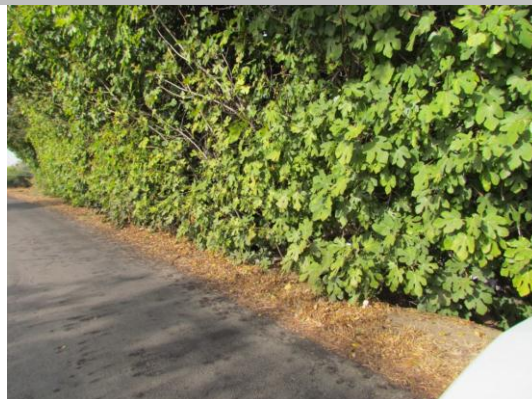
Photo 1 of 1 : FA_2014_RD0556_18_376_20141113_00017.jpg

LM Start	0.61	Rating **	U	Issue No.	376
LM End	0.90	Issue Type +	Ma	Location *	LS
Category	Earthen Levee			GPS Latitude/Longitude	
				Start	End
Item	Vegetation			38.231535 °	38.228602 °
				-121.522675 °	-121.526289 °
DWR ID	DWR_RD0556_01_s_2014_376				
Action/Comments					
Trees / Woody Vegetation					
Inspector Comments: District should remove these unwanted fig trees from the landside slope, unable to see ground.

Remove unwanted fig trees present on the landside slope.

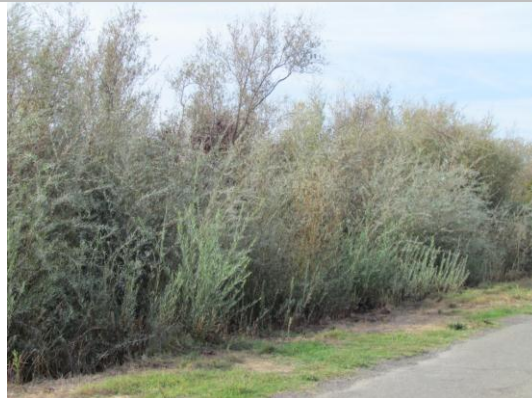
Photo 1 of 1 : FA_2014_RD0556_18_49_20141113_00019.jpg

LM Start	1.75	Rating **	U	Issue No.	49
LM End	1.98	Issue Type +	Ma	Location *	WS
Category	Earthen Levee			GPS Latitude/Longitude	
				Start	End
Item	Vegetation			38.224120 °	38.223590 °
				-121.538137 °	-121.542387 °
DWR ID	DWR_RD0556_01_f_2014_49				
Action/Comments					
Trees / Woody Vegetation					
Inspector Comments: Remove the unwanted tree growth from the levee section water ward.

Woody tree growth blocks view of the waterward slope.

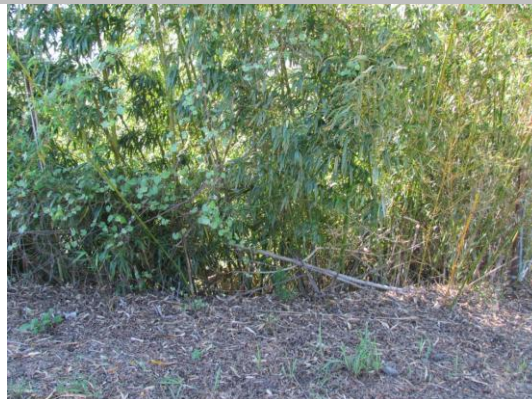
Photo 1 of 1 : FA_2014_RD0556_18_390_20141030_00010.jpg

LM Start	2.70	Rating **	U	Issue No.	390
LM End	2.70	Issue Type +	Ma	Location *	LS
Category	Earthen Levee			GPS Latitude/Longitude	
				Start	End
Item	Vegetation			38.215149 °	38.215177 °
				-121.540802 °	-121.540875 °
DWR ID	DWR_RD0556_01_s_2014_390				
Action/Comments					
Remove the wild growth other than native grasses from the levee slopes.					
Inspector Comments: Wild growth of bambo on levee slope and shoulder landside.

Unsatisfactory growth of bambo on the landside slope and toe.

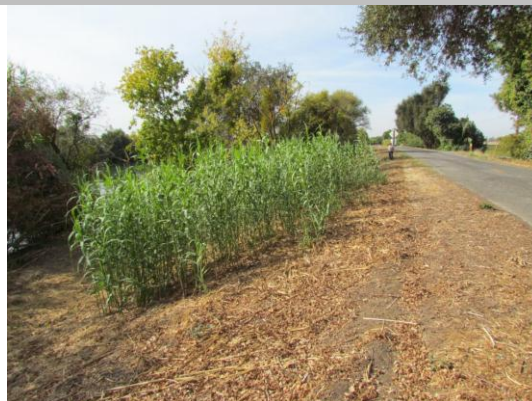
Photo 1 of 1 : FA_2014_RD0556_18_64_20141113_00021.jpg

LM Start	3.12	Rating **	M	Issue No.	64
LM End	3.14	Issue Type +	Ma	Location *	WS
Category	Earthen Levee			GPS Latitude/Longitude	
				Start	End
Item	Vegetation			38.211060 °	38.210913 °
				-121.538132 °	-121.538463 °
DWR ID	DWR_RD0556_01_f_2014_64				
Action/Comments					
Control annual grass and weeds on the levee slopes and easements. Inspector Comments: Remove the arundo from the levee section while its at a young stage.

Waterside levee mile 3-12 to 3.14: young patch of arundo growing.

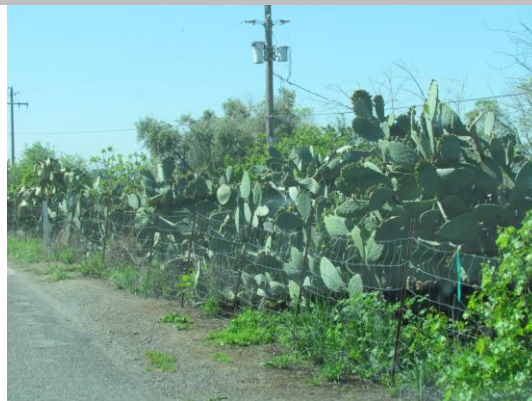
Photo 1 of 1 : FA_2014_RD0556_18_395_20141030_00011.jpg

DWR Start	3.24	Rating **	U	Issue No.	395
LM End	3.35	Issue Type +	Ma	Location *	LS
Category	Earthen Levee			GPS Latitude/Longitude	
				Start	End
Item	Vegetation			38.210185 °	38.208899 °
				-121.540264 °	-121.541340 °
DWR ID	DWR_RD0556_01_f_2013_395				
Action/Comments					
Remove the wild growth other than native grasses from the levee slopes.					
Inspector Comments: This wild growth is unsatisfactory and blocking visibility and access.

Unsatisfactory wild growth of cactus completely blocking visibility of the entire levee section between levee mile 3.24 thru 3.35. No new photo taken fall 2014, no change at this Issue.

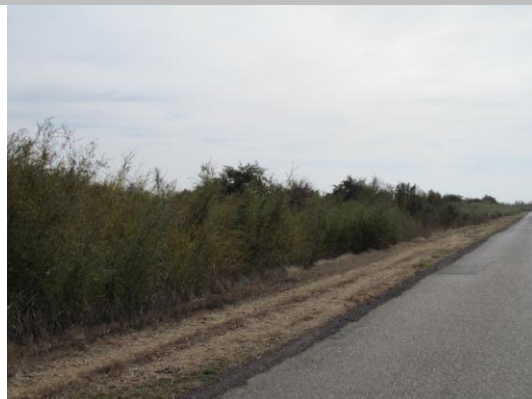
Photo 1 of 1 : FA_2014_RD0556_18_68_20141113_00024.jpg

LM Start	3.58	Rating **	U	Issue No.	68
LM End	3.84	Issue Type +	Ma	Location *	WS
Category	Earthen Levee			GPS Latitude/Longitude	
				Start	End
Item	Vegetation			38.205630 °	38.202080 °
				-121.541647 °	-121.541003 °
DWR ID	DWR_RD0556_01_f_2014_68				
Action/Comments					
Trees / Woody Vegetation					
Inspector Comments: Control unwanted wild trees waterside slope.

Unwanted woody tree growth view of slope and toe waterward.

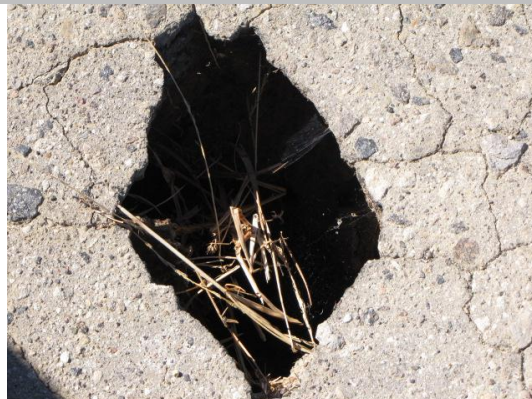
Photo 1 of 1 : FA_2014_RD0556_18_69_20141030_00008.jpg

LM Start	4.05	Rating **	U	Issue No.	69
LM End	4.05	Issue Type +	Ma	Location *	LS
Category	Earthen Levee			GPS Latitude/Longitude	
				Start	End
Item	Animal Control			38.995700 °	38.995700 °
				-120.346300 °	-120.346300 °
DWR ID	DWR_RD0556_01_s_2013_69				
Action/Comments					
No rodents visible, but rodent burrows visible; need to backfill and compact or grout burrows.					
Inspector Comments: There is a rodent hole in crown roadway more than 3-feet deep. The RD need to fix this rodent hole in the crown roadway. No new photo taken at this location. No repair made.

This rodent hole is in the levee crown roadway and goes down some 3-4 feet deep. Repairs are needed before rainwater get inside causing more problems. Status: unsatisfactory. There was no new photo taken of this site during the inspection of 4-2014. No new photo taken; this hole has not been backfilled.

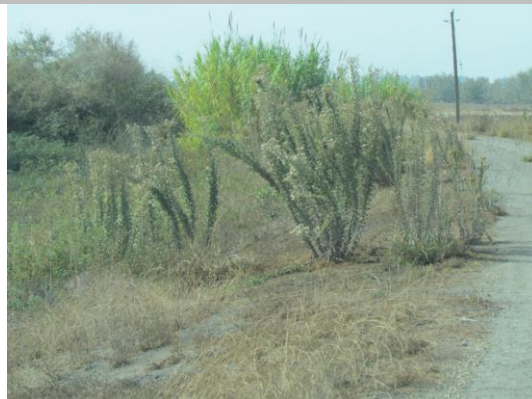
Photo 1 of 1 : FA_2014_RD0556_18_67_20141113_00029.jpg

LM Start	4.05	Rating **	U	Issue No.	67
LM End	5.46	Issue Type +	Ma	Location *	WS
Category	Earthen Levee			GPS Latitude/Longitude	
				Start	End
Item	Vegetation			38.200658 °	38.186464 °
				-121.544711 °	-121.562550 °
DWR ID	DWR_RD0556_01_s_2013_67				
Action/Comments					
Remove the wild growth other than native grasses from the levee slopes.					
Inspector Comments: Remove the wild weed growth and Arundo from the waterside levee section.

Unwanted tall weeds along with Arundo present on the waterside slope.

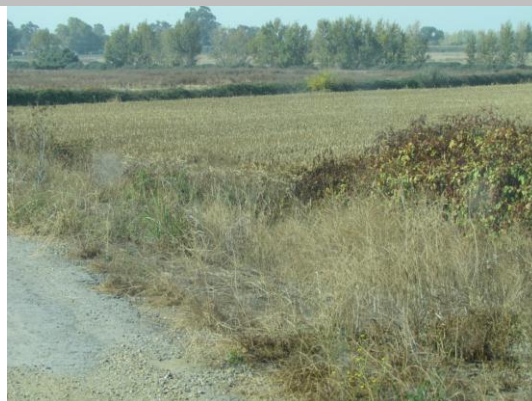
Photo 1 of 1 : FA_2014_RD0556_18_66_20141113_00028.jpg

Unwanted tall weeds and berries growing on the landside slope and toe.

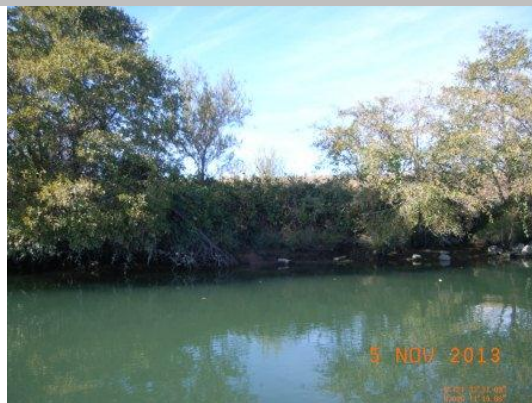
Photo 1 of 1 : FA_2014_RD0556_18_16_20141030_00003.jpg

LM Start	5.11	Rating **	M	Issue No.	16
LM End	5.28	Issue Type +	Ma	Location *	WS
Category	Supplemental			GPS Latitude/Longitude	
				Start	End
Item	USACE Erosion Survey			38.189775 °	38.187967 °
				-121.557729 °	-121.559572 °
DWR ID	DWR_RD0556_01_f_2014_16				
Action/Comments					
Inspector Comments: 1997 - Toe damaged rock. 1999 - One pocket filled with gravel. 2000 - Eroding beach with some biotech rolls and stakes; some gravel on slope. 2001 - Staked, low fascine walls at bankline. 2005 - Stone revetment in between pockets. 2006 - New rock on upper slope behind brush boxes at the upstream end, Stone is sliding off the hard toe. 2013: No observed changes. [2013 Site ID: GEO_7-0_R]

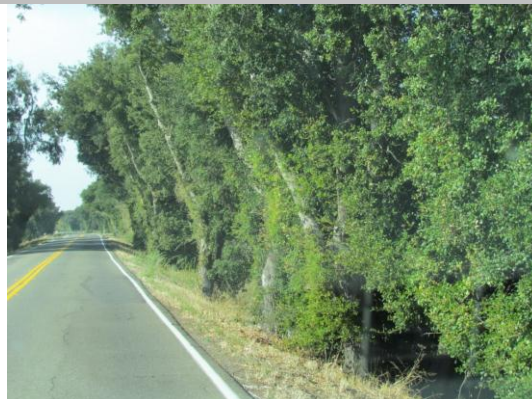
Photo 1 of 1 : FA_2014_RD0556_19_32_20141113_00026.jpg

Woody tree growth on the waterside levee section.

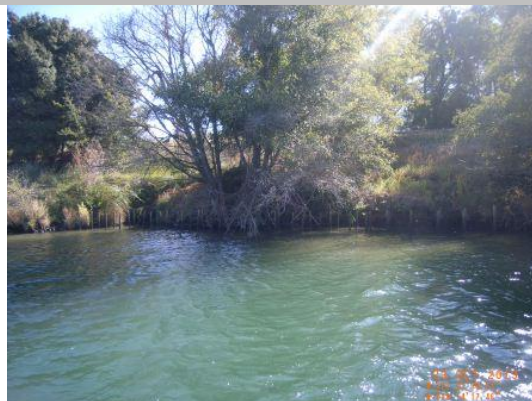
Photo 1 of 1 : FA_2014_RD0556_19_28_20141030_00010.jpg

LM Start	0.31	Rating **	M	Issue No.	28
LM End	0.60	Issue Type +	Ma	Location *	WS
Category	Supplemental			GPS Latitude/Longitude	
				Start	End
Item	USACE Erosion Survey			38.238784 °	38.237862 °
				-121.523932 °	-121.529188 °
DWR ID	DWR_RD0556_02_f_2014_28				
Action/Comments					
Inspector Comments: 2002 - Two rocked sections (150 ft long) at the downstream end. 2005 - Lots of old brush boxes, some with established vegetation in the area behind the boxes. 2006 - Some small spots fixed with stone. 2009 - Minimal new erosion, rock in the middle of the reach may be new. 2011 - Minor new erosion at the toe. 2013: Minor new erosion. [2013 Site ID: SAC_26-0_L]

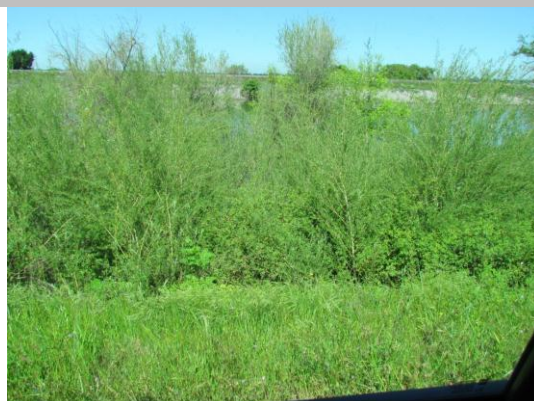
Photo 1 of 1 : FA_2014_RD0556_19_69_20141030_00013.jpg

Unwanted wild growth on the water side slope and toe. No new photo taken during Fall inspection 2014.

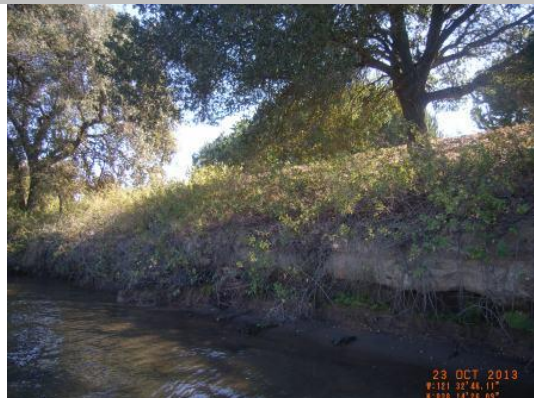
Photo 1 of 1 : FA_2014_RD0556_19_26_20141030_00008.jpg

LM Start	1.45	Rating **	M	Issue No.	26
LM End	1.59	Issue Type +	Ma	Location *	WS
Category	Supplemental			GPS Latitude/Longitude	
				Start	End
Item	USACE Erosion Survey			38.240401 °	38.240772 °
				-121.544106 °	-121.546791 °
DWR ID	DWR_RD0556_02_f_2014_26				
Action/Comments					
Inspector Comments: 1997 - Slow erosion of the berm at the waterline; bench below water. 2005 - Brush boxes present. 2010 - Minor new erosion. 2013: There is little to no berm remaining at downstream end of this site. [2013 Site ID: SAC_24-8_L]

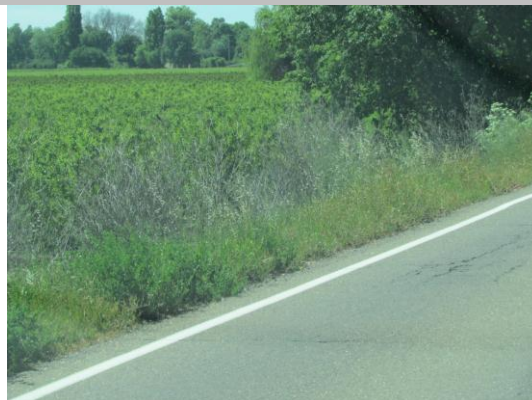
Photo 1 of 1 : FA_2014_RD0556_19_71_20141030_00014.jpg

Wild growth on landward levee section greater than 4-foot tall covering the levee slope and toe. No new photo Fall 2014.

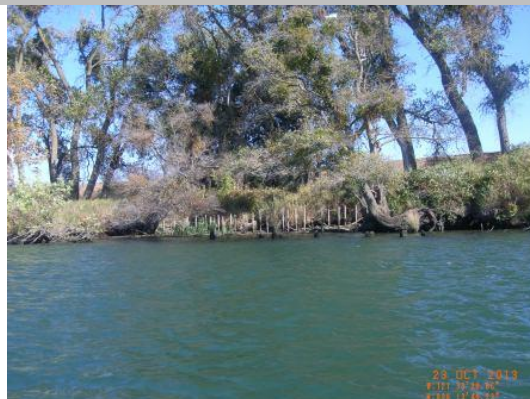
Photo 1 of 1 : FA_2014_RD0556_19_25_20141030_00007.jpg

LM Start	2.96	Rating **	M	Issue No.	25
LM End	3.02	Issue Type +	Ma	Location *	WS
Category	Supplemental			GPS Latitude/Longitude	
				Start	End
Item	USACE Erosion Survey			38.228202 °	38.226601 °
				-121.555502 °	-121.555605 °
DWR ID	DWR_RD0556_02_f_2014_25				
Action/Comments					
Inspector Comments: 1997 - Few scallops in berm, some getting close to levee toe. 2005 - Brush boxes present. 2012 - More erosion of the toe since last year. 2013: No observed changes. [2013 Site ID: SAC_23-3_L]

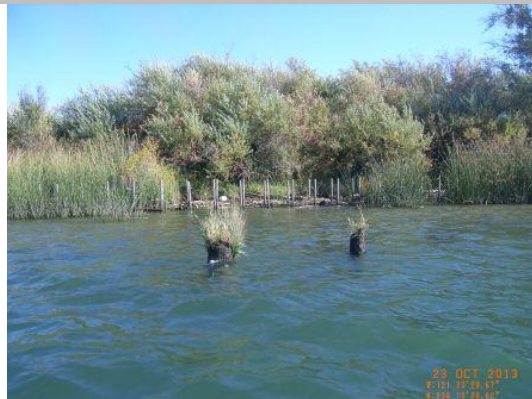
Photo 1 of 1 : FA_2014_RD0556_19_23_20141030_00005.jpg

LM Start	3.16	Rating **	M	Issue No.	23
LM End	3.25	Issue Type +	Ma	Location *	WS
Category	Supplemental			GPS Latitude/Longitude	
				Start	End
Item	USACE Erosion Survey			38.224850 °	38.223233 °
				-121.555641 °	-121.555687 °
DWR ID	DWR_RD0556_02_f_2014_23				
Action/Comments					
Inspector Comments: 2000 - Recently fallen cottonwood at the downstream end. 2005 - Empty brush boxes. 2011 - A few trees have fallen since last year. 2012 - Potential new tree popout since last year. 2013: New erosion at downstream end of site and a recent tree pop-out observed. [2013 Site ID: SAC_23-2_L]

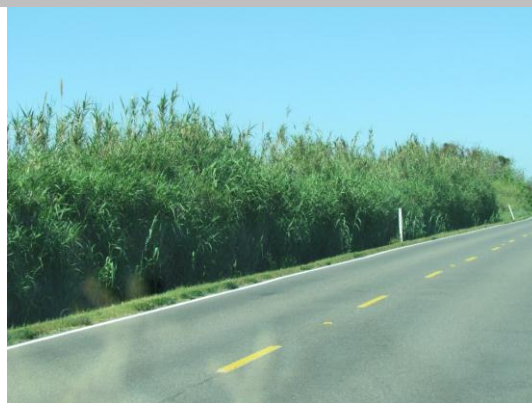
Photo 1 of 1 : FA_2014_RD0556_19_35_20141030_00011.jpg

Unsatisfactory wild growth of bambo blocking view of the levee section on the waterside shoulder and slope. No new photo.

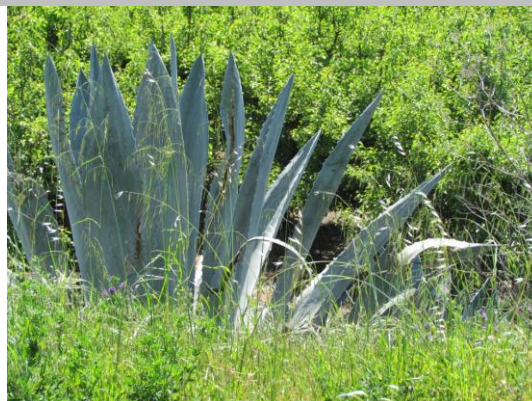
Photo 1 of 1 : FA_2014_RD0556_19_59_20141030_00012.jpg

Unsatisfactory growth on landward levee.
