**Flood Control Project Maintenance  
Levee Inspections**

## Maintenance Issue Types Only, Levee Inspection Report By Mile - Fall 2015

### Reclamation District No. 0556 Upper Andrus

Waterway	Bank	Unit Miles	Inspection Start/End	Inspector
Unit No. 01 Georgiana Slough	Right	5.48	09/25/2015 09/25/2015	Herman Phillips

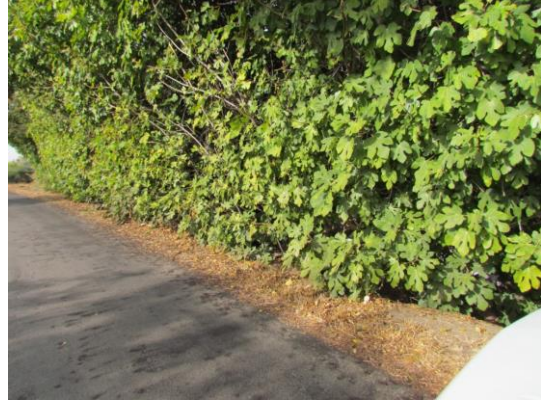
Photo 1 of 1 : FA\_2015\_RD0556\_18\_376\_20150915\_00018.jpg

LM Start	0.68	Rating **	U	Issue No.	376
LM End	0.90	Issue Type +	Ma	Location *	LS
Category	Earthen Levee			GPS Latitude/Longitude	
				Start	End
Item	Vegetation			38.230785 °	38.228602 °
				-121.523470 °	-121.526289 °
DWR ID	DWR_RD0556_01_s _ 2014_376				
Action/Comments					
Trees / Woody Vegetation					
Inspector Comments: District should remove these unwanted fig trees from the landside slope, unable to see ground.

Remove unwanted fig trees present on the landside slope.

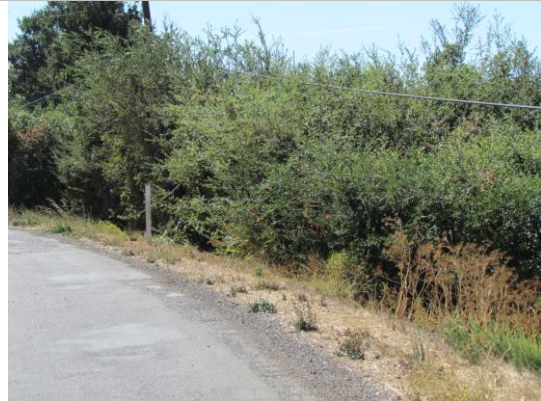
Photo 1 of 1 : FA\_2015\_RD0556\_18\_10\_20151007\_00029.jpg

LM Start	0.93	Rating **	U	Issue No.	10
LM End	1.54	Issue Type +	Ma	Location *	LS
Category	Earthen Levee			GPS Latitude/Longitude	
				Start	End
Item	Trim / Thin Trees			38.228295 °	38.225368 °
				-121.526688 °	-121.534677 °
DWR ID	DWR_RD0556_01_f _ 2015_10				
Action/Comments					
Trim trees to at least five feet above ground level. Inspector Comments: Remove the woody tree growth from the landside levee section.

Unsatisfactory woody tree growth on the landside shoulder and slope.

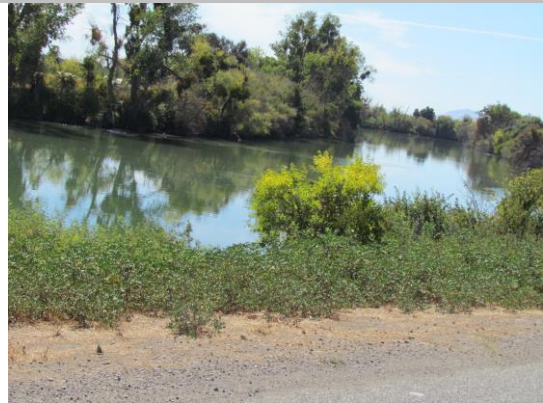
Photo 1 of 1 : FA\_2015\_RD0556\_18\_71\_20151006\_00022.jpg

LM Start	1.37	Rating **	U	Issue No.	71
LM End	1.55	Issue Type +	Ma	Location *	WS
Category	Earthen Levee			GPS Latitude/Longitude	
				Start	End
Item	Vegetation			38.227320 °	38.225285 °
				-121.532710 °	-121.534787 °
DWR ID	DWR_RD0556_01_f_2015_71				
Action/Comments					
Control annual grass and weeds on the levee slopes and easements. Inspector Comments: Remove the unsatisfactory wild growth of roses from the levee section.

Looking downstream from levee mile 1.27- 1.55 wild roses on waterside slope and berm.

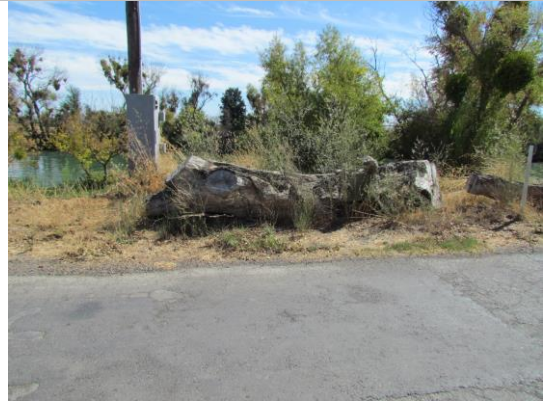
Photo 1 of 1 : FA\_2015\_RD0556\_18\_9\_20151006\_00025.jpg

LM Start	1.55	Rating **	U	Issue No.	9
LM End	1.57	Issue Type +	Ma	Location *	WS
Category	Earthen Levee			GPS Latitude/Longitude	
				Start	End
Item	Encroachments			38.225191 °	38.224976 °
				-121.534799 °	-121.535043 °
DWR ID	DWR_RD0556_01_s_2012_9				
Action/Comments					
Tree or limb					
Inspector Comments: These cut up tree sections remain on the waterward slope. The owner is on the Reclamation District's Board, Mr. Silva said he will ask him to remove the encroachment.

Unsatisfactory dumping of cut up tree sections on the waterside levee shoulder.

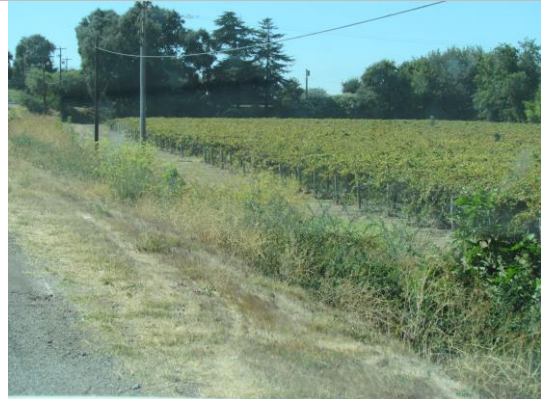
Photo 1 of 1 : FA\_2015\_RD0556\_18\_73\_20151006\_00026.jpg

LM Start	1.72	Rating **	U	Issue No.	73
LM End	1.95	Issue Type +	Ma	Location *	LS
Category	Earthen Levee			GPS Latitude/Longitude	
				Start	End
Item	Vegetation			38.224283 °	38.223678 °
				-121.537625 °	-121.541652 °
DWR ID	DWR_RD0556_01_f_2015_73				
Action/Comments					
Control annual grass and weeds on the levee slopes and easements. Inspector Comments: Remove this unwanted weed growth from the levee slope.

Looking downstream from landside levee mile 1.72-1.95 unsatisfactory tall weed growth on the slope and toe.

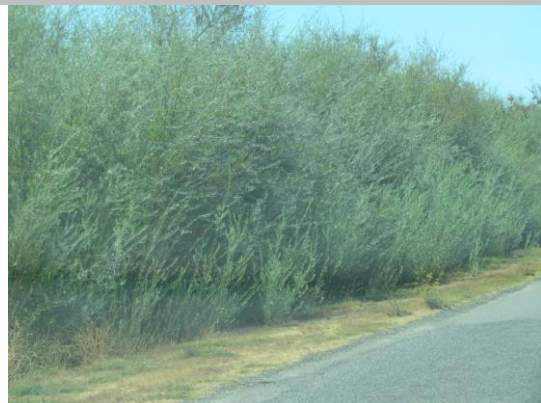
Photo 1 of 1 : FA\_2015\_RD0556\_18\_74\_20151006\_00027.jpg

LM Start	1.74	Rating **	U	Issue No.	74
LM End	2.29	Issue Type +	Ma	Location *	WS
Category	Earthen Levee			GPS Latitude/Longitude	
				Start	End
Item	Vegetation			38.224198 °	38.220317 °
				-121.537987 °	-121.544172 °
DWR ID	DWR_RD0556_01_f_2015_74				
Action/Comments					
Trees / Woody Vegetation					
Inspector Comments: This arundo needs to be removed, this vegetation blocks the view of the waterside slope.

Levee mile 1.74-2.00 waterside wild growth of arundo present on levee shoulder and slope, unable to see the ground.

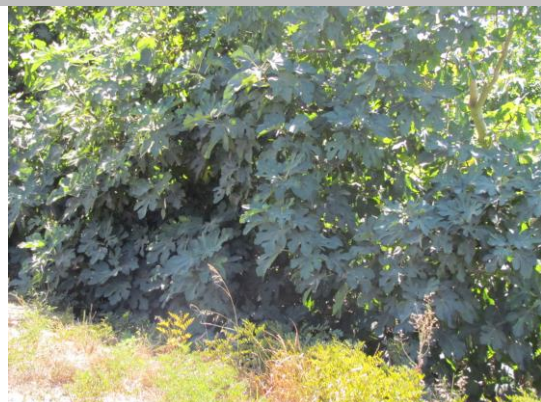
Photo 1 of 1 : FA\_2015\_RD0556\_18\_24\_20151007\_00028.jpg

LM Start	2.32	Rating **	U	Issue No.	24
LM End	2.34	Issue Type +	Ma	Location *	LS
Category	Earthen Levee			GPS Latitude/Longitude	
				Start	End
Item	Vegetation			38.219822 °	38.219592 °
				-121.544000 °	-121.543927 °
DWR ID	DWR_RD0556_01_s_2012_24				
Action/Comments					
Trees / Woody Vegetation					
Inspector Comments: Unable to see the levee section for heavy growth of trees. Remove them or thin them out so the ground can be seen.

Unsatisfactory woody tree growth of Fig trees blocking the view of both the shoulder and slope landward.

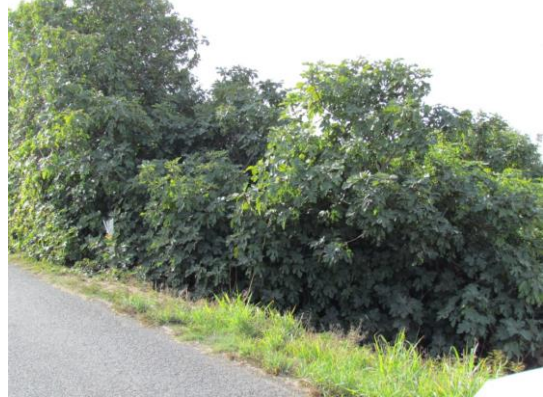
Photo 1 of 1 : FA\_2015\_RD0556\_18\_47\_20150915\_00009.jpg

LM Start	2.42	Rating **	U	Issue No.	47
LM End	2.46	Issue Type +	Ma	Location *	LS
Category	Earthen Levee			GPS Latitude/Longitude	
				Start	End
Item	Vegetation			38.218426 °	38.217846 °
				-121.543800 °	-121.543796 °
DWR ID	DWR_RD0556_01_f_2012_47				
Action/Comments					
Trees / Woody Vegetation					
Inspector Comments: This section of trees need to be removed from levee section, visibility completely blocked.

Unsatisfactory tree growth completely blocking visibility of the levee section at this location.

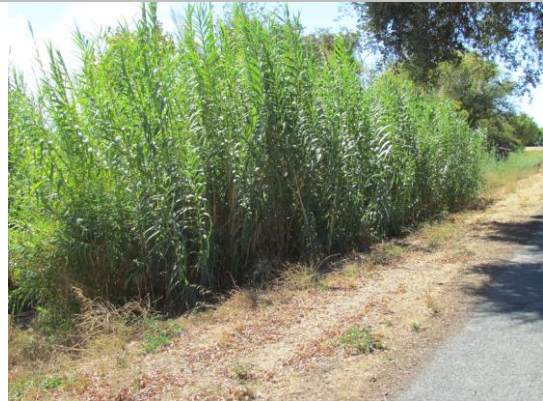
Photo 1 of 1 : FA\_2015\_RD0556\_18\_78\_20151007\_00039.jpg

LM Start	3.12	Rating **	U	Issue No.	78
LM End	3.15	Issue Type +	Ma	Location *	WS
Category	Earthen Levee			GPS Latitude/Longitude	
				Start	End
Item	Vegetation			38.211090 °	38.210927 °
				-121.537983 °	-121.538473 °
DWR ID	DWR_RD0556_01_f_2015_78				
Action/Comments					
Control annual grass and weeds on the levee slopes and easements. Inspector Comments: Remove the arundo from the levee slope waterside.

Looking downstream from waterside shoulder, arundo blocking view of levee section.

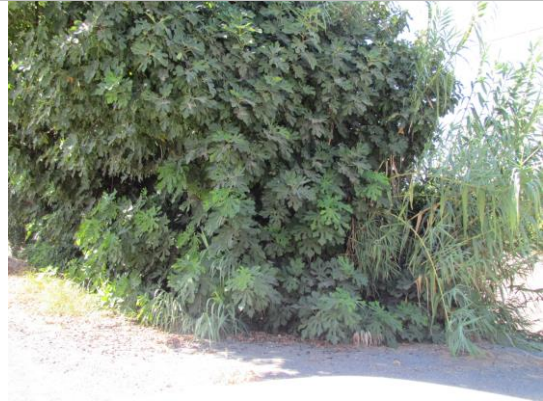
Photo 1 of 1 : FA\_2015\_RD0556\_18\_79\_20151007\_00038.jpg

LM Start	3.17	Rating **	U	Issue No.	79
LM End	3.28	Issue Type +	Ma	Location *	LS
Category	Earthen Levee			GPS Latitude/Longitude	
				Start	End
Item	Vegetation			38.210823 °	38.209983 °
				-121.538813 °	-121.540533 °
DWR ID	DWR_RD0556_01_f_2015_79				
Action/Comments					
Remove the wild growth other than native grasses from the levee slopes.					
Inspector Comments: Remove the unsatisfactory growth of vegetation from the levee section.

Unsatisfactory woody tree growth and arundo blocking view of landside levee shoulder and slope.

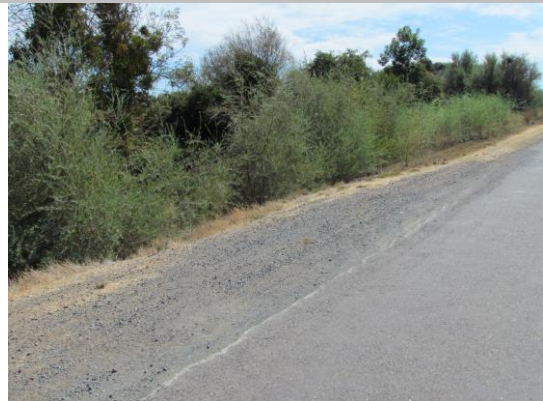
Photo 1 of 1 : FA\_2015\_RD0556\_18\_80\_20151007\_00037.jpg

LM Start	3.32	Rating **	U	Issue No.	80
LM End	3.92	Issue Type +	Ma	Location *	WS
Category	Earthen Levee			GPS Latitude/Longitude	
				Start	End
Item	Vegetation			38.209497 °	38.201645 °
				-121.540917 °	-121.542198 °
DWR ID	DWR_RD0556_01_f_2015_80				
Action/Comments					
Remove the wild growth other than native grasses from the levee slopes.					
Inspector Comments: Remove this unsatisfactory growth from the waterside so the slope can be inspected.

Looking downstream from levee mile 3.32-3.92 waterside unsatisfactory growth of willows blocks the view of the slope.

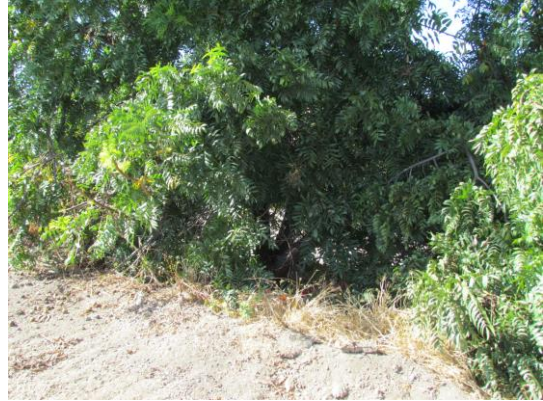
Photo 1 of 1 : FA\_2015\_RD0556\_18\_83\_20151007\_00034.jpg

Looking downstream from the landside slope unsatisfactory woody tree growth blocking view of levee section.

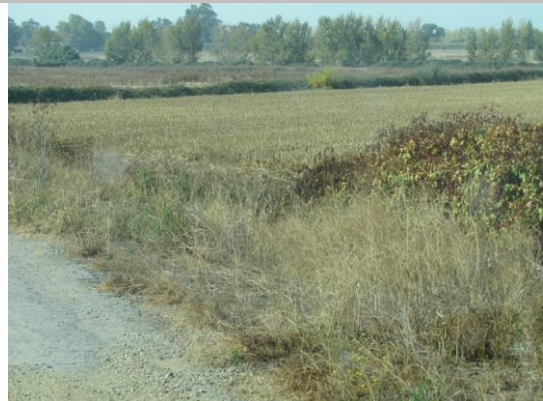
Photo 1 of 1 : FA\_2015\_RD0556\_18\_66\_20150915\_00012.jpg

Unwanted tall weeds and berries growing on the landside slope and toe.

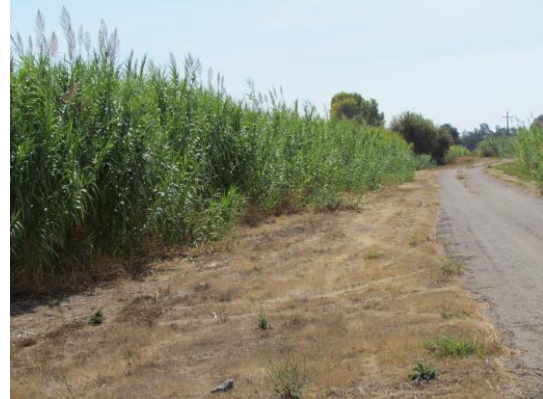
Photo 1 of 1 : FA\_2015\_RD0556\_18\_67\_20151007\_00032.jpg

Looking downstream on waterside the arundo completely covering the levee section.

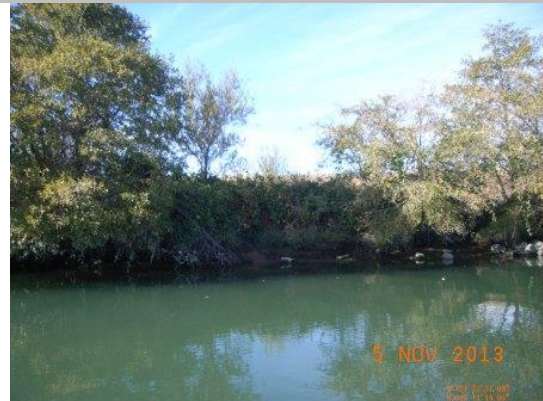
Photo 1 of 1 : USACE2013A\_GEO\_7-0\_R\_7.jpg

LM Start	5.12	Rating **	M	Issue No.	1
LM End	5.27	Issue Type +	Ma	Location *	WS
Category	Supplemental			GPS Latitude/Longitude	
				Start	End
Item	2015 USACE Erosion Survey, DRAFT			38.189775 °	38.188121 °
				-121.557729 °	-121.559413 °
DWR ID					
Action/Comments					
Inspector Comments: 1997 - Toe damaged rock. 1999 - One pocket filled with gravel. 2000 - Eroding beach with some biotech rolls and stakes; some gravel on slope. 2001 - Staked, low fascine walls at bankline. 2005 - Stone revetment in between pockets. 2006 - New rock on upper slope behind brush boxes at the upstream end, Stone is sliding off the hard toe. 2015: Last observed in 2013. [2015 Site ID: GEO_7-0_R]

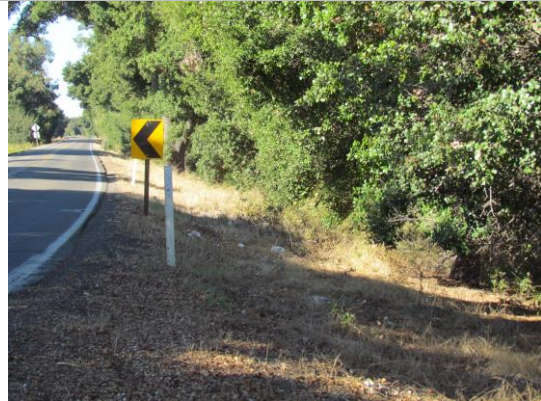
Photo 1 of 1 : FA\_2015\_RD0556\_19\_82\_20151106\_00028.jpg

RD 556 Levee mile 0.00 waterside looking downstream.

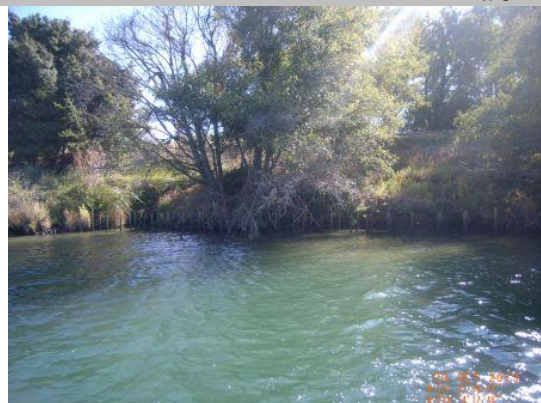
Photo 1 of 1 : USACE2013A\_SAC\_26-0\_L\_18.jpg

LM Start	0.31	Rating **	M	Issue No.	12
LM End	0.60	Issue Type +	Ma	Location *	WS
Category	Supplemental			GPS Latitude/Longitude	
				Start	End
Item	2015 USACE Erosion Survey, DRAFT			38.238784 °	38.237862 °
				-121.523932 °	-121.529188 °
DWR ID					
Action/Comments					
Inspector Comments: 2002 - Two rocked sections (150 ft long) at the downstream end. 2005 - Lots of old brush boxes, some with established vegetation in the area behind the boxes. 2006 - Some small spots fixed with stone. 2009 - Minimal new erosion, rock in the middle of the reach may be new. 2011 - Minor new erosion at the toe. 2013 - Minor new erosion. 2015: Site is currently under construction. [2015 Site ID: SAC_26-0_L]

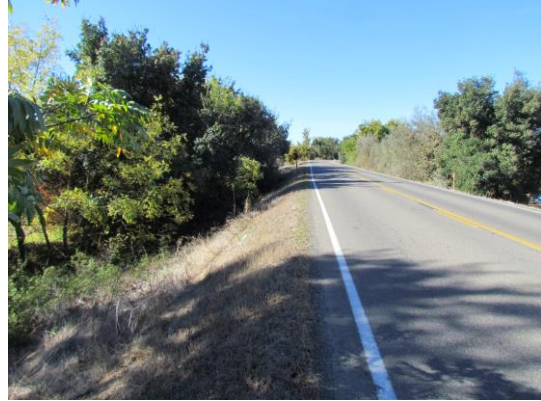
Photo 1 of 1 : FA\_2015\_RD0556\_19\_66\_20151106\_00030.jpg

Looking downstream from the landside levee slope levee mile ,0.57.

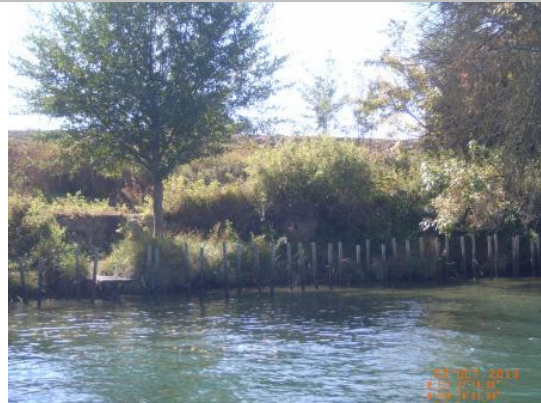
Photo 1 of 1 : USACE2013A\_SAC\_25-2\_L\_9.jpg

LM Start	1.03	Rating **	M	Issue No.	2
LM End	1.15	Issue Type +	Ma	Location *	WS
Category	Supplemental			GPS Latitude/Longitude	
				Start	End
Item	2015 USACE Erosion Survey, DRAFT			38.238772 °	38.239265 °
				-121.536788 °	-121.538845 °
DWR ID					
Action/Comments					
Inspector Comments: 1997 - Rock is in poor condition and has failed in many places. Scallops in berm with remnants of old rock in the toe area. 2005 - Brush boxes present. 2013 - Site extended upstream approximately 300 ft to include new erosion pockets. 2015: Minor new erosion at toe. [2015 Site ID: SAC_25-2_L]

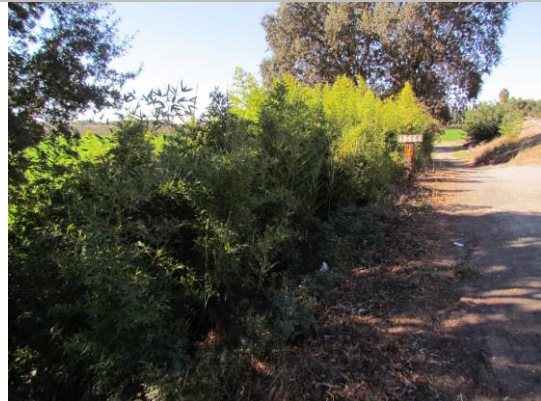
Photo 1 of 1 : FA\_2015\_RD0556\_19\_76\_20151106\_00031.jpg

LM Start	1.35	Rating **	U	Issue No.	76
LM End	1.37	Issue Type +	Ma	Location *	LS
Category	Earthen Levee			GPS Latitude/Longitude	
				Start	End
Item	Vegetation			38.239820 °	38.239905 °
				-121.542502 °	-121.542778 °
DWR ID	DWR_RD0556_02_f_2015_76				
Action/Comments					
Control annual grass and weeds on the levee slopes and easements. Inspector Comments: Remove the bambo from the landside levee slope.

Unsatisfactory growth of bambo on the landside shoulder.

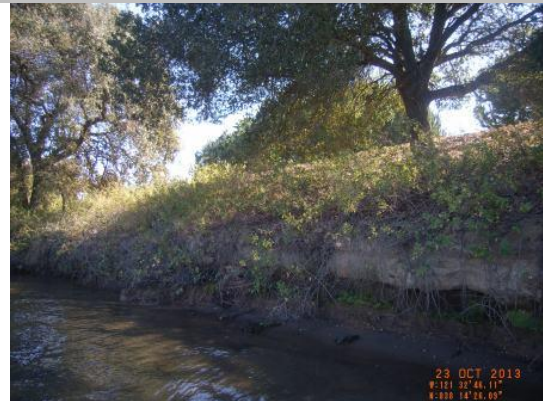
Photo 1 of 1 : USACE2013A\_SAC\_24-8\_L\_9.jpg

LM Start	1.45	Rating **	M	Issue No.	5
LM End	1.59	Issue Type +	Ma	Location *	WS
Category	Supplemental			GPS Latitude/Longitude	
				Start	End
Item	2015 USACE Erosion Survey, DRAFT			38.240401 °	38.240772 °
				-121.544106 °	-121.546791 °
DWR ID					
Action/Comments					
Inspector Comments: 1997 - Slow erosion of the berm at the waterline; bench below water. 2005 - Brush boxes present. 2010 - Minor new erosion. 2013 - There is little to no berm remaining at downstream end of this site. 2015: No observed changes. [2015 Site ID: SAC_24-8_L]

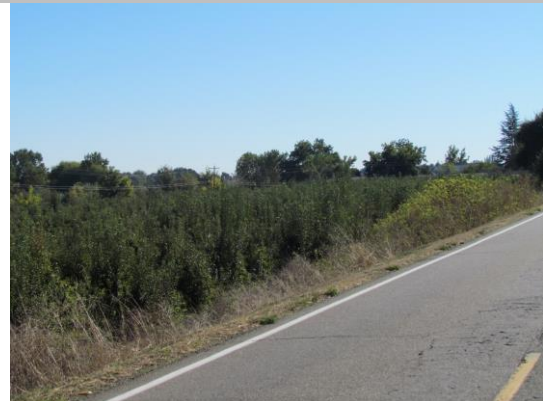
Photo 1 of 1 : FA\_2015\_RD0556\_19\_80\_20151106\_00033.jpg

LM Start	2.61	Rating **	U	Issue No.	80
LM End	3.40	Issue Type +	Ma	Location *	LS
Category	Earthen Levee			GPS Latitude/Longitude	
				Start	End
Item	Vegetation			38.232545 °	38.221512 °
				-121.557112 °	-121.555715 °
DWR ID	DWR_RD0556_02_f_2015_80				
Action/Comments					
Control annual grass and weeds on the levee slopes and easements. Inspector Comments: Remove the wild growth from the landside levee slope.

Looking downstream landside at wild roses bamboo and other growth covering the slope.

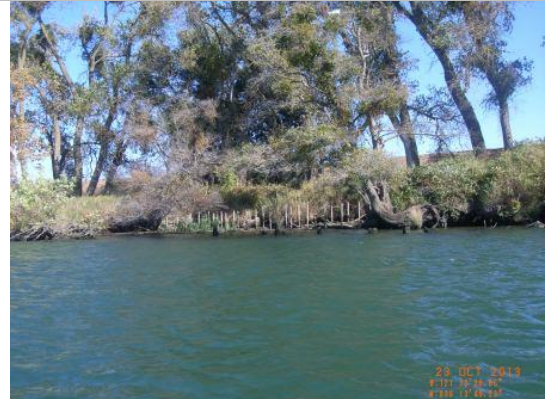
Photo 1 of 1 : USACE2013A\_SAC\_23-3\_L\_2.jpg

LM Start	2.93	Rating **	M	Issue No.	11
LM End	3.04	Issue Type +	Ma	Location *	WS
Category	Supplemental			GPS Latitude/Longitude	
				Start	End
Item	2015 USACE Erosion Survey, DRAFT			38.228202 °	38.226601 °
				-121.555502 °	-121.555605 °
DWR ID					
Action/Comments					
Inspector Comments: 1997 - Few scallops in berm, some getting close to levee toe. 2005 - Brush boxes present. 2012 - More erosion of the toe since last year. 2015: No observed changes. [2015 Site ID: SAC_23-3_L]

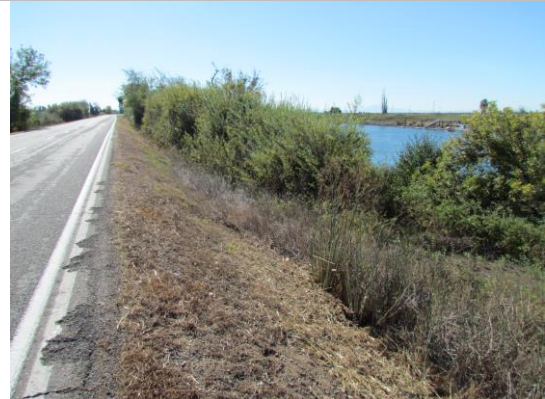
Photo 1 of 1 : FA\_2015\_RD0556\_19\_84\_20151106\_00032.jpg

LM Start	3.16	Rating **	U	Issue No.	84
LM End	5.58	Issue Type +	Ma	Location *	WS
Category	Earthen Levee			GPS Latitude/Longitude	
				Start	End
Item	Vegetation			38.224918 °	38.192550 °
				-121.555422 °	-121.565230 °
DWR ID	DWR_RD0556_02_f_2015_84				
Action/Comments					
Control annual grass and weeds on the levee slopes and easements.					
Inspector Comments: Control

Looking downstream from the waterside levee slope at the bambo and other unsatisfactory weeds covering the levee slope from 3.16 to 5.58.

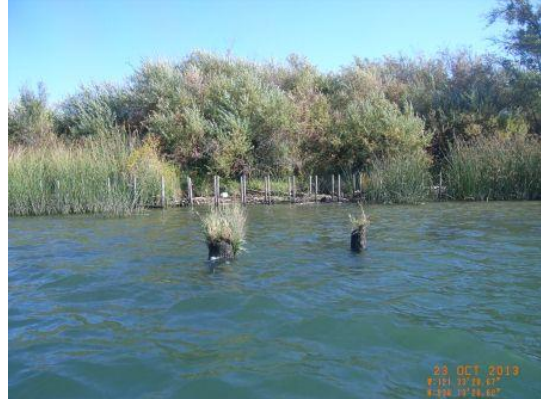
Photo 1 of 1 : USACE2013A\_SAC\_23-2\_L\_4.jpg

LM Start	3.17	Rating **	M	Issue No.	10
LM End	3.28	Issue Type +	Ma	Location *	WS
Category	Supplemental			GPS Latitude/Longitude	
				Start	End
Item	2015 USACE Erosion Survey, DRAFT			38.224850 °	38.223233 °
				-121.555641 °	-121.555687 °
DWR ID					
Action/Comments					
Inspector Comments: 2000 - Recently fallen cottonwood at the downstream end. 2005 - Empty brush boxes. 2011 - A few trees have fallen since last year. 2012 - Potential new tree popout since last year. 2013 - New erosion at downstream end of site and a recent tree pop-out observed. 2015: No observed changes. [2015 Site ID: SAC_23-2_L]

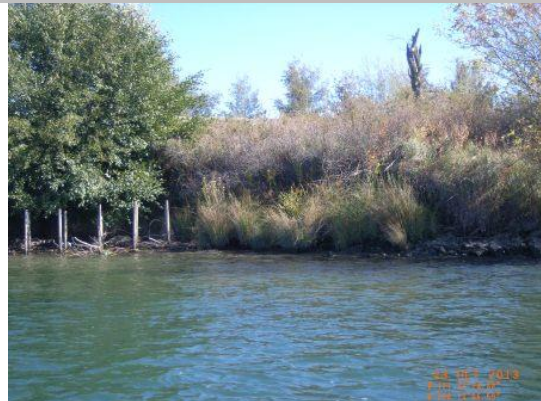
Photo 1 of 1 : USACE2013A\_SAC\_22-7\_L\_5.jpg

LM Start	3.58	Rating **	M	Issue No.	8
LM End	3.64	Issue Type +	Ma	Location *	WS
Category	Supplemental			GPS Latitude/Longitude	
				Start	End
Item	2015 USACE Erosion Survey, DRAFT			38.218951 °	38.218104 °
				-121.556689 °	-121.556819 °
DWR ID					
Action/Comments					
Inspector Comments: 1997 - Scallops into berm and very close to levee toe. 2005 - Brush boxes present. 2011 - New toe scour and freshly fallen tree. 2012 - New tree popout has taken significant portion of soil out of the levee. 2015: No observed changes. [2015 Site ID: SAC_22-7_L]

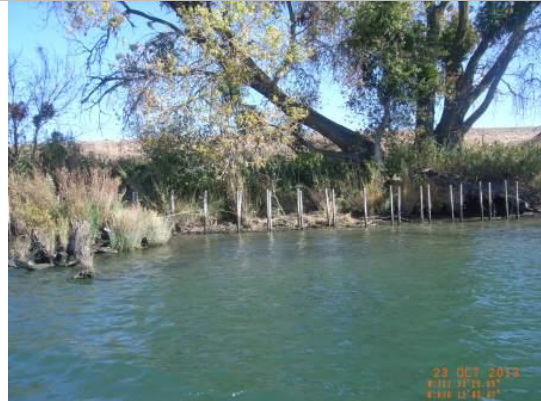
Photo 1 of 1 : USACE2013A\_SAC\_22-5\_L\_13.jpg

LM Start	3.95	Rating **	M	Issue No.	4
LM End	4.12	Issue Type +	Ma	Location *	WS
Category	Supplemental			GPS Latitude/Longitude	
				Start	End
Item	2015 USACE Erosion Survey, DRAFT			38.213581 °	38.211112 °
				-121.557197 °	-121.557042 °
DWR ID					
Action/Comments					
Inspector Comments: 2002 - Spot rock along berm, but not in the erosion pockets. 2005 - Some new minor stone revetment at the upstream end. Brush boxes present. 2006 - Currently installing new brush in downstream brush boxes. 2007 - Rock in middle portion for about 150 ft. 2010 - Some attempt at repairs but still has pockets of erosion. 2012 - More erosion along the toe. 2015: No observed changes. [2015 Site ID: SAC_22-5_L]

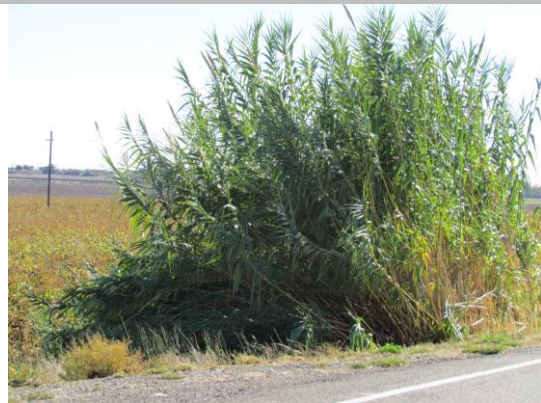
Photo 1 of 1 : FA\_2015\_RD0556\_19\_86\_20151110\_00034.jpg

LM Start	3.99	Rating **	U	Issue No.	86
LM End	3.99	Issue Type +	Ma	Location *	LS
Category	Earthen Levee			GPS Latitude/Longitude	
				Start	End
Item	Vegetation			38.212918 °	38.212918 °
				-121.556848 °	-121.556848 °
DWR ID	DWR_RD0556_02_f_2015_86				
Action/Comments					
Remove the wild growth other than native grasses from the levee slopes.					
Inspector Comments: Remove the patch of bamboo from the landside shoulder.

Landside levee shoulder levee mile 3.99 RD 556 Unit 2.

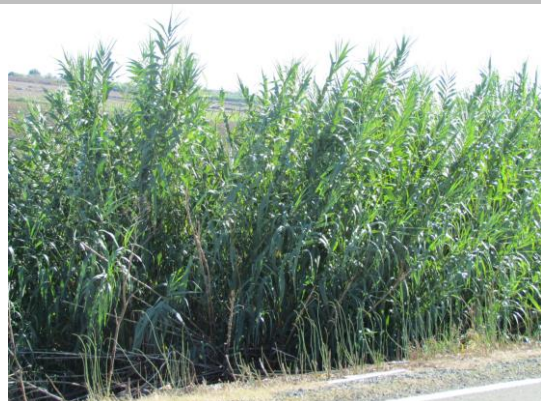
Photo 1 of 1 : FA\_2015\_RD0556\_19\_87\_20151110\_00035.jpg

LM Start	4.21	Rating **	U	Issue No.	87
LM End	4.22	Issue Type +	Ma	Location *	LS
Category	Earthen Levee			GPS Latitude/Longitude	
				Start	End
Item	Vegetation			38.209818 °	38.209638 °
				-121.556818 °	-121.556835 °
DWR ID	DWR_RD0556_02_f_2015_87				
Action/Comments					
Remove the wild growth other than native grasses from the levee slopes.					
Inspector Comments: Remove the unsatisfactory patch of bamboo from the landside levee shoulder and slope.

RD 556 Unit 2 looking downstream from the landside shoulder levee miles 4.21-4.22.

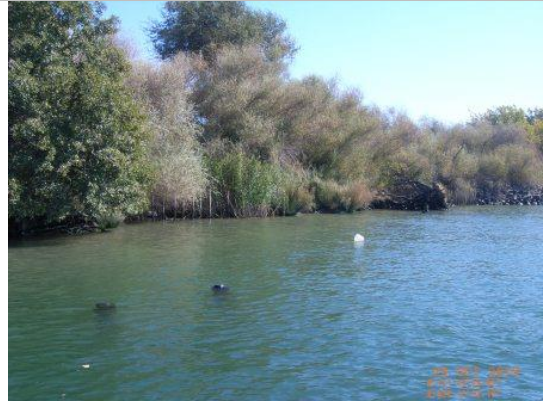
Photo 1 of 1 : USACE2013A\_SAC\_21-9\_L\_5.jpg

LM Start	4.45	Rating **	M	Issue No.	7
LM End	4.49	Issue Type +	Ma	Location *	WS
Category	Supplemental			GPS Latitude/Longitude	
				Start	End
Item	2015 USACE Erosion Survey, DRAFT			38.206377 °	38.205729 °
				-121.557184 °	-121.557108 °
DWR ID					
Action/Comments					
Inspector Comments: 2013 - Erosion pockets encroaching on levee foundation. 2015: No observed changes. [2015 Site ID: SAC_21-9_L]

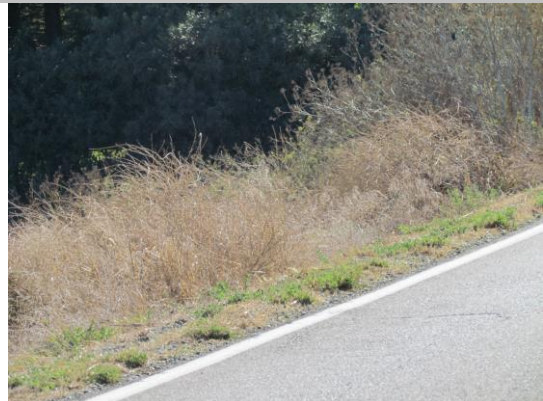
Photo 1 of 1 : FA\_2015\_RD0556\_19\_88\_20151110\_00036.jpg

RD 556 Unit 2 looking downstream from levee miles 4.31 - 5.31 unsatisfactory tall weed growth on the landside levee slope.

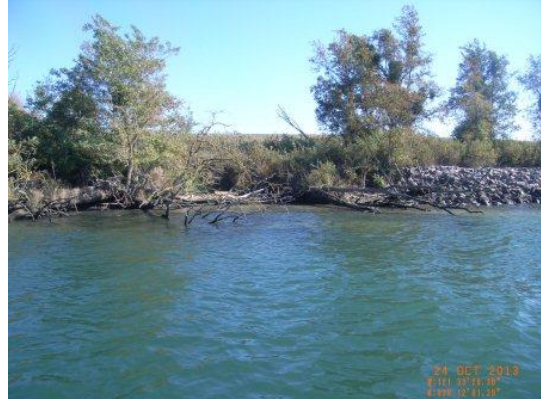
Photo 1 of 1 : USACE2013A\_SAC\_21-5\_L\_2.jpg

LM Start	4.77	Rating **	M	Issue No.	3
LM End	4.88	Issue Type +	Ma	Location *	WS
Category	Supplemental			GPS Latitude/Longitude	
				Start	End
Item	2015 USACE Erosion Survey, DRAFT			38.201687 °	38.200225 °
				-121.557305 °	-121.557749 °
DWR ID					
Action/Comments					
Inspector Comments: 1999 - Downstream 140 ft repaired with rock. 2010 - Lots of woody debris, but no changes to site. 2015: Site extended upstream due to erosion pockets. [2015 Site ID: SAC_21-5_L]
